REPORT

SL 2020/14

REPORT ON THE AIR ACCIDENT AT OSLO AIRPORT GARDERMOEN, NORWAY ON 18 DECEMBER 2018 WITH BOEING 787-9 DREAMLINER, ET-AUP OPERATED BY ETHIOPIAN AIRLINES

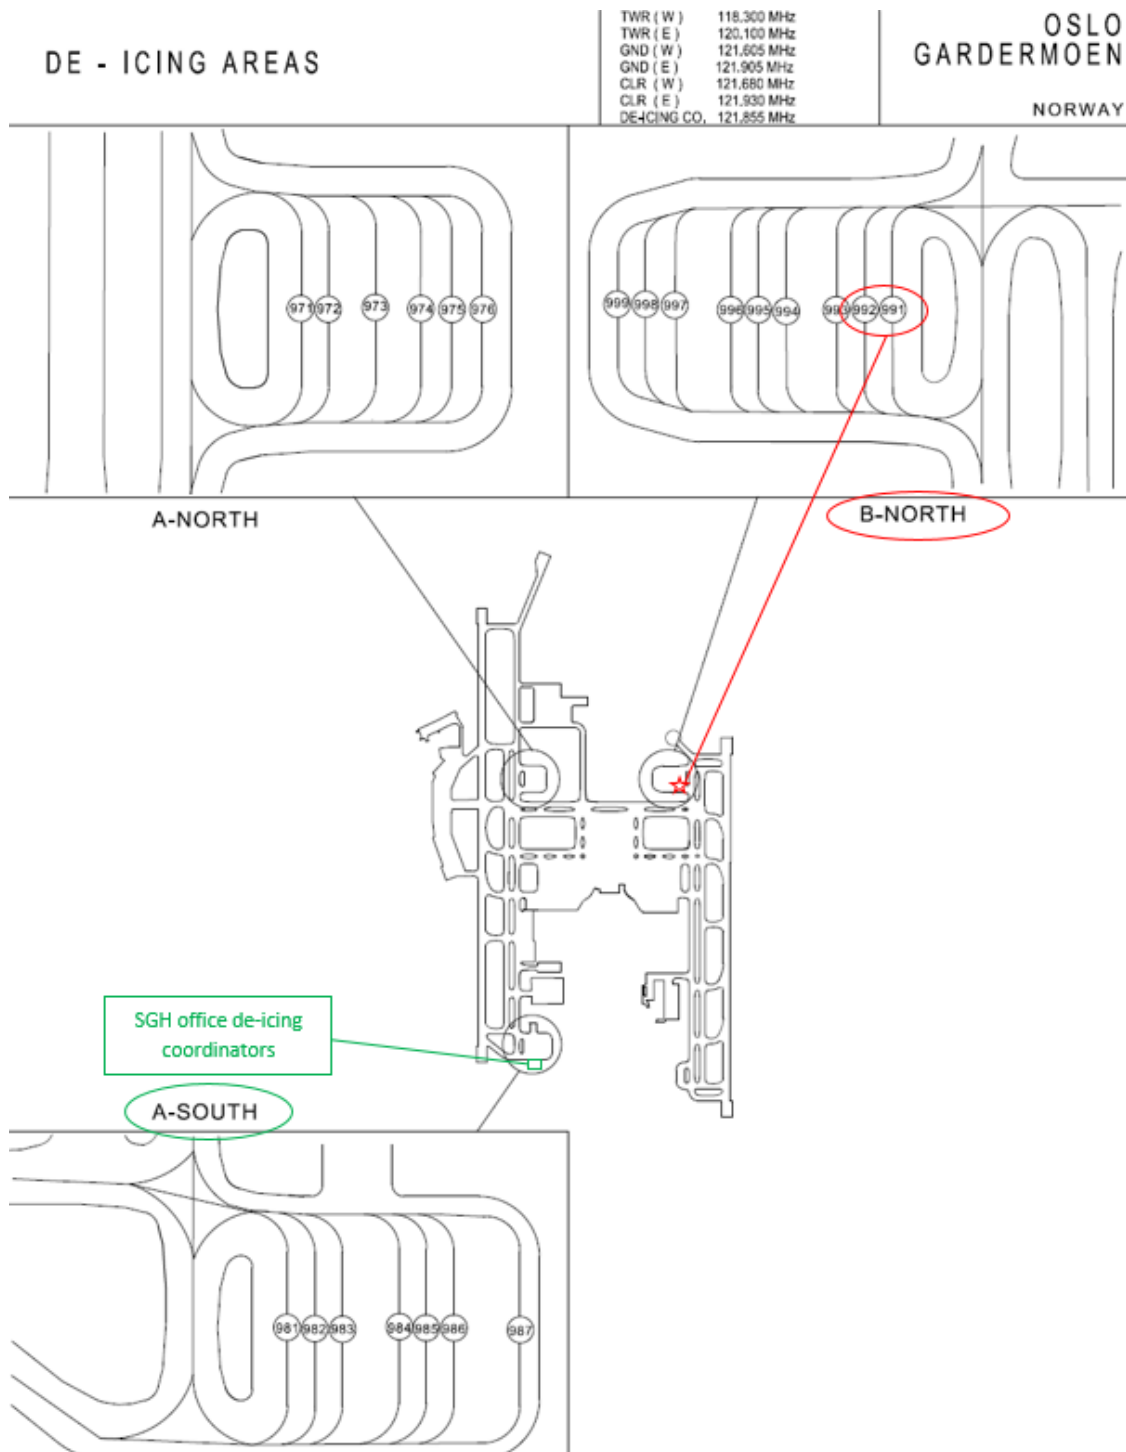
- 1.10.3 There were no electronic systems at the airport to automatically warn of an aircraft taxiing towards the wrong de-icing stand.
- 1.10.4 By way of comparison, at the terminal gates, there is a docking system which monitors and provides information about the nose of the aircraft in relation to its correct position. The system notifies both the crew and the gate personnel in the event of any deviation.

Figure 8: The AIP chart current at the time of the accident shows Oslo Airport Gardermoen with the location of the de-icing areas and the SGH office used by the de-icing coordinators. Source: Avinor. Illustration: AIBN

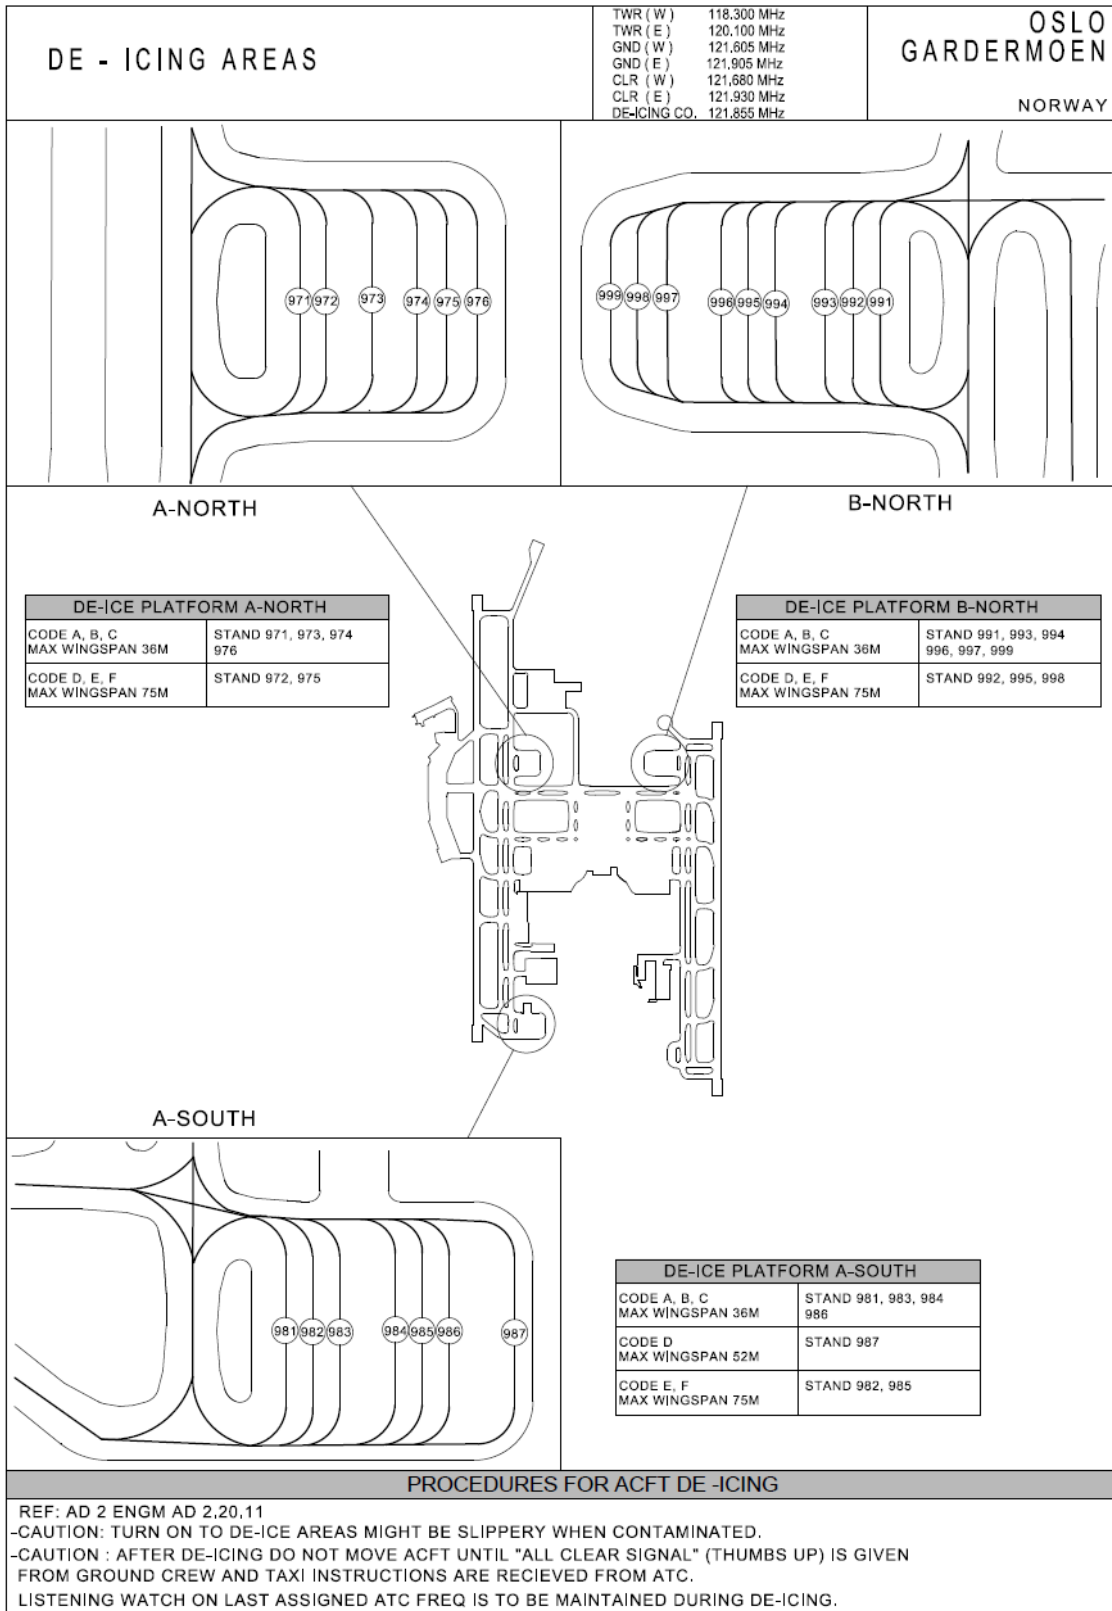
CHANGES: WINGSPAN LIMITATIONS.

Figure 14: Revised AIP chart from October 2019 announcing the maximum allowed wingspan at the various de-icing stands. Source: Avinor

The information above was included in AIP Norway on 10 October 2019 (see Figure 14).
