REPORT

SL 2020/17

REPORT CONCERNING AIR ACCIDENT ON STAVNES, KRAGERØ, NORWAY ON 23 MARCH 2019 INVOLVING A ROBINSON HELICOPTER R44, LN-OGF

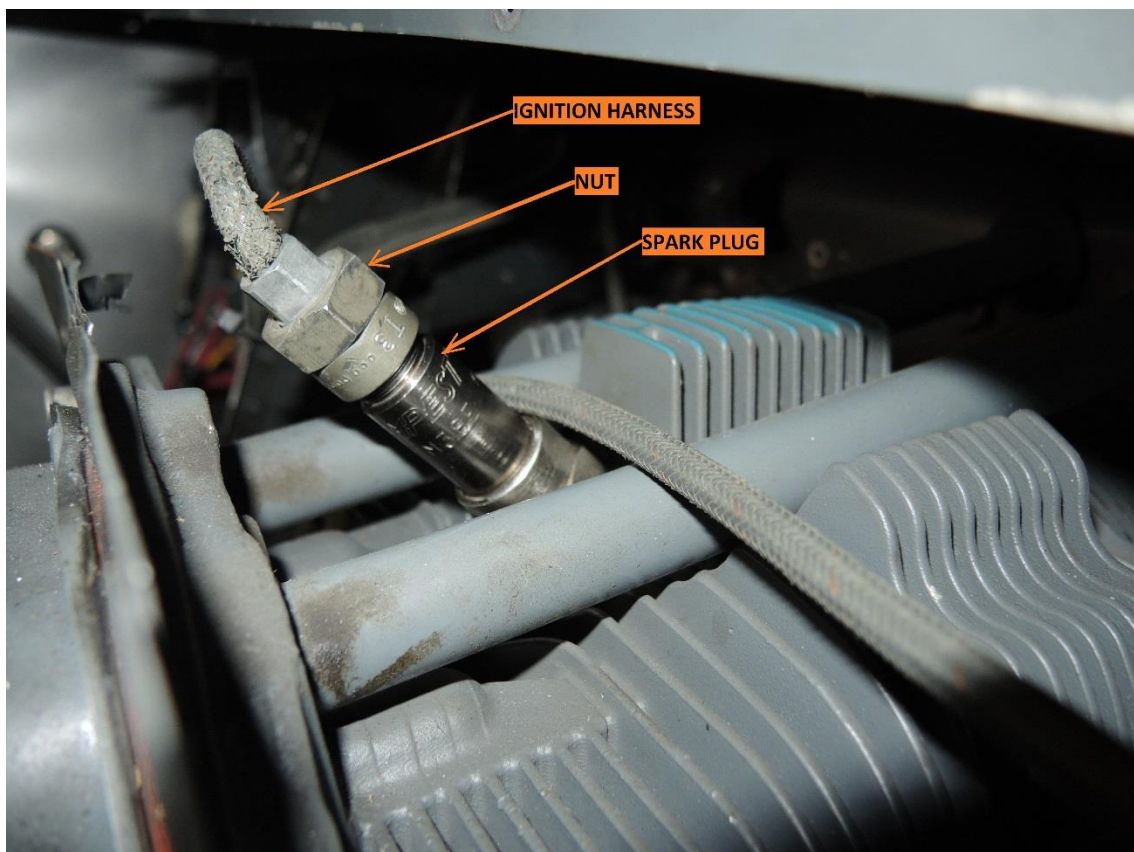
1.16.3.2 Due to the extensive leakage, it was decided to remove cylinder no. 5 (see the first indent in the paragraph above). When the top spark plug was about to be unscrewed, it was found to be rotating when the spark plug nut was about to be loosened. It was discovered that the spark plug was completely loose so that it was possible to turn it by hand clockwise 180° from a position where the spark plug harness was in normal position. Consequently, it was necessary to hold the spark plug with a pair of pliers in order to loosen the spark plug nut (see Figure 6). It was established that the spark plug could be turned 190–200° from the position it was in when it was found, until it had the correct torque. Other than that, both spark plugs in cylinder no. 5 were in good condition and had a normal light brown color.

Figure 6: Photo of a correctly installed spark plug with wire. Photo: NSIA
