# REPORT

Aviation 2021/03

## *REPORT ON AIR ACCIDENT ON NORDNESTJØNN, EAST OF ARENDAL AIRPORT GULLKNAPP ON 14 AUGUST 2019 INVOLVING PIPISTREL ALPHA ELECTRO, LN-ELA*

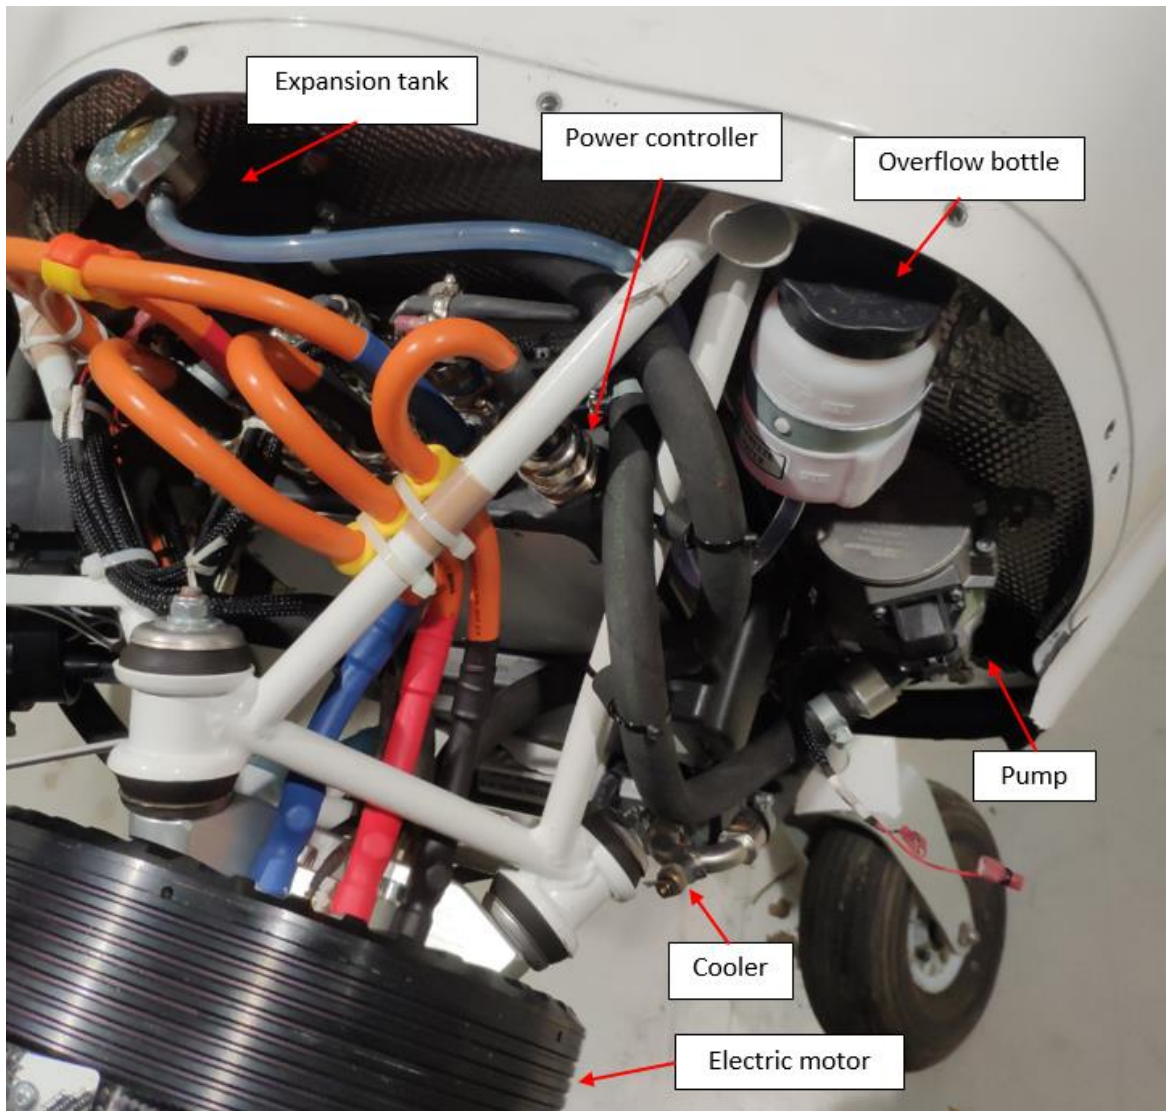
- 1.6.3 Cooling system
- 1.6.3.1 On Alpha Electro, motor and power controller are liquid-cooled. The coolant is circulated by an electric water pump in a closed cooling system. A cooler (radiator) is located in the lower, forward part of the aircraft's nose. It has an opening to the airstream below the propeller (see Figure 6). The system has an expansion tank with a removable lid and a plastic overflow bottle, also with a removable lid. The expansion tank lid has spring-loaded ventilation, which both releases overpressure and lets air back in again in the event of underpressure in the system. The lid is connected to the overflow bottle by a transparent plastic hose for collection of any coolant from the expansion tank (see

Figure 6). According to the maintenance manual<sup>6</sup>, the system can hold 1 liter of fluid. The fluid consist of a 50/50 mixture of antifreeze and water<sup>7</sup>.

Figure 6: LN-ELA motor installation showing the main components of the cooling system. Photo: Pipistrel

Before returning LN-ELA to service, NLF contacted Pipistrel and described the incident. They also sent a picture showing a mixture of coolant and air in the transparent plastic tube running from the expansion tank to the overflow bottle (see Figure 6). Pipistrel then prescribed a test that should be performed to check that the power controller would deactivate at the right temperature. If this test was successful, the aircraft could be put back in operation. The test was performed successfully, and LN-ELA was returned to operation.

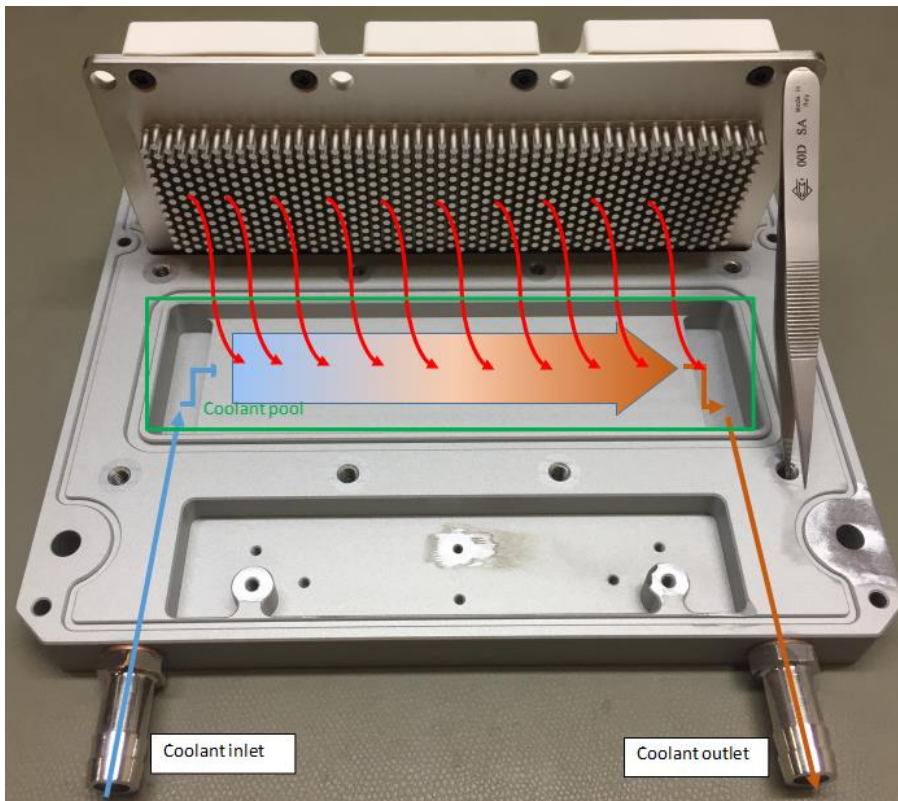
1.6.3.3 The power controller has a total of four sensors, three of which are adjacent to their respective Insulated Gate Bipolar Transistor (IGBT) in each of the three electronics chambers. The fourth temperature sensor is located at the warmest point on the outside of the power controller's capacitor housing. Figures 8 and 9 show the principle for cooling of the power controller electronic chambers, and the location of the three IGBTs with one temperature sensor each.

Figure 8: The principle for liquid-cooling of the power controller's electronics chambers. There are three electronics chambers on top of "the lid" and cooling ribs underneath. The chambers are displayed in Figure 9. Illustration: EMSISO

1.6.3.7 According to EMSISO, if an air pocket forms in the power controller cooling chamber, it could cause local overheating of one temperature sensor, which again would result in deviating sensor temperature readings, causing the unit to enter failure mode and thus cutting power to the motor.

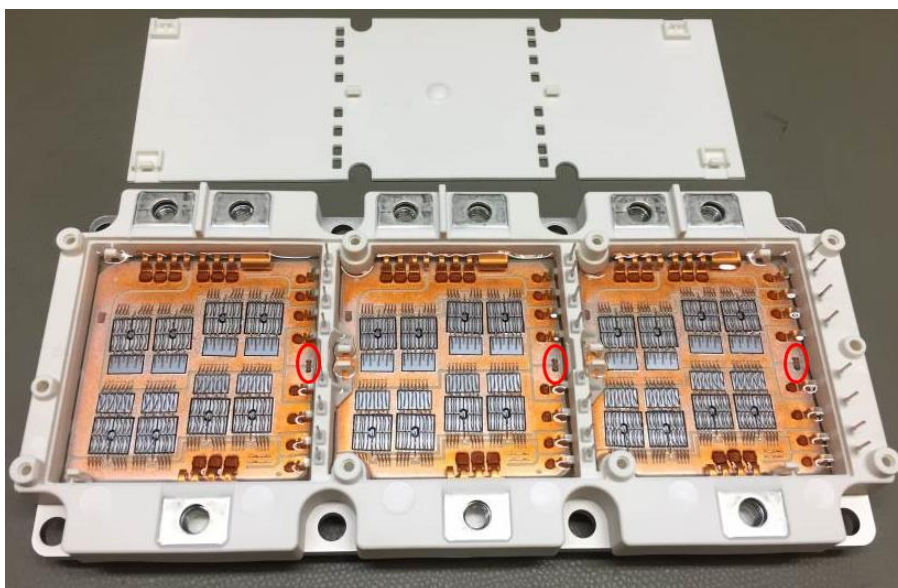
Figure 9: The three electronics chambers in the power controller. Three IGBTs with their associated temperature sensors indicated by a red circle. Illustration: EMSISO

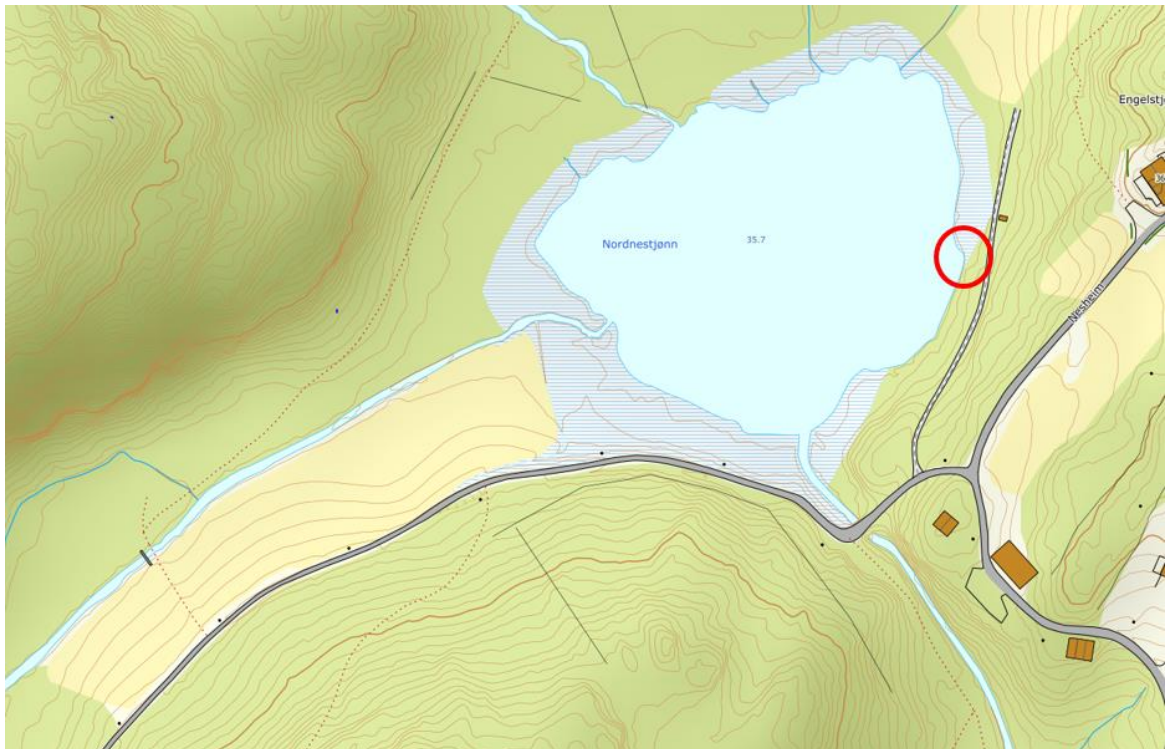
- 1.12.1.1 The emergency landing on Nordnestjønn took place in a north-easterly direction. LN-ELA first passed over a narrow field near the small lake. The field is less than 200 meters long. There were some trees between the field and the lake. From the lakeshore nearest the field, the distance to the spot where the aircraft was pulled up, is about 125 meters.

Figure 14: Map section showing Nordnestjønn and the field LN-ELA flew over before landing on the lake. The red circle indicates the area where the aircraft reached the shore. Map: © The Norwegian Mapping Authority

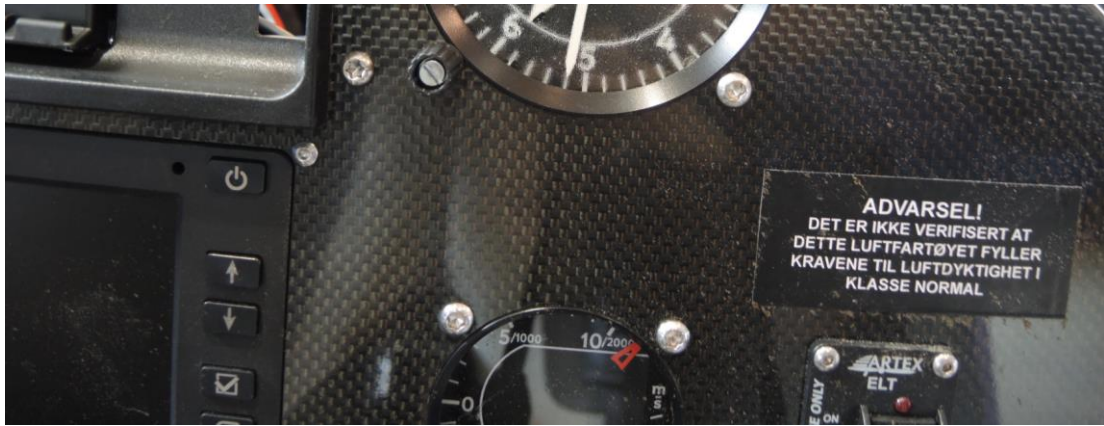
Figure 18: Passenger information placard on board LN-ELA. The text translates: "WARNING! It has not been verified that this aircraft complies with the normal class airworthiness requirements". Photo: NSIA

- 1.17.2.3 At the 2019 Norwegian Aviation Conference, NSIA addressed passengers' opportunity to make informed choices, before accepting the risk associated with taking a flight with aircraft that did not satisfy ordinary airworthiness requirements. NSIA questioned whether the above-mentioned markings and placards were sufficient.
