Aviation 2021/09

*REPORT ON AIR ACCIDENT NEAR
SKJELBREITJØRNA IN SANDNES
MUNICIPALITY, ROGALAND COUNTY,
NORWAY ON 6 APRIL 2020 INVOLVING
AIRBUS HELICOPTERS AS350 B3,
LN-OFQ, OPERATED BY HELITRANS AS*

REPORT ON AIR ACCIDENT

Type of aircraft:	Airbus Helicopters AS350 B3
Nationality and registration:	Norwegian, LN-OFQ
Owner:	Skjolden Invest AS, Hønefoss, Norway
Operator:	Helitrans AS, Stjørdal, Norway
Crew:	1, the commander
Passengers:	None
Accident site:	Northwest of Skjelbreitjørna in Sandnes, Rogaland, Norway (N 58° 49.951´ E 5° 51.434´)
Time of accident:	At 0857 hours on Monday 6 April 2020

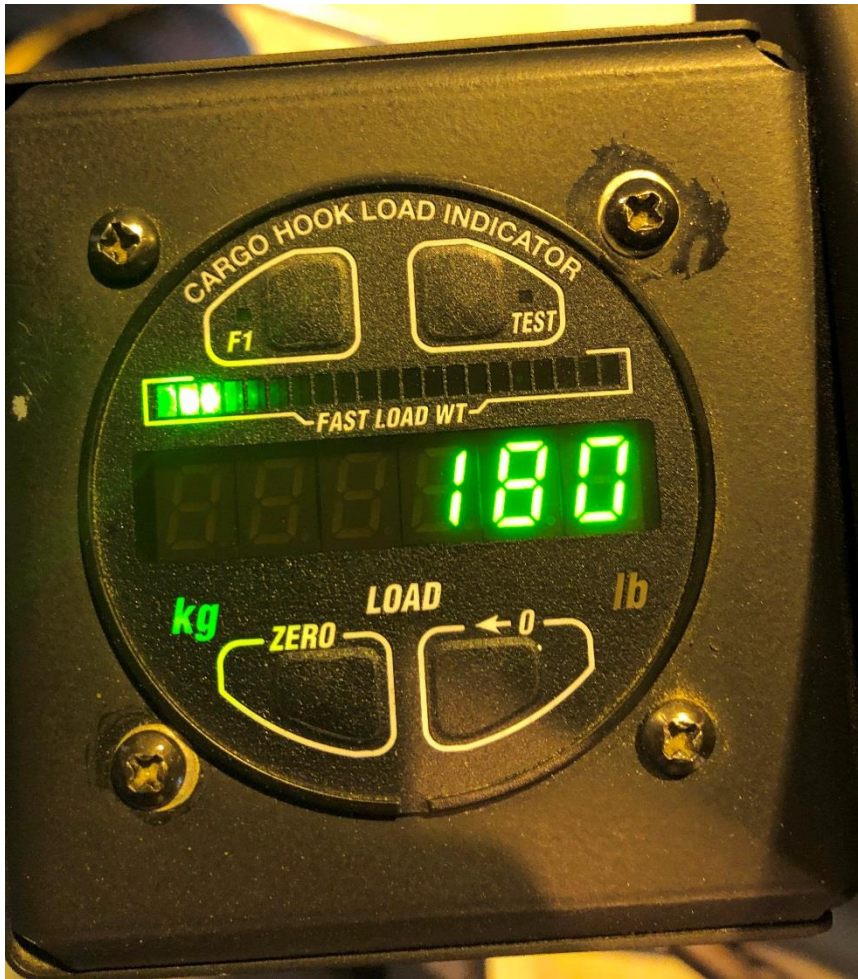
The helicopter was equipped with a cargo hook weight. A cargo hook load indicator connected to the weight was installed on the right-hand side of the cockpit. The instrument indicates the mass of the load suspended from the hook in kilos or pounds. The instrument also displays a series of green diodes indicating the load (FAST LOAD WT). One diode emits light even if there is no load on the cargo hook. The next diode is lit when the weight reaches 100 kg or more. Two diodes are lit when the weight exceeds 180 kg, as shown in Figure 5. If the load is increased to 350 kg, six diodes are lit.

Figure 5: Two green diodes are lit to indicate a load of 180 kg. Reflections in the glass can give the impression that four diodes are lit. Photo: Helitrans AS

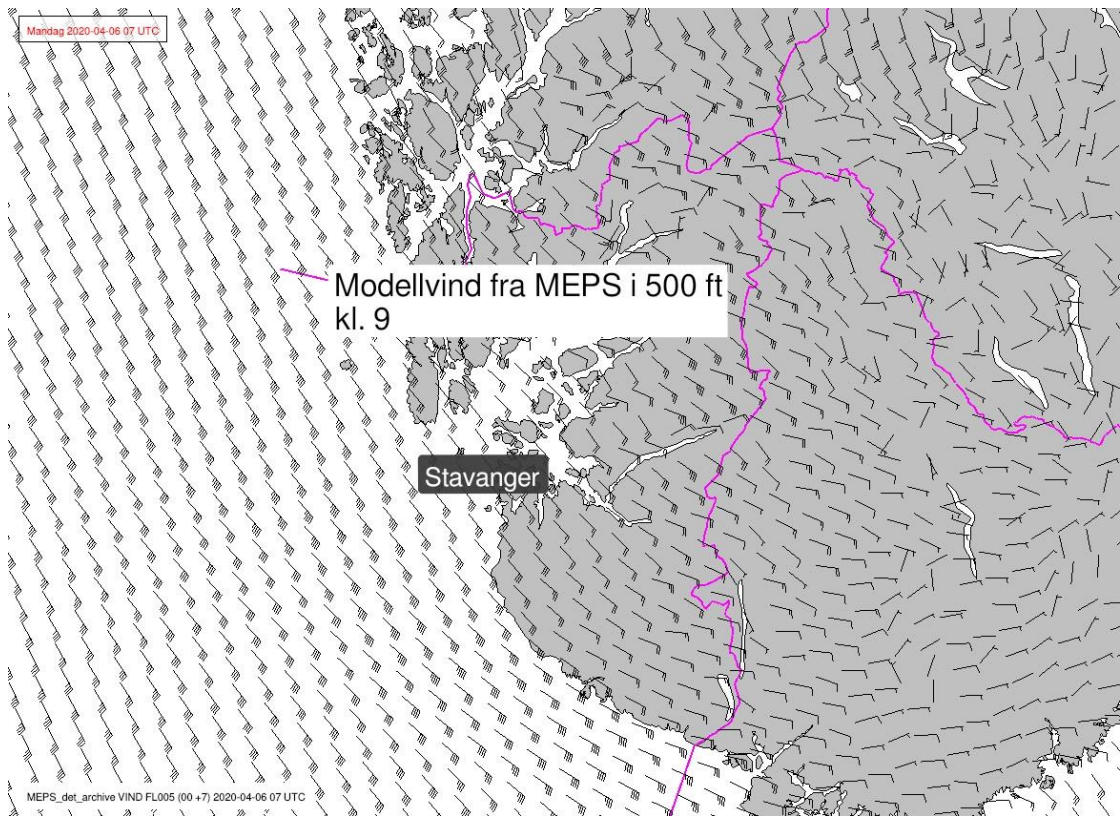
Figure 7: According to the map, at 0900 hours the wind was southeasterly with a mean wind speed of 20 kt at a level of 500 ft above the accident site. Source: Norwegian Meteorological Institute

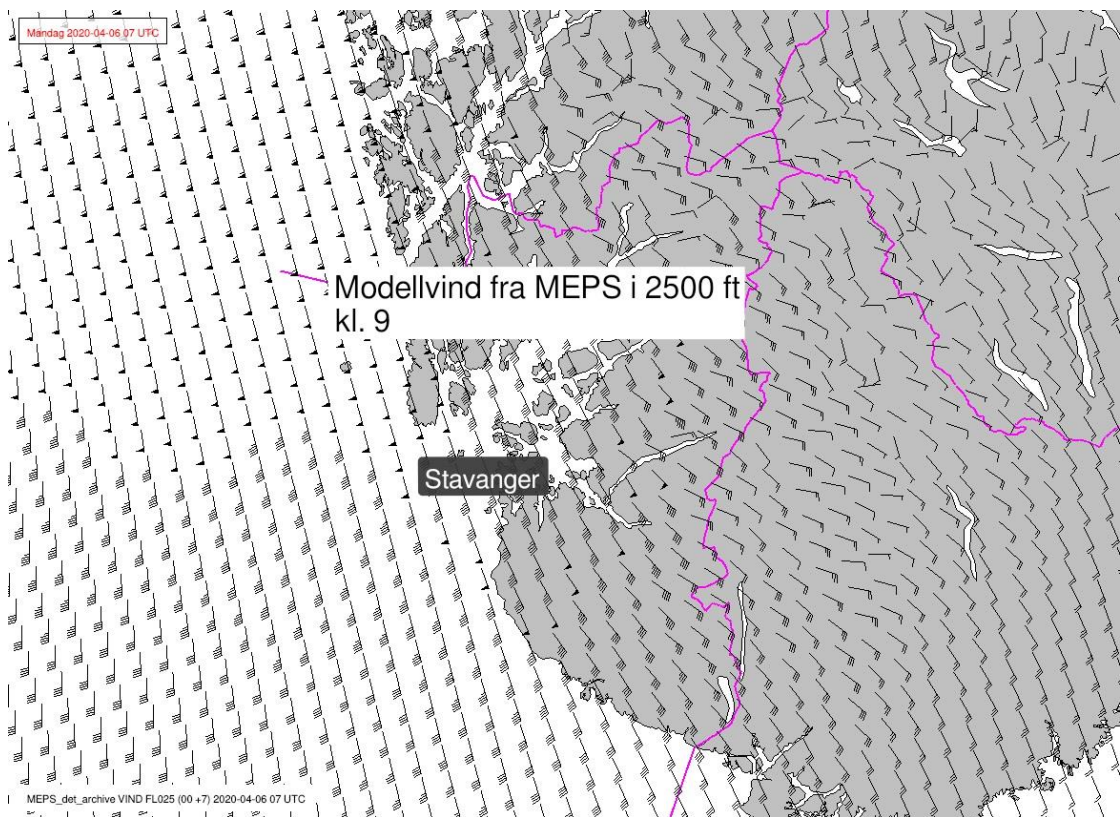
Figure 8: According to the map, at 0900 hours the wind was southeasterly with a mean wind speed of 45 kt at a level of 2,500 ft above the accident site. Source: Norwegian Meteorological Institute

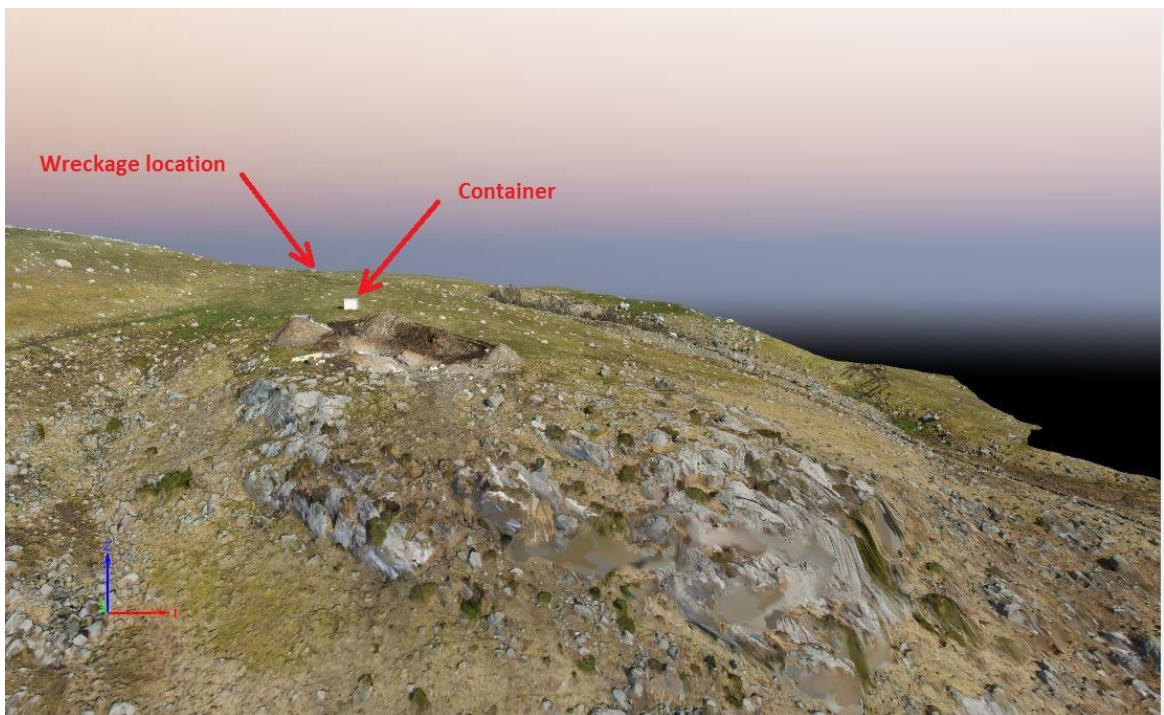
- 1.12.1.1 The accident took place in a relatively flat, open and rocky grazing area 460 metres northwest of Skjelbreitjørna lake (see Figure 10). The helicopter came to rest partly on a big rock protruding from the ground. The accident site is approximately 170 metres (558 ft) above sea level. South of the accident site, the terrain slopes down towards Skjelbreitjørna. In the whole sector south of the accident site (from 80 to 270 degrees), the terrain was partly mountainous, with peaks of from 200 to 384 metres above sea level.
- 1.12.1.2 The accident took place shortly after Norway was shut down as a result of the Covid-19 pandemic. The NSIA did not travel to the accident site and decided to order drone documentation from Nordic Unmanned. The work consisted of, among other things, 3D documentation as shown in Figure 11 and Figure 12.

Figure 12: 3D illustration of the accident site, looking northeast, the day after the helicopter was removed. The hole in the ground is for pylon 155. Source: Nordic Unmanned/NSIA

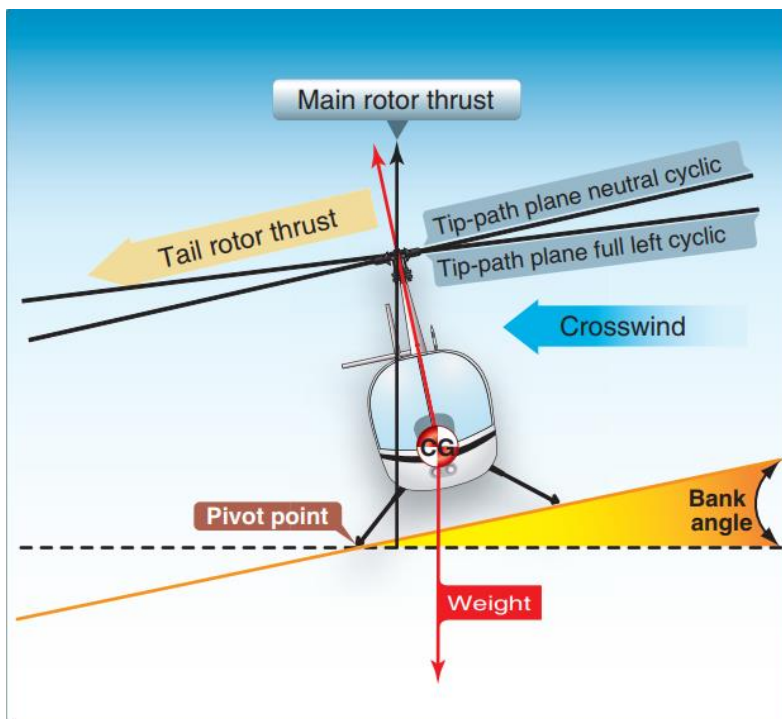
- 1.18.1.1 A dynamic rollover normally occurs if a helicopter has one skid on the ground at the same time as it is affected by a lateral force or movement. As the helicopter starts to pivot, the main rotor thrust will contribute to further pivot the helicopter around the skid. When the critical rollover angle is exceeded, dynamic rollover cannot be prevented by corrective cyclic control alone, and the main rotor will hit the ground. Dynamic rollover is most likely to occur in sideways sloping terrain, but can also occur on a horizontal surface, for example if a skid gets caught in something in connection with take-off (see Figure 14).
- 1.18.1.2 A form of dynamic rollover can also occur if a longline or underslung load gets caught in something on the ground while the helicopter is moving horizontally.

Figure 14: Illustration of factors in a dynamic rollover caused by crosswinds and tail rotor thrust. Source: Flight Literacy
