REPORT AVIATION 2022/04

Report on the air accident on the E18 road in Eidanger, Vestfold and Telemark county, Norway on 17 June 2021 involving a Robinson R44 Raven I helicopter, LN-OGT

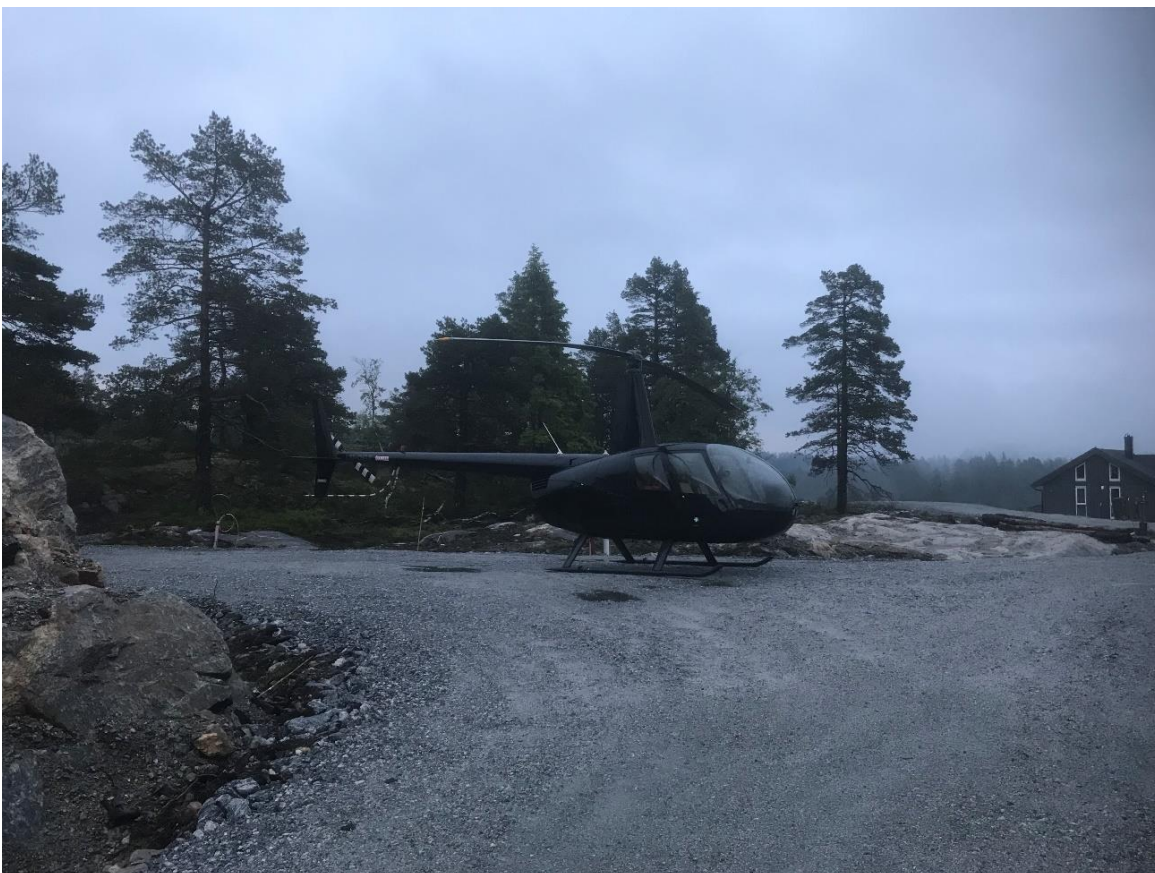
Figure 1: Photo of the helicopter north of Tveitvatnet lake, taken by the commander at 2141 hrs.

The NSIA has gained access to the commander's mobile phone. The log shows that there was contact between the commander and the owner of the helicopter on several occasions. The commander called the owner and explained that he had landed north of Tveitvatnet as he thought the weather was not looking good ahead of him. The owner of the helicopter has explained that he then checked available weather radar information online. He then informed the commander that the weather was bad with heavy rain in the area, and that he should expect to remain on the ground for at least three hours. The owner also sent him a link to the website www.accuweather.com. At 2150 hrs, the commander sent the owner a photo of the helicopter that showed where he was parked. Fifteen minutes later, the commander called and said that the

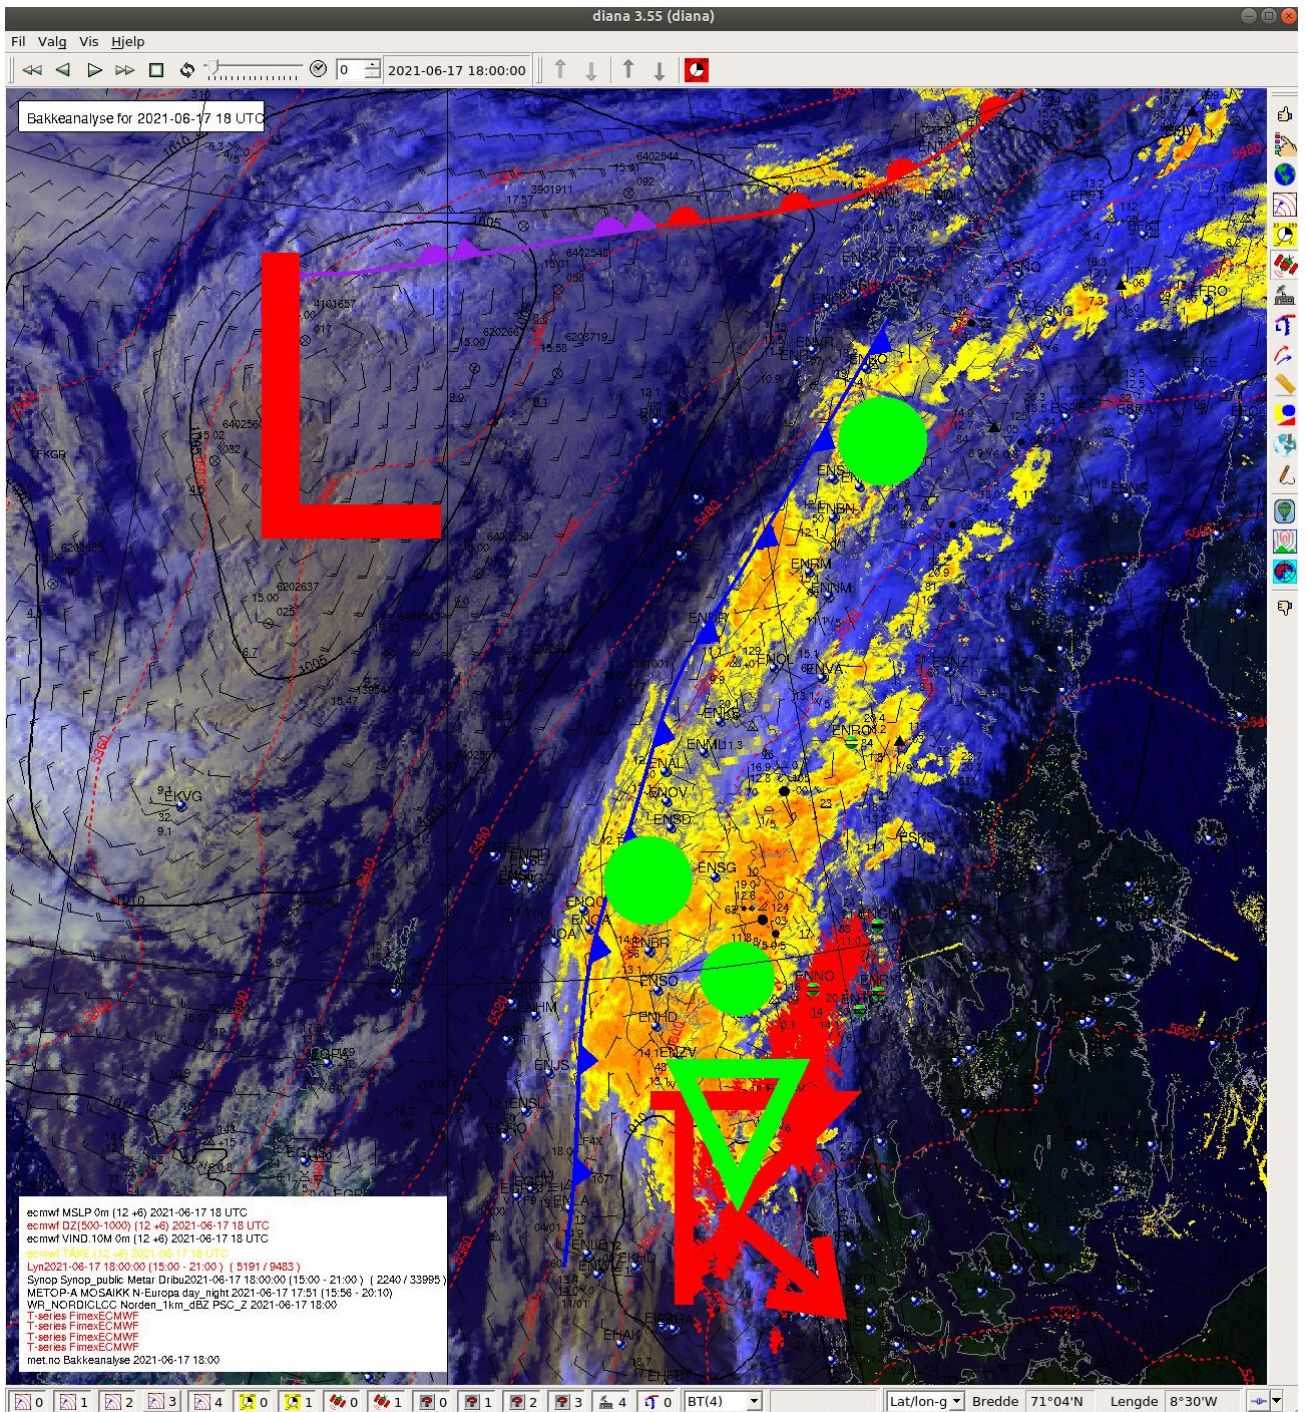
Figure 5: Ground analysis at 2000 hrs on 17 June 2021. Source: Norwegian Meteorological Institute/NSIA

East of this line of showers, the weather is cloudy or partially cloudy with some light rain showers, a cloud base of at least 4,000 ft and visibility of more than 10 km (METAR Torp (ENTO) and Gardermoen (ENGM)). The aircraft in question started the flight under these conditions.
