REPORT AVIATION 2022/05

Serious aviation incident near Råde Church in Østfold, Norway, on Wednesday 21 June 2017 involving Diamond DA 40 NG, LN-FTR, operated by Pilot Flight Academy

Report on serious aviation incident

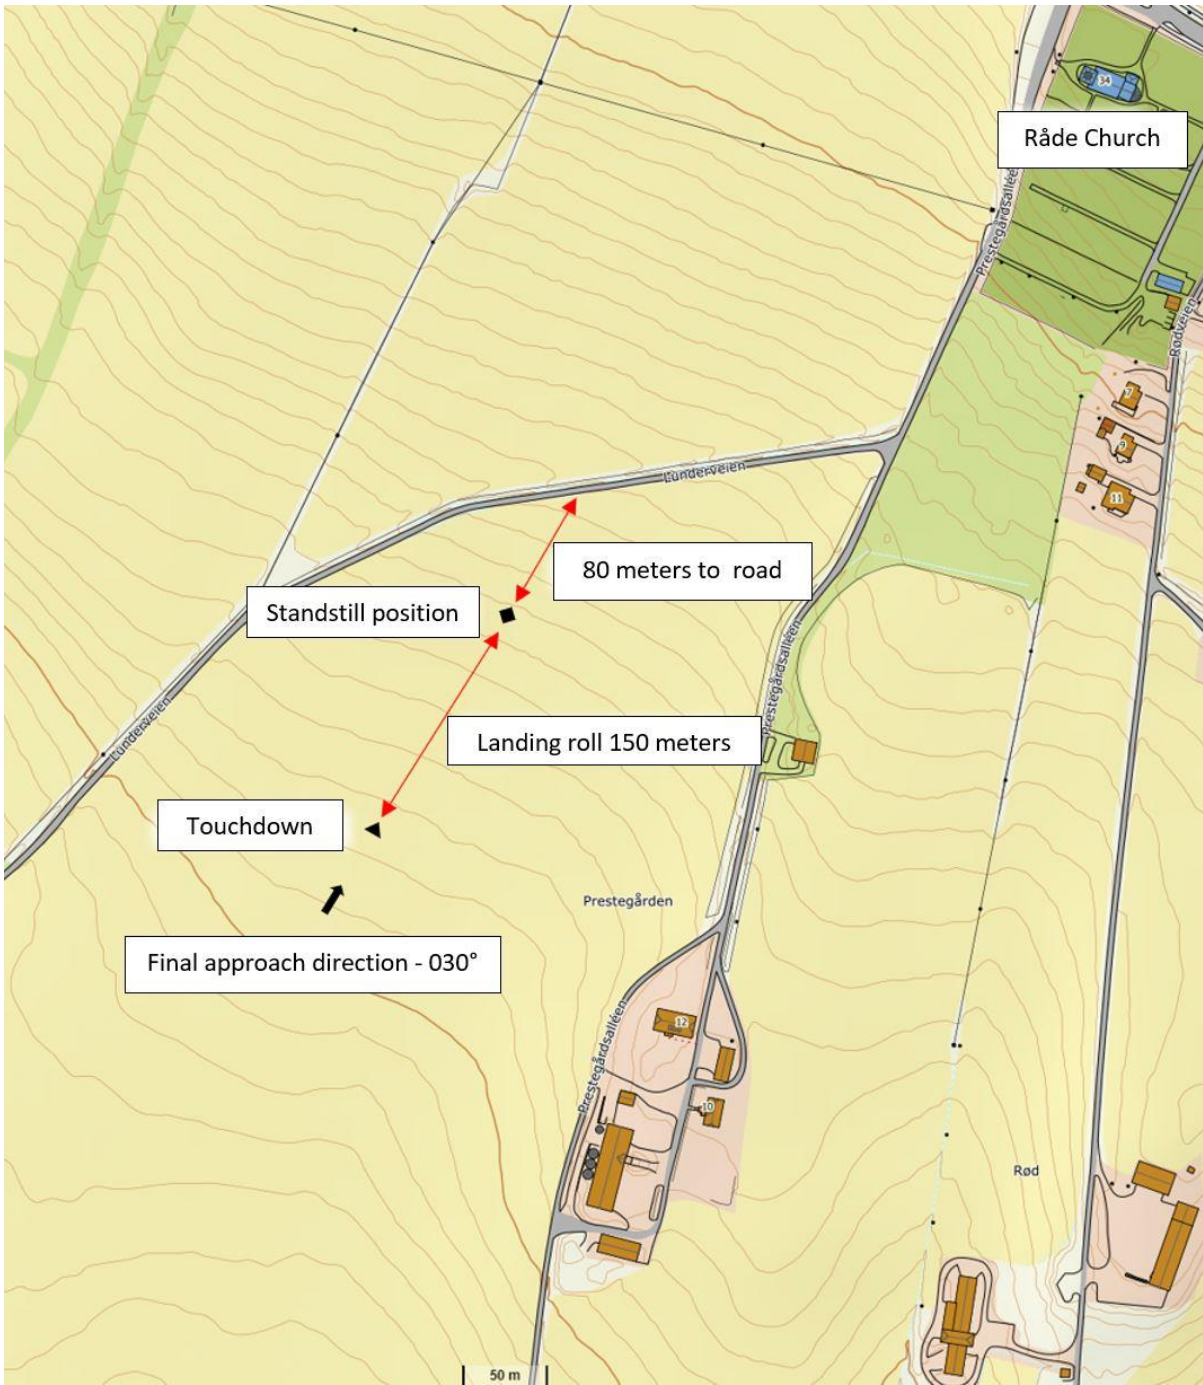
Figure 6 shows a map section with indication of the approach direction, touch-down point and stop point for the aircraft after it landed. The landing roll was slightly uphill. The field's surface was relatively soft, and the final part of the rollout left deep wheel tracks (see Figure 7).

Figure 6: Map section showing the landing site, marked in accordance with the NSIA's measurements. Map: © Norwegian Mapping Authority. Markings: NSIA
