REPORT

AVIATION 2022/08

***Aviation incident offshore by Ekofisk
Lima in the North Sea on 25 September
2021 involving Sikorsky S-92A, LN-ONH
operated by Bristow Norway AS***

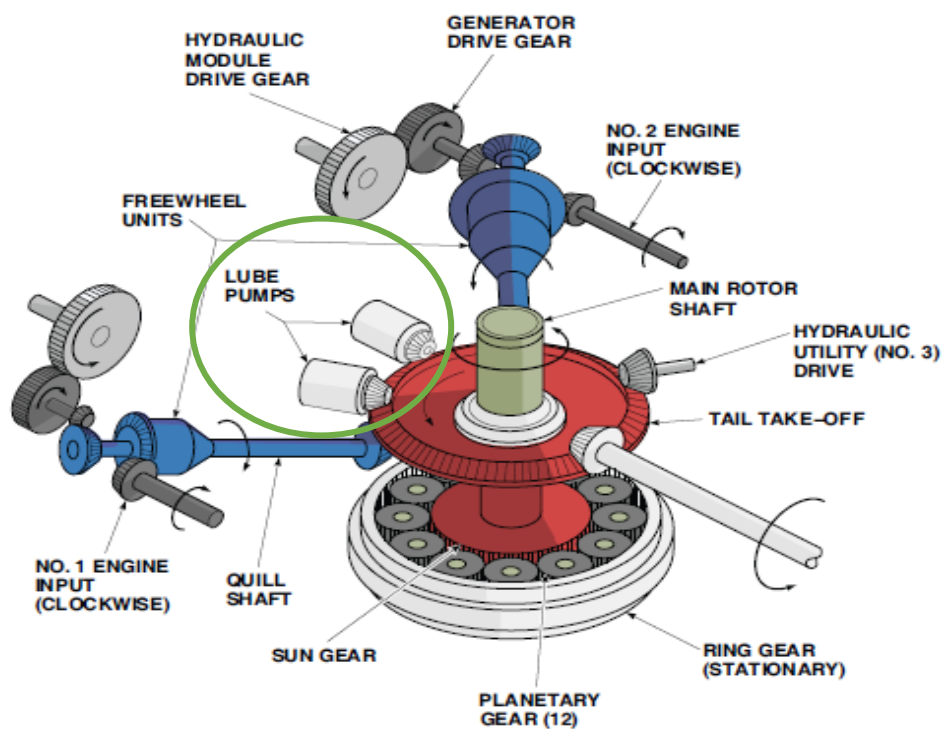
The oil pumps are driven by a bevel gear in the main gearbox module (see Figure 2). The Vespel spline adapter is positioned outside the spline on the oil pump driveshaft and engages the bevel gear. Both the driveshaft and the bevel gear are metal. The adapter ensures good contact between the oil pump and the bevel gear. In addition, it is meant to limit wear by eliminating metal on metal contact.

Figure 2: Illustration of how the bevel gear drives the oil pumps. Schematic: Sikorsky/NSIA

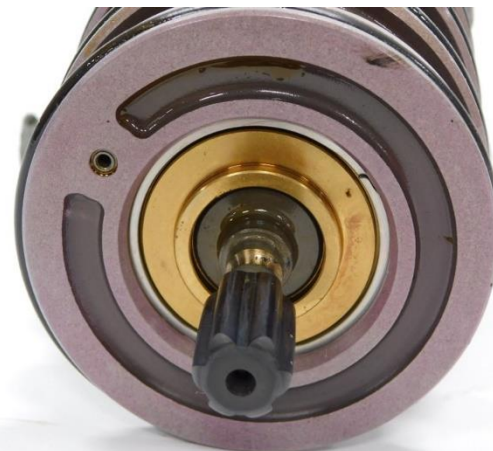
Figure 4: The oil pump and driveshaft with the Vespel spline adapter removed. The Vespel spline adapter slides on the driveshaft. Photo: Sikorsky/NSIA

The driveshaft of oil pump #1 was examined under a microscope and no signs of wear or defects were found.

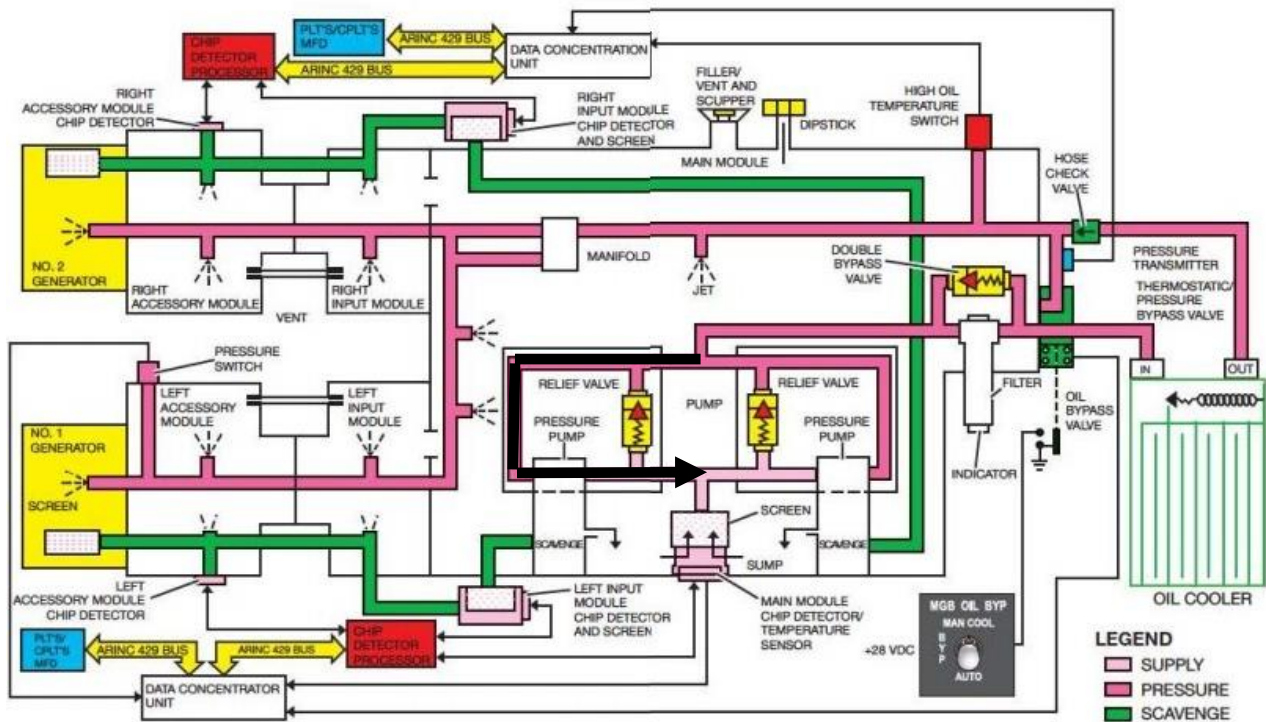
If the Vespel spline adapter of one of the oil pumps fails, without the pump jamming, the pump is free to rotate and does not hinder oil flow. Sikorsky has told the NSIA that the oil flow from the functioning oil pump will drive the failed oil pump. The failed oil pump will in this scenario function as a pseudo regulating valve. See the black arrow in Figure 5. This leads to the oil pressure stabilising at around 5–10 psi. Sikorsky has informed the NSIA that the S-92A can, in theory, continue operating with such low oil pressure for longer than it has fuel.

Figure 5: Illustration of the lubrication system for the main gearbox. The black arrow illustrates how the oil flows through one oil pump if the Vespel spline adapter fails without the pump jamming. Schematic: Sikorsky/NSIA

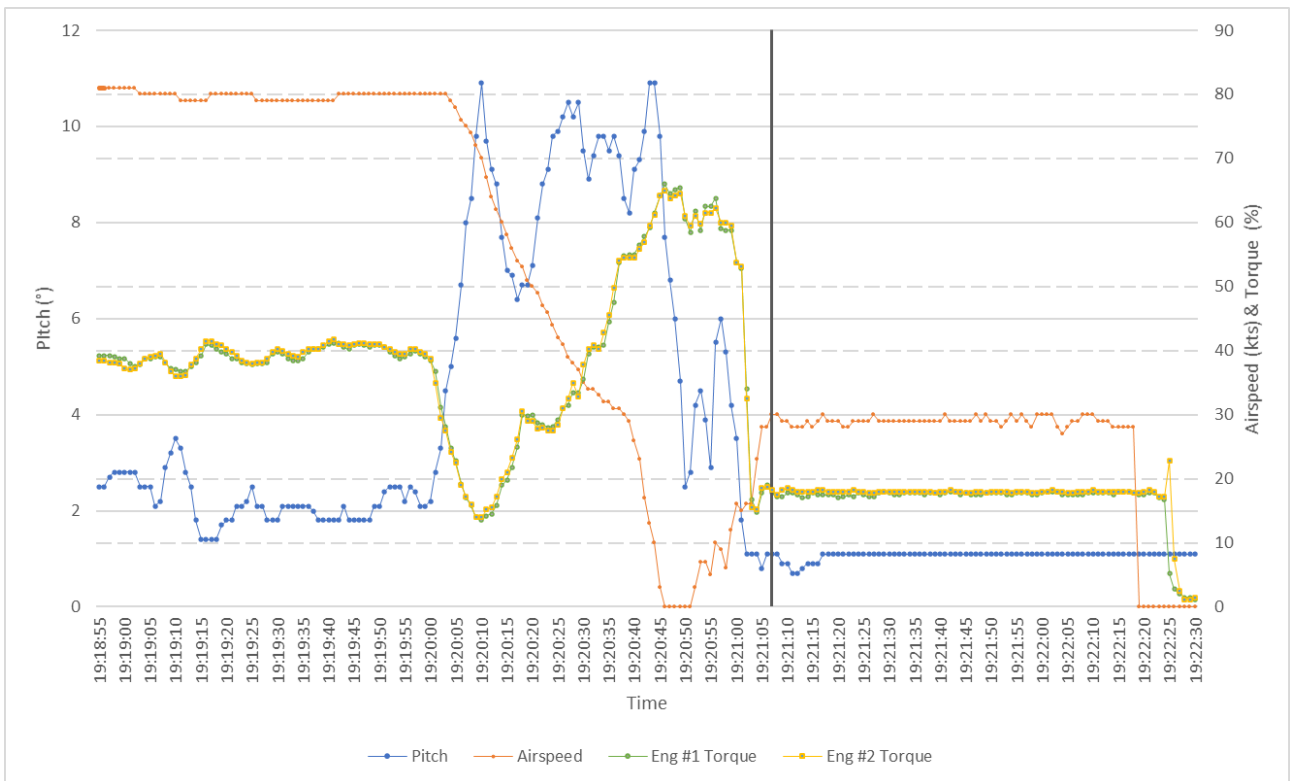
Figure 7 shows relevant parameters from the flight. The NSIA has also obtained information that the Auxiliary Power Unit (APU) was started at 19:21:36, 30 seconds after the helicopter landed on the oil rig.

Figure 7: Pitch, airspeed and torque for both engines during the incident. The black line marks the landing on the oil rig. Source: FDR/NSIA
