# REPORT

AVIATION 2023/01

***Serious aviation incident 20 NM north of  
Flesland on 20 January 2020 involving  
DHC-8-311, LN-WFO***

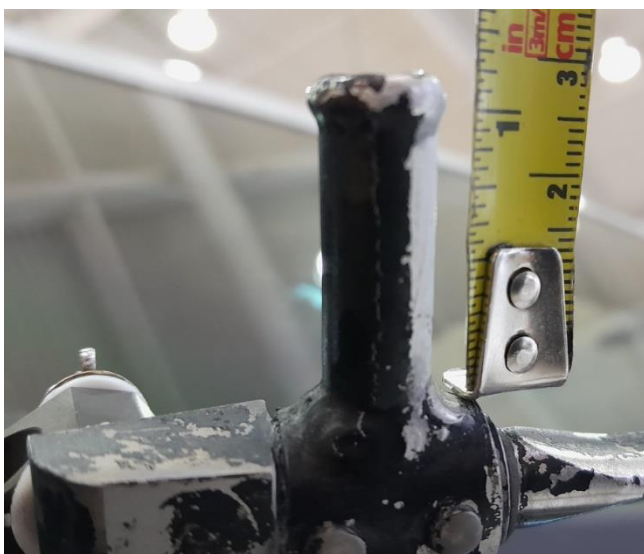
There is also a spigot installed on each windshield wiper arm to indicate ice formation. The spigot is easily visible to pilots and projects just over an inch into the airflow.

Figure 13: Spigot of the type shown in Figure 2. Photo: Widerøe

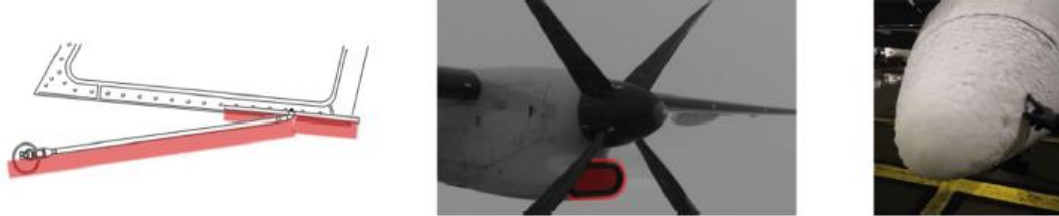
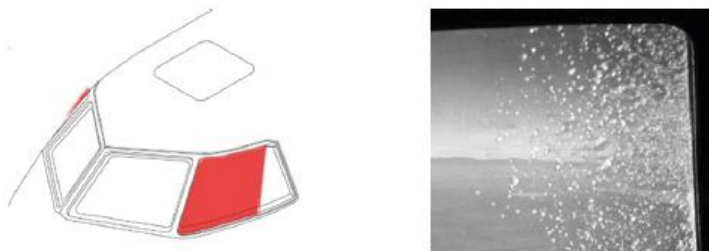
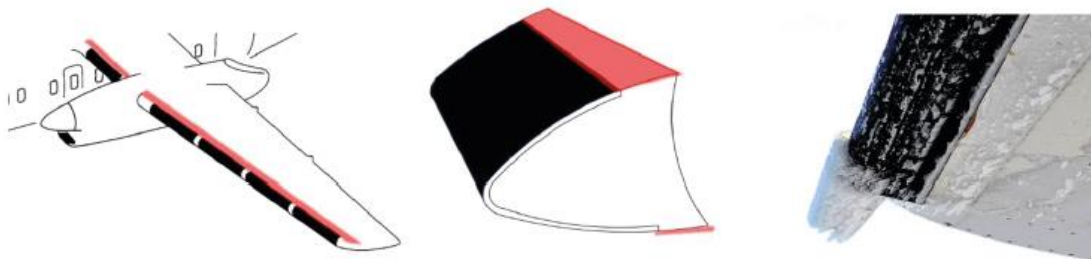
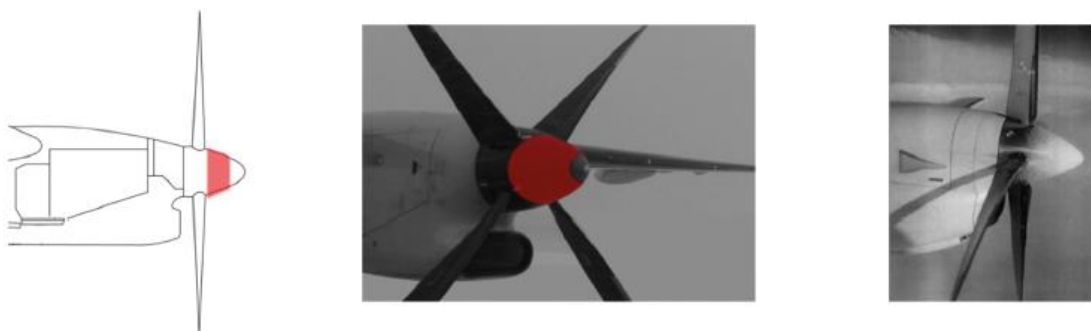
Figure 24: *Cues of Severe Icing*. Source: Widerøe OM B

- Unusual extensive ice on the airframe in areas not normally observed to collect ice;

- Ice accumulation on the flight deck side windows, aft of the leading edge;

- Ice accumulation on the upper or lower wing surface, aft of the protected area;

- Ice accumulation on the propeller spinner farther aft than normally observed.

Widerøe has also amended OM B following the incident. Section 2.11.8.21.2 *Cues of Severe Icing* has been re-written, and photos have been added to illustrate what the crew should look for to verify severe icing on the aircraft. Figure 24 is taken from the updated version of OM B.

If severe icing is encountered, immediately request priority handling from ATC to facilitate a route or an altitude change to exit the icing conditions. The QRH item FLIGHT IN SEVERE ICING CONDITIONS shall be actioned to ensure all vital actions have been completed, including disengagement of the autopilot.

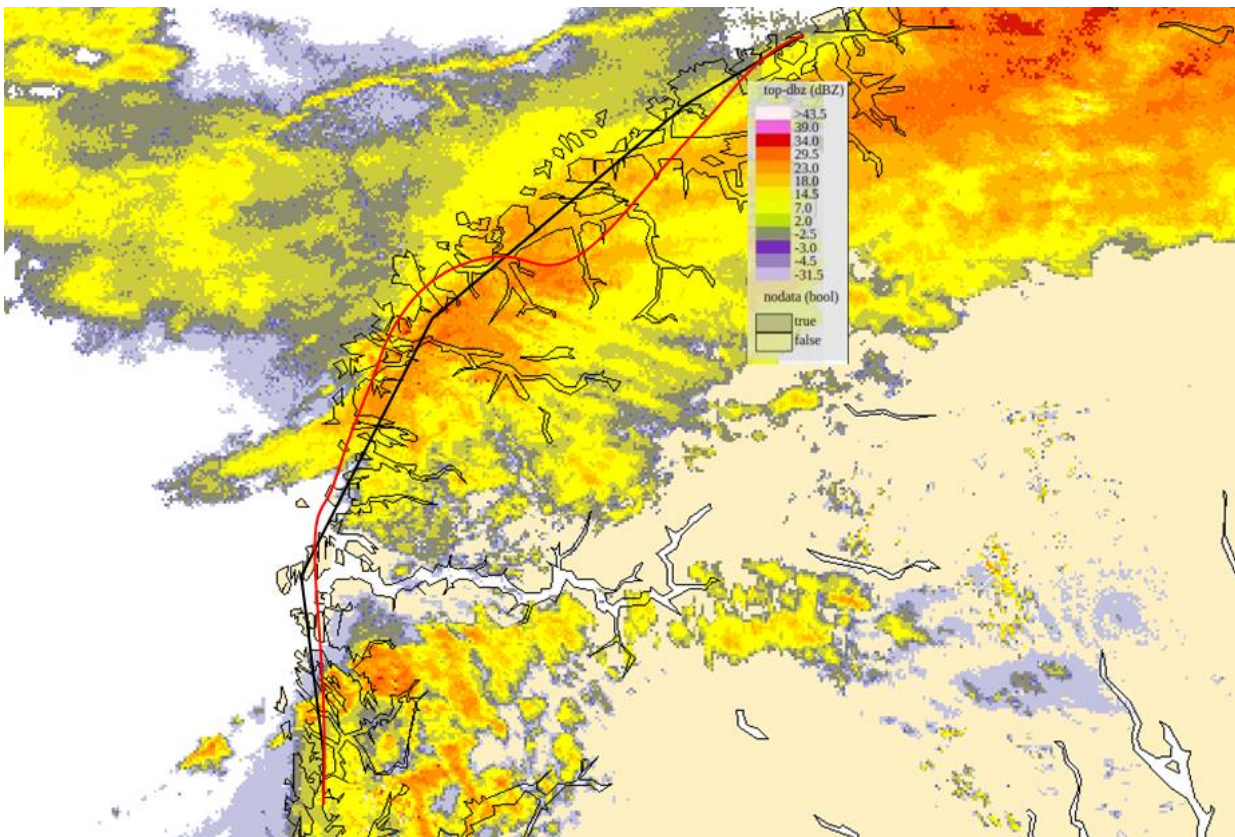
An analysis carried out by weather radar specialists with the Norwegian Meteorological Institute has concluded that the actual precipitation measured during the period in question exceeds that indicated by the radar image. Part of the reason for this is blockage caused by mountain formations blocking the radar beams. The degree of beam blockage in the area where the aircraft experienced the most intense icing is between 30% and 40%.

Figure 25: Map showing the weather situation and route between Kvernberget and Flesland airports. The planned route is shown in black, while the actual route is shown in red. The intensity of icing is indicated in yellow, orange and dark orange. Dark orange indicates the most severe icing. See the dBZ scale provided in the figure. Source: Norwegian Meteorological Institute/NSIA

After take-off from Kvernberget, the air traffic service offered the crew a direct route to NIDGI, which is the first approach point to Flesland. The offer was accepted, and they turned to a more southerly course (see Figure 25). It has emerged that this choice of route took WF577 further inland, where the precipitation was heavier and the risk of icing higher.

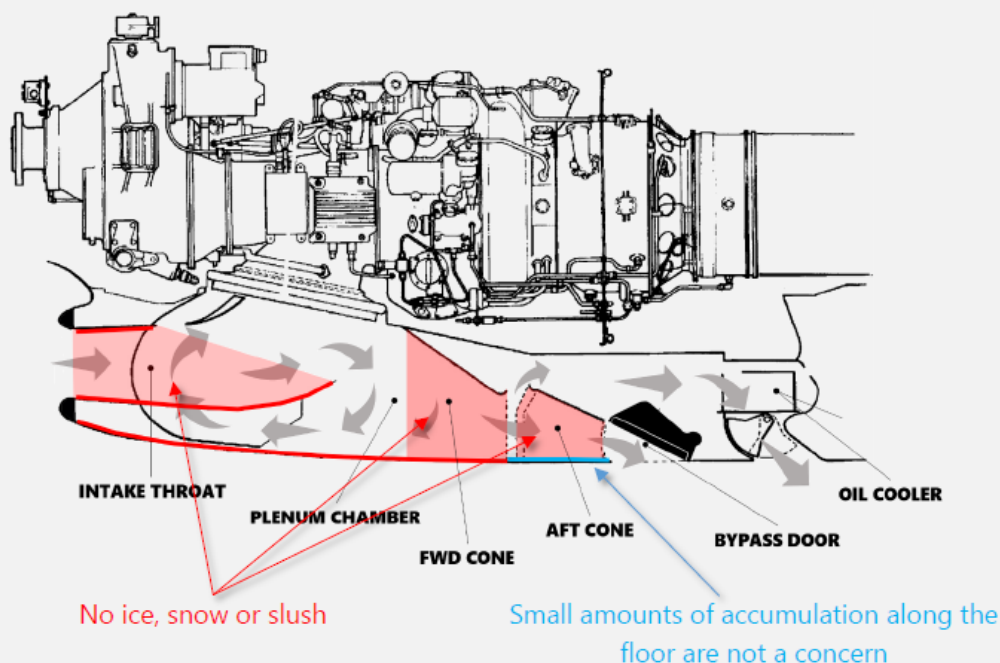
However, progressive ice accumulation in multiple flight segments or on the ground is a particular concern that must be addressed through company policies, procedures, and maintenance practices. Under such circumstances, ice can progressively accumulate in the engine air intake, both in the intake throat and immediately ahead of the bypass door. If this ice accumulation is not removed, it can potentially cause an engine power interruption.

As a result of actual occurrences, Widerøe has implemented the following inspection procedures for the engine nacelles. Stepladders required for inspection are found at every third gate at all major network destinations, and close to the parking position at the regional airports. If in doubt, a request for information on the actual location of the stepladder can be made to the ground service provider.

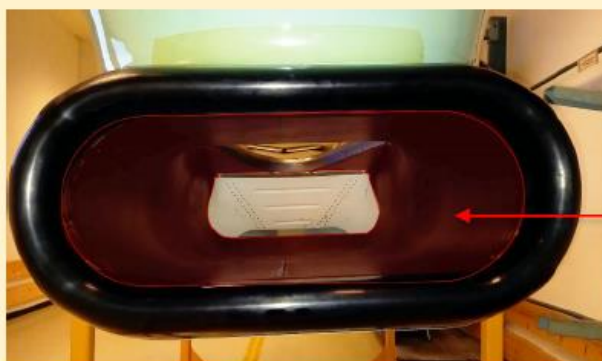
No ice, slush or snow

5. If snow, slush or ice is found, contact MOC (7551 3607) for technical assistance to remove the contaminants according to maintenance procedures. Except for slush and snow that can be removed by a gloved hand (no equipment), pilots or ground personnel shall not attempt to remove contaminants inside the nacelles.
6. On the DHC-8 Q400, close the bypass doors before engine start.

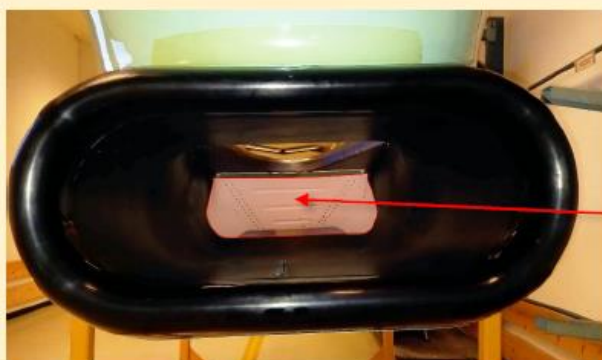
No ice, slush or snow
