AVIATION 2023/02

***Air accident 8 km west-northwest of
Larvik in Vestfold og Telemark County,
Norway on 23 November 2021 involving a
Diamond DA 42 NG, LN-PFM, operated by
Pilot Flight Academy***

Aviation accident report

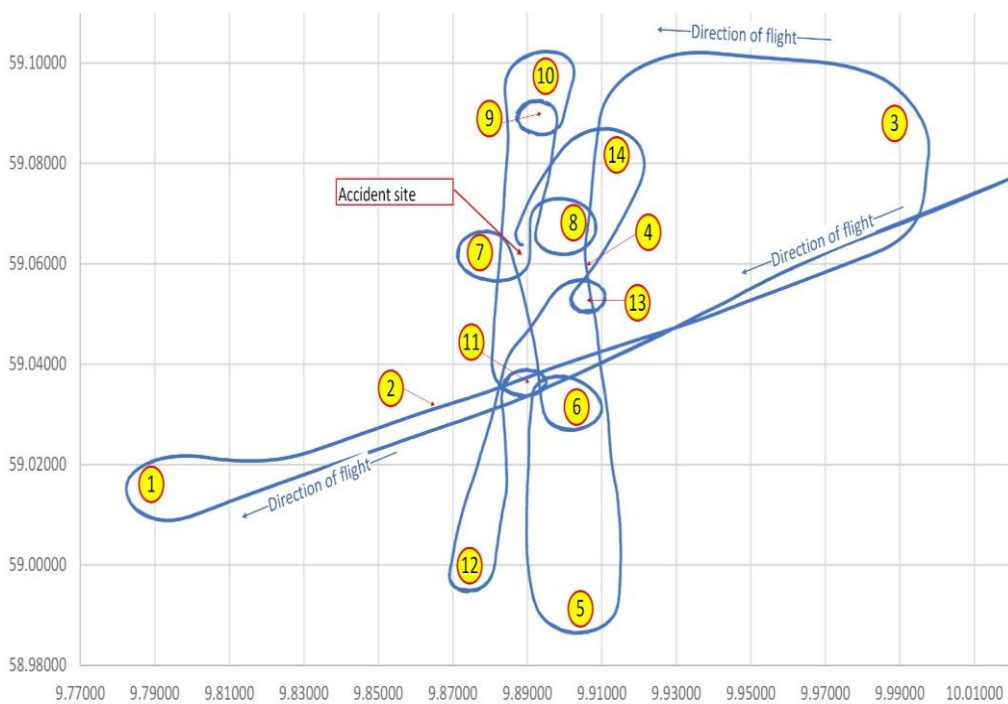
Figure 2: The airplane's manoeuvres during the final 28 minutes or so of the flight in the Helgeroa 1 training area. Manoeuvres marked with a yellow circle are explained below. The red rectangle indicates the accident site. Source: Avinor/Flightradar24/NSIA

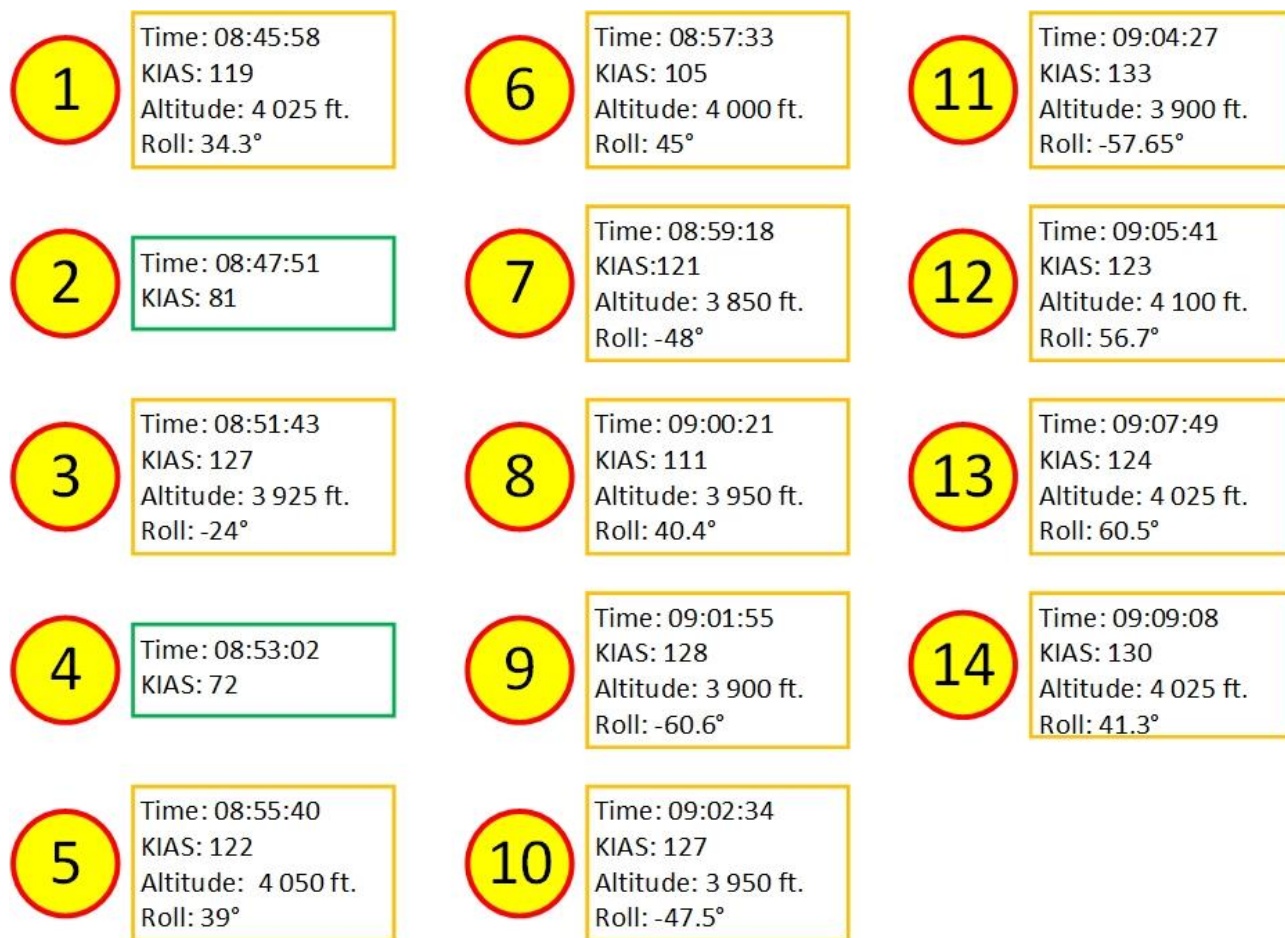
Figure 3: Indicated airspeed (KIAS), altitude above mean sea level (AMSL) and roll angle (positive values indicate rolling to the left while negative values indicate rolling to the right) at the points presented graphically in the previous figure. Source: Avinor/Flightradar24/NSIA

Two slow flight sequences were performed during the relevant period (see the labels with green outline in Figure 3). The speed was reduced to 81 kt and 72 kt, respectively. It is likely that a stall warning (first indication) was received during the second sequence. The NSIA believes that control of the airplane was probably lost during a third sequence, while the speed was being reduced once again. Examination of the wreckage showed that both flaps and landing gear had been deployed when the airplane hit the ground. It can therefore be assumed that the flaps and landing gear were also extended during the slow flight. It has been impossible to determine whether the instructor was flying the airplane to demonstrate the manoeuvre to the student, or whether the student was at the controls. Regardless of who flew the airplane when the problems arose, the instructor would be required to abort the manoeuvre and level the flight if the student did not master the situation.

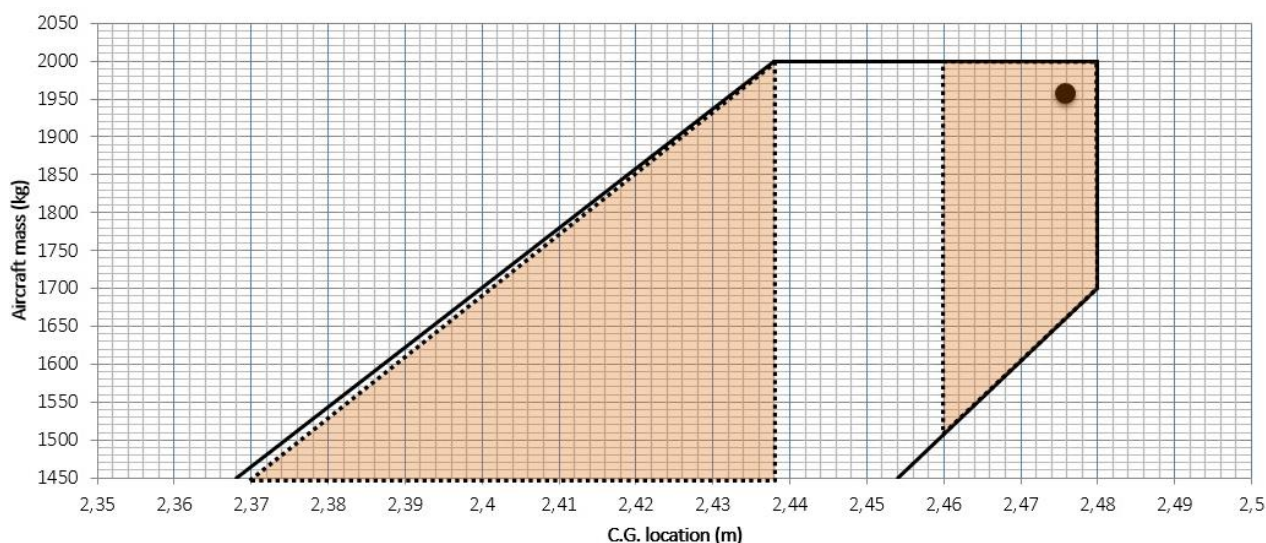
Figure 5: The figure shows the estimated centre of gravity at the time of the accident (black circle). Following the accident, the flight school has decided that certain exercises, including slow flight demonstrations (V_{MCA}) and full stalls, may only be conducted if the centre of gravity lies in the unhighlighted area between the dashed lines. Source: Pilot Flight Academy/NSIA

The calculations show that, at the time of the accident, the airplane's mass was 42 kg below the maximum take-off weight and that the centre of gravity was at 2.476 metres (arm). Given such a mass, the forward and aft centre of gravity limits were 2.434 metres (arm) and 2.48 metres (arm), respectively. This means that the aircraft was within its mass and balance limits when the accident occurred.

Following the LN-PFM accident, Pilot Flight Academy immediately decided that carrying passengers in the rear seat would no longer be permitted during instruction flights. PFA has subsequently lifted this limitation, and instead introduced centre of gravity limits for certain exercises, including slow flight and stall training. During such exercises, the centre of gravity must be between 2.438 and 2.46 metres, which, in practice, precludes carrying passengers (see Figure 5).

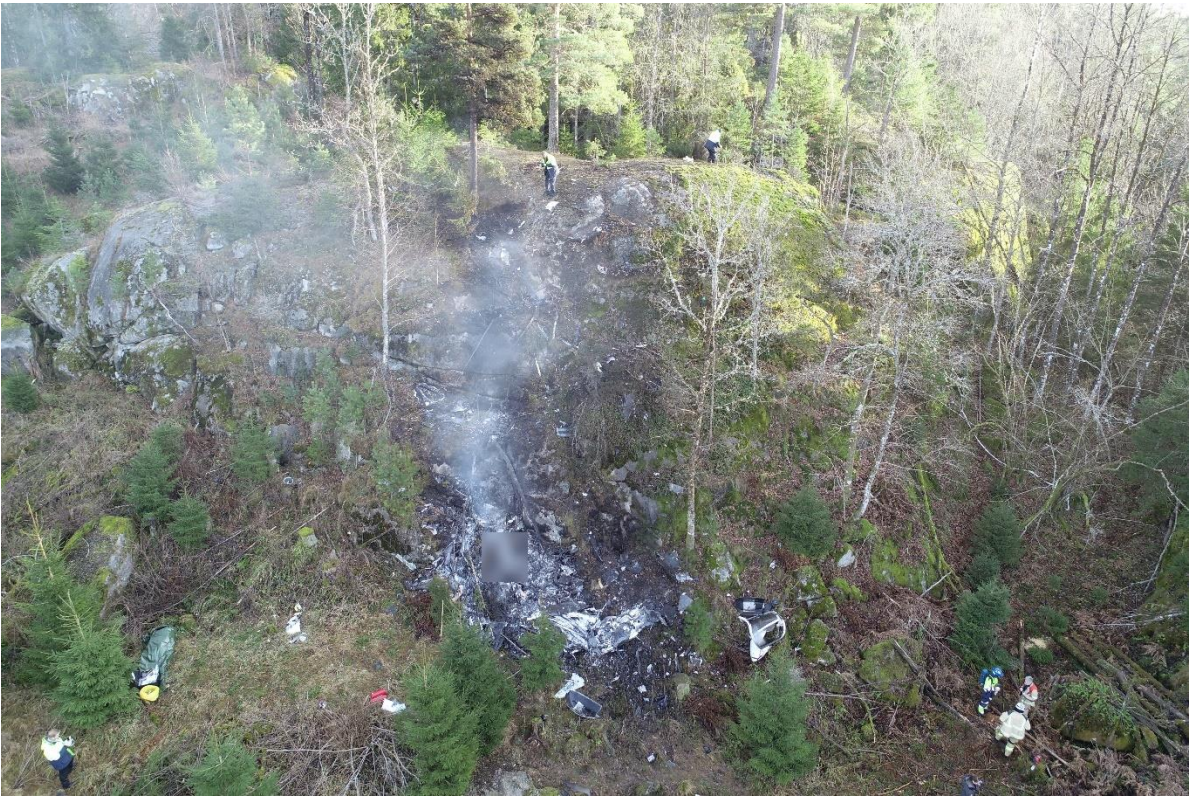
Figure 11: Photo of the crash site looking east, shortly before 1400 hrs. Photo: NSIA

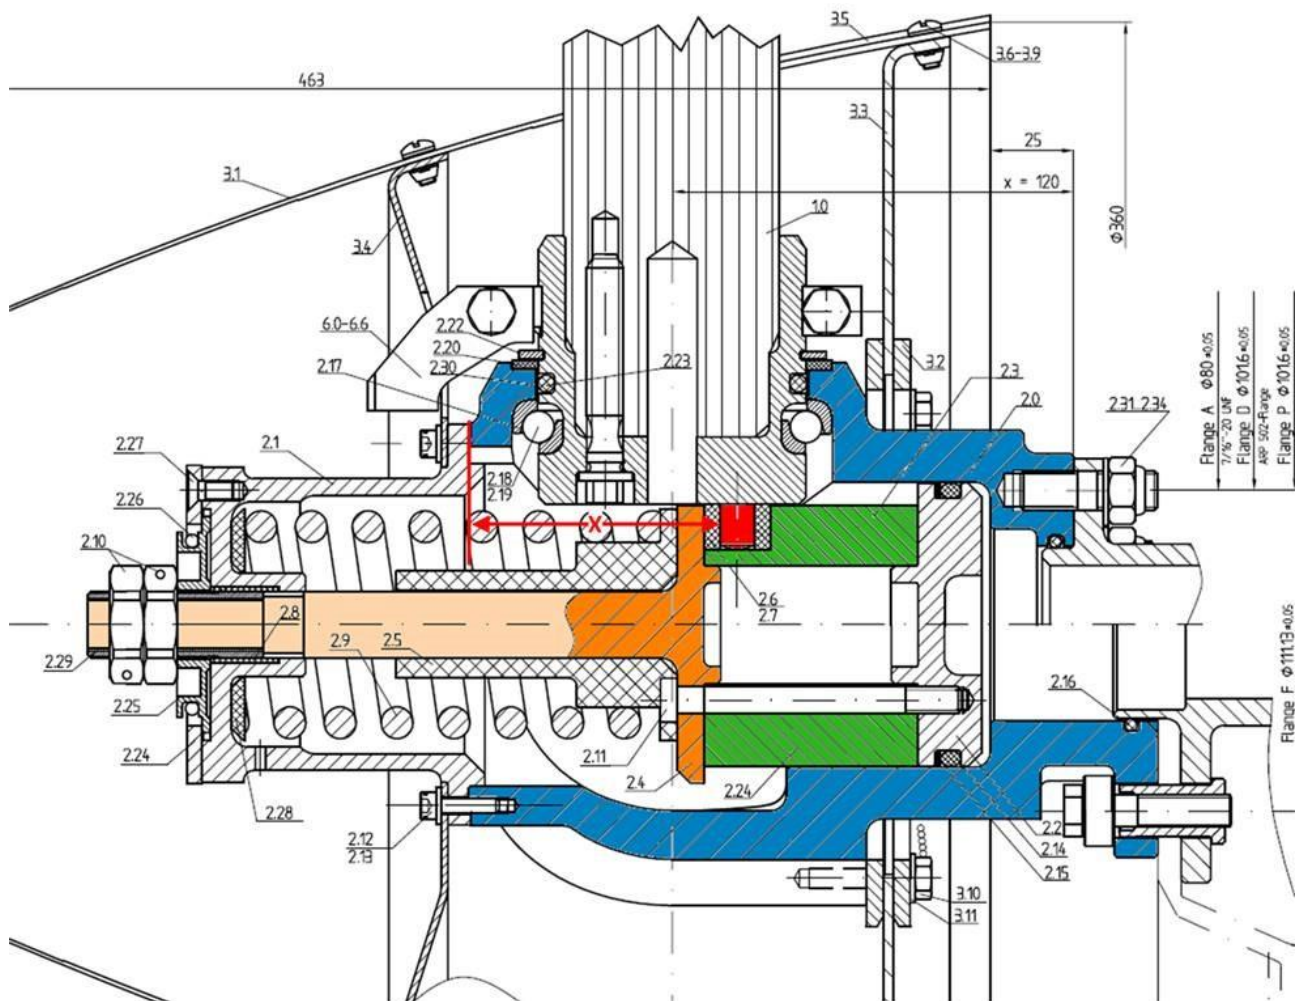
Figure 23: Section drawing of propeller. Source: MT-Propeller/NSIA

The left propeller was heavily damaged and the front housing (2.1), including the return spring (2.9), had been knocked off. Blade 1 was broken near the middle. The two other blades were broken at the root. The hub (highlighted in blue in the drawing) had fractured and blade 1 was loose. Damage to the hub made it impossible to take out the piston (highlighted in green in the drawing). Furthermore, the black plastic blocks around the guide pins (highlighted in red in the drawing) for blades 1 and 2 were fractured. To establish the blade angle, if possible, the distance from the blades' guide pins to the forward end of the hub was measured (see the red arrow in Figure 23). The following distances were measured:

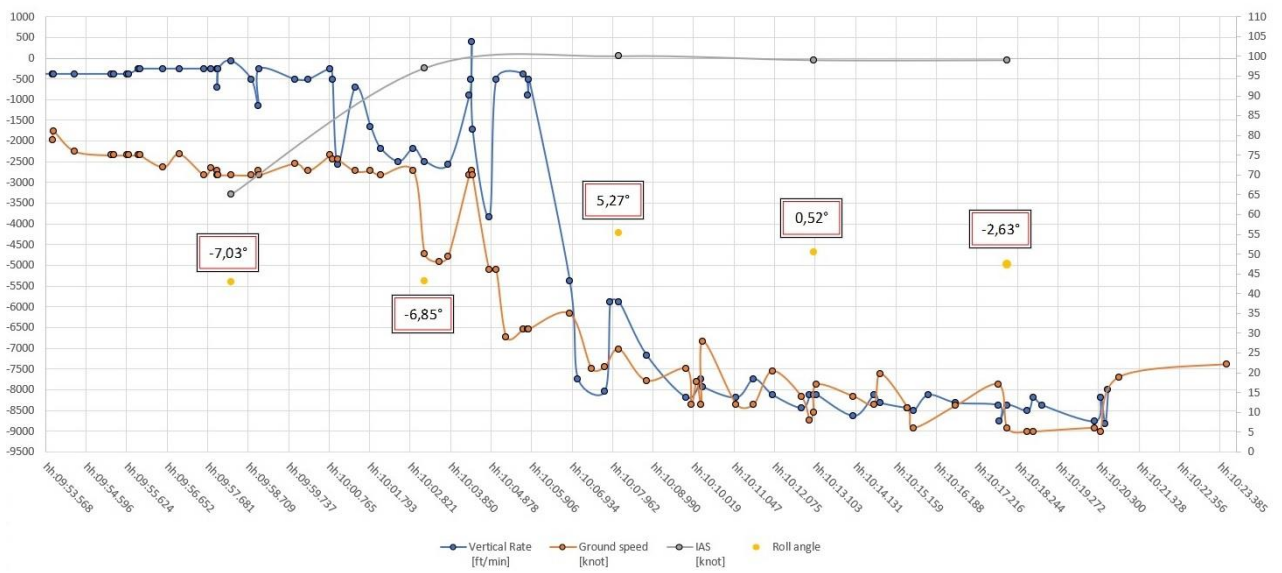
Figure 25: A compilation of data for the final 30 seconds for which data were available. The scale on the left shows vertical speed in feet per minute. The scale on the right shows speed in knots. Data for roll angle is indicated as yellow dots. Negative angles indicate rolling to the left. The graph was prepared by the NSIA

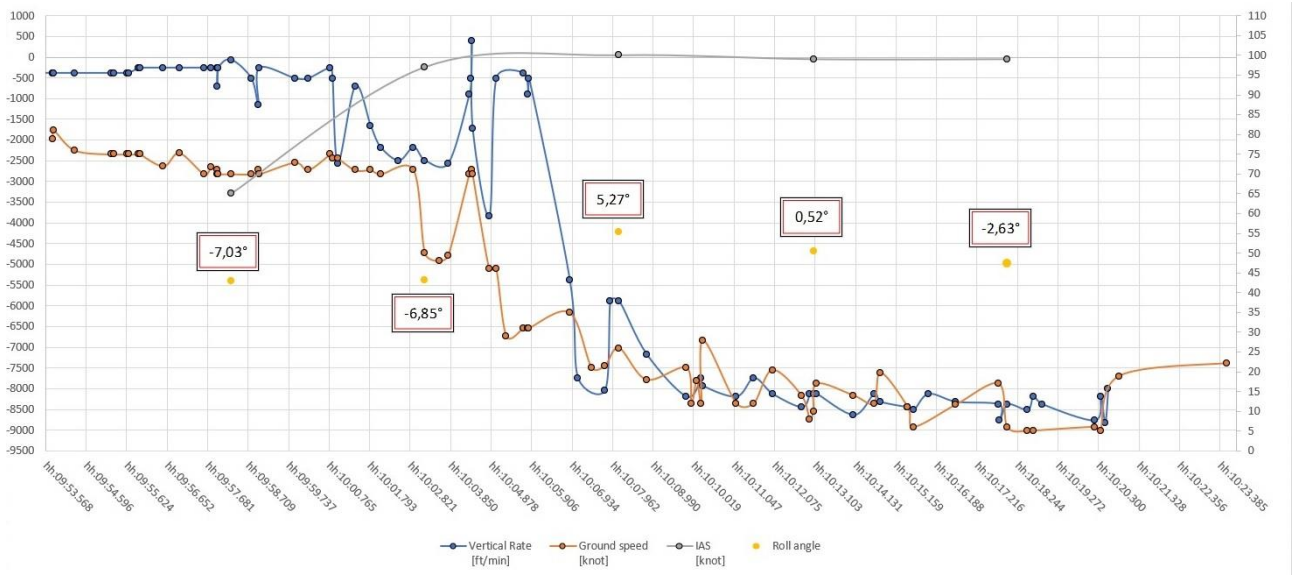
As suggested by Diamond Aircraft Industries' test pilot, the airplane probably oscillated a few times before gaining a stable sink rate after 7–8 seconds. That would explain the initial wide variations in sink rate and ground speed (GS) shown in Figure 31.

Figure 31: A compilation of data for the final 30 seconds for which data were available. The scale on the left shows vertical speed in feet per minute. The scale on the right shows speed in knots. Data for roll angle is indicated as yellow dots. Negative angles indicate rolling to the left. The graph was prepared by the NSIA
