Published December 2023

REPORT AVIATION 2023/09

***Air accident in Verdal in Trøndelag
County on 1 November 2022 involving
an Airbus Helicopters AS 350 B3,
LN-OBP operated by Midtnorsk
Helikopterservice AS***

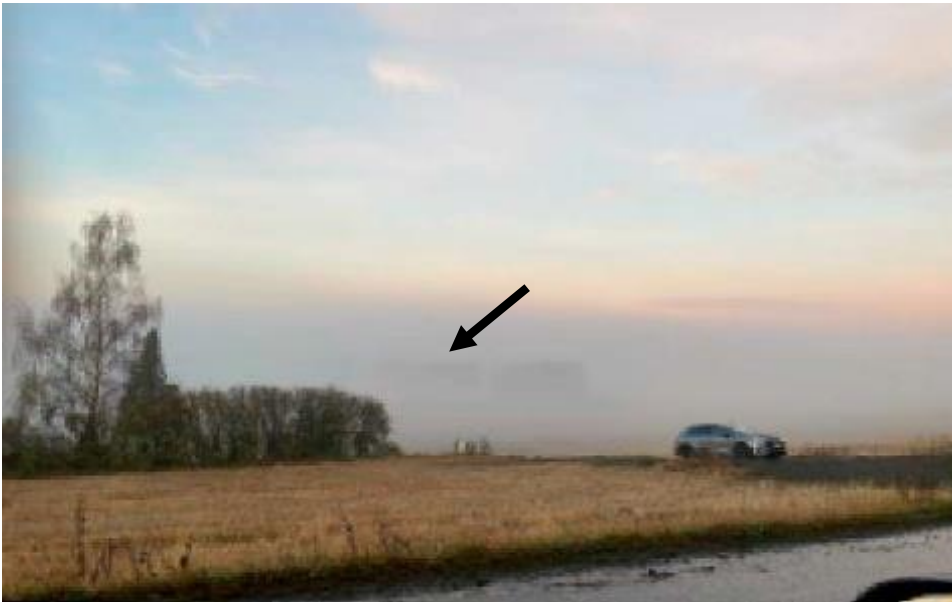
Figure 2: Photo taken by the commander at 0758 hrs about 2.5 hrs before the accident. The helicopter base is located 1.3 km behind the birch to the left in the photo. It is about 500 m to the trees in the background marked with the black arrow. Photo: The commander / NSIA

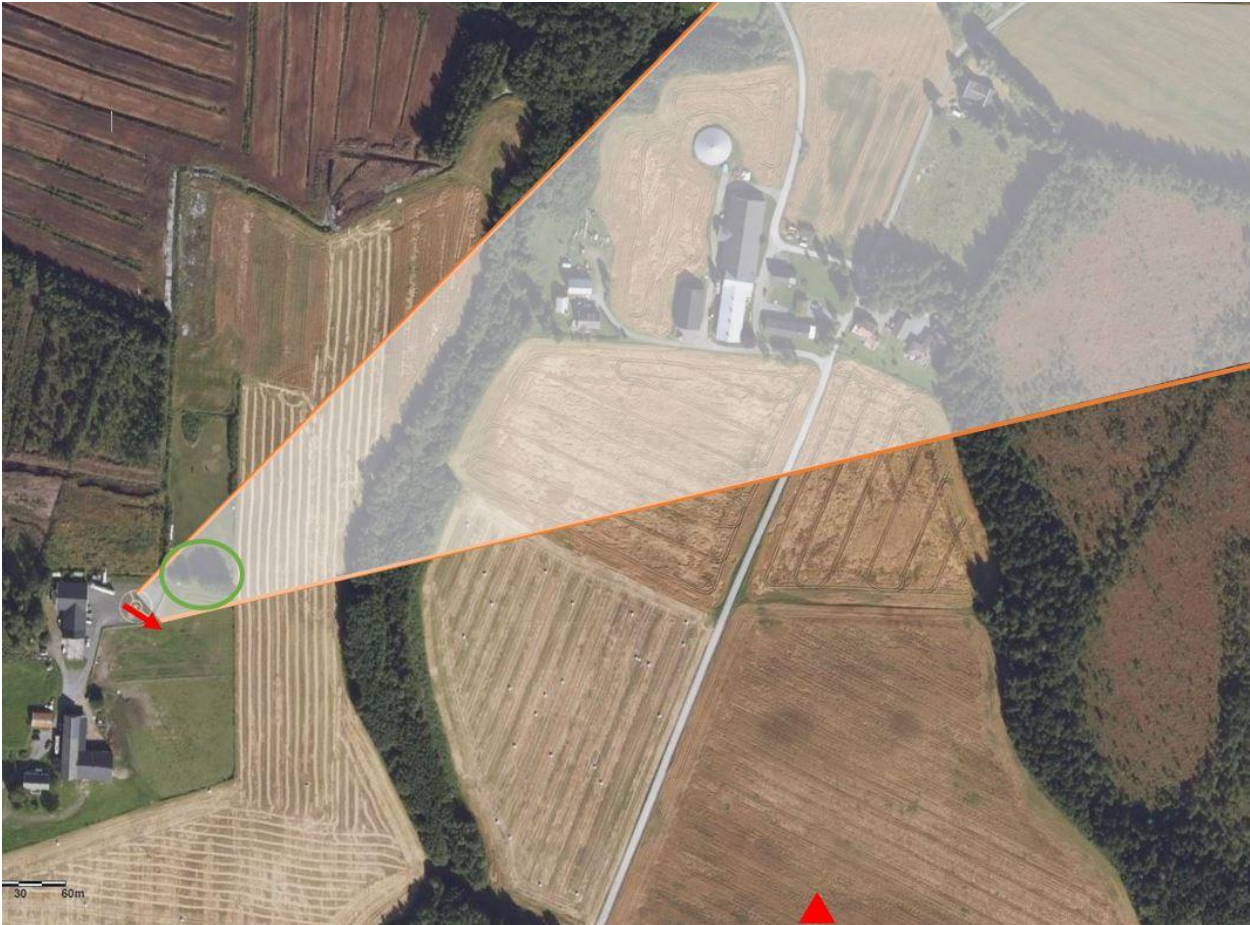
The commander has explained that, due to the improvement in the weather, he intended to perform a normal departure towards the north-east. To do this, he had to fly around a cluster of trees close to the helipad, see Figure 3 and Figure 5.

Figure 5: Map drawn based on a sketch by the commander of where he perceived an improvement in the weather (shaded area). The direction the helicopter was facing before take-off (red arrow), a cluster of trees close to the helipad (green circle) and the accident site (red triangle) are indicated. Picture: © The Norwegian Mapping Authority. Illustration: The Commander / NSIA

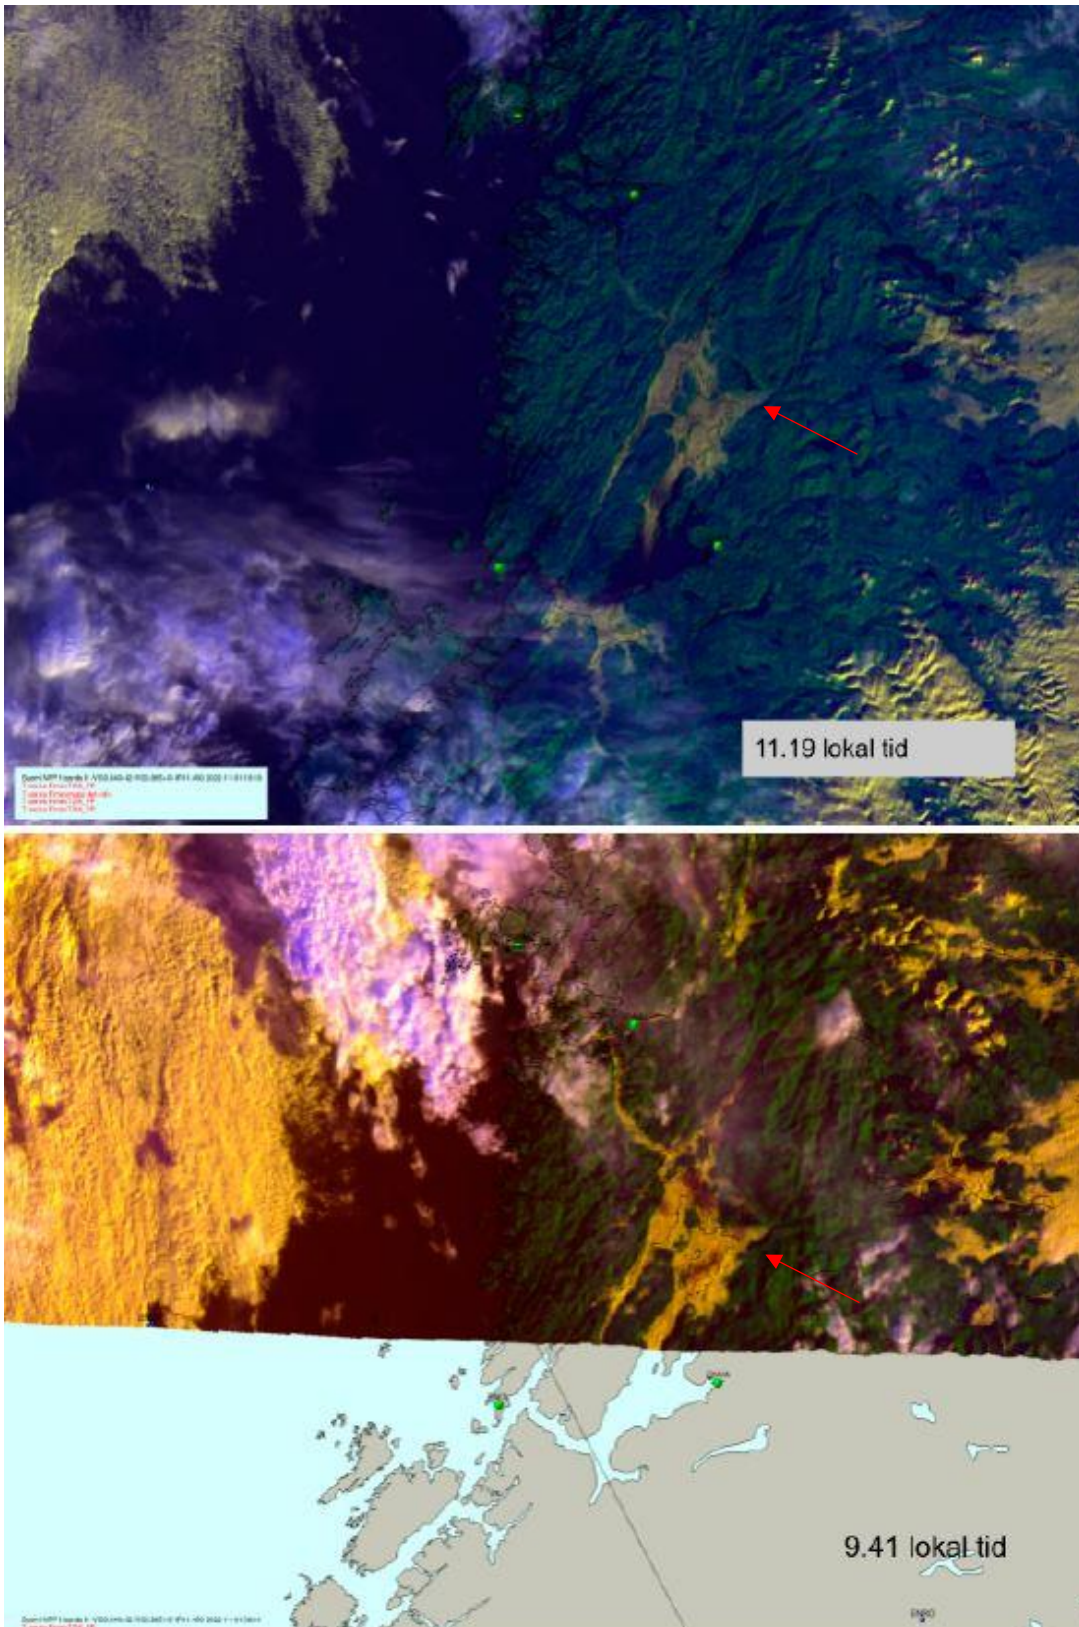
Figure 12: Satellite images of Trøndelag. Low clouds are a yellow colour, higher clouds are purple/blue or white. The red arrow indicates Verdalen. Source: The Norwegian Meteorological Institute / NSIA

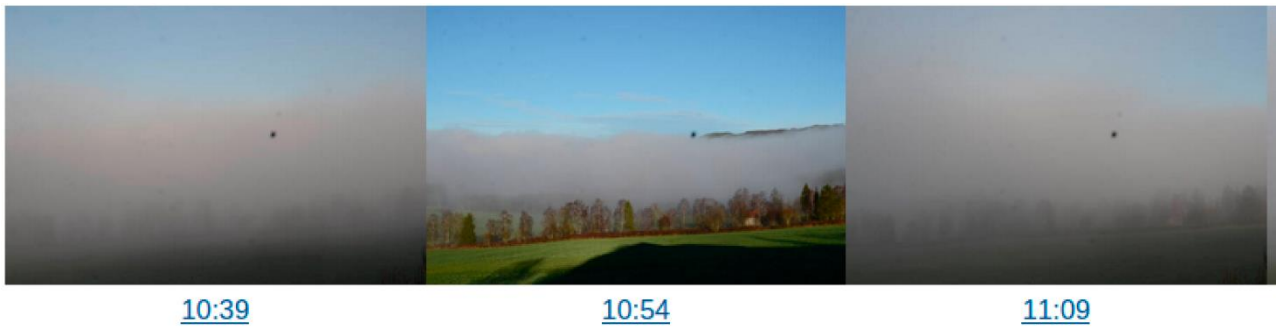
Figure 13: Photos from the HemsWX weather service taken in Namdalseid. Photo: Norwegian Air Ambulance AS / NSIA

Figure 13 shows the fog variation in Trøndelag. The photos are taken in Namdalseid, about 50 km from the accident site. The photos serve to illustrate how varied fog can be, as it can change density and coverage quickly. Visibility can also vary a lot both vertically and horizontally.

Fog is a phenomenon that can vary a lot over a short period of time. Figure 13 illustrates how great this contrast can be. In a span of 30 minutes, the fog goes from being so dense that taking off is impossible to clearing up before again condensing. The NSIA would like to emphasise that the image only shows the variation. It says nothing about how long the time window was when the fog lifted.

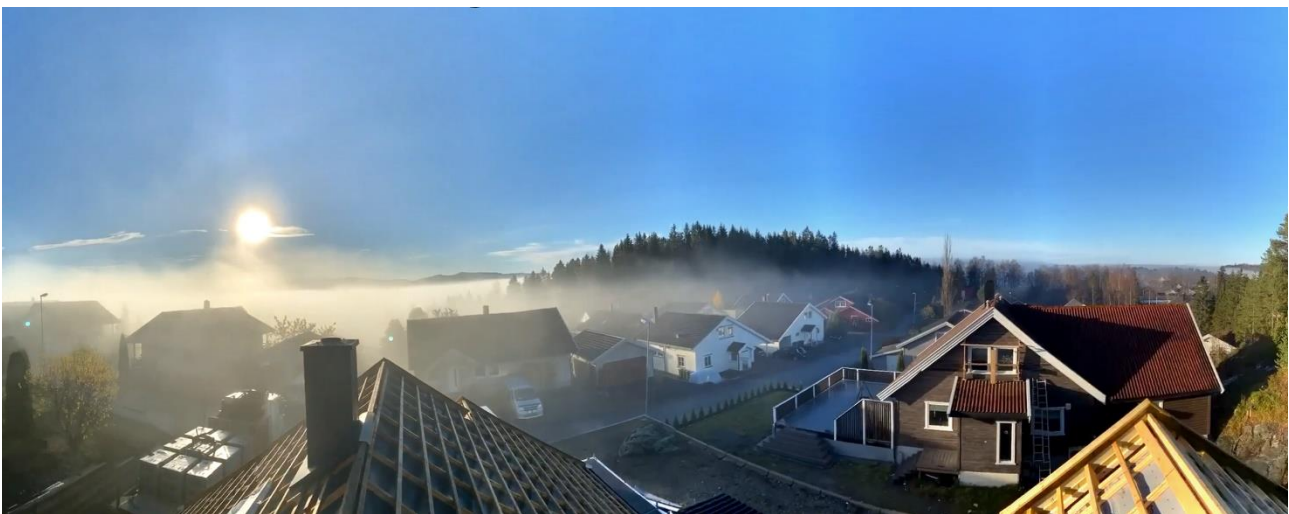
A person was laying roof tiles on a house in Forbregd Lein and took a video of the weather conditions at 1022 hrs, see Figure 14. The altitude of the houses and the fog are about 130 m above mean sea level (MSL). The helicopter company base is located behind the hill, just left of the centre of the image, and about 100 m lower. Fog can be seen on both sides of the hill.

Figure 14: Mosaic of still images from a video taken in Forbregd Lein at 1022 hrs. Photo: Private/NSIA

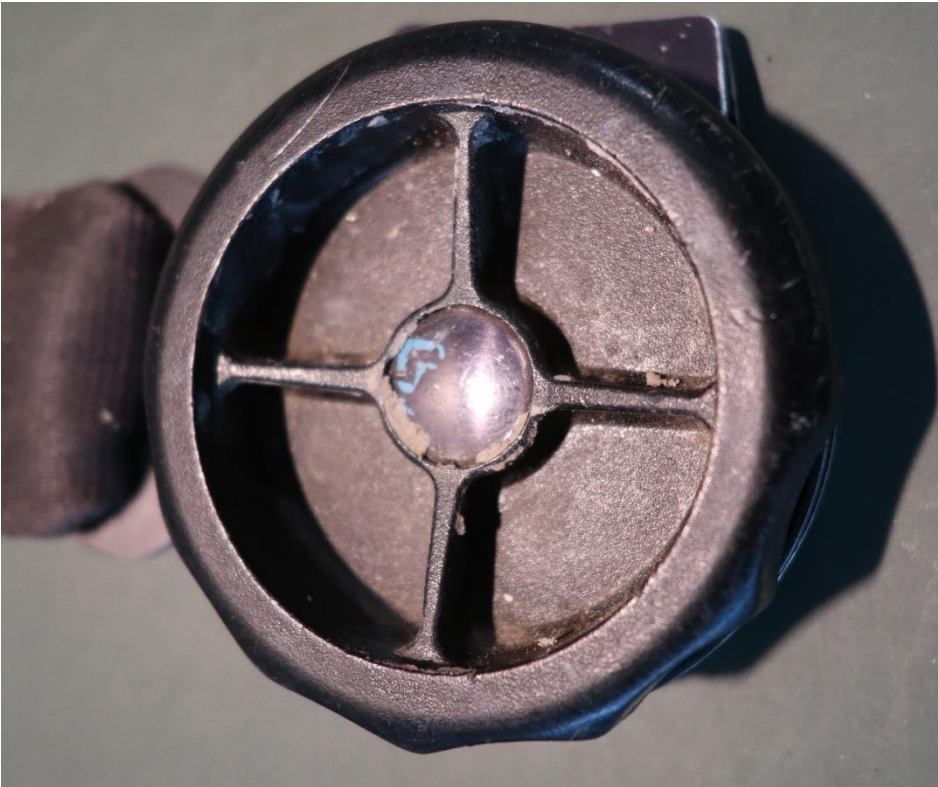
The screws that keep the rotary buckle together are zinc-plated steel screws, see Figure 20 and Figure 21. As part of the production process, the screws have to be baked at a high temperature after the plating to prevent hydrogen embrittlement¹³. The way the subcontractor performed this process meant that not all the screws were heated enough to diffuse out the hydrogen. This led to some of the screws undergoing hydrogen embrittlement and therefore fracturing when torqued. The production of rotary buckles was stopped, and all buckles already manufactured were inspected. Due to the incident in 2012, Parker-Meggitt chose to change the screw material to stainless steel in 2013, which eliminated the problem of hydrogen embrittlement.

Figure 20: The commander's intact rotary buckle to illustrate what an intact rotary buckle looks like. The ring is twisted to release the straps. One of the straps is permanently attached. Photo: NSIA

issued two safety bulletins (SB 1111548-25-001-2023 and SB 1111475-25-001-2023) informing customers about the issue and how to correct it. The FAA and EASA has informed the NSIA that they will issue Airworthiness Directives, which make the correction mandatory. The NSIA therefore does not issue any safety recommendation about this.

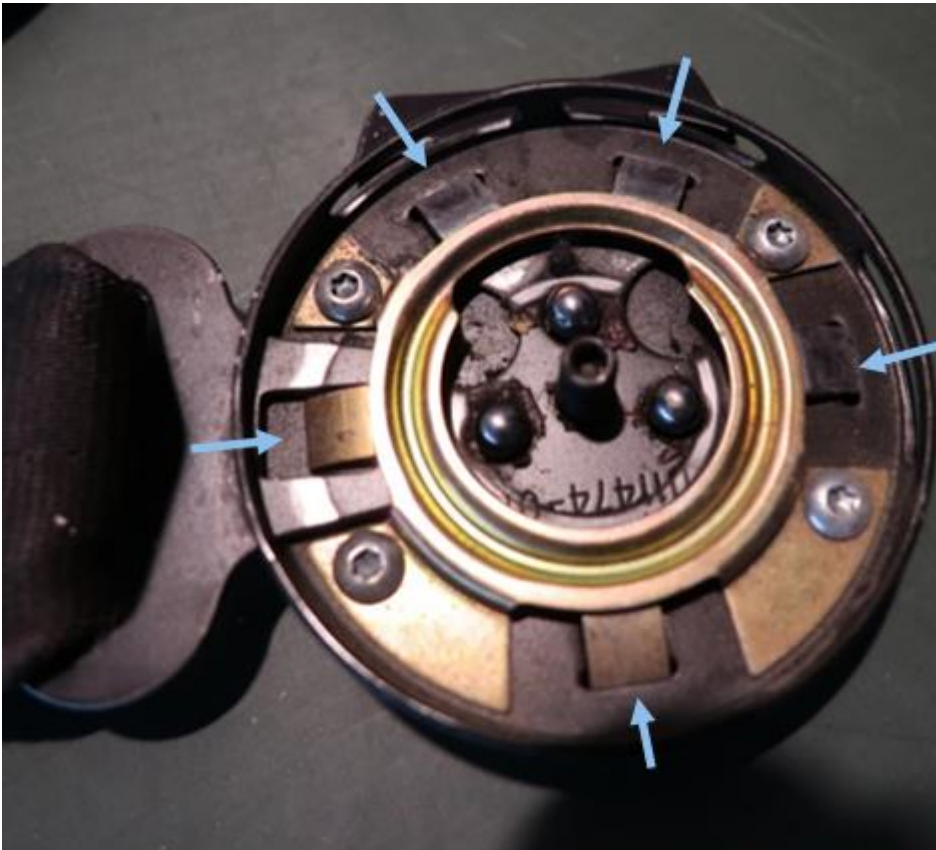
Figure 21: The commander's intact rotary buckle to illustrate what it looks like with the twist grip removed. The four intact screws are clearly visible. The five blue arrows point to the retainers that keep the straps fastened horizontally. The gold coloured part that the screws are fastened through is the thrust plate that keeps the straps fastened vertically. Photo: NSIA
