AVIATION 2024/04

***Aviation incident in Bergen on
26 August 2022 involving a DJI Mavic 3
drone, LN-02023CM, operated by TV 2
Luftfoto***

Report on aviation incident

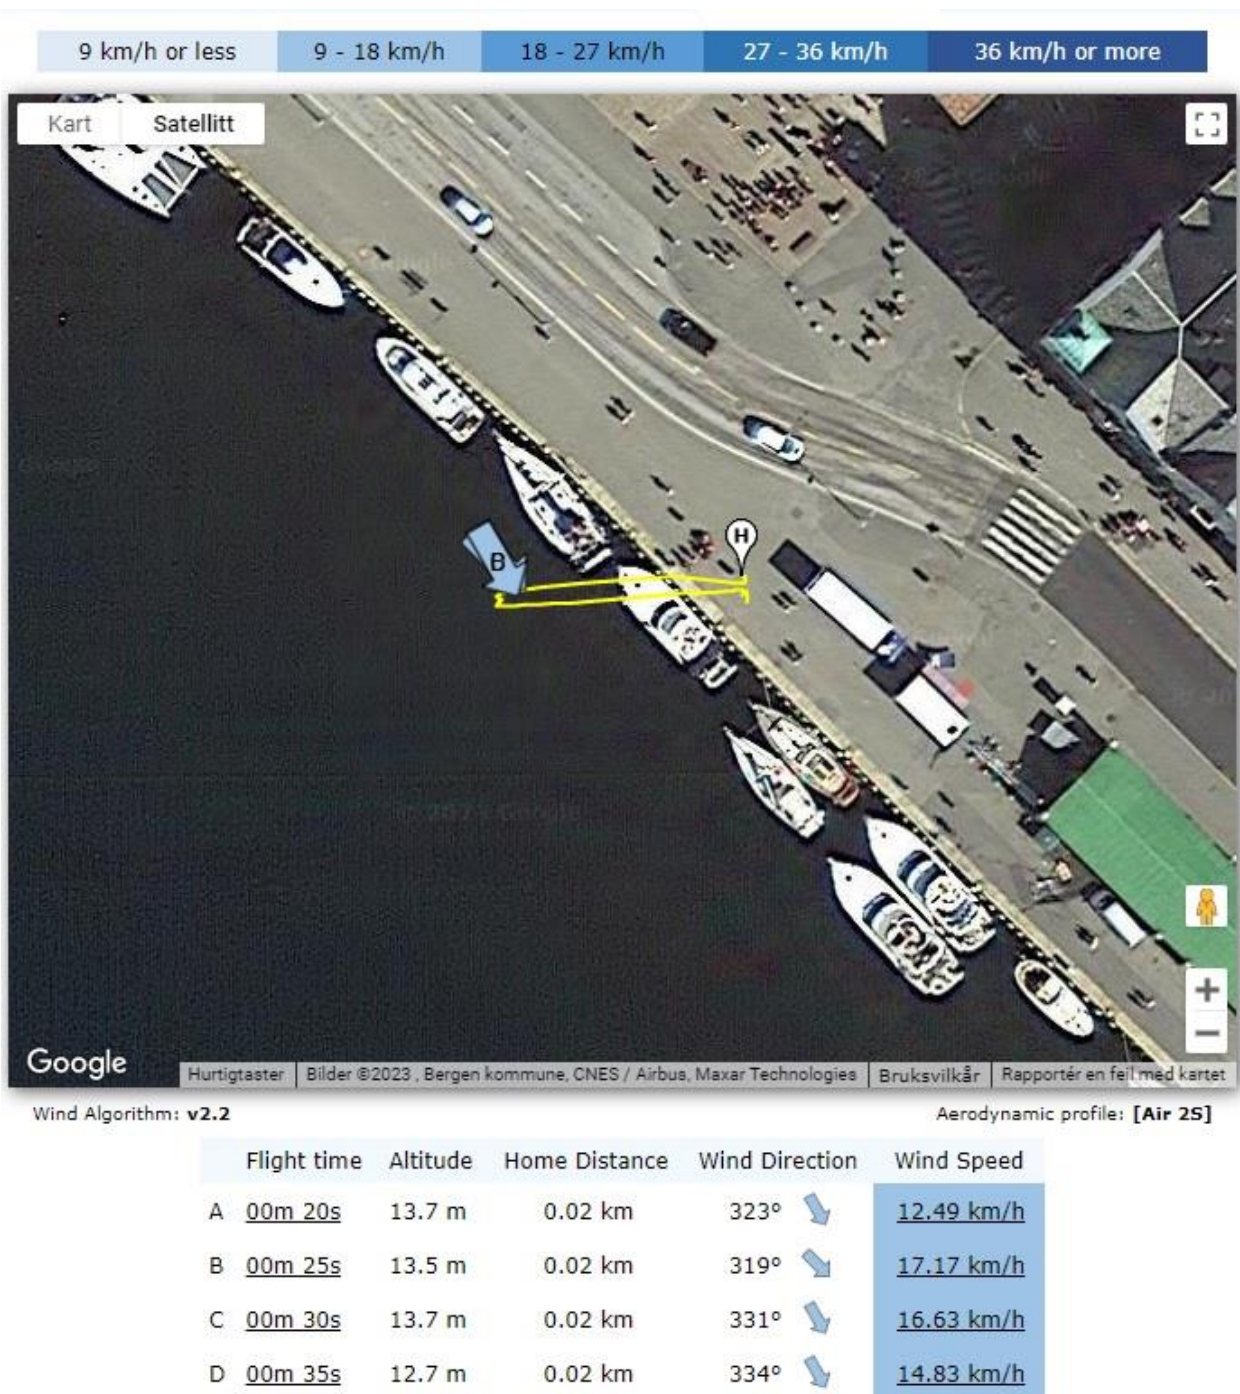
The operational manager flew his DJI Air2S drone at the same time as the drone pilot. Wind data from DJI Air2S were used in the investigation because Mavic 3 did not record a sufficient number of datapoints before it crashed.

Figure 3: Wind calculation based on data from Mavic Air2S drone in the same area during the period in question. Source: TV 2 / NSIA

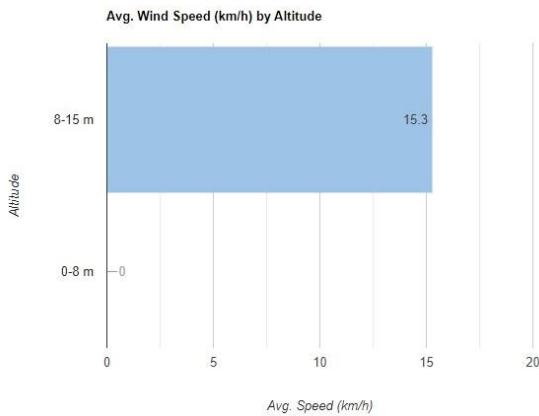
Figure 4: Wind speed at altitude registered by DJI Air2S Source: TV 2 / NSIA

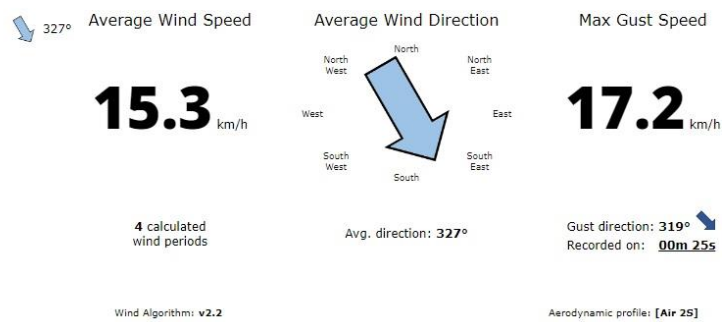
Figure 5: Wind speed and direction registered by DJI Air2S. Source: TV 2 / NSIA

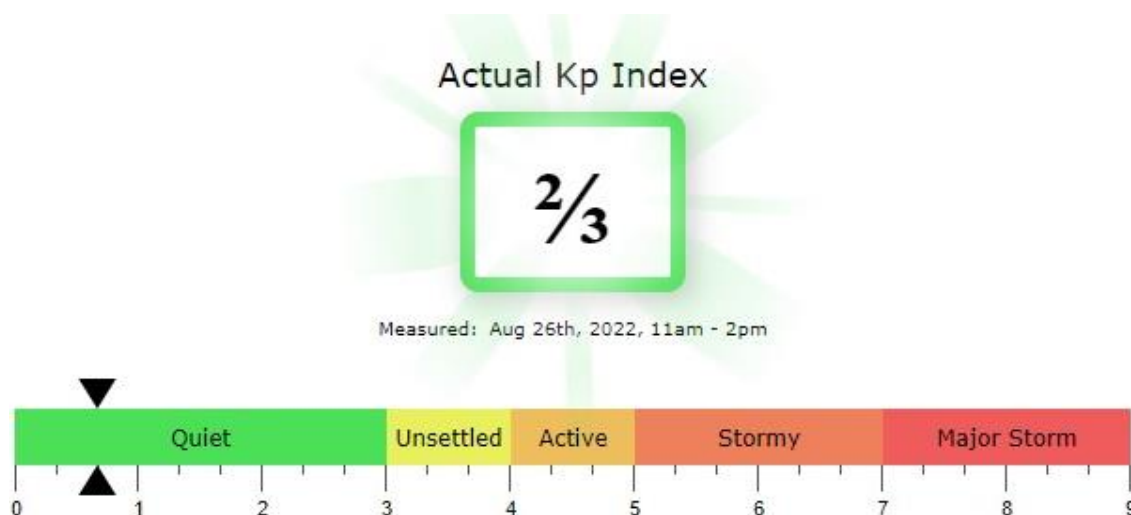
Figure 8 shows how the Kp index, which is an index for geomagnetic disruption of the signal between the drone and remote controller, is calculated.

The Kp Index measures geomagnetic disruption caused by solar activity around the world, on a scale from 0 (calm) to 9 (major storm).

The higher the Kp index, the more likely the drone is to have problems.

Figure 8: Kp index from Airdata. Source: TV 2 / NSIA

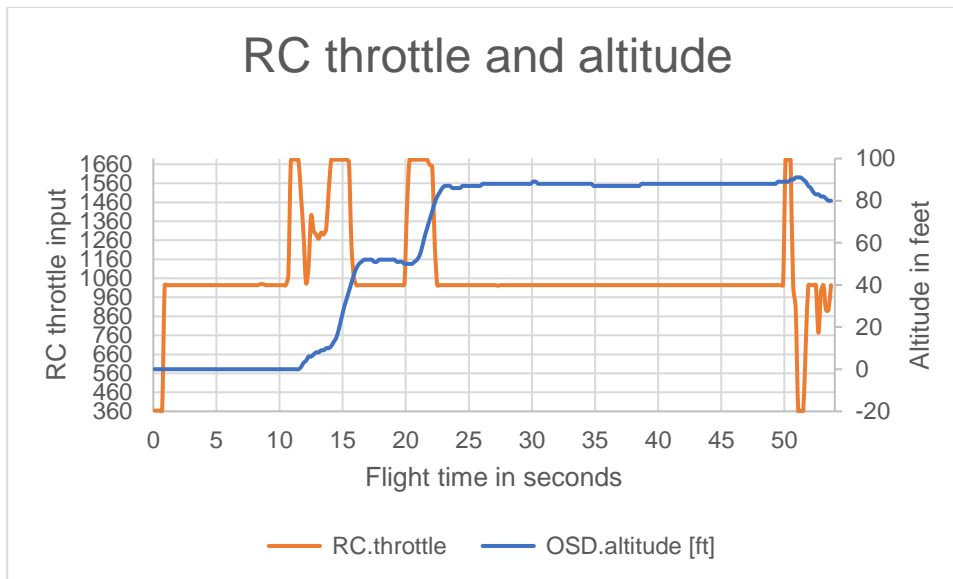
Moving the left control stick on the remote controller forward or backward sent a command to the drone to either ascend or descend. The flight record refers to this control stick as *RC throttle*. Input from *RC throttle* can be compared to the drone's altitude, shown in Figure 17, and its vertical speed, shown in Figure 18.

Figure 17: Altitude command input and the drone's altitude. Source: TV 2 / NSIA
