REPORT

AVIATION 2024/06

Aviation accident on 28 April 2023 at Rønneld airfield for model aircraft near Skjeberg, Norway, involving a 1:2 scale remotely piloted ASG-29 glider

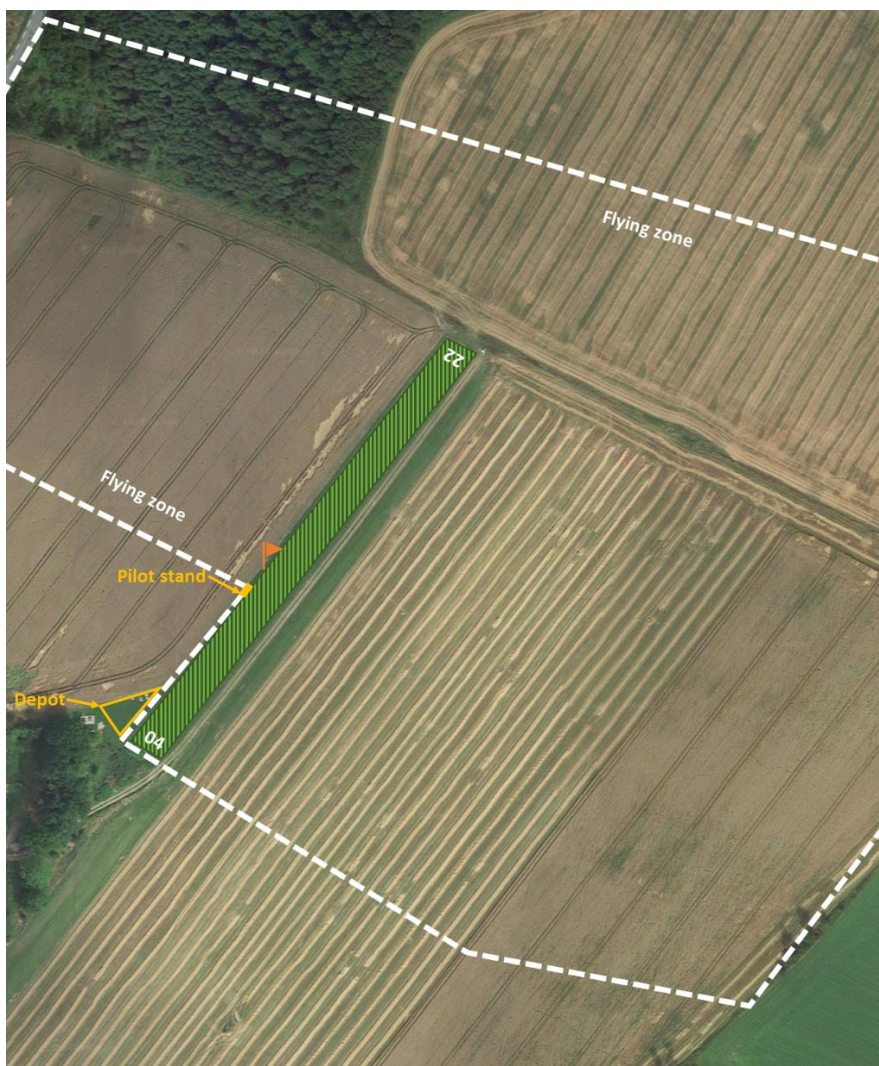
About 80 metres from the threshold of runway 04, on the west side of the runway there is a pilot stand with a low safety net (about 1 m) and a windsock.

Figure 2: Outline of Rønneld airfield and the surrounding areas. Photo: Google Earth. Illustration: NSIA
