REPORT AVIATION 2024/07

***Air incident during approach to Bergen
Airport Flesland, Norway 11 June 2022
with Airbus A320-232, HA-LWZ, operated
by Wizz Air Hungary Kft***

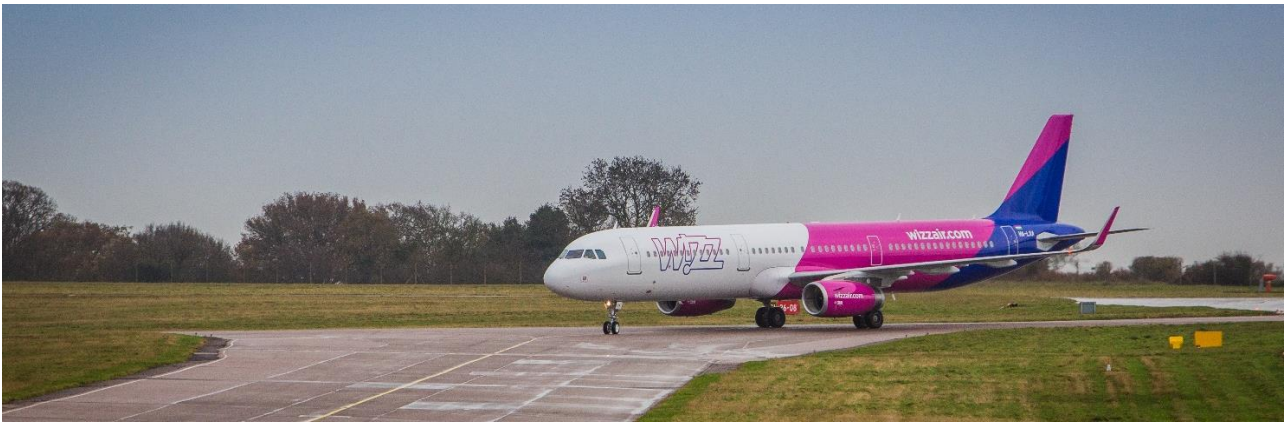
On Saturday 11 June 2022, Wizz Air flight number W6-2151 was enroute from Szczecin Airport Goleniow (EPSC) in Poland to Bergen Airport, Flesland (ENBR). The aircraft was an Airbus A320, see Figure 1.

Figure 1: An Airbus A320 from Wizz Air. Photo: Wizz Air/NSIA

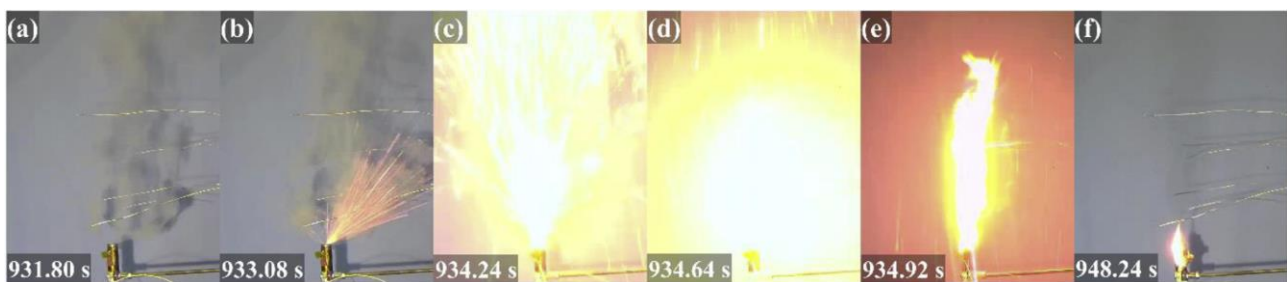
A TR will create a lot of heat that will propagate to other cells, and an increasing number of cells will reach the critical threshold temperature. During a TR, flammable, toxic and acidic gases will form, as well as oxygen. First, the electrolyte will ignite, and then the metals and other solids will catch fire. Due to the release of oxygen, a fire will be completely or partly self-sustaining. The development is illustrated in Figure 3.

Figure 3: The last part of a TR in a LIB cell. The left picture shows when the cell starts to release gases, and then ignition and fire. The time stamp in seconds down to the left in each picture is with reference to the start of the experiment. Source: «An experimental study on thermal runaway characteristics of lithium-ion batteries with high specific energy and prediction of heat release rate», Haodong Chen, Jonathan E.H. Buston, Jason Gill, Daniel Howard, Rhiannon C.E. Williams, Chandra M. Rao Vendra, Ashish Shelke, Jennifer X. Wen / NSIA.

During a fire, the temperature in the cell can reach 900 °C, and the jet flame can exceed 1,000 °C.
