REPORT AVIATION 2024/11

Aviation accident at Villmobakken airstrip on Vannøya in Troms County on 6 August 2024 involving a Vans RV-14, SP-YBI

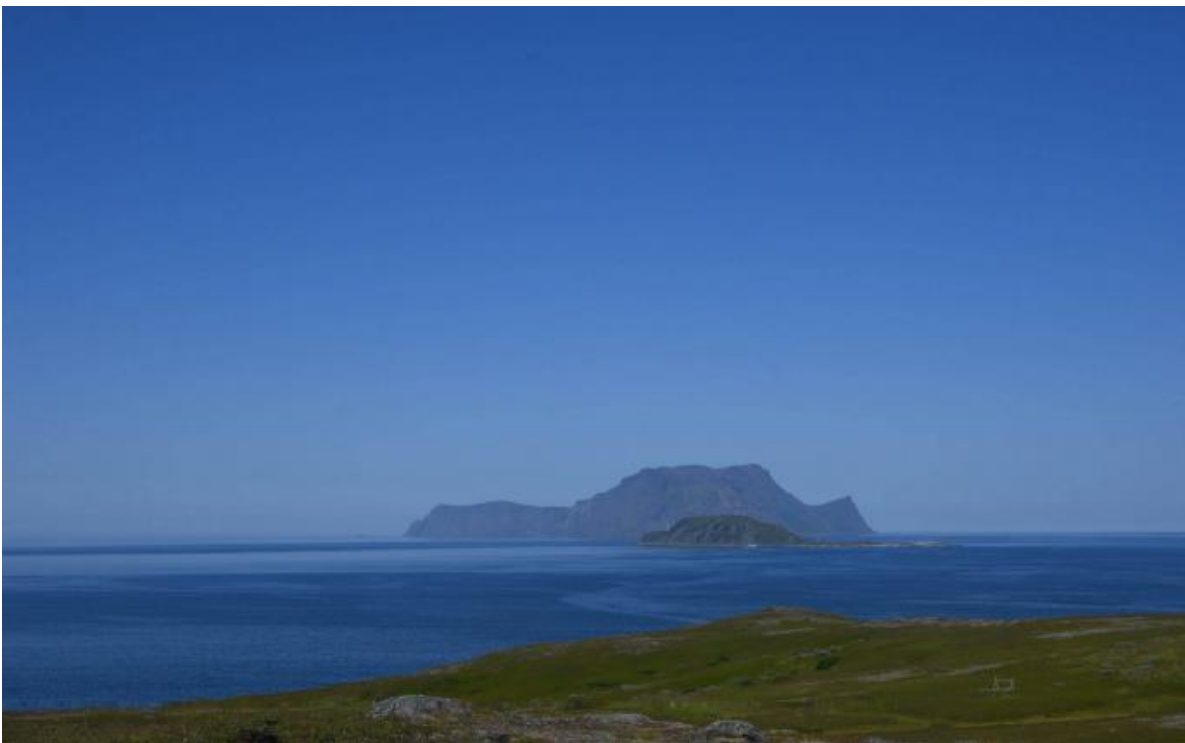
The weather report from the Norwegian Meteorological Institute contains photos from the HEMSWX² station in the south-east of Vannøya. The photos show very good summer weather (see Figure 5).

Figure 5: Photo from the HEMSWX station located southeast on Vannøya, approx. 1.5 hours after the accident. Source: Norwegian Meteorological Institute / NSIA
