AVIATION 2025/01

Aviation accident at Songesand, Sandnes municipality, Rogaland on 16 November 2020 involving Airbus Helicopters AS 350 B3, LN-OAX, operated by Heli-Team AS

Air accident report

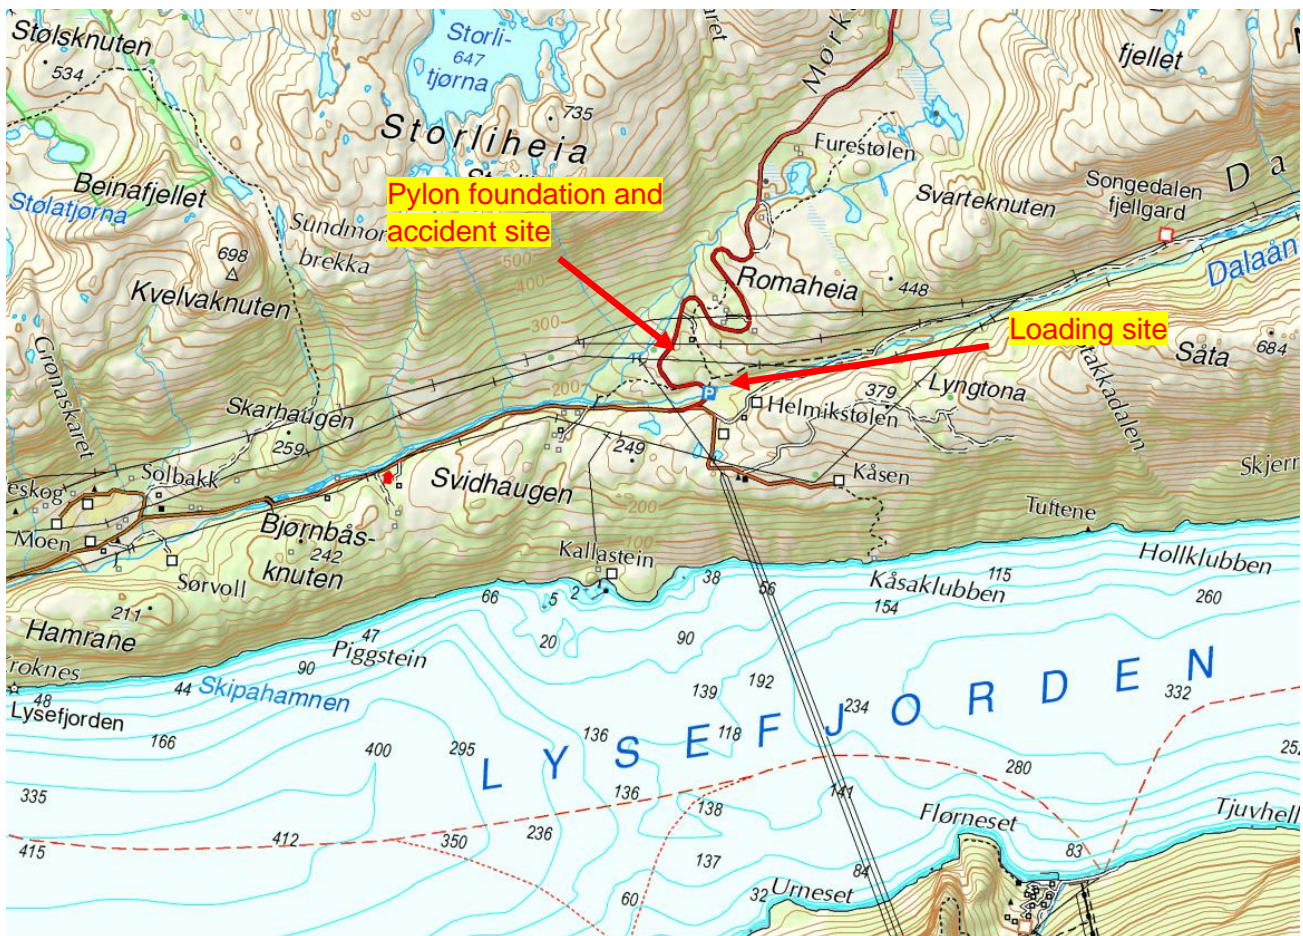
Figure 1: Map of the area showing the loading site and pylon foundation 49. Map: The Norwegian Mapping Authority. Markings: NSIA

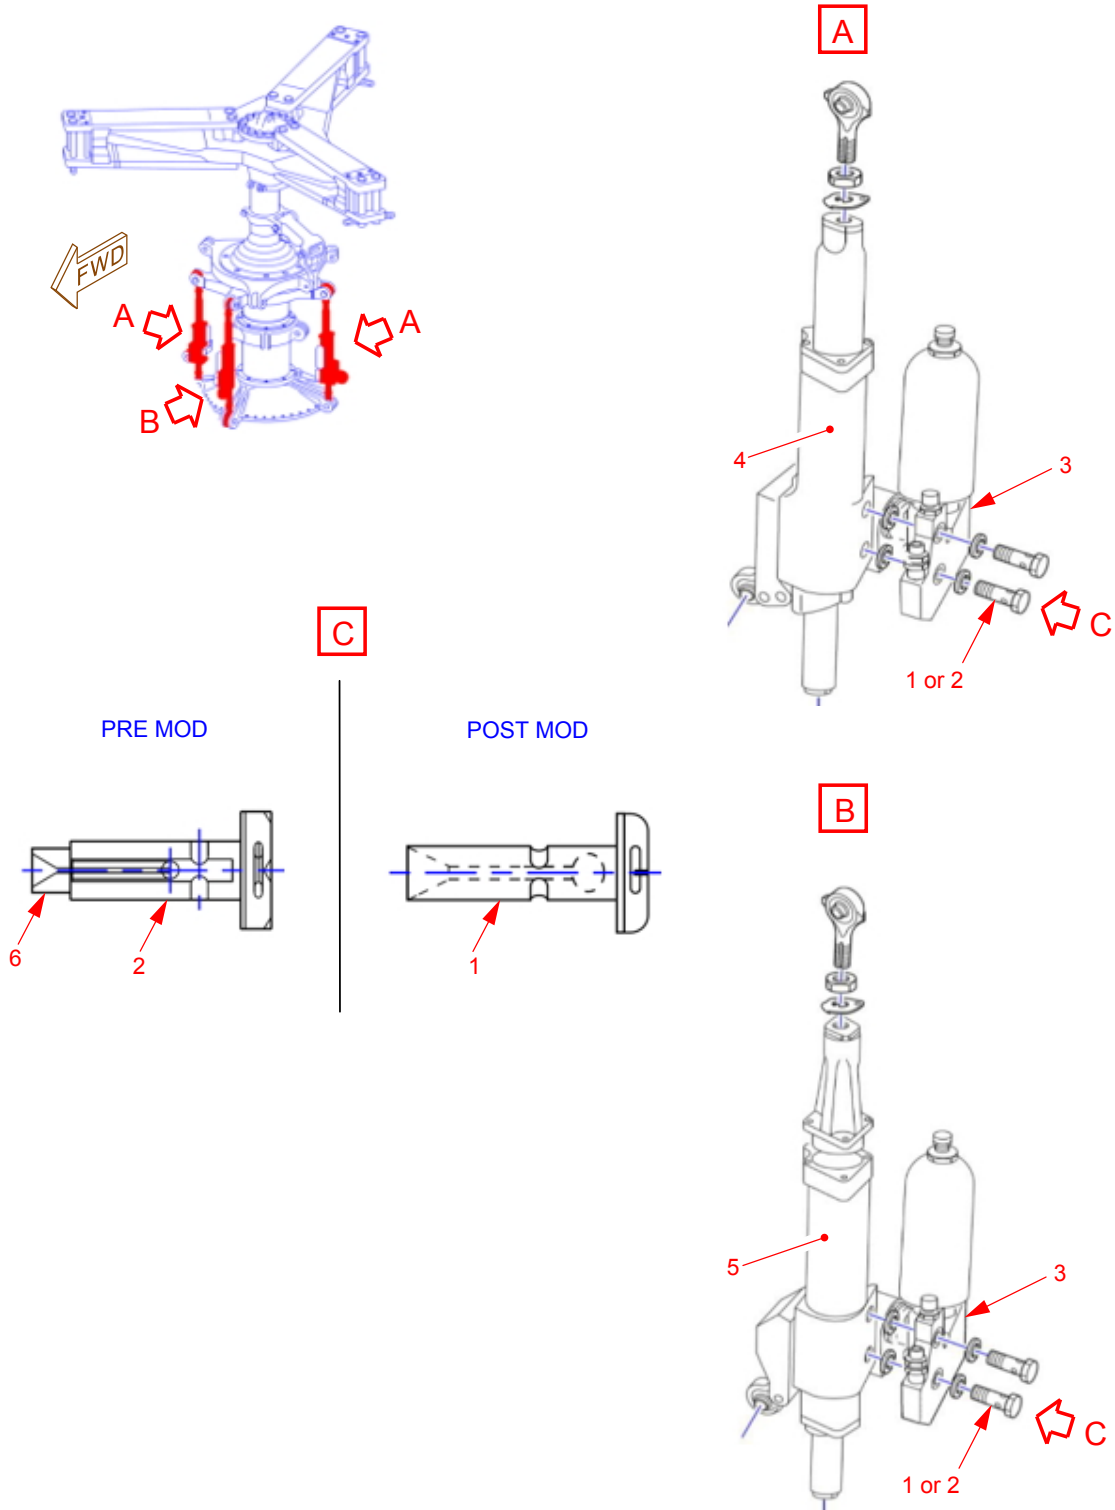
Figure 1

For helicopters POST MOD 073152, a restrictor (6) is installed in the banjo screw (2).

- 4.1. Remove the banjo screws (2) ([Figure 1](#)) from the manifold assemblies (3) of the main servo-controls (4) and (5):
- For helicopter version B2 or B3, refer to Stripping / Dressing - Main servocontrol - Rotor actuators (Single hydraulic) [AMM 67-32-00, 4-2.](#)
 - For helicopter version B, BA, BB, B1, D or L1, refer to Accessories installed on the main rotor actuator: Removal - Installation - Rotor actuators / Load compensator [MET 67-30-00-401.](#)
- 4.2. Discard the banjo screws (2) and, if installed, their restrictors (6).

- 4.3. Install the Banjo screw 350A08-2321-20 (1) on the manifold assemblies (3) of the main servo-controls (4) and (5):
- For helicopter version B2 or B3, refer to Stripping / Dressing - Main servocontrol - Rotor actuators (Single hydraulic) [AMM 67-32-00, 4-2.](#)
 - For helicopter version B, BA, BB, B1, D or L1, refer to Accessories installed on the main rotor actuator: Removal - Installation - Rotor actuators / Load compensator [MET 67-30-00-401.](#)
