Published February 2025

# REPORT

AVIATION 2025/01

***Aviation accident at Songesand, Sandnes municipality, Rogaland on 16 November 2020 involving Airbus Helicopters AS 350 B3, LN-OAX, operated by Heli-Team AS***

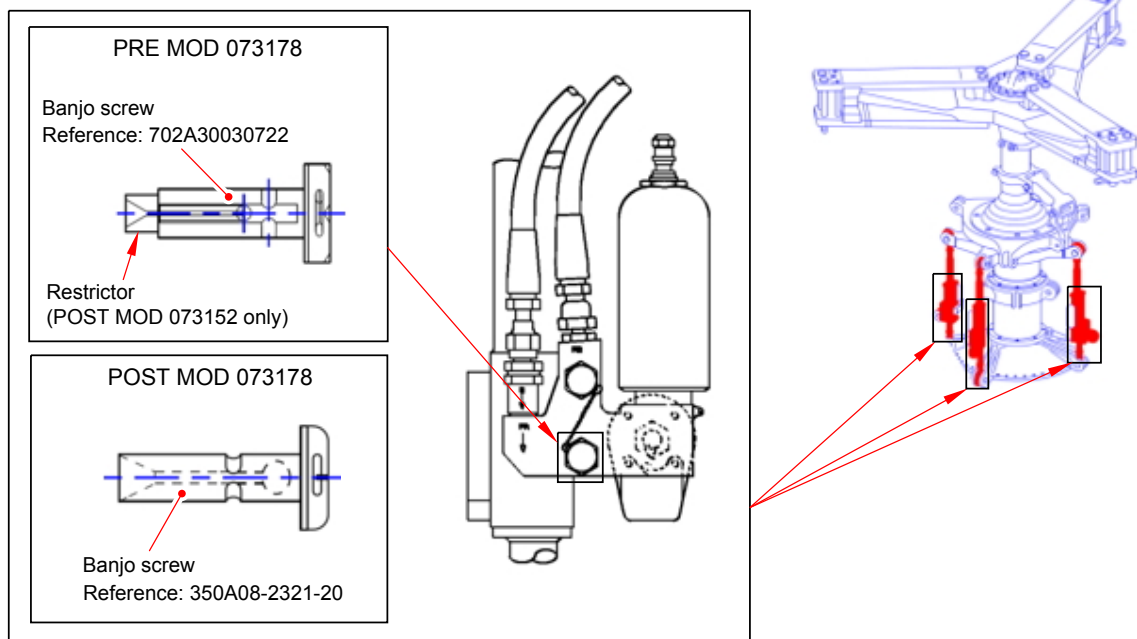
### GENERAL ILLUSTRATION

The banjo screw reference: 350A08-2321-20 is painted in blue.

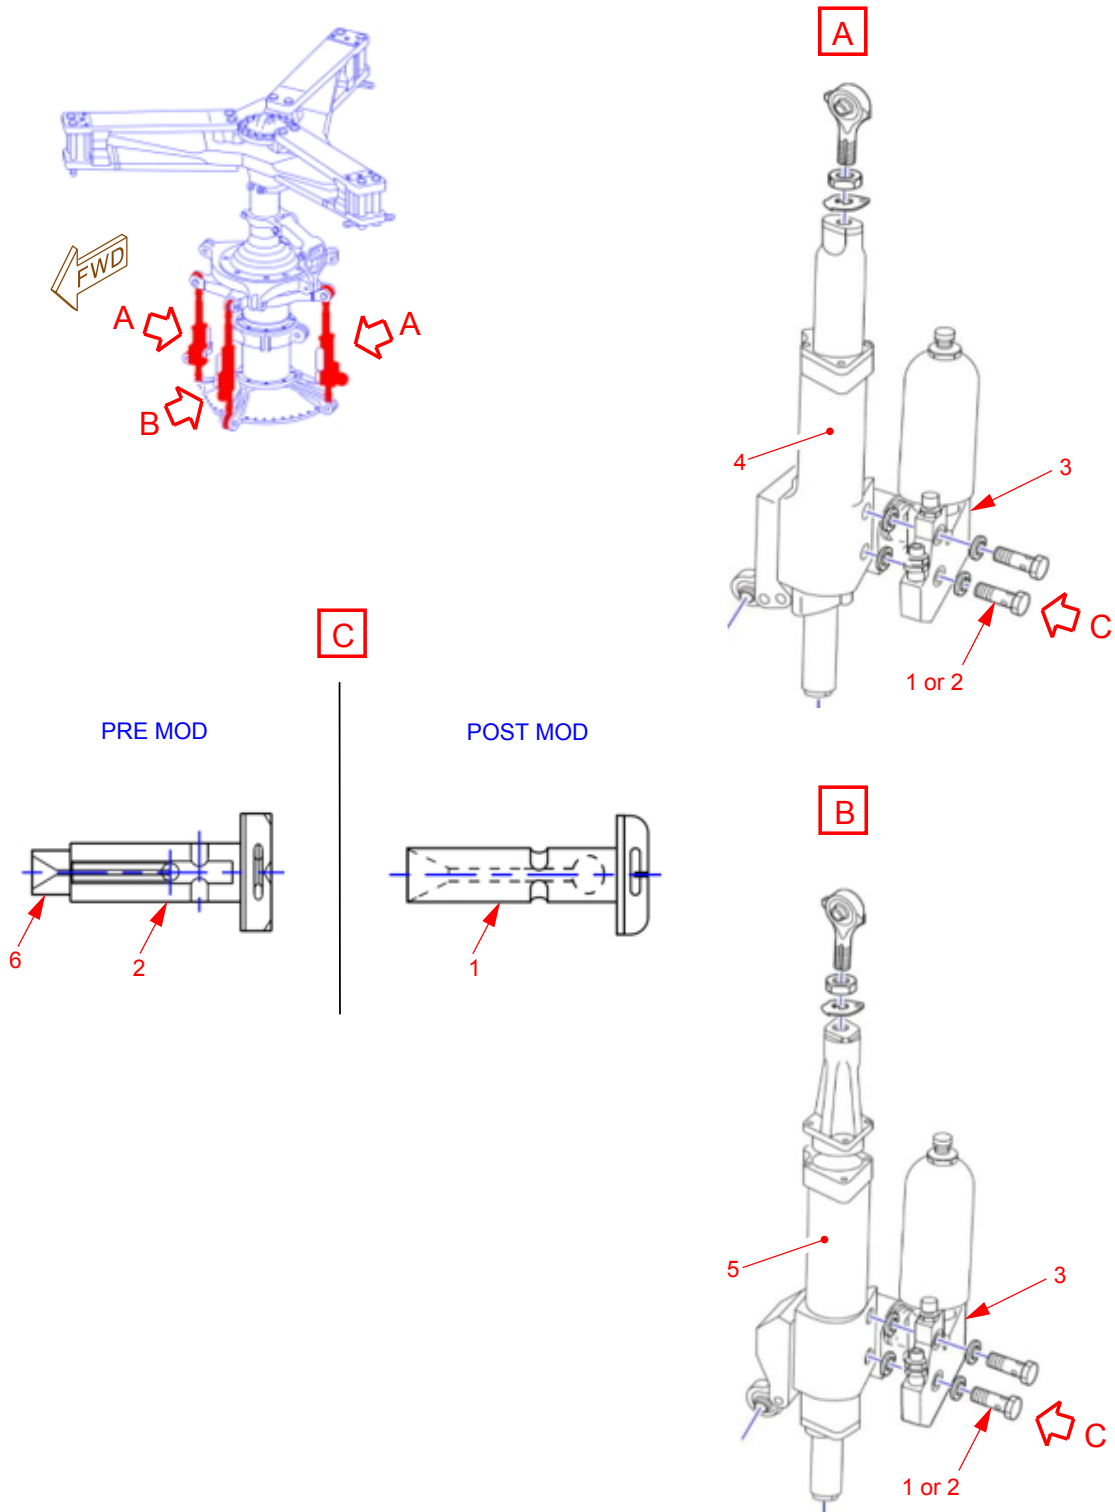
Figure 1

For helicopters POST MOD 073152, a restrictor (6) is installed in the banjo screw (2).

- 4.1. Remove the banjo screws (2) ([Figure 1](#)) from the manifold assemblies (3) of the main servo-controls (4) and (5):
- For helicopter version B2 or B3, refer to Stripping / Dressing - Main servocontrol - Rotor actuators (Single hydraulic) [AMM 67-32-00, 4-2.](#)
  - For helicopter version B, BA, BB, B1, D or L1, refer to Accessories installed on the main rotor actuator: Removal - Installation - Rotor actuators / Load compensator [MET 67-30-00-401.](#)
- 4.2. Discard the banjo screws (2) and, if installed, their restrictors (6).

- 4.3. Install the Banjo screw 350A08-2321-20 (1) on the manifold assemblies (3) of the main servo-controls (4) and (5):
- For helicopter version B2 or B3, refer to Stripping / Dressing - Main servocontrol - Rotor actuators (Single hydraulic) [AMM 67-32-00, 4-2.](#)
  - For helicopter version B, BA, BB, B1, D or L1, refer to Accessories installed on the main rotor actuator: Removal - Installation - Rotor actuators / Load compensator [MET 67-30-00-401.](#)
