REPORT AVIATION 2025/03

Serious aviation incident at Skjetten in Akershus County, Norway on 20 January 2024 involving an Aquila AT01, LN-NRC

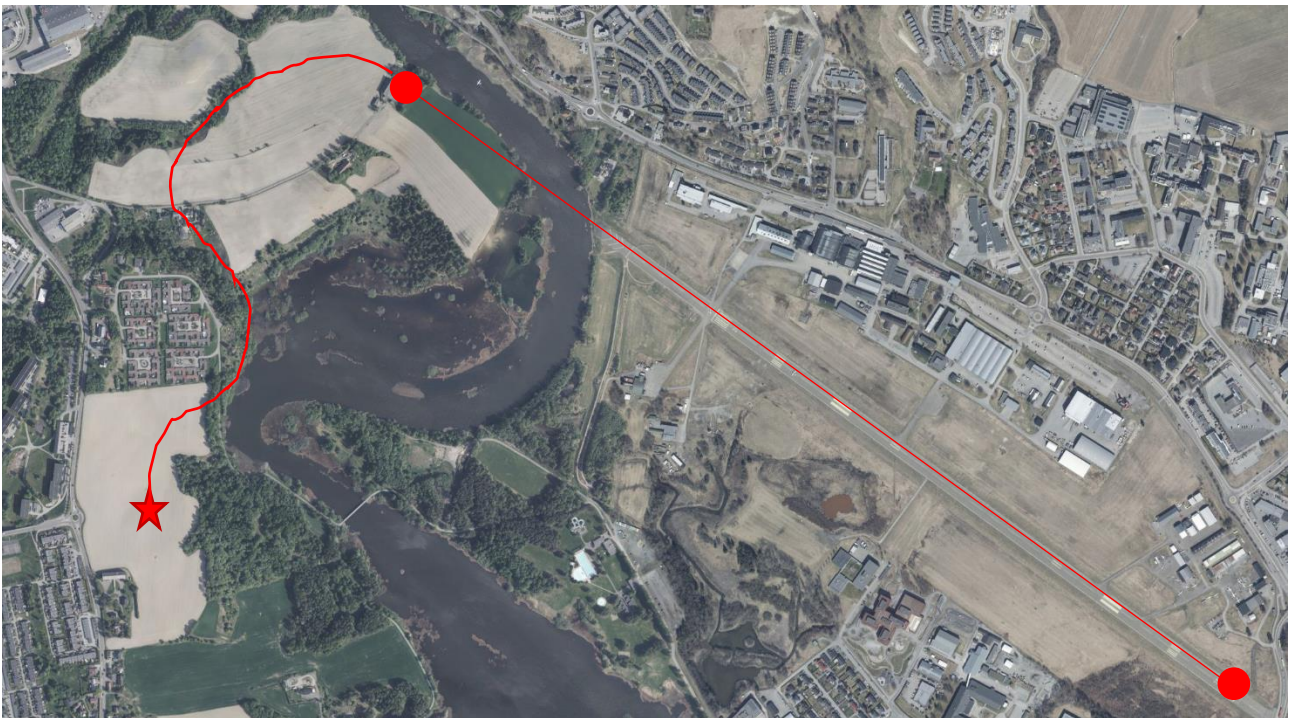
The pilot is familiar with the area around the airport and immediately started a left hand turn to land in a snow-covered field at Skjetten (Figure 1). The field is well known among pilots at Kjeller as a suitable emergency landing site if the engine should cut out during climb-out from runway 30. The pilot considered he had enough energy and elected not to fly over some houses and performed the emergency landing as normal as possible. The deceleration was so sudden that the nose-wheel broke (Figure 2). After the emergency landing, the pilot shut off power and the fuel supply. He then evacuated the aircraft and notified the emergency services.

Figure 1: Satellite image of Kjeller airfield. The aircraft flight path is illustrated by the NSIA. The red circles are take-off position and engine failure, the red star is the emergency landing site. Photo: © norgeskart.no
Illustration: NSIA

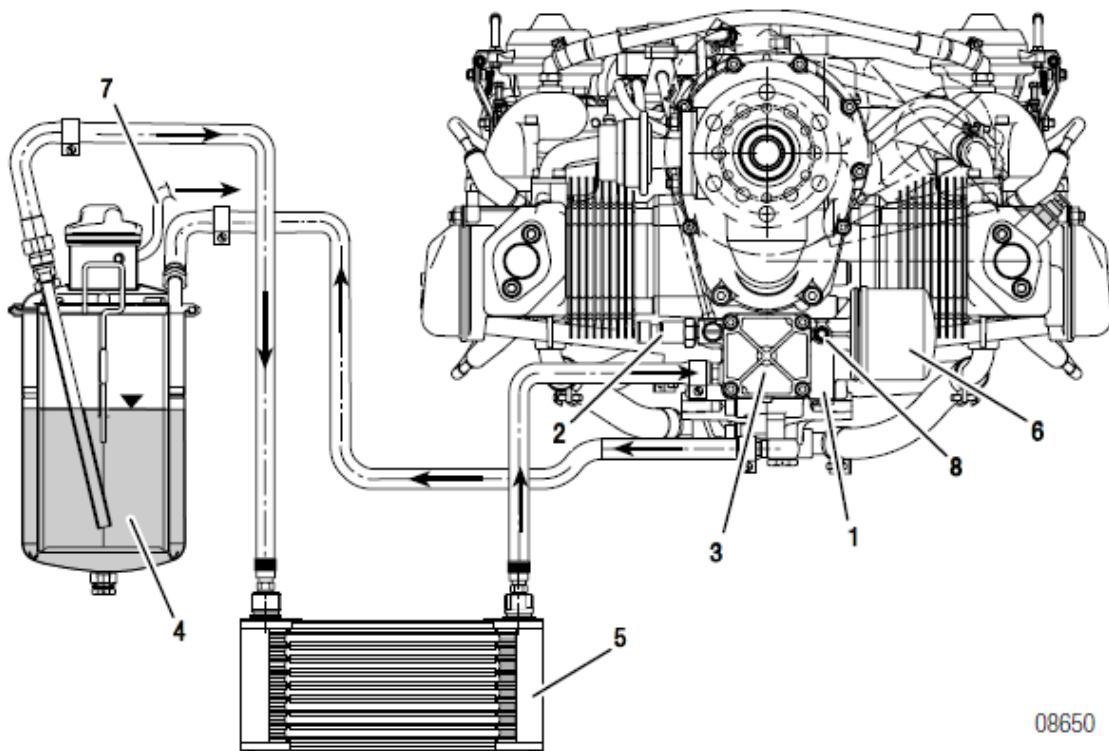
Rotax 912 has a dry sump system. The oil pump is driven directly by the camshaft and the sensors for oil temperature and oil pressure are in the oil pump housing. The oil is sucked from the external oil tank, via the oil cooler before being distributed in the engine. After circulating in the engine, the oil collects at the bottom of the crankcase and is forced back to the oil tank by the pressure that develops in the crankcase when the engine is turning. To measure the correct oil level before starting, the engine must be hand cranked such that any oil that has collected at the bottom of the crankcase is forced back to the oil tank. See Figure 7 for system description.

Figure 6: Lubrication system

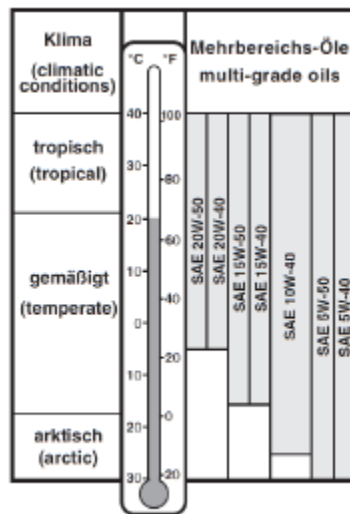
Figure 1-2

The proper oil viscosity is dependent on ambient temperature. The instructions in the aircraft flight manual are shown in Figure 10, while the engine manufacturer's instructions in the engine operating manual are shown in Figure 11. The Rotax 'Service Instruction' SI-912-016R15 recommends using SHELL ® AeroShell Oil Sport Plus 4, which is a 10W-40 oil, and this was the oil used in LN-NRC. On 21 February 2024, SI-912-016R15 was replaced by SI-912-016R16 where XPS ® Full Synthetic Aviation Engine Oil, which is a 5W-50 oil, is also recommended. The 5W-50 oil has a lower viscosity at lower temperatures and will be more fluid.

The following chart shows the recommended oil viscosity as a function of the climatic conditions. The use of multi-grade oils is recommended.

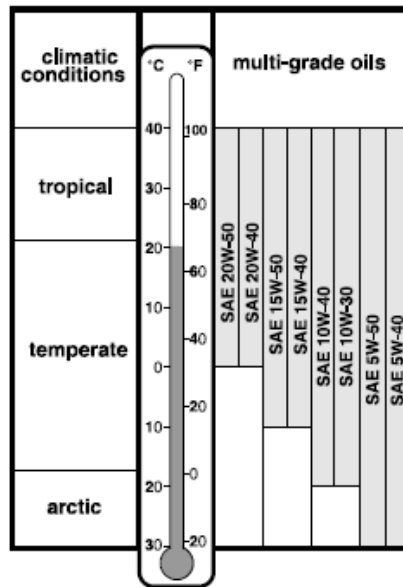
Since the temperature range of neighboring SAE grades overlap, there is no need for change of oil viscosity at short duration of ambient temperature fluctuations.

Figure 11: Excerpt from the engine operation manual concerning recommended oil viscosity. Source: Rotax/NSIA

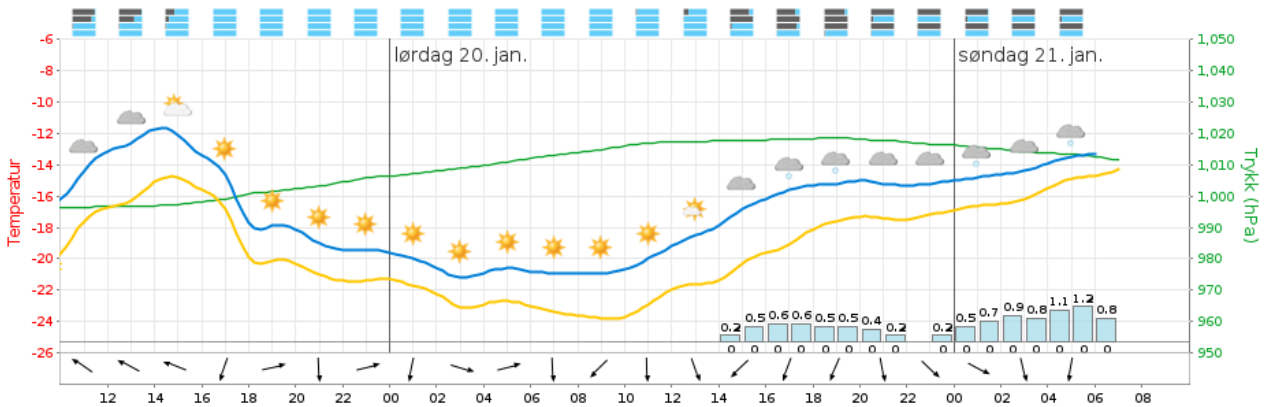
The weather was cold and fine. The forecasted weather and temperature measurements from the meteorological station at Kjeller airport are presented below. It was almost -30 °C at 0800 hrs.

Figure 15: Meteogram for Kjeller airfield. The forecasted temperature was warmer than the recorded temperature. Source: Norwegian Meteorological Institute/NSIA

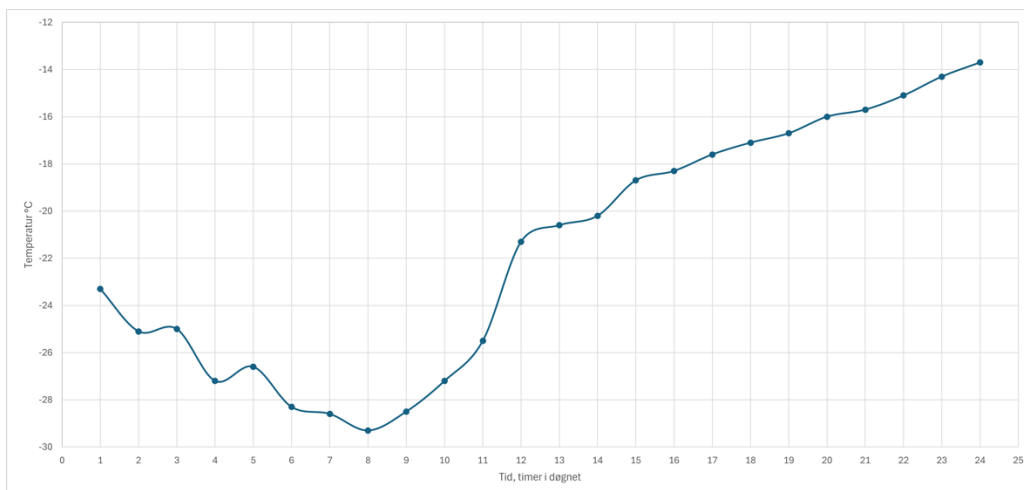
Figure 16: Recorded temperatures at Kjeller meteorological station on 20 January 2024. Source: Norwegian Meteorological Institute/NSIA
