Defence 2021/02

*REPORT ON SERIOUS AVIATION  
INCIDENT ON 11 MARCH 2020  
INVOLVING A C-130J SUPER HERCULES  
MILITARY TRANSPORT AIRCRAFT  
AT MOSKEN, A ROCKY ISLAND IN  
VÆRØY MUNICIPALITY IN NORDLAND  
COUNTY*

**REPORT ON SERIOUS AVIATION INCIDENT**

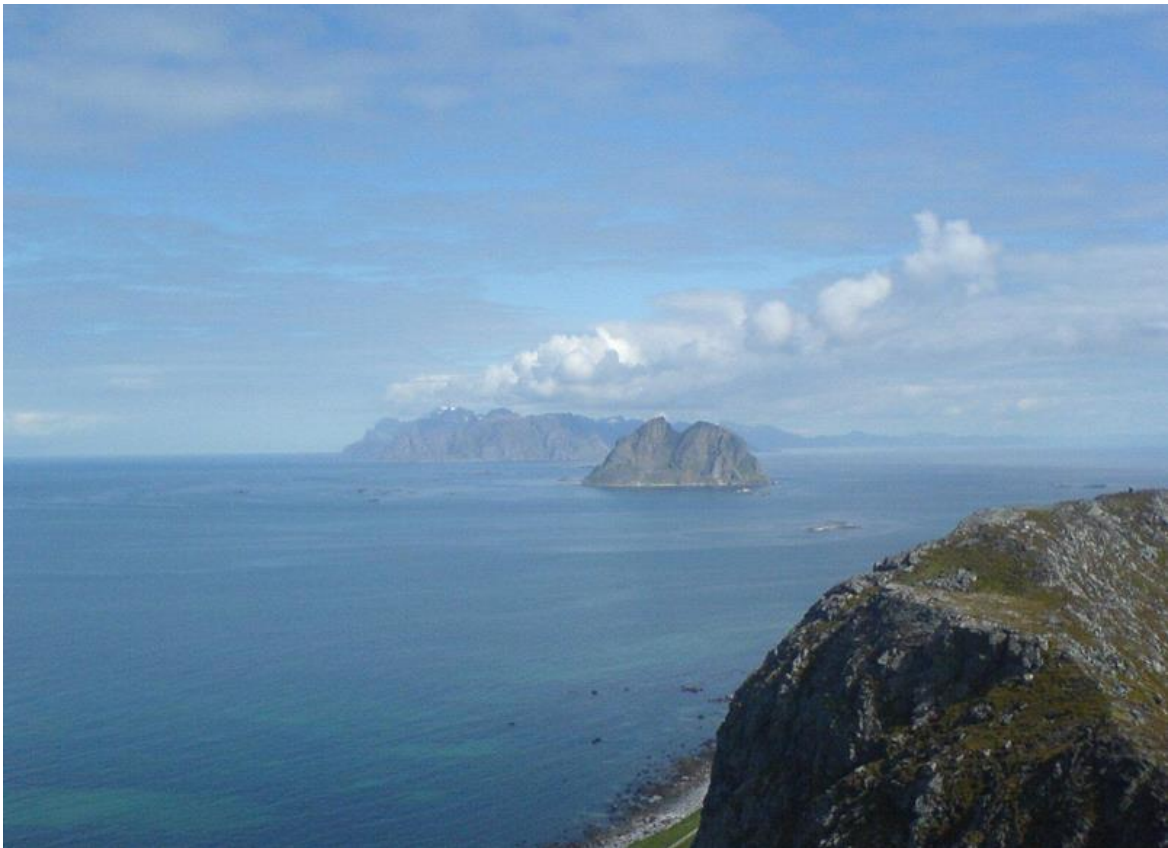
MG32's closest proximity to Mosken in connection with the avoidance manoeuvre was approximately 1,500 m. After maintaining a northerly course for about 10 seconds, the aircraft was turned to the right and set course for Bodø. In connection with this latter turn, the lowest height was only 374 ft AGL. Figure 10 shows MG32's ground track around Mosken. Figure 11 is a photo of Mosken looking north from the island of Værøy.

Figure 11: Mosken Island viewed from Værøy Island. Photo: Jostein Torstensen

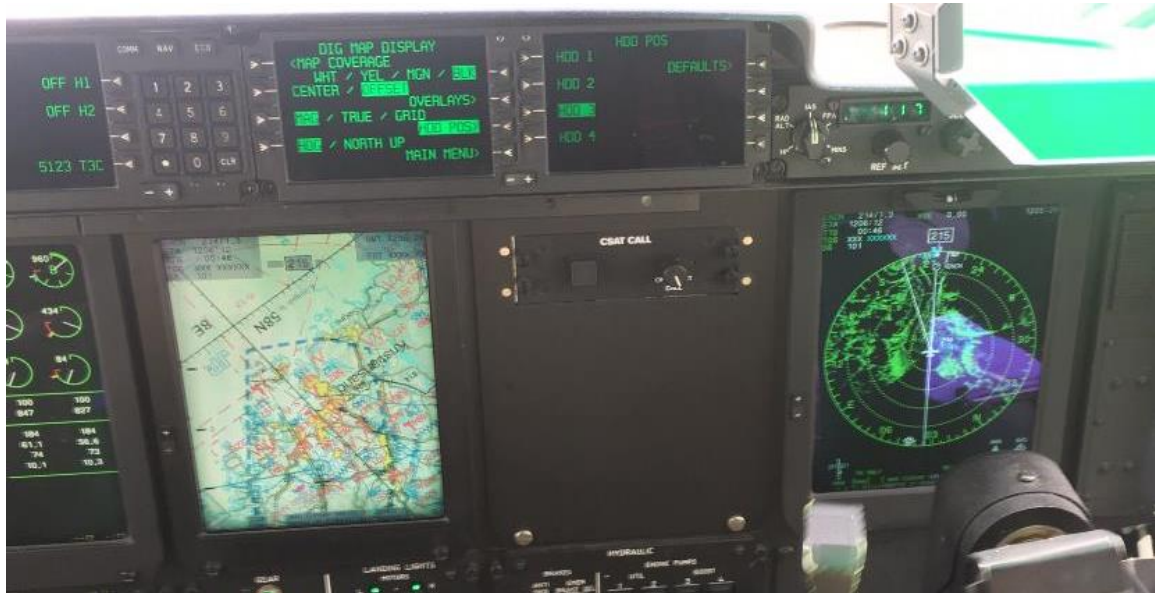
At the time, the crew had selected NAV RADAR display and Monopulse Ground Map (MGM) on HDD 1 and HDD 4 in the cockpit (see Figure 15). In this configuration, the terrain in front of the aircraft is displayed, but only in black and white. This function is chosen for flights under instrument meteorological conditions (IMC) when approaching land from the open sea, among other things to be able to confirm the aircraft's position and distance from shore.

Figure 15: HDD 3 and HDD 4 on the right-hand side of the cockpit. HDD 3 displays a digital map while HDD 4 displays a monopulse ground map (MGM). Source: RNoAF

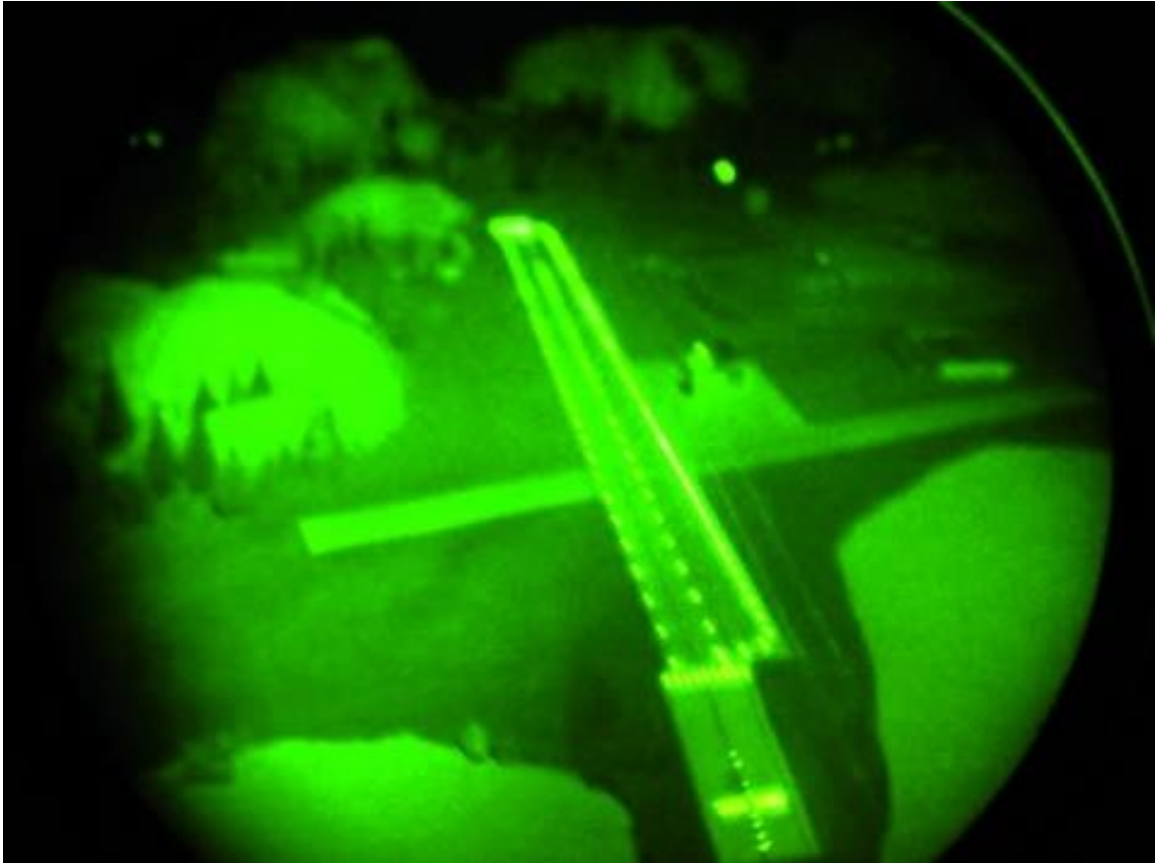
Figure 16: Photo of a runway seen through NVG. Photo: RNoAF

The pilots in both aircraft and the loadmaster in the cockpit of MG32 wore NVG. The loadmaster in the cockpit of MG31 was not wearing NVG at the time of the incident. The passenger in the cockpit of MG32 used a hand-held light-enhancing monocular. Three of the NVGs used during the mission have been examined by the Norwegian Defence Logistics Organisation (NDLO), namely those worn by PF MG31, PM MG31 and PF MG32. The examination showed that the NVGs had no faults or defects that would reduce their performance or resolution.

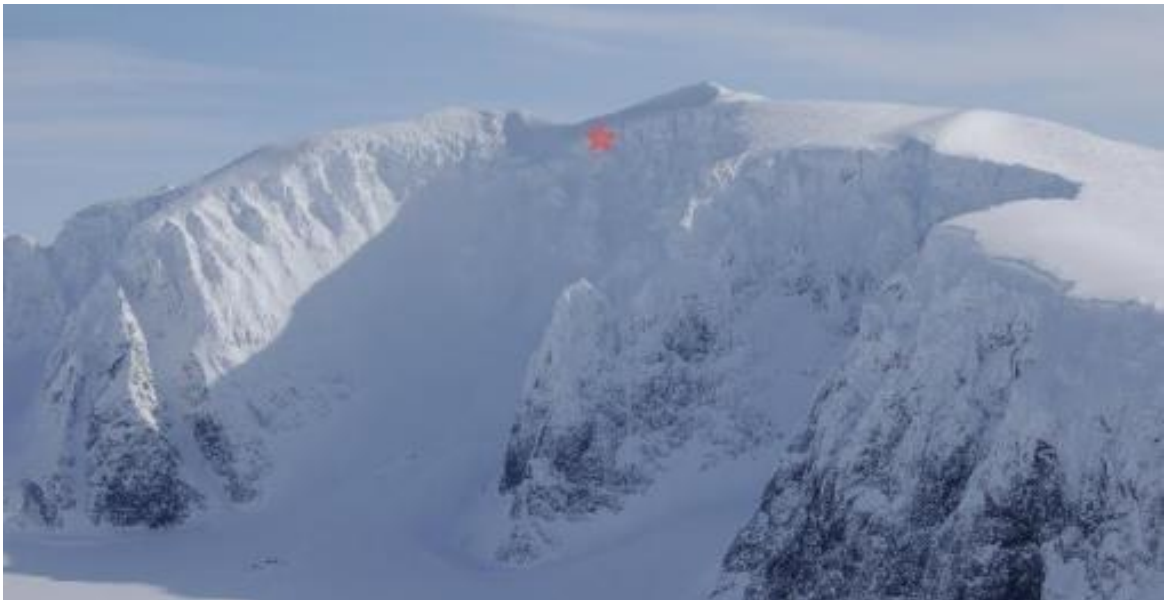
On 15 March 2012, in connection with Cold Response 2012, a C-130J aircraft collided with the Kebnekaise mountain in Sweden (see Figure 24). Five people died. The accident was investigated by the Swedish Accident Investigation Authority (Swedish SHK). NORKOM, a delegation from the NJHQ, assisted the Swedish SHK in the investigation. Representatives of the Accident Investigation Board Norway<sup>42</sup> also participated in the early phase of the investigation and at the scene of the accident. The Swedish SHK's report was published on 2 October 2013<sup>43</sup>.

Figure 24: Photo of Kebnekaise. The photo was taken in the direction of flight at the same height as the point of impact (marked). Photo: Swedish Accident Investigation Authority, 2013

The mission was to fly a transport flight under IFR to Kiruna in Sweden to pick up Norwegian military personnel and materiel and fly them back to Evenes. On the flight operations side, the investigation found shortcomings in the RNoAF's procedures for planning and following up air missions. In combination with what was probably a high level of confidence in air traffic control, this meant that the crew did not realise that the clearance received from the control tower in Kiruna entailed an altitude that did not allow for adequate terrain separation (Swedish SHK, 2013).

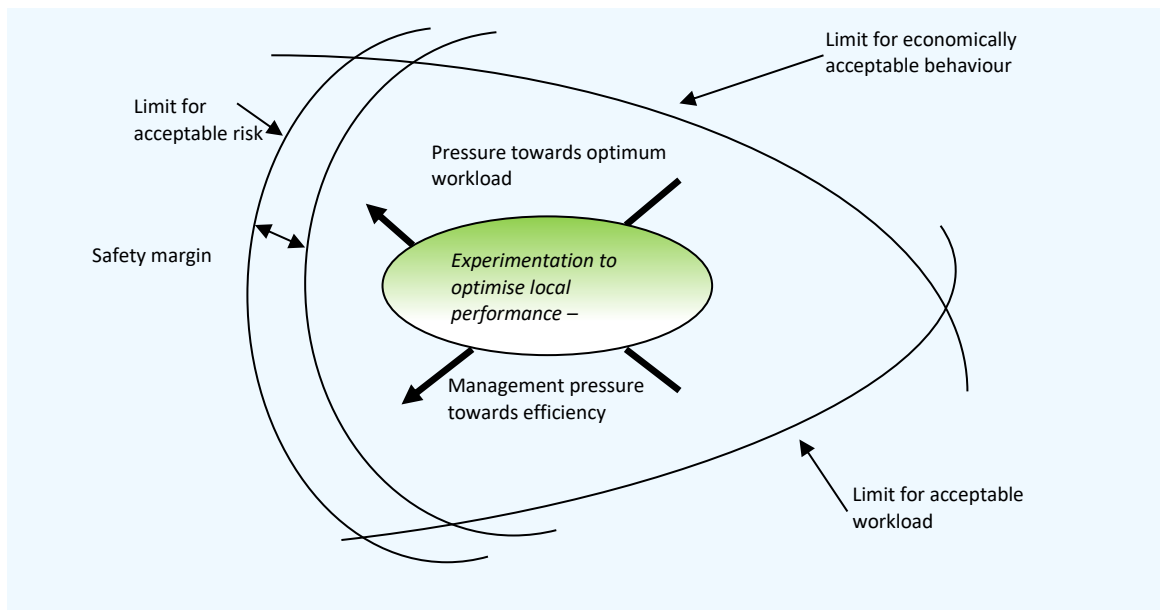
Figure 25: Rasmussen's adaptation model. As a consequence of pressure towards efficiency and other performance goals, behaviour will drift towards the boundary for acceptable risk. Illustration: Adapted by NSIA, based on Rasmussen (1997)

The NSIA acknowledges that pressure to deliver and performance culture are necessary components of military operations. What worries the NSIA relates to the shift towards a 'pressure culture' that approaches the limit for acceptable risk (the 'practical drift' referred to in Figure 25) during peacetime exercises and missions, as was the case in the 335 squadron. In an organisation that is not sufficiently informed and learning, risks can be introduced with the introduction of new tasks and systems that the organisation is not properly equipped to handle. As a consequence, risk is not identified, assessed or dealt with before a serious incident or accident 'suddenly' occurs.

In particular, the dimensioning of the 335 squadron was never followed up; its resources and personnel were not balanced with the demanding mission portfolio, which in turn caused a drift towards the limit for acceptable risk ('practical drift', ref. Figure 25). The examples of the 335 squadron's occasional breaches of rules and regulations are indications of inadequate internal control and follow-up at management level.

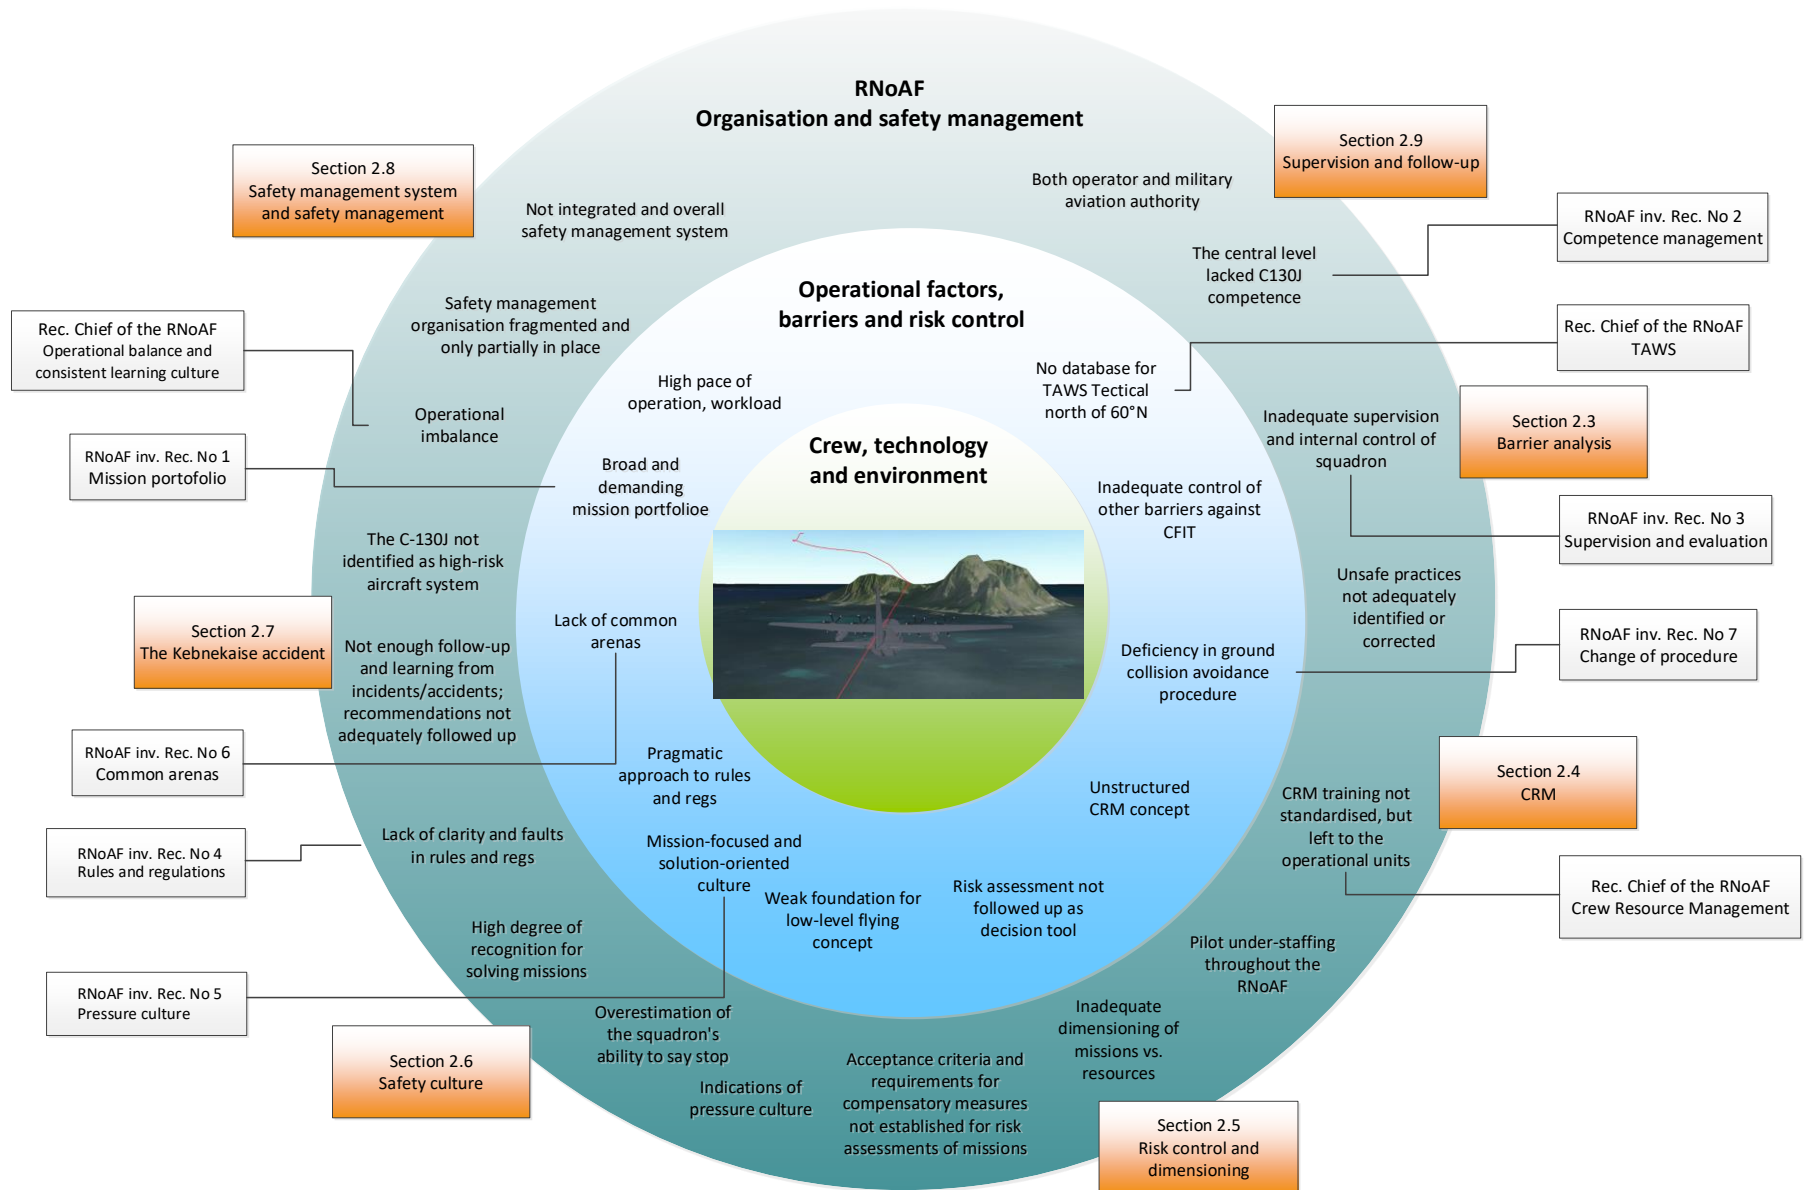
The analysis then proceeds from the operational and technical level to a more general analysis of possible underlying causal factors. This includes an analysis of operational factors such as defective barriers, CRM and risk control at squadron level (blue in Figure 27), as well as the RNoAF's organisation and safety management (dark green in Figure 27). It also includes a review of recommendations and advice issued in connection with previous incidents, including follow-up after the Kebnekaise accident.

Figure 27: Organisational and systemic factors of relevance to the Mosken incident. The main sections of the analysis (highlighted in orange) and areas covered by the RNoAF investigation. Illustration: NSIA
