# REPORT

Sjø 2010/04

THE JOINT ACCIDENT INVESTIGATION BOARD NORWAY &  
BAHAMAS MARITIME AUTHORITY MARINE ACCIDENT REPORT

CRETE CEMENT - IMO NO. 9037161, GROUNDING  
AT ASPOND ISLAND IN THE OSLO FJORD,  
NORWAY, ON 19 NOVEMBER 2008

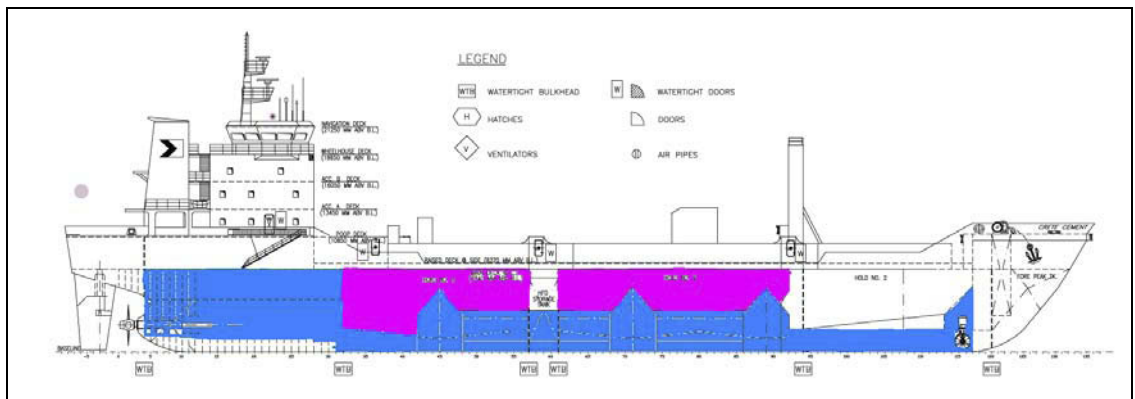
Figure 6: Flooding of vessel after running aground (scenario 2a).

1.6.7 Figures 6 and 7 show how the *Crete Cement* was flooded with water after running aground. The areas highlighted in blue were flooded within a short period of time, while it took somewhat longer for the areas highlighted in red to become flooded.

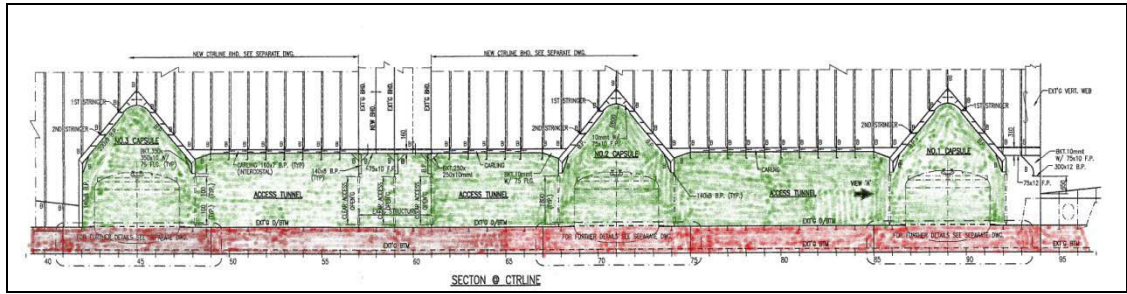
Figure 11: The blow-tank tunnel (green) and the pipe trunk (red).

1.10.2.4 Figure 11 shows the arrangement of blow tanks, the blow-tank tunnel and the pipe trunk. The blow-tank tunnel is shaded green, and the pipe trunk red. The figure shows an alongships section along the vessel's centreline.

1.10.2.5 Because it is not possible to close the hatches shown in figure 10 so that they are watertight, any water ingress into the bow-thruster room will lead to flooding of the spaces shown in figures 12 and 13, provided that all watertight sections are intact.
