REPORT

Mar 2010/11

REPORT ON INVESTIGATION OF MARINE ACCIDENT STAR ISMENE - LANT5, NANTONG CHINA 16 DECEMBER 2008

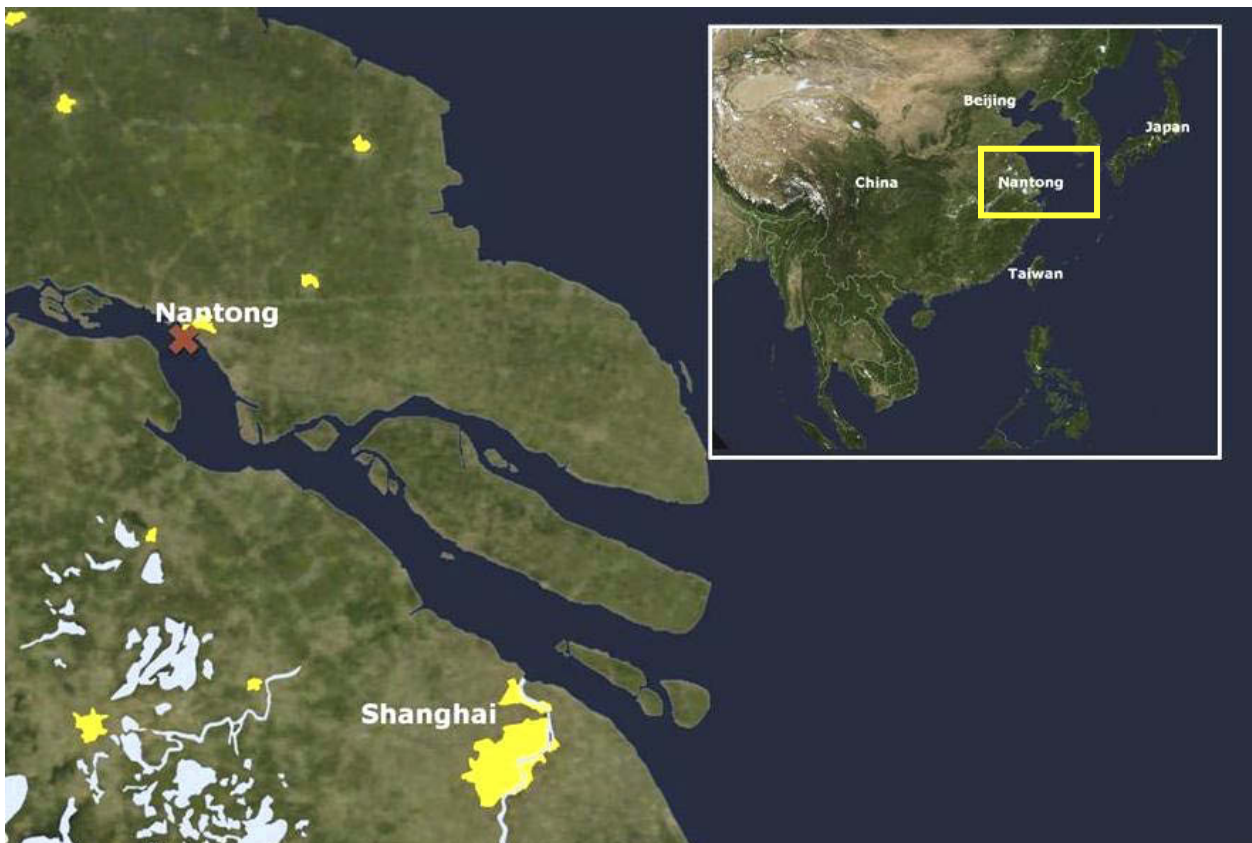
Figure 1: The accident occurred while the *Star Ismene* lay at anchor in Nantong.

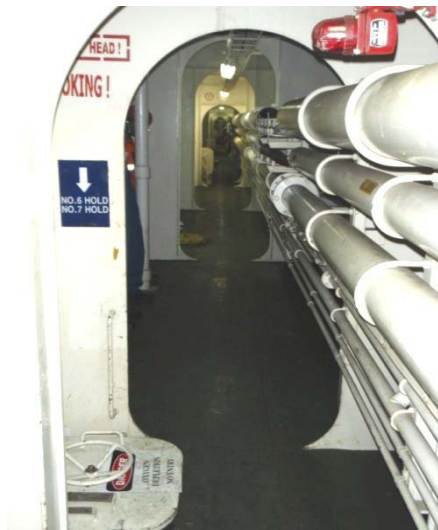
The AIBN has been informed that the starboard passageway is often used by the crew when the ship is at sea and in port.

Figure 9: Enclosed passageway on the starboard side looking forward from the aft end. An access hatch for one of the cargo holds can be seen at the bottom left of the photo.

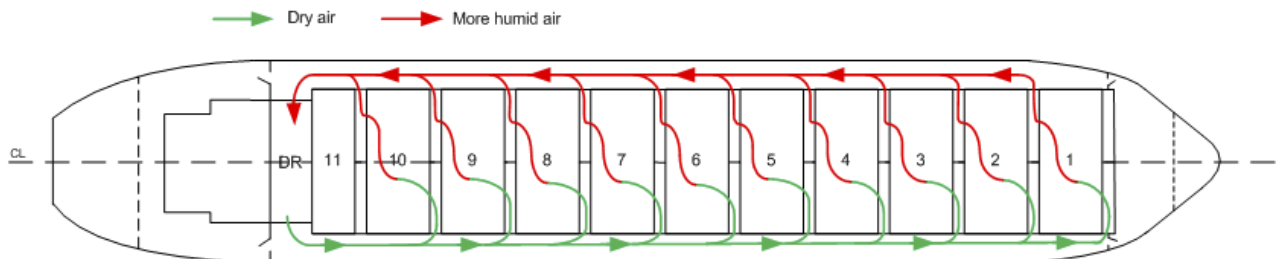
The passageways on both sides form part of the ship’s arrangement for ventilation and dehumidification of the cargo holds. In front of the superstructure, fans have been installed to dehumidify the cargo. Dry air from this dehumidifier room is fed into the aft end of the passageway on the starboard side, see figure 10.

Figure 10: Plan showing the schematic arrangement for dehumidifying the cargo. Cross-section of the deck with passageways, seen from above. DR: dehumidification room/fan room.

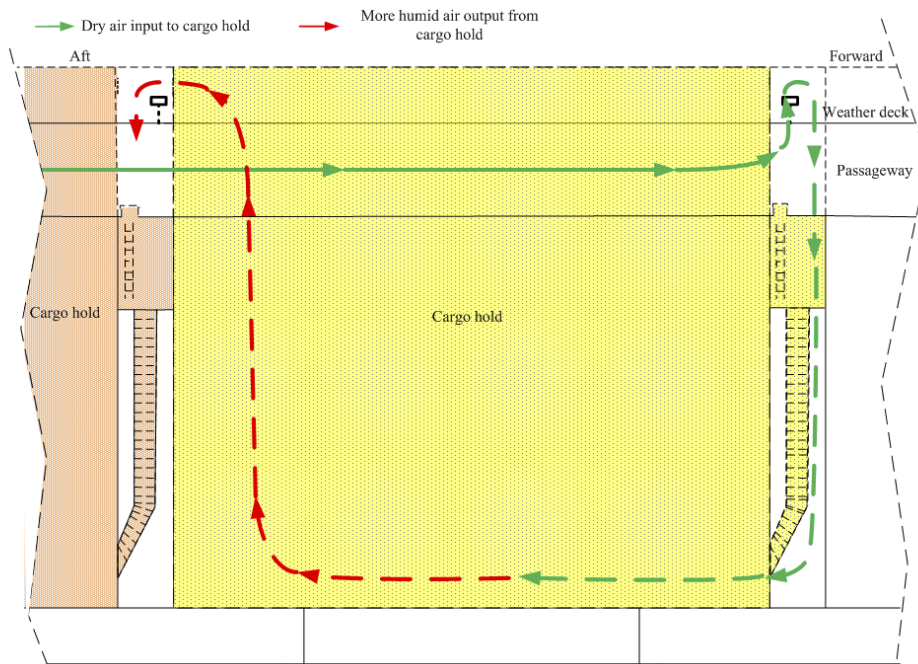
The air is pushed through the ventilation hatches in the passageway bulkhead and into the rooms on the inside of the passageway, from where it moves up into the spaces above the deck between the coamings of the large cargo hatches. From there, the dry air is pushed down to the bottom at the forward end of the cargo hold aft of each space. The humid air is pushed back up at the aft end of the cargo hold, and moves up into the port side of the space between the hatch coamings. From there, the air moves back down below deck and out into the passageway on the port side. Figures 11 and 12 show a simplified and schematic presentation of how the arrangement for the dehumidification of the cargo holds works.

Figure 11: Profile drawing showing the schematic arrangement for dehumidifying the cargo. Seen from the starboard side. Dry air is fed into the starboard passageway (green, solid line) and then into the rooms between the hatch coamings.

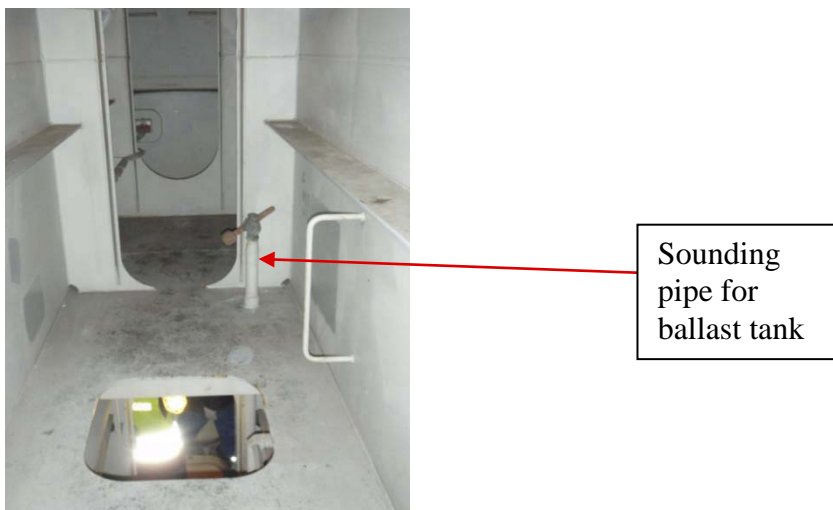
In addition to the *Star Ismene's* automatic tank sounding system, the ship has sounding pipes for manual sounding of all bottom tanks. These sounding pipes are located in the spaces between the coamings of the large cargo hatches. Figure 13 shows the sounding pipe for water ballast tank 4 on the starboard side.

Figure 13: Space between the hatch coamings for cargo holds 6 and 7.
