REPORT

Sjø 2012/08

REPORT ON INVESTIGATION OF MARINE ACCIDENT, LANGELAND LDJB3, FOUNDER IN THE KOSTERFJORD, SWEDEN 31 JULY 2009

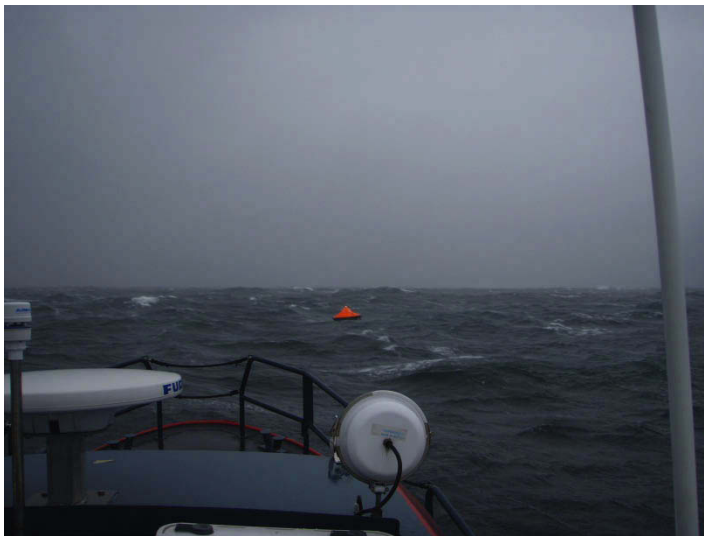
Figure 8: One of the Langeland's rafts. (Photo: SSRA)

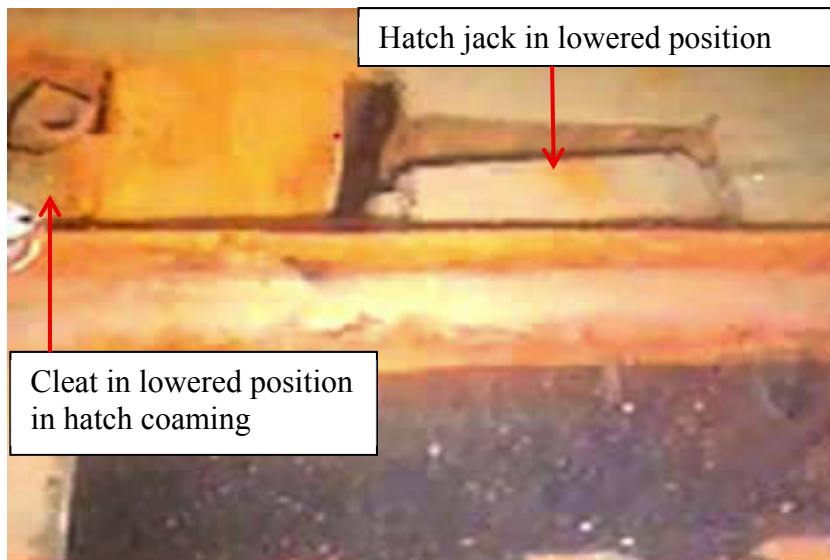
Figure 11: One of the hatch jacks in the lowered position and a cleat in the lowered position. (Photo: KBV)

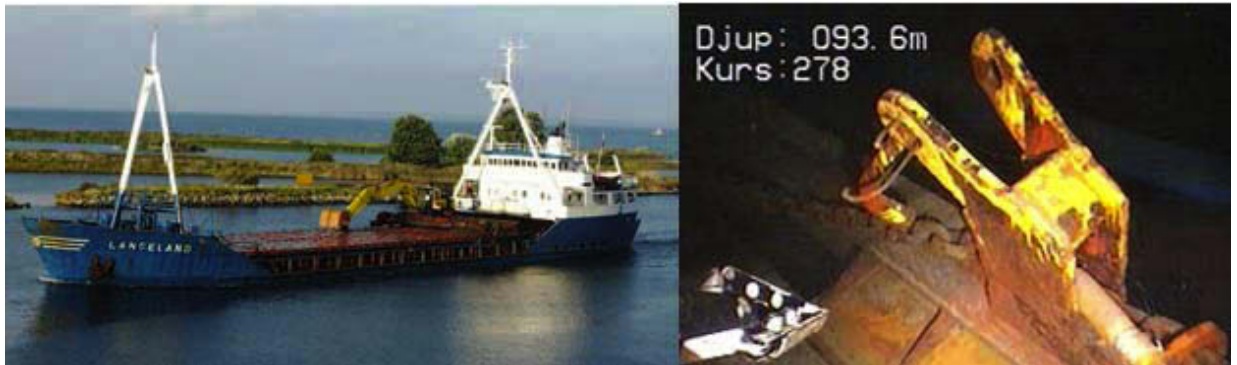
Figure 14: (Left) Excavator parked in normal position. (Right) One of two excavator attachments (starboard)

The traverse and excavator were parked in front of the deckhouse. We do not know whether the excavator itself was standing in the centre of the traverse before the loss or on the starboard side as shown in Fig. 5. If the excavator weighing 27 t had slid from its position to starboard across the traverse to port, that would have given a heeling moment of around 200 tm which would have given a heeling of 1.5-2°. The Accident Investigation Board does not believe the excavator movement in itself could have caused the list that was reported.

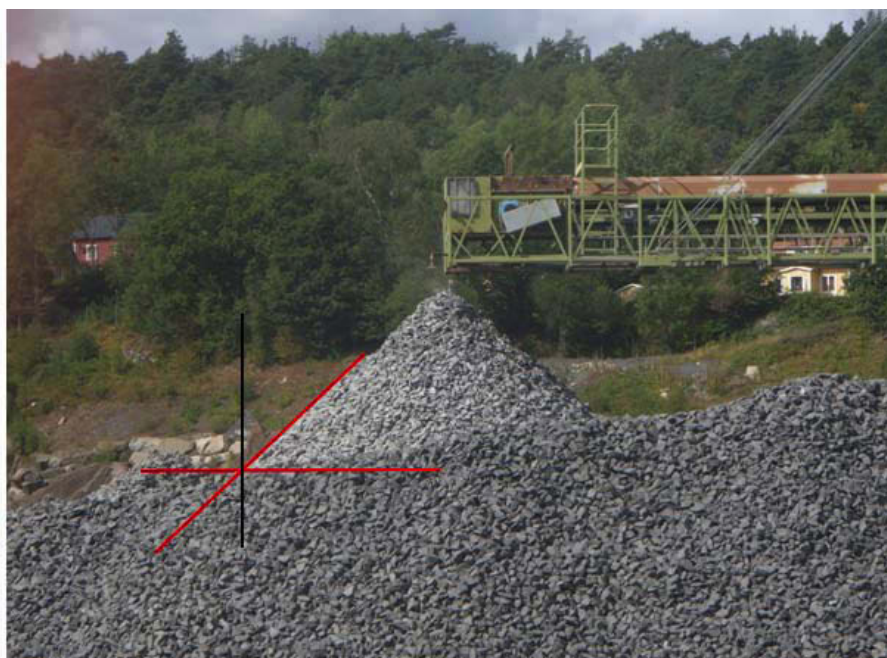
Figure 18: The cargo's angle of repose, approx. 45°.

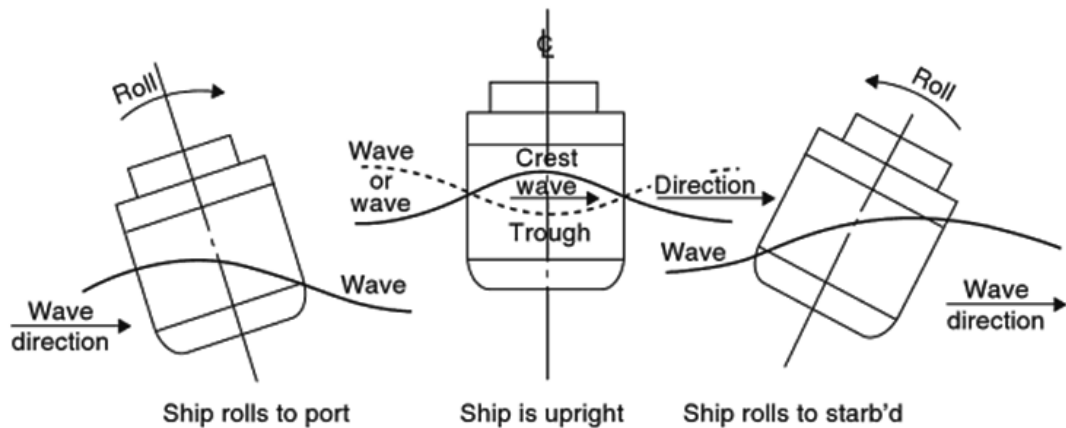
In view of this, the Accident Investigation Board believes it is likely that the Langeland may have been exposed to synchronous rolling, with rolling surges resulting. The cargo may probably have shifted as a result of such large, rapid rolling surges. Fig. 24 shows a ship rolling synchronously with the waves in the ratio of 2:1 (inherent roll period equals twice wave period).

Figure 24: Ship rolling synchronously in a ratio of 2:1 (inherent roll period twice wave period)

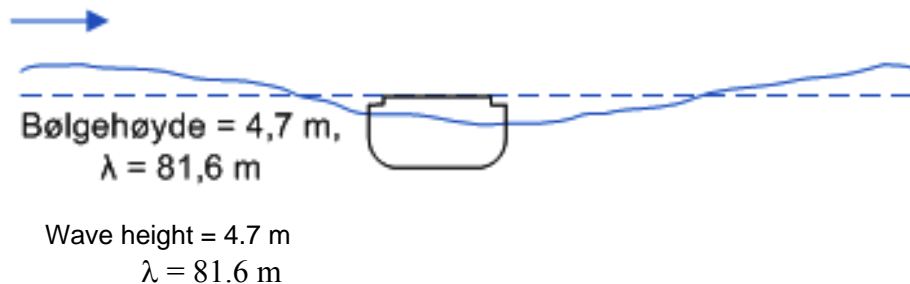
Figure 25: Sketch showing vessel with sea abeam.

As the vessel had little freeboard, we may assume that the vessel was exposed to excessive seas on deck. Information from discussions with the shipping company confirms that the vessel would have been exposed to water on deck more or less continuously in its loaded condition and under the sea conditions prevailing at the time. The image below shows the Langeland sailing earlier with cargo on board. The space in which the hatches were stacked during loading and unloading may be assumed to have been partly filled with sea water.

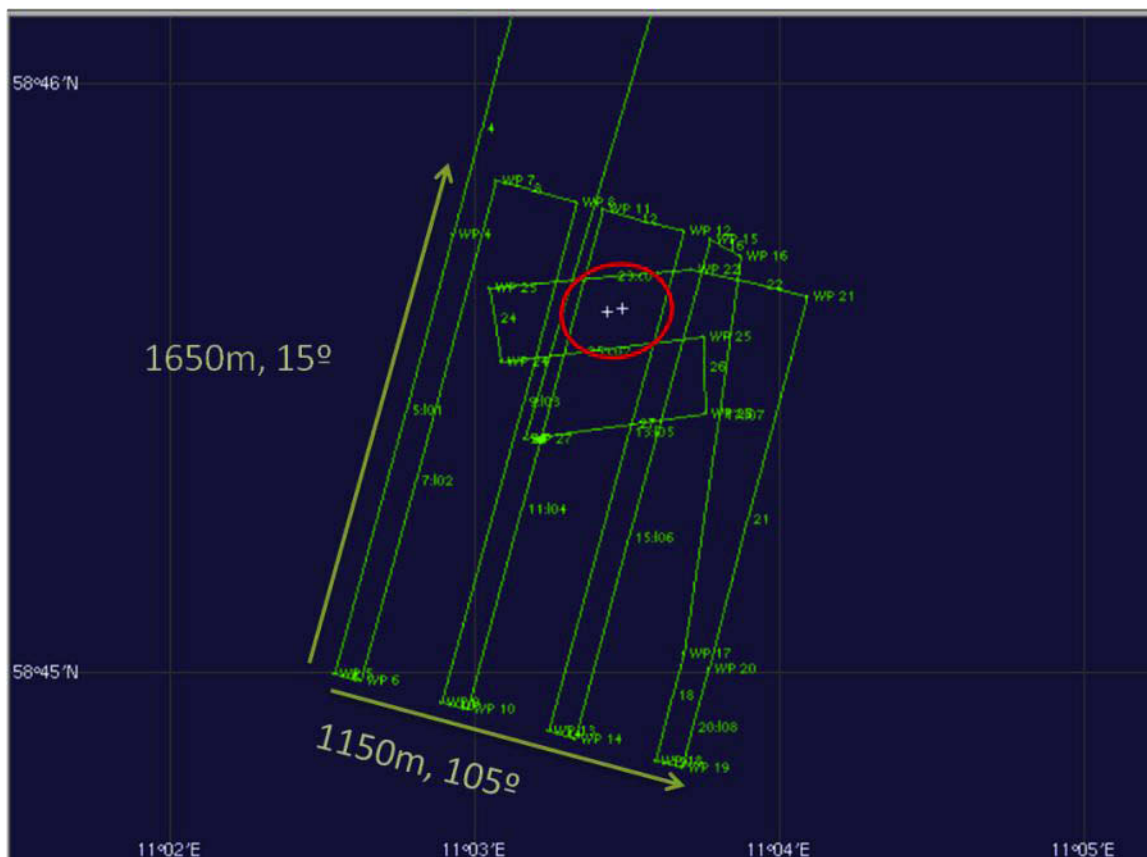
Figur 2.1: Toktplan for dykket

På EM710 ble det observert et objekt 250m 190° for vraket. Objektet var av samme størrelsesorden som gravemaskinen, og to kryssende toktlinjer ble derfor lagd rundt dette også.

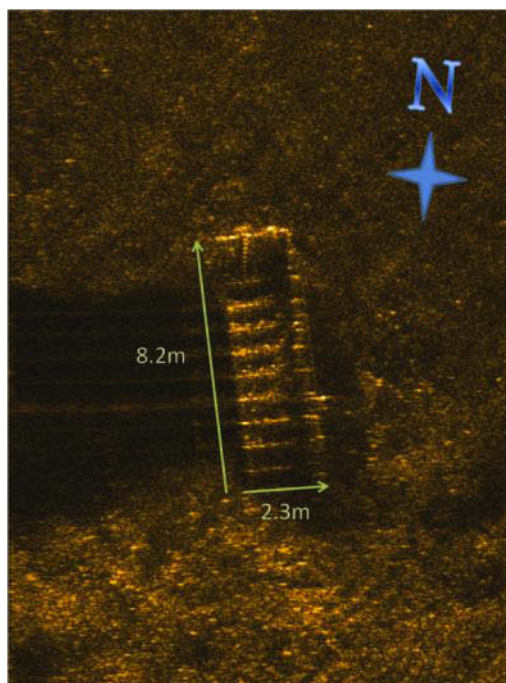
Figur 3.6: Objekt L1. Bildet er tatt fra nord.

I området rundt fremre del av vraket er det observert 3 objekter som kan være lasteluker. Disse objektene er navngitt L1, L2 og L3 og er vist i Figur 3.6 til Figur 3.12. Plasseringen av disse i forhold til vraket er vist i Figur 3.13.

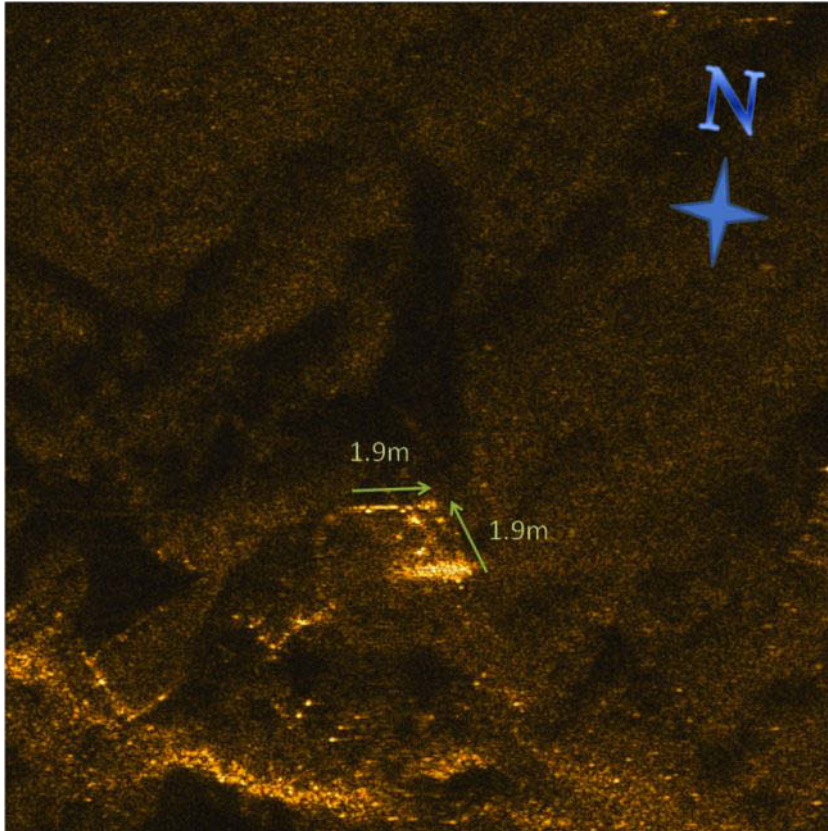
Figur 3.10: Objekt L2. Bildet er tatt fra sør. Objektets akustiske skygge antyder at det stikker omtrent 1m opp fra bunn.

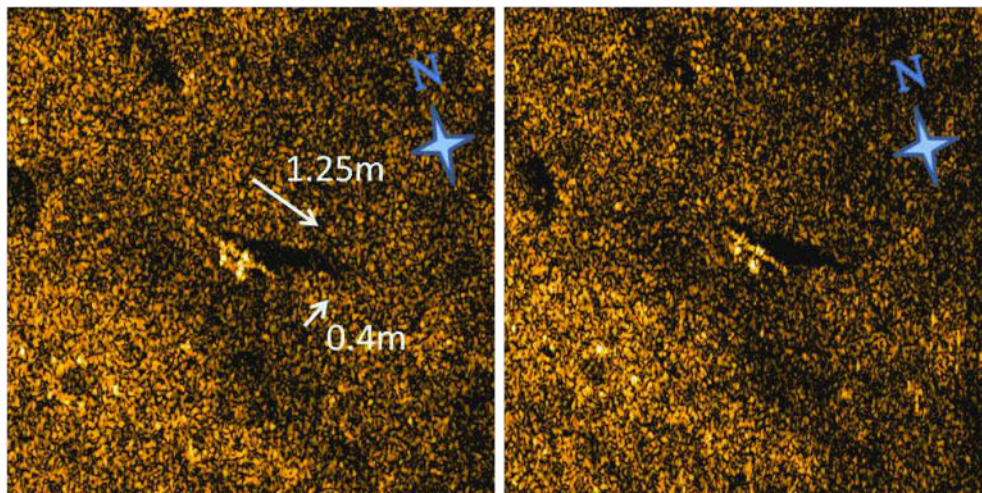
Figur 3.15 Objekt V1. Bildene er tatt fra vest i forhold til objektet.

Andre mulige vrakrester, navngitt V1 til V4, er også funnet i nærområdet til vraket. Sonarbilder av objektene vises i Figur 3.15 til Figur 3.17.

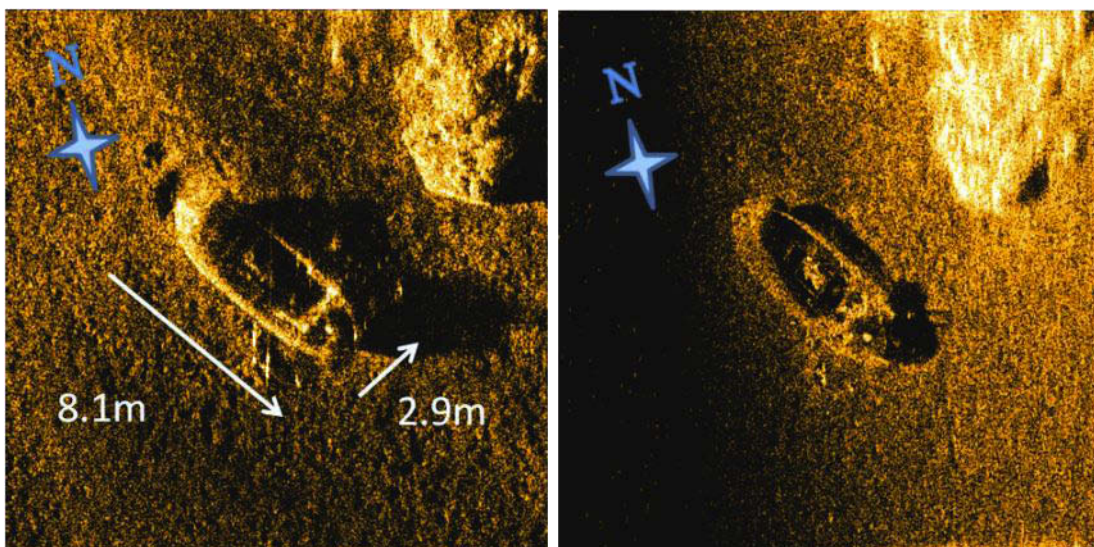
Ved posisjon 58°45.221N, 11°03.159E ble det observert et lite vrak med dimensjoner 7.8m x 2.9m. Dette er 780m i retning 200° for MV Langeland. Båten er vist i Figur 3.18.

Figur 3.18 Lite vrak observert syd for MV Langeland. Bildene er tatt fra vest.

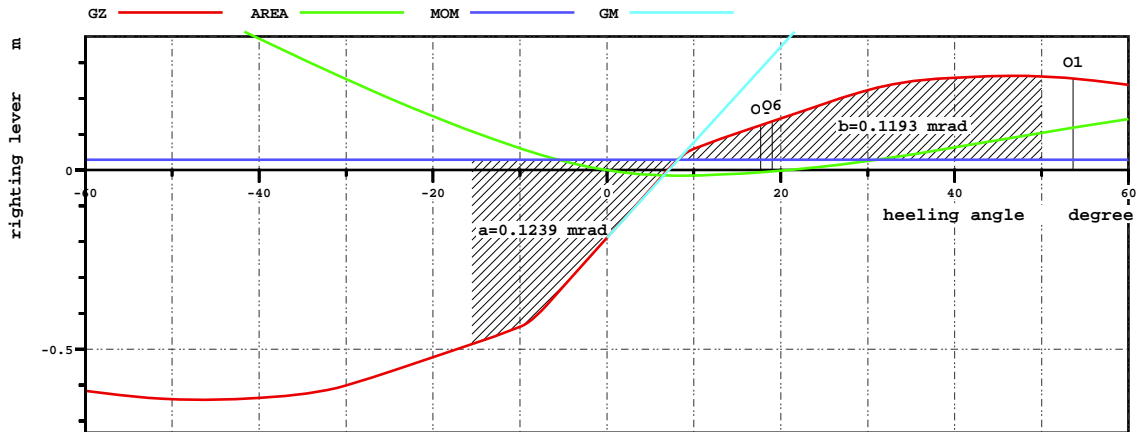
Loading condition C04

RCR	TEXT	REQ	ATTV	MARGIN	UNIT	STAT
AREA30	GZ Area up to 30 deg.	0.055	0.052	0.003	mrad	NOT .
AREA40	GZ Area up to 40 deg.	0.090	0.095	0.005	mrad	OK
AREA3040	Minarea 30-40deg	0.030	0.043	0.013	mrad	OK
GZ0.2	Max GZ > 0.2	0.200	0.263	0.063	m	OK
MAXGZ25	Max GZ at angle > 25deg	25.000	46.792	21.792	deg	OK
GM0.15	GM > 0.15 m	0.150	1.529	1.379	m	OK
IMOWEATHER	IMO weather crit.	1.000	0.963	0.037		NOT .

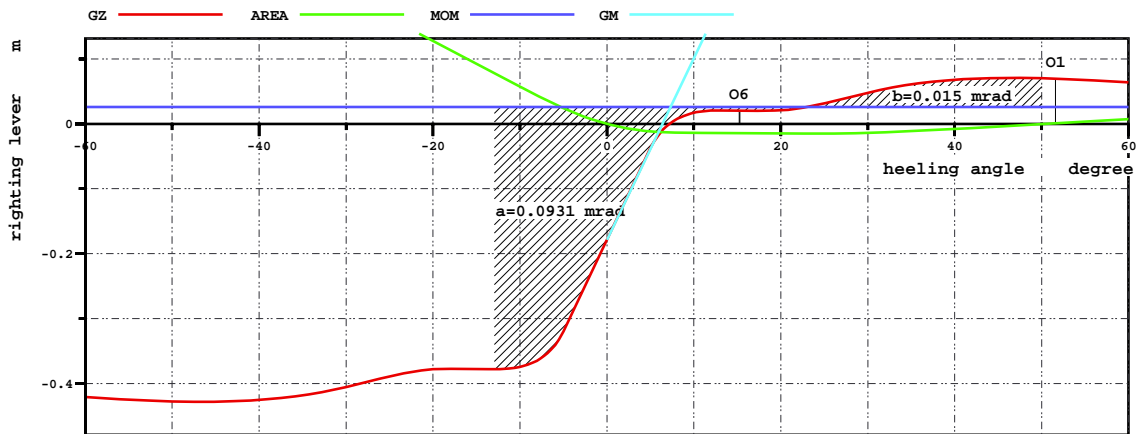
Loading condition C05

RCR	TEXT	REQ	ATTV	MARGIN	UNIT	STAT
AREA30	GZ Area up to 30 deg.	0.055	0.010	0.045	mrad	NOT .
AREA40	GZ Area up to 40 deg.	0.090	0.020	0.070	mrad	NOT .
AREA3040	Minarea 30-40deg	0.030	0.010	0.020	mrad	NOT .
GZ0.2	Max GZ > 0.2	0.200	0.071	0.129	m	NOT .
MAXGZ25	Max GZ at angle > 25deg	25.000	46.635	21.635	deg	OK
GM0.15	GM > 0.15 m	0.150	1.602	1.452	m	OK
IMOWEATHER	IMO weather crit.	1.000	0.161	0.839		NOT .

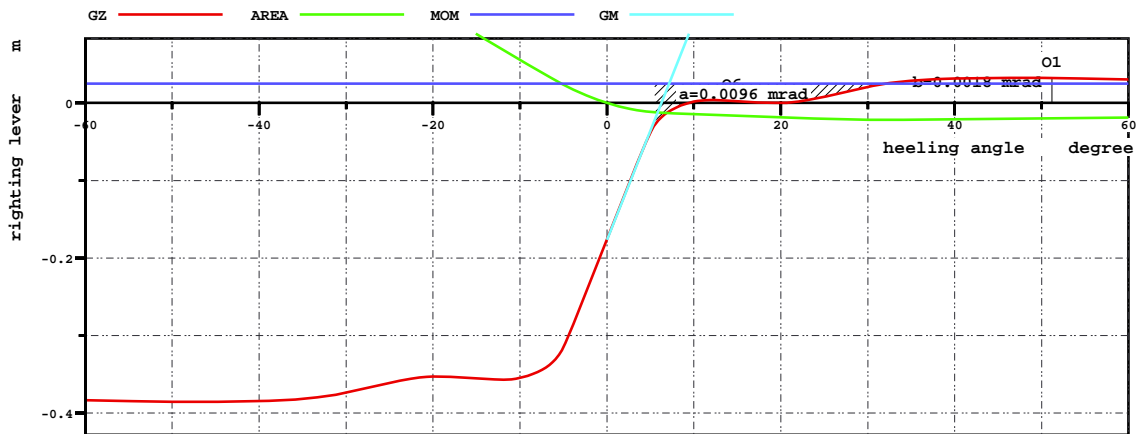
Loading condition C06

RCR	TEXT	REQ	ATTV	MARGIN	UNIT	STAT
AREA30	GZ Area up to 30 deg.	0.055	0.002	0.053	mrad	NOT .
AREA40	GZ Area up to 40 deg.	0.090	0.006	0.084	mrad	NOT .
AREA3040	Minarea 30-40deg	0.030	0.005	0.025	mrad	NOT .
GZ0.2	Max GZ > 0.2	0.200	0.032	0.168	m	NOT .
MAXGZ25	Max GZ at angle > 25deg	25.000	46.941	21.941	deg	OK
GM0.15	GM > 0.15 m	0.150	1.617	1.467	m	OK
IMOWEATHER	IMO weather crit.	1.000	0.187	0.813		NOT .

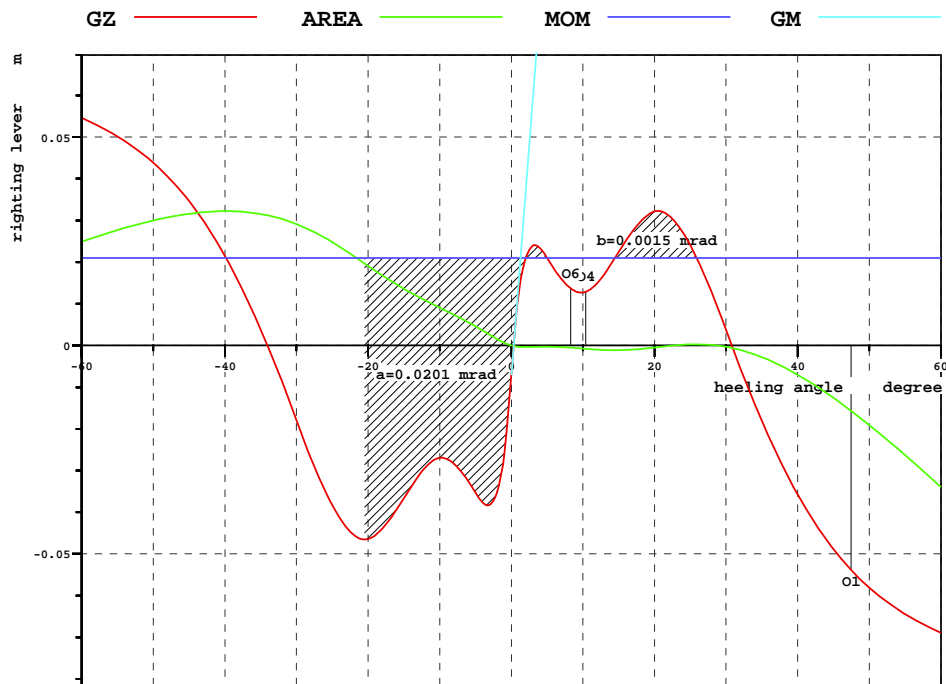
Loading condition C06

RCR	TEXT	REQ	ATTV	MARGIN	UNIT	STAT
AREA30	GZ Area up to 30 deg.	0.055	0.011	0.044	mrad	NOT .
AREA40	GZ Area up to 40 deg.	0.090	0.011	0.079	mrad	NOT .
AREA3040	Minarea 30-40deg	0.030	0.000	0.030	mrad	NOT .
GZ0.2	Max GZ > 0.2	0.200	0.004	0.196	m	NOT .
MAXGZ25	Max GZ at angle > 25deg	25.000	20.487	4.513	deg	NOT .
GM0.15	GM > 0.15 m	0.150	1.261	1.111	m	OK
IMOWEATHER	IMO weather crit.	1.000	0.076	0.924		NOT .

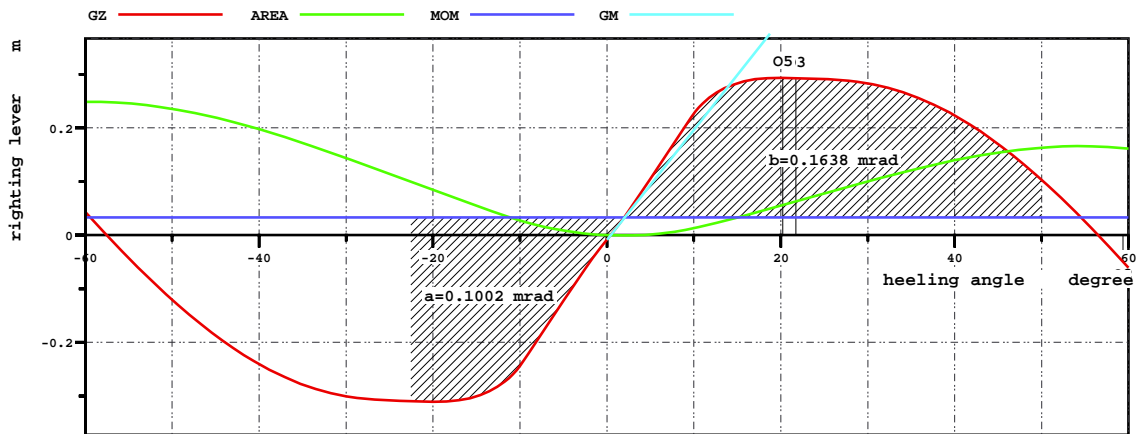
Loading condition HL1

RCR	TEXT	REQ	ATTV	MARGIN	UNIT	STAT
AREA30	GZ Area up to 30 deg.	0.055	0.117	0.062	mrad	OK
AREA40	GZ Area up to 40 deg.	0.090	0.163	0.073	mrad	OK
AREA3040	Minarea 30-40deg	0.030	0.045	0.015	mrad	OK
GZ0.2	Max GZ > 0.2	0.200	0.283	0.083	m	OK
MAXGZ25	Max GZ at angle > 25deg	25.000	19.478	5.522	deg	NOT .
GM0.15	GM > 0.15 m	0.150	1.176	1.026	m	OK
IMOWEATHER	IMO weather crit.	1.000	1.636	0.636		OK

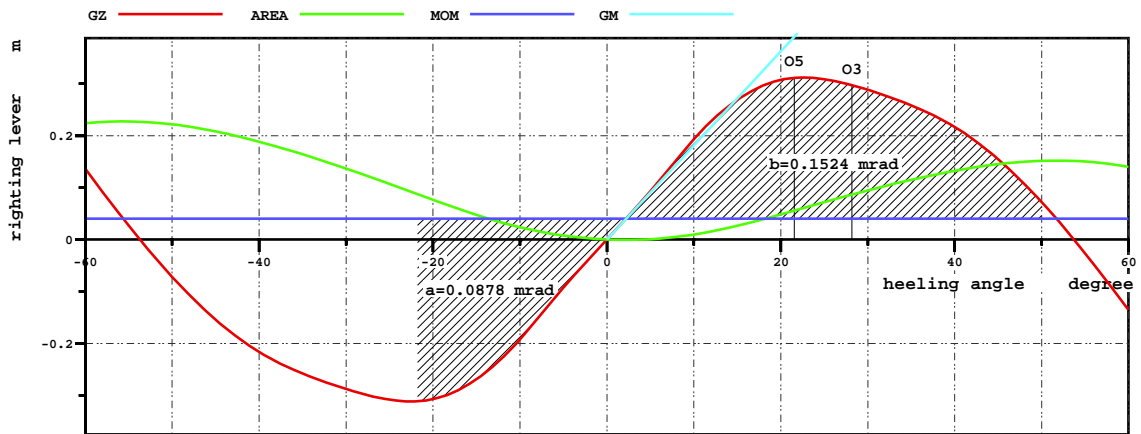
Loading condition HL2

RCR	TEXT	REQ	ATTV	MARGIN	UNIT	STAT
AREA30	GZ Area up to 30 deg.	0.055	0.116	0.061	mrad	OK
AREA40	GZ Area up to 40 deg.	0.090	0.160	0.070	mrad	OK
AREA3040	Minarea 30-40deg	0.030	0.045	0.015	mrad	OK
GZ0.2	Max GZ > 0.2	0.200	0.288	0.088	m	OK
MAXGZ25	Max GZ at angle > 25deg	25.000	22.505	2.495	deg	NOT .
GM0.15	GM > 0.15 m	0.150	1.038	0.888	m	OK
IMOWEATHER	IMO weather crit.	1.000	1.735	0.735		OK

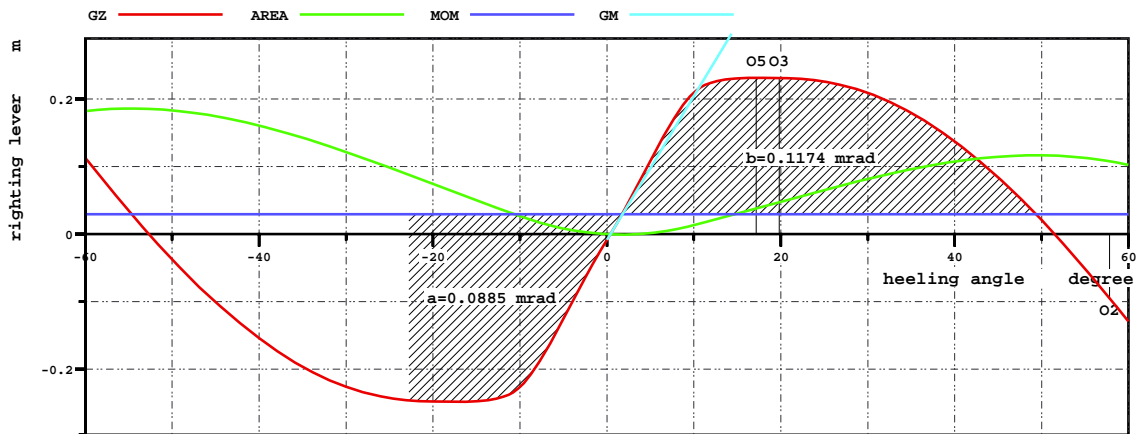
Loading condition HL5

RCR	TEXT	REQ	ATTV	MARGIN	UNIT	STAT
AREA30	GZ Area up to 30 deg.	0.055	0.097	0.042	mrاد	OK
AREA40	GZ Area up to 40 deg.	0.090	0.128	0.038	mrاد	OK
AREA3040	Minarea 30-40deg	0.030	0.031	0.001	mrاد	OK
GZ0.2	Max GZ > 0.2	0.200	0.209	0.009	m	OK
MAXGZ25	Max GZ at angle > 25deg	25.000	17.851	7.149	deg	NOT .
GM0.15	GM > 0.15 m	0.150	1.221	1.071	m	OK
IMOWEATHER	IMO weather crit.	1.000	1.328	0.328		OK

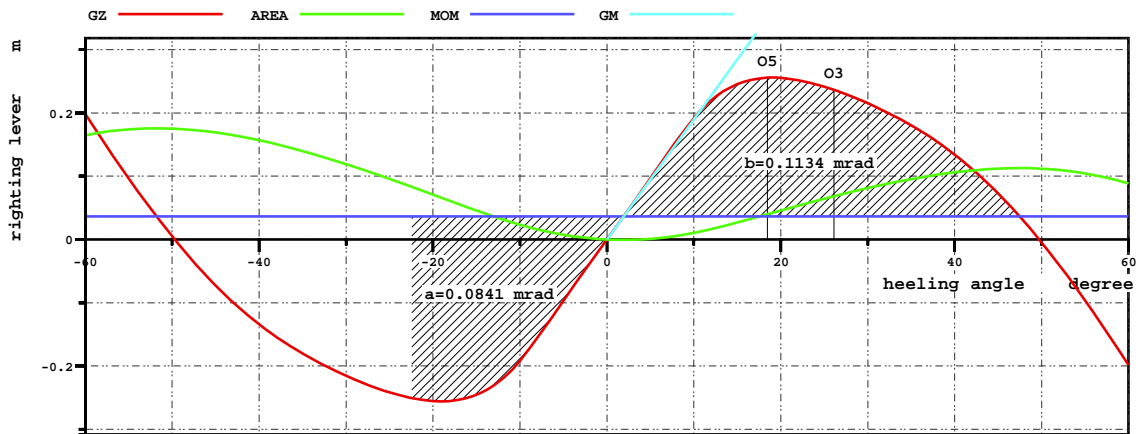
Loading condition HL6

RCR	TEXT	REQ	ATTV	MARGIN	UNIT	STAT
AREA30	GZ Area up to 30 deg.	0.055	0.100	0.045	mrad	OK
AREA40	GZ Area up to 40 deg.	0.090	0.131	0.041	mrad	OK
AREA3040	Minarea 30-40deg	0.030	0.031	0.001	mrad	OK
GZ0.2	Max GZ > 0.2	0.200	0.215	0.015	m	OK
MAXGZ25	Max GZ at angle > 25deg	25.000	19.018	5.982	deg	NOT .
GM0.15	GM > 0.15 m	0.150	1.088	0.938	m	OK
IMOWEATHER	IMO weather crit.	1.000	1.348	0.348		OK

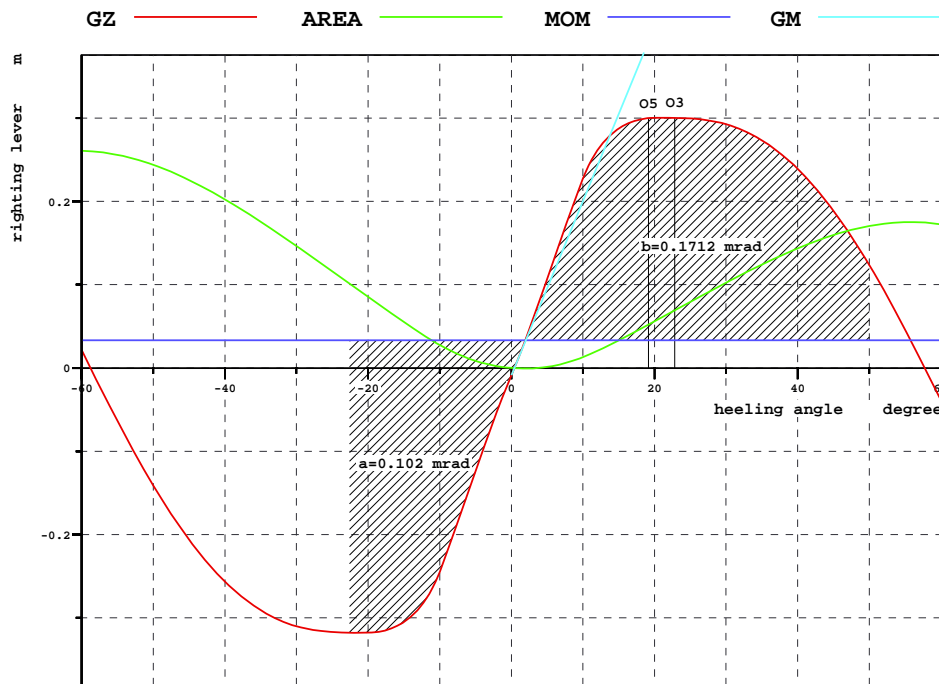
Loading condition HL1_UA

RCR	TEXT	REQ	ATTV	MARGIN	UNIT	STAT
AREA30	GZ Area up to 30 deg.	0.055	0.120	0.065	mrad	OK
AREA40	GZ Area up to 40 deg.	0.090	0.167	0.077	mrad	OK
AREA3040	Minarea 30-40deg	0.030	0.047	0.017	mrad	OK
GZ0.2	Max GZ > 0.2	0.200	0.293	0.093	m	OK
MAXGZ25	Max GZ at angle > 25deg	25.000	21.250	3.750	deg	NOT .
GM0.15	GM > 0.15 m	0.150	1.198	1.048	m	OK
IMOWEATHER	IMO weather crit.	1.000	1.679	0.679		OK

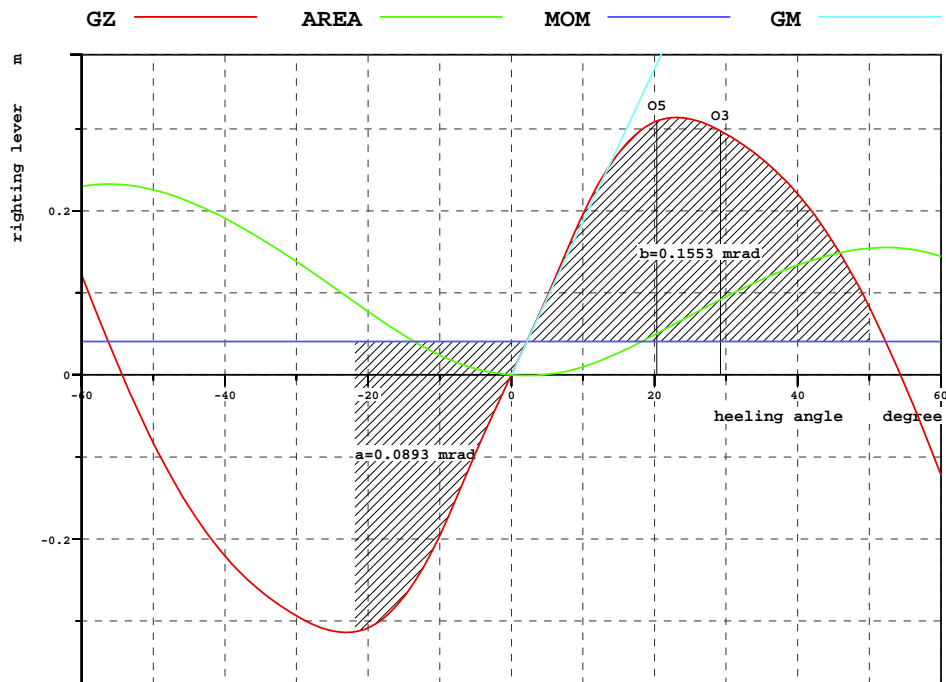
Loading condition HL2_UA

RCR	TEXT	REQ	ATTV	MARGIN	UNIT	STAT
AREA30	GZ Area up to 30 deg.	0.055	0.117	0.062	mrad	OK
AREA40	GZ Area up to 40 deg.	0.090	0.162	0.072	mrad	OK
AREA3040	Minarea 30-40deg	0.030	0.046	0.016	mrad	OK
GZ0.2	Max GZ > 0.2	0.200	0.294	0.094	m	OK
MAXGZ25	Max GZ at angle > 25deg	25.000	23.039	1.961	deg	NOT .
GM0.15	GM > 0.15 m	0.150	1.069	0.919	m	OK
IMOWEATHER	IMO weather crit.	1.000	1.739	0.739		OK

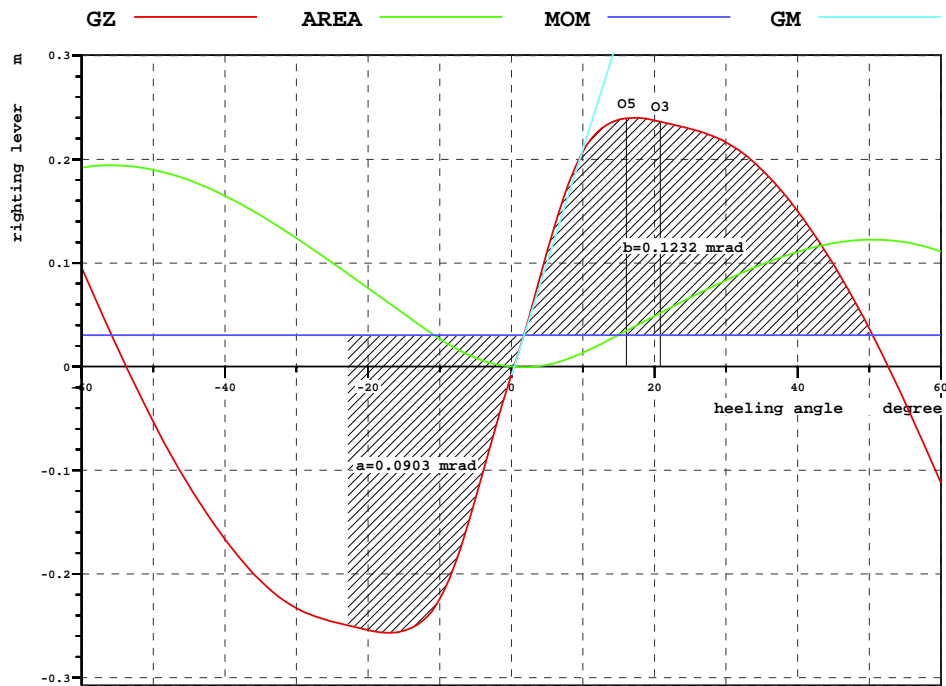
Loading condition HL5_UA

RCR	TEXT	REQ	ATTV	MARGIN	UNIT	STAT
AREA30	GZ Area up to 30 deg.	0.055	0.099	0.044	mrad	OK
AREA40	GZ Area up to 40 deg.	0.090	0.132	0.042	mrad	OK
AREA3040	Minarea 30-40deg	0.030	0.033	0.003	mrad	OK
GZ0.2	Max GZ > 0.2	0.200	0.217	0.017	m	OK
MAXGZ25	Max GZ at angle > 25deg	25.000	17.132	7.868	deg	NOT .
GM0.15	GM > 0.15 m	0.150	1.248	1.098	m	OK
IMOWEATHER	IMO weather crit.	1.000	1.364	0.364		OK

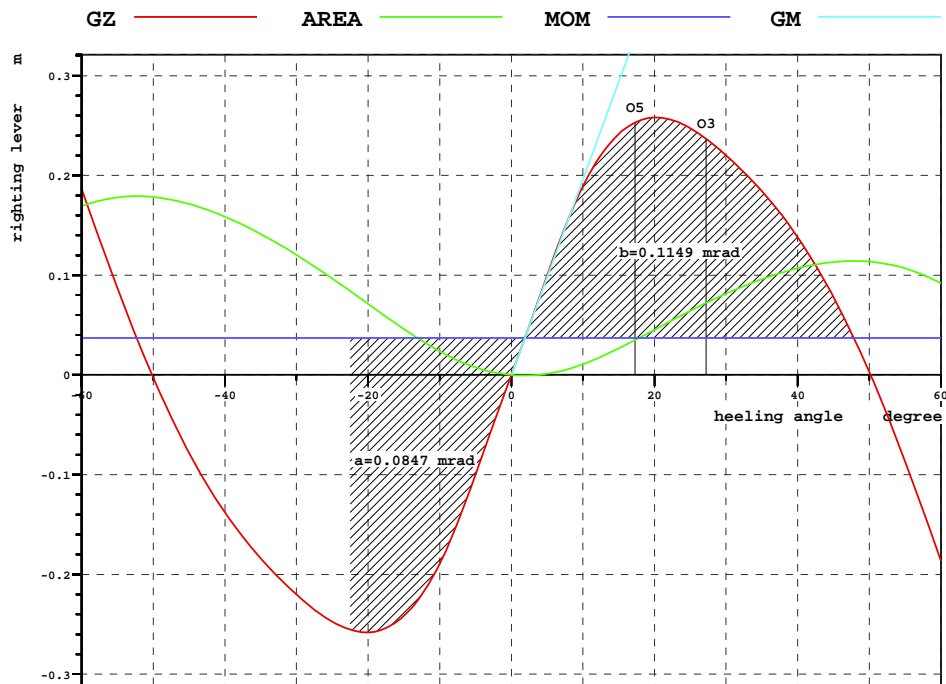
Loading condition HL6_UA

RCR	TEXT	REQ	ATTV	MARGIN	UNIT	STAT
AREA30	GZ Area up to 30 deg.	0.055	0.101	0.046	mrad	OK
AREA40	GZ Area up to 40 deg.	0.090	0.133	0.043	mrad	OK
AREA3040	Minarea 30-40deg	0.030	0.032	0.002	mrad	OK
GZ0.2	Max GZ > 0.2	0.200	0.220	0.020	m	OK
MAXGZ25	Max GZ at angle > 25deg	25.000	20.192	4.808	deg	NOT .
GM0.15	GM > 0.15 m	0.150	1.122	0.972	m	OK
IMOWEATHER	IMO weather crit.	1.000	1.357	0.357		OK
