# REPORT

Sjø 2013/01

## MARINE INCIDENT REPORT M/S TIDEROSE LEGL/9510242 PASSENGER OVERBOARD NEAR VESTNES ON 16 SEPTEMBER 2012

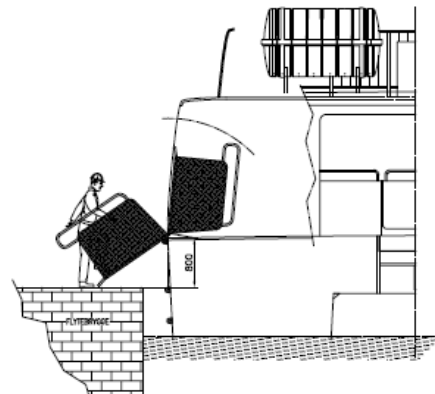
Figure 5: Arrangement sketch of the port aft gangway. The gangway on the starboard side is the same. Source: Norled AS.

During crossings, the gangways function as gates in the side of the vessel, see Figure 3. A bolt at the front of the gangway is used to secure the gangway in the vertical position, see Figure 6 and Figure 7. The ordinary seaman must stand in front of the gangway when securing it. From this position, it will also be possible to see whether or not the gangway has been secured. It is not possible to see whether the gangway has been secured from other positions.

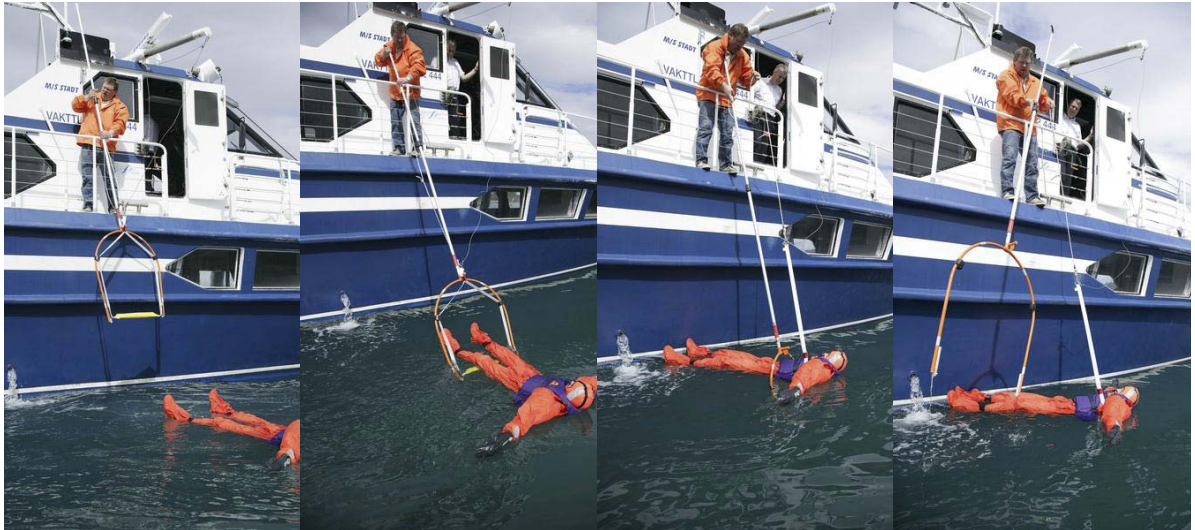
Figure 11: Illustration photos. Use of the SB Rescue Slings to recover a person and hoist him/her aboard. Photo: [www.sula.as](http://www.sula.as).

Once the crew has placed the rescue sling under the arms of the person in the water, the sling is released from the frame. The person is manually hoisted aboard using the winch, see Figure 11.

The manufacturer has set an upper limit of 4 metres freeboard for use of the rescue frame. It is a condition for use of the rescue frame that the person is floating and remains still when the frame is placed around him/her. If a person does not remain still, it could be necessary for one of the rescue personnel to jump into the water to help to put the sling under the person's arms, but the manufacturer does not recommend this, since it will endanger the rescuer's life.

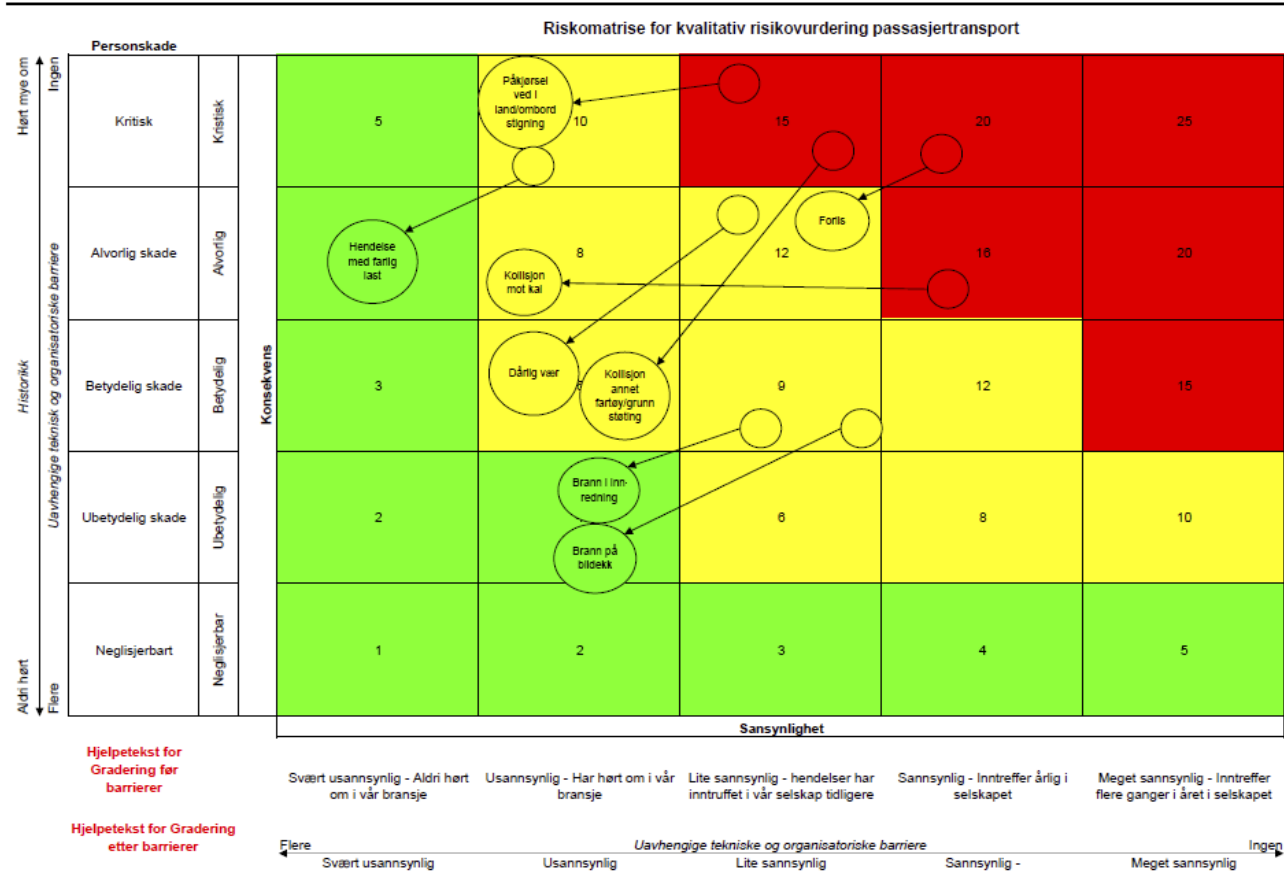
### Passasjersikkerhet(signifikant og uakseptabel risiko)

This risk assessment was part of the shipping company's safety management system.

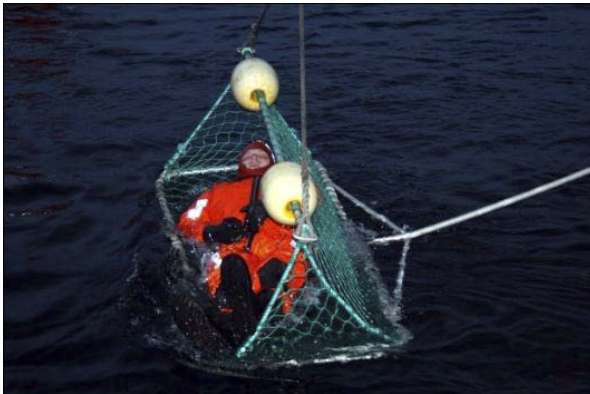
*Figure 13: Måløy rescue cages with cranes have been installed on the large SAR vessels. The rescue cage is effective and simple to use, and recovery is quick. It can be used up to moderate weather conditions. Source: the Norwegian Society for Sea Rescue.*

The NSSR's experience of using the rescue frame from these vessels is that it can be used effectively to control a person in the water, but they then use the rescue cage and crane to hoist the person from the sea. The NSSR's experience is that the rescue frame can be quickly re-armed. It can be used at a distance of 3-4 metres from the vessel's railing. The challenge in relation to these vessels is that the freeboard is so high that the rescue personnel are not near the surface and the person in the water.

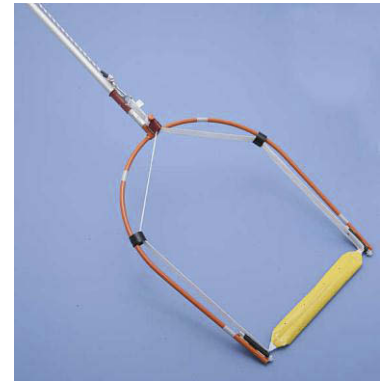
*Figure 14: SB Rescue Sling. Source: the Norwegian Society for Sea Rescue.*

Many of the Norwegian Society for Sea Rescue's (NSSR) vessels have a rescue frame on board, see Figure 14. It can be part of the rescue equipment on all vessels with a length of up to 100 feet. Larger SAR vessels (longer than about 65 feet) also have a rescue cage and crane, see Figure 13. The freeboard of these vessels is around 1.7–2.5 metres.

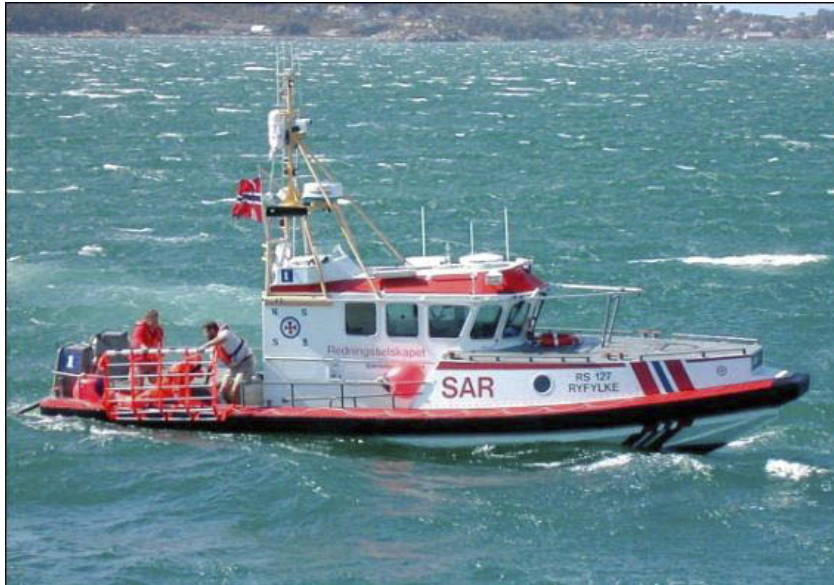
*Figure 15: SAR vessel with a Dacon rescue net. These are used on board SAR vessels with low freeboard. Source: the Norwegian Society for Sea Rescue.*

Small NSSR SAR vessels (with lower freeboard) were also equipped with rescue nets, see Figure 15. The SAR vessels also have different MOB boat concepts. The SAR vessels also use surface divers in such operations.
