REPORT

Sjø 2013/03

REPORT ON THE INVESTIGATION OF A MARINE ACCIDENT CLIPPER SUND LAIR6 OCCUPATIONAL ACCIDENT ANTWERP 6 SEPTEMBER 2011

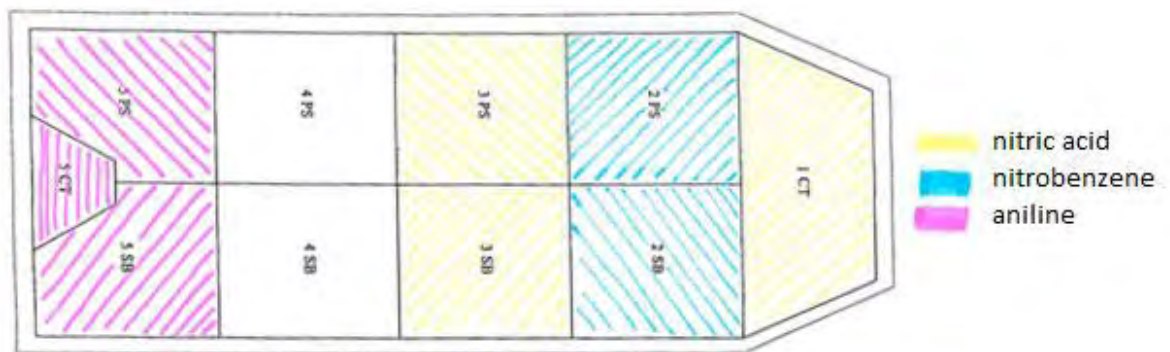
Figure 3: Tank arrangement and cargo distribution on arrival in Antwerp. Tanks 4 PS and 4 SB were empty. Illustration: Brødrene Klovning Shipping/AIBN

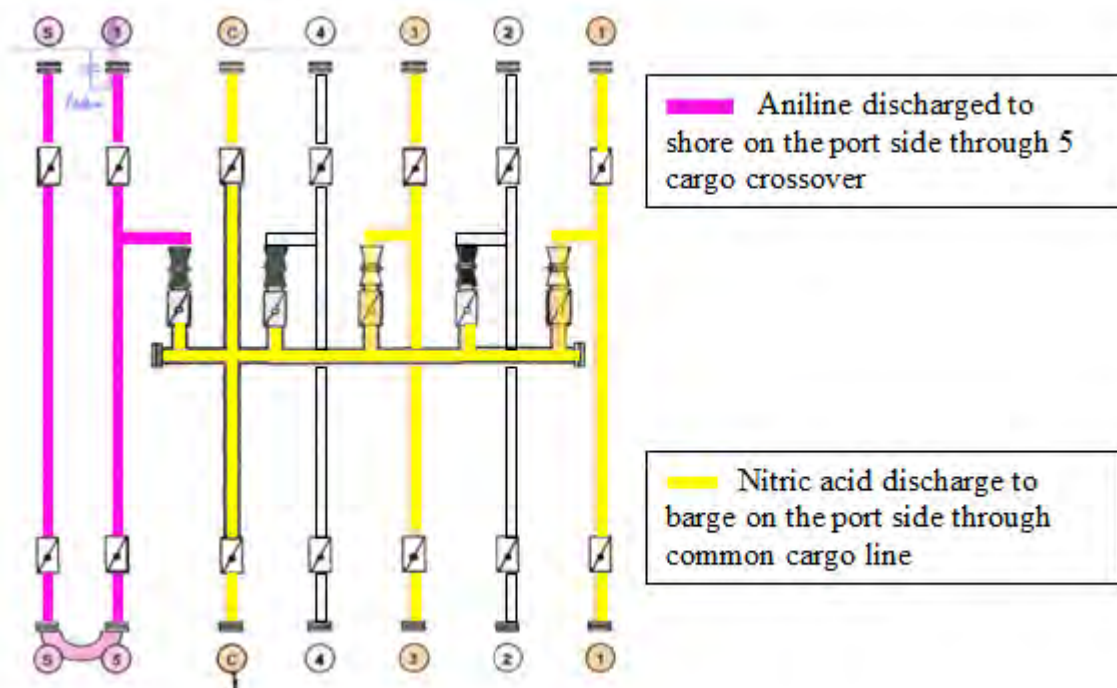
Figure 4: Overview of how the discharge lines were lined up, and of which lines were used to discharge the aniline and nitric acid. This manifold plan is a key part of the vessel’s plan for carrying out loading and discharging. Illustration: Brødrene Klovning Shipping/AIBN

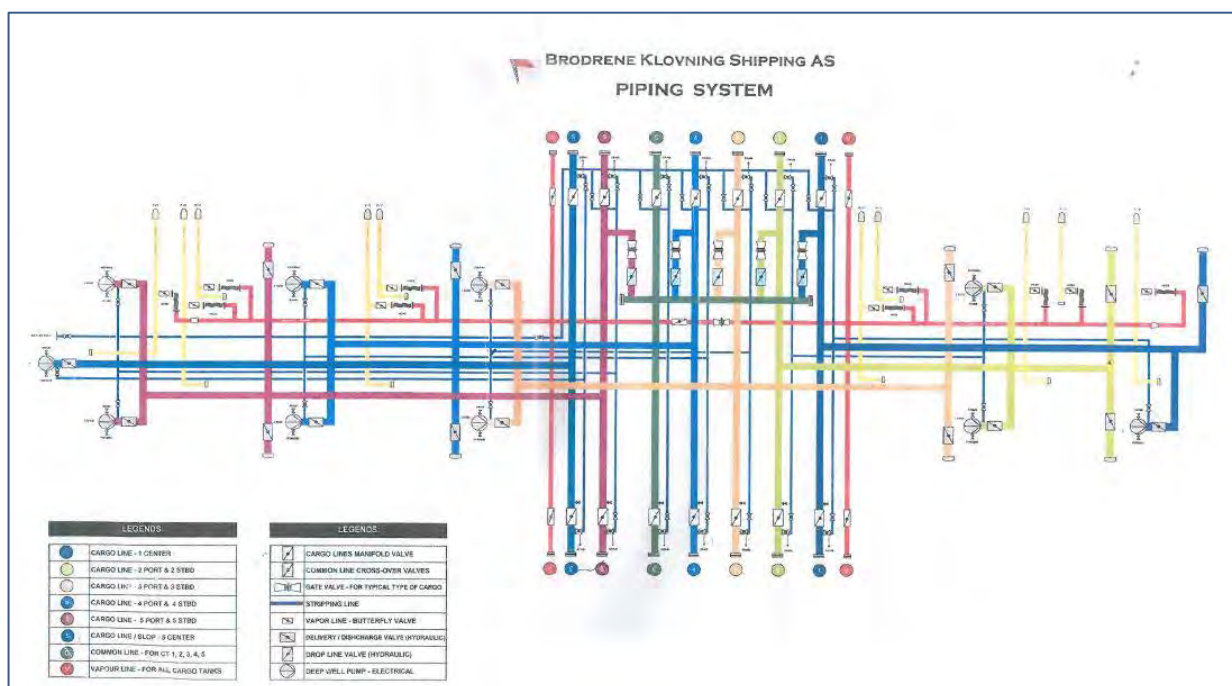
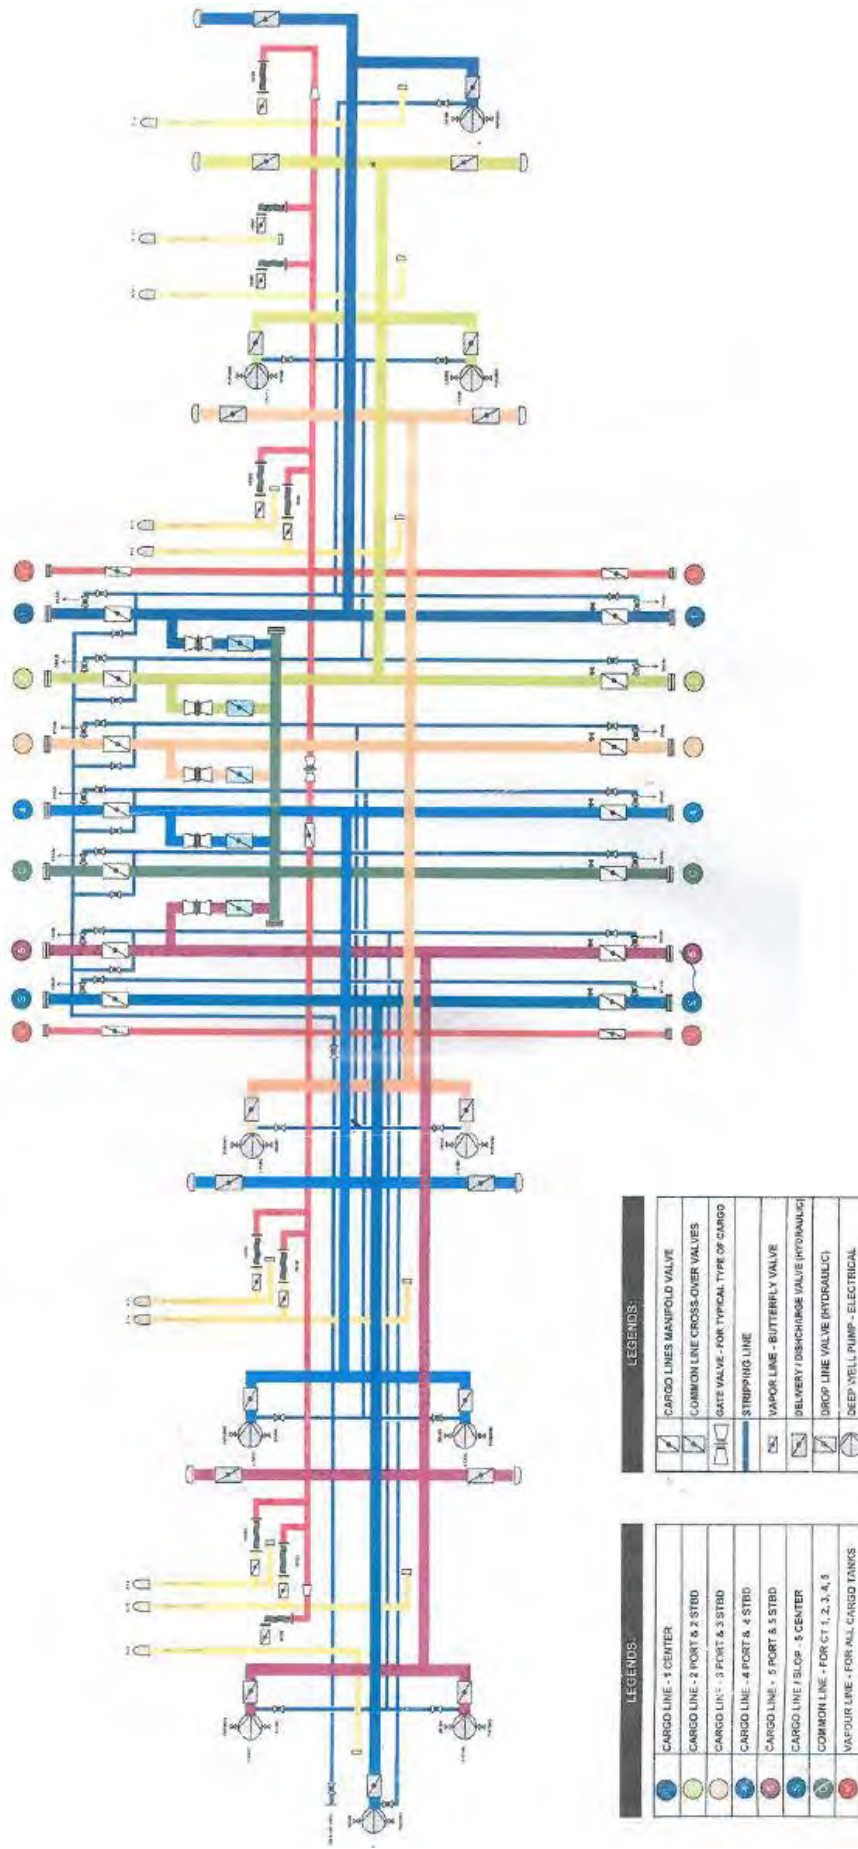
The pipe system for cargo handling includes the main cargo system (for loading and discharging) and the system for stripping and draining; see Figure 9.

Figure 9: The figure shows the pipe system for cargo handling. The drip trays with pertaining pipe connections to the drainline are not shown here, but they are illustrated and described later in the report (see also Appendix E). Illustration: Brødrene Klovning Shipping

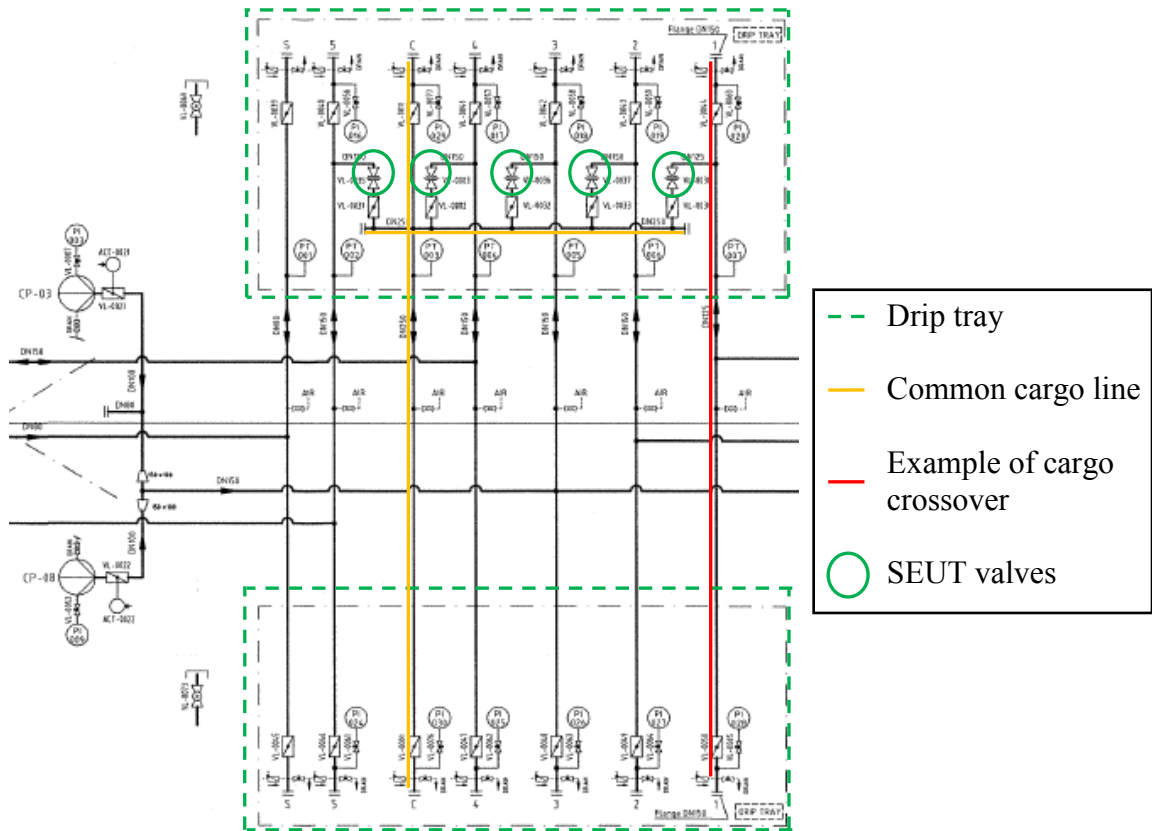
Figure 10: A section of the manifold area and the main loading and discharge lines. Illustration: Brødrene Klovning Shipping/AIBN

With the exception of cargo tank 5C, all the cargo tanks are connected to a common cargo line, as shown in Figure 10. The tanks can be segregated using blind flange valves, SEUT⁶ valves, from the common cargo line.

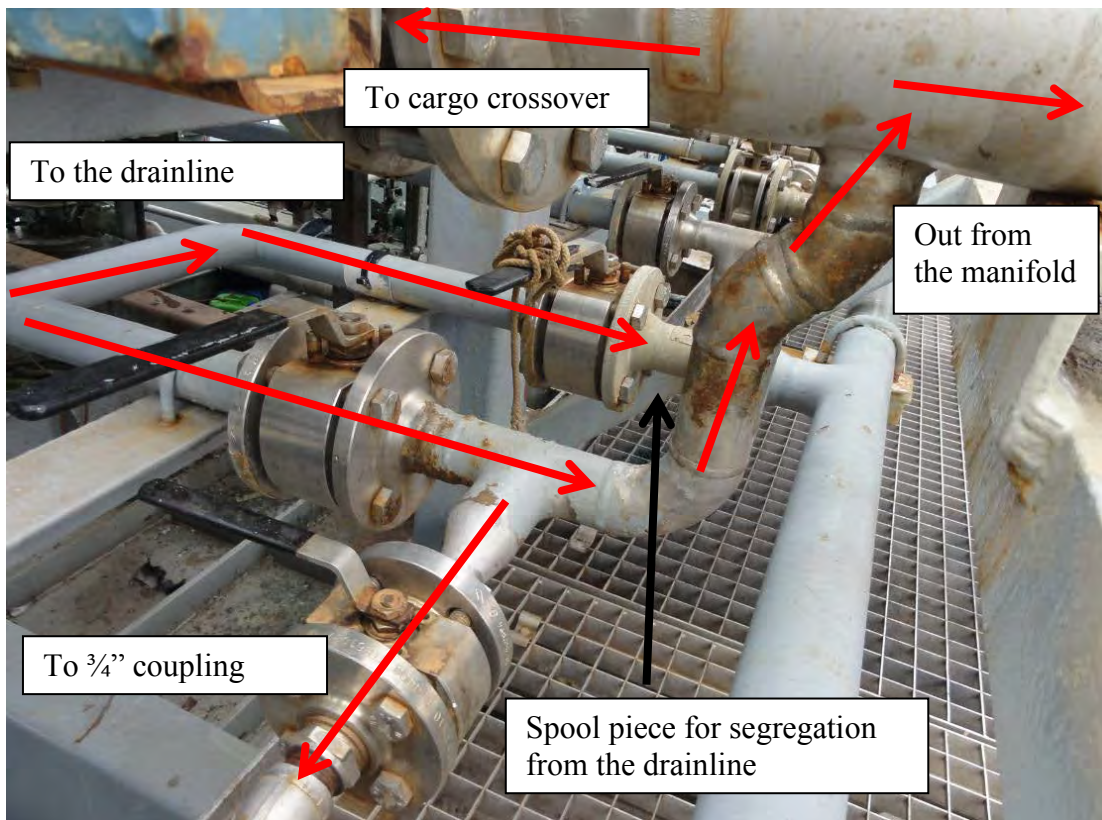
When cargo residues come through the stripping lines to the manifold, there are four possibilities; see Figure 12:

- Discharge the cargo residues directly from the manifold
- Let the cargo residues into the main pipe system for loading and discharging, via the cargo crossover for the tank in question
- Let the cargo residues out through a ¾” ball valve with a snap coupling and cap for sample taking, draining and blowing through with air or nitrogen.
- Fit a spool piece between the stripping line and the drainline and let the cargo residues into the drainline for draining to the slop tank.

Figure 12: Alternative ways to lead cargo residues when they come through the stripping line from the individual cargo tanks. Photo: AIBN
