# REPORT

## MARINE 2014/06

## REPORT ON MARINE ACCIDENT – NORTH TUG, LG7141 (NOR) AND OCEAN PRINCESS IMO NO 9187899 (BERMUDA) CAPSIZING AND SINKING IN KIRKENES, NORWAY, 10 JUNE 2013

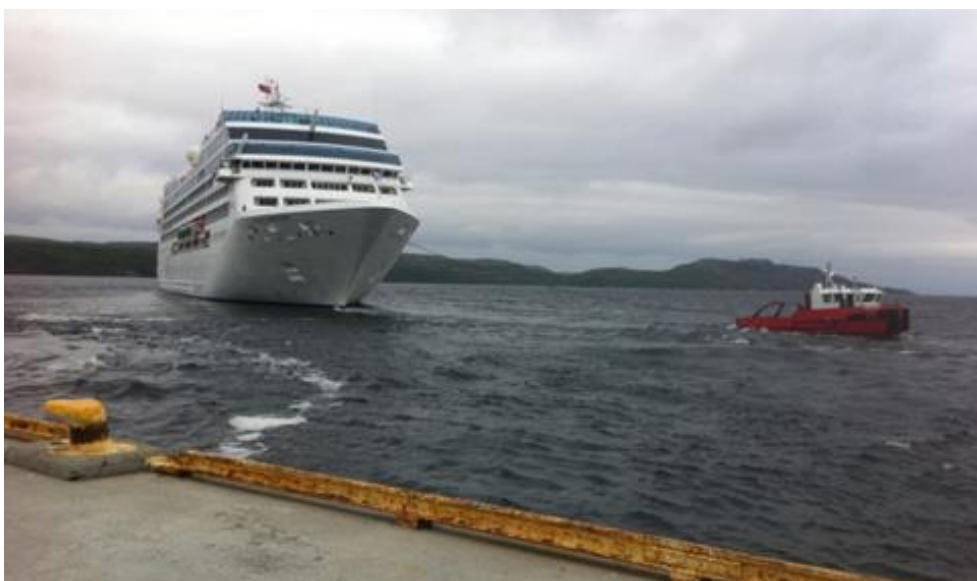
Figure 2: The workboat 'North Tug' and the cruise ship 'Ocean Princess' on departure from Kirkenes on 10 June 2013. Photo: Private
