## MARINE 2014/07

## REPORT ON MARINE ACCIDENT POLARIS I, IMO NO 4500163, PERSONAL INJURY, YMERBUKTEN BAY IN THE ISFJORD ON SVALBARD, 21 AUGUST 2012

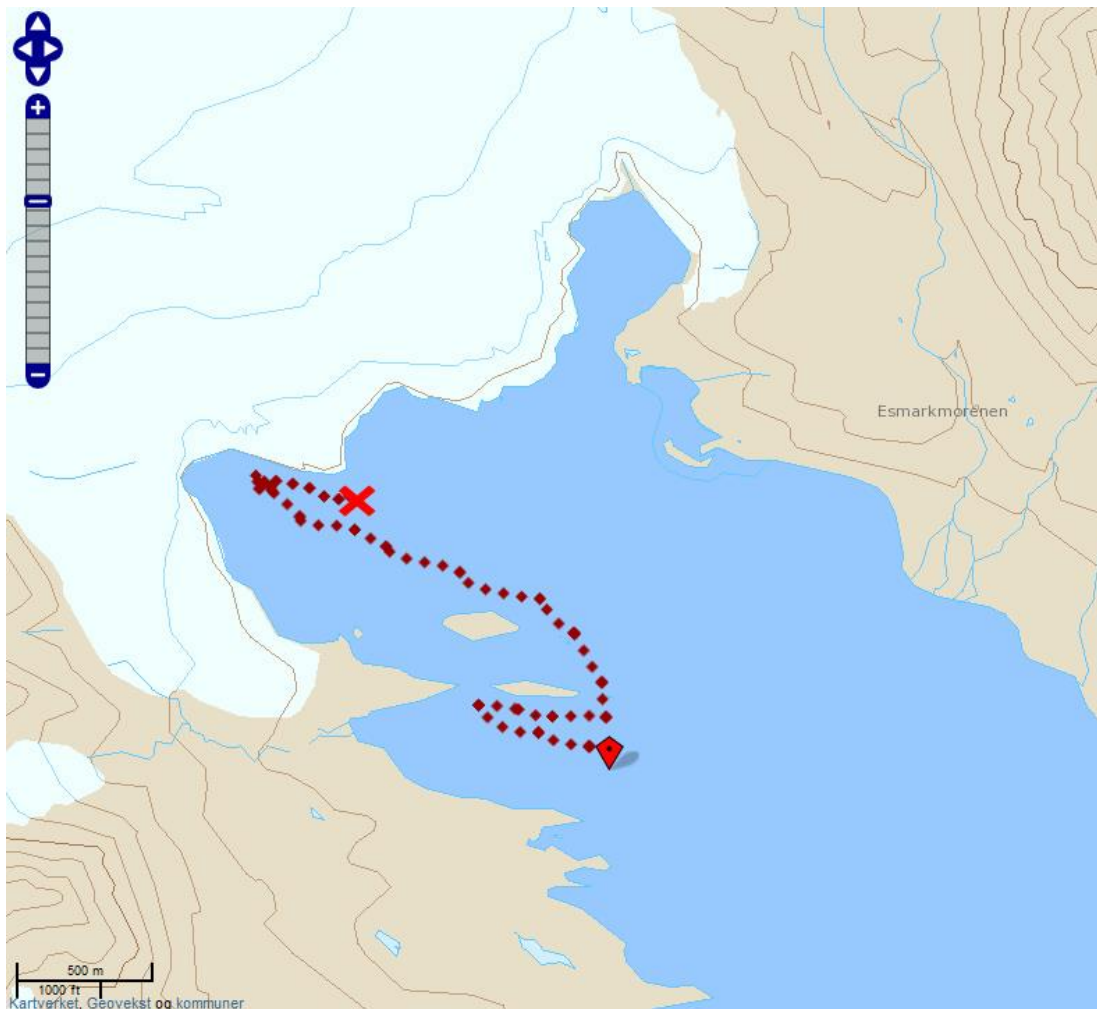
Figure 3: Map of Ymerbukten bay and the Esmarkbreen glacier. As the glacier is constantly changing, the map does not give an accurate description of the glacier front. *Polaris I* was anchored further out in Ymerbukten bay, indicated by a diamond-shaped tag. The red line indicates where the dinghies went before the accident, but this is not stated in more detail in relation to the position and distance to the glacier front. The accident took place in the area around the red X. Source: the Norwegian Mapping Authority

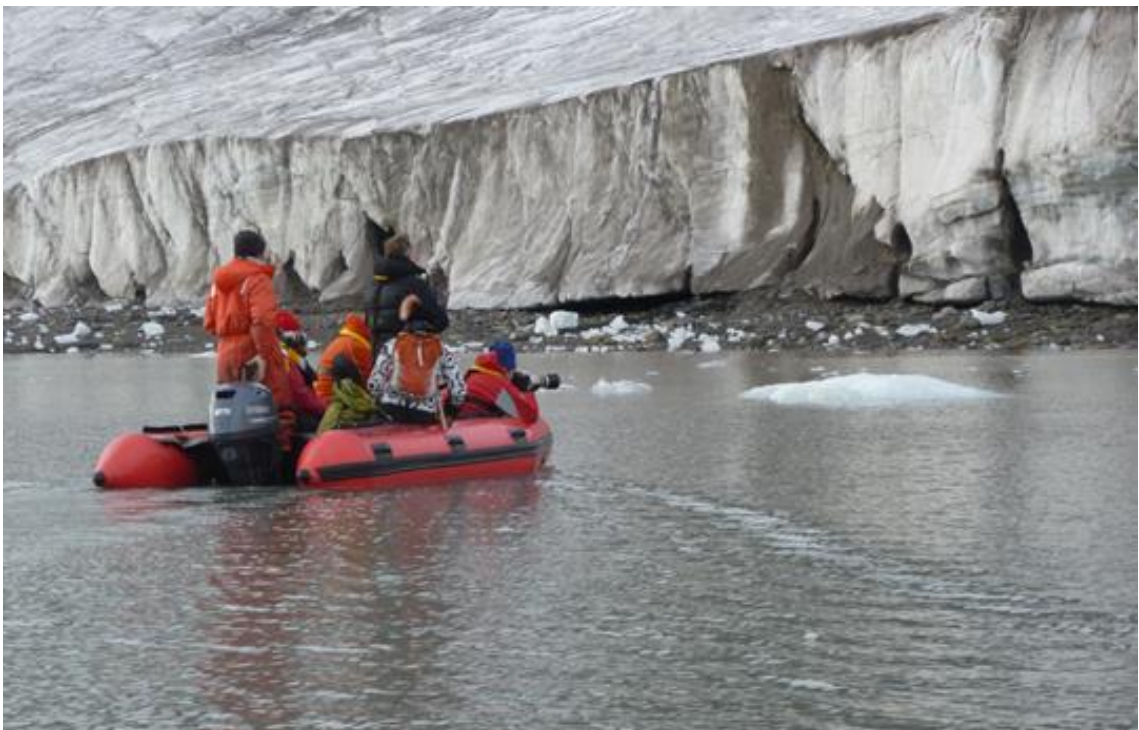
*Figure 6: The photo shows Dinghy 1 on the west side of the bay. The photo was taken from Dinghy 2 before the accident. Photo: Private.*

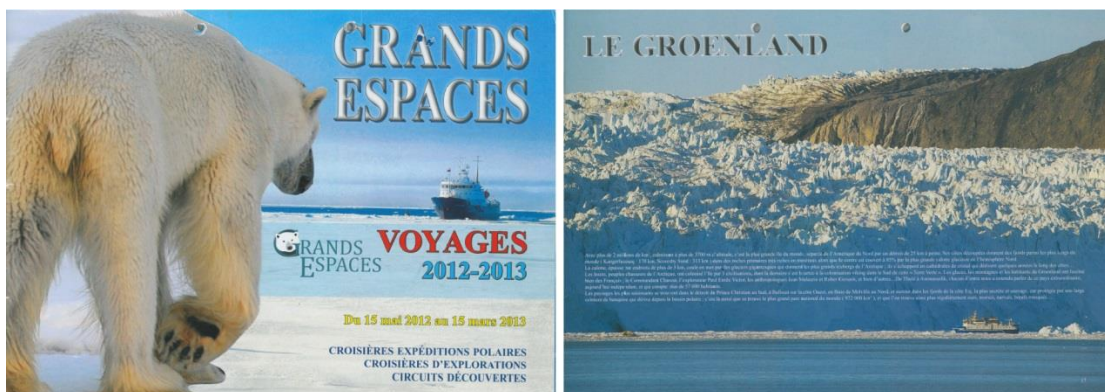
Figure 11: The photo on the left is the cover photo of the tour operator's advertising brochure. The photo on the right shows the vessel in front of a glacier front. Photo: Grands Espaces Sàrl

- The advertising brochure shows photos of the vessel that give the impression that it is right next to a glacier front; see Figure 11. In another accident on Svalbard in 2007, several passengers suffered injuries because the vessel was too close to the glacier front when it calved. It is assumed that this accident may have been known to the tour operators on Svalbard.

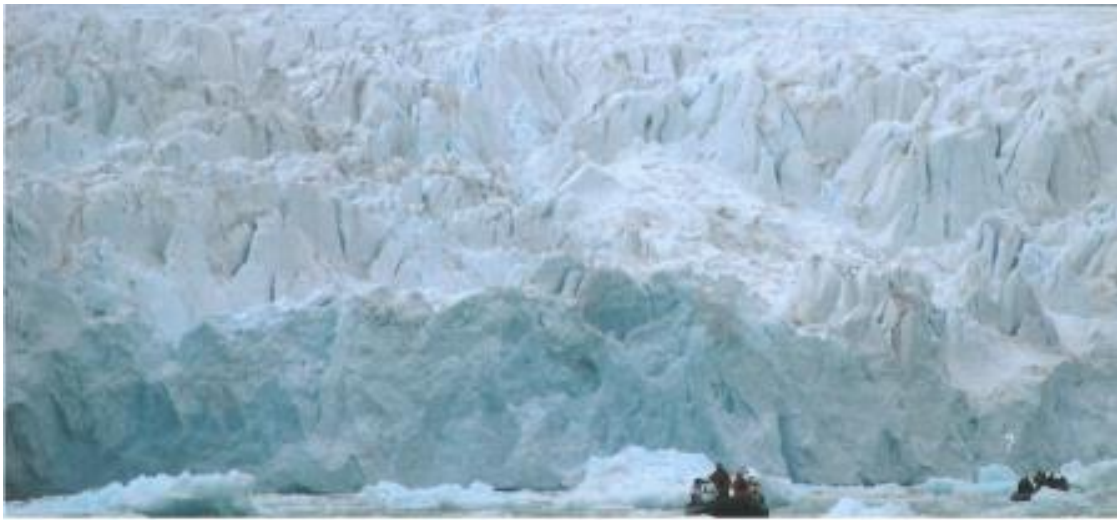
Figure 12: The photo shows two dinghies in front of a glacier. From page 7 of the tour operator’s advertising brochure. Photo: Grands Espaces Sàrl

- The advertising brochure shows photos of rubber dinghies that appear to be very close to a glacier front. There is a great deal of ice in the water, which could prevent a swift retreat away from the glacier front; see Figure 12. The instructions for the guides state that the minimum safety distance is 200 metres. The instructions also state that there is always a danger associated with calving from glacier fronts. This is also emphasised in AECO's guidelines.

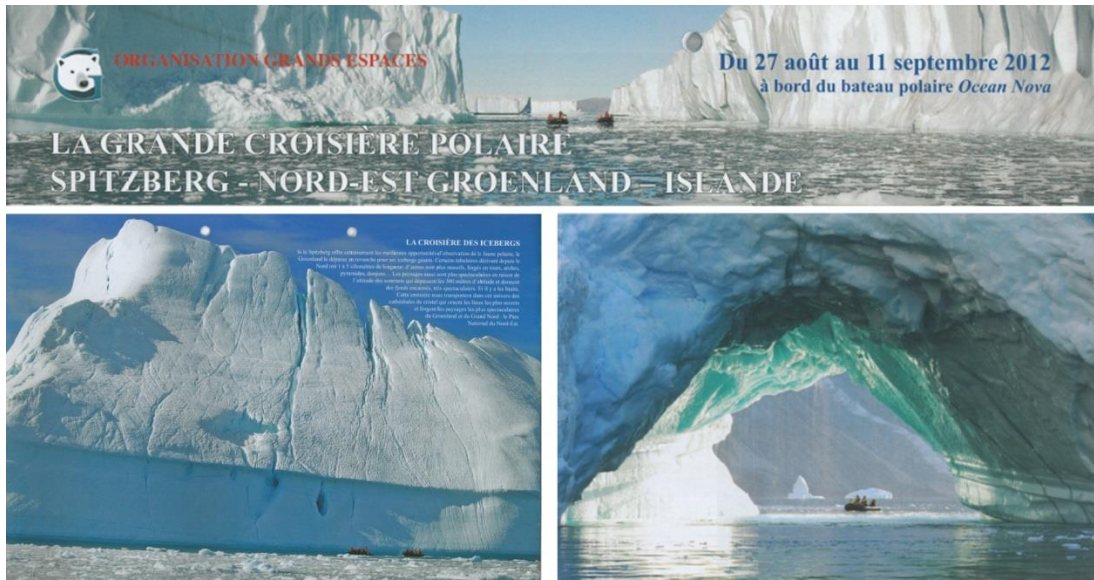
Figure 13: The photo shows a dinghy close to an iceberg. From pages 18, 19 and 21 of the tour operator’s advertising brochure. Photo: Grands Espaces Sàrl

- The advertising brochure shows photos of rubber dinghies that appear to sail very close to icebergs. In one of the photos, there is a great deal of ice in the sea just outside where the dinghy is. The photo gives the impression that the ice prevents a swift retreat away from the iceberg; see Figure 13. The instructions for the guides state that, when approaching an iceberg, you should identify a possible escape route in case the iceberg tips. AECO's guidelines are more detailed in this regard. Here, it says that icebergs are potentially unstable, that they can quickly tip and it is therefore necessary to keep distance. It also makes reference to a description of calving glacier fronts.

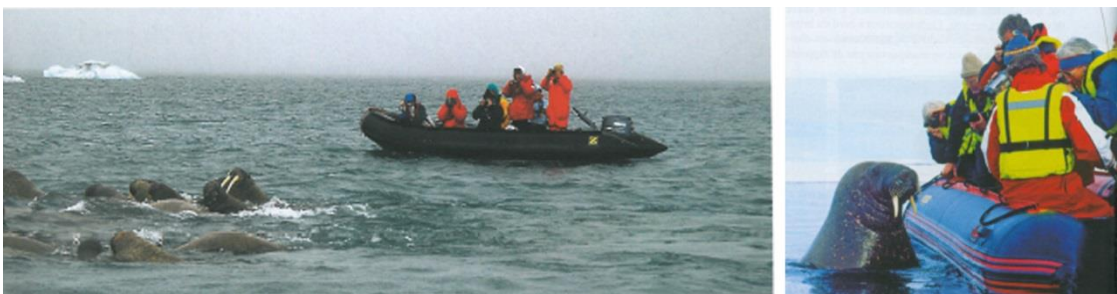
Figure 14: The photo on the left shows a dinghy with passengers close to a herd of walrus. The photo on the right shows a walrus next to a dinghy with passengers. From pages 8 and 34 of the tour operator’s advertising brochure. Photo: Grands Espaces Sàrl

- The advertising brochure shows photos of a rubber dinghy in the water right next to a herd of walrus, only a few metres away. One of the photos shows a walrus in the sea that appears to be only centimetres away from the rubber dinghy. Some of the passengers are sitting on the edge of the boat, while others are standing up taking photos; see Figure 14. In the instructions for the guides, the walrus is described as a dangerous animal. It must be considered dangerous when it is closer than 10–15 metres from the dinghy. In such case, passengers shall be instructed to get down on their knees. The dinghy shall not remain stationary and wait for the passengers to take photos, but move quickly away from the walrus. AECO's guidelines contain similar instructions.
