## MARINE 2014/09

## REPORT ON MARINE ACCIDENT FINNØYGLIMT – LNIM FOUNDERED AT SLETTA NORTH OF HAUGESUND 7 OCTOBER 2011

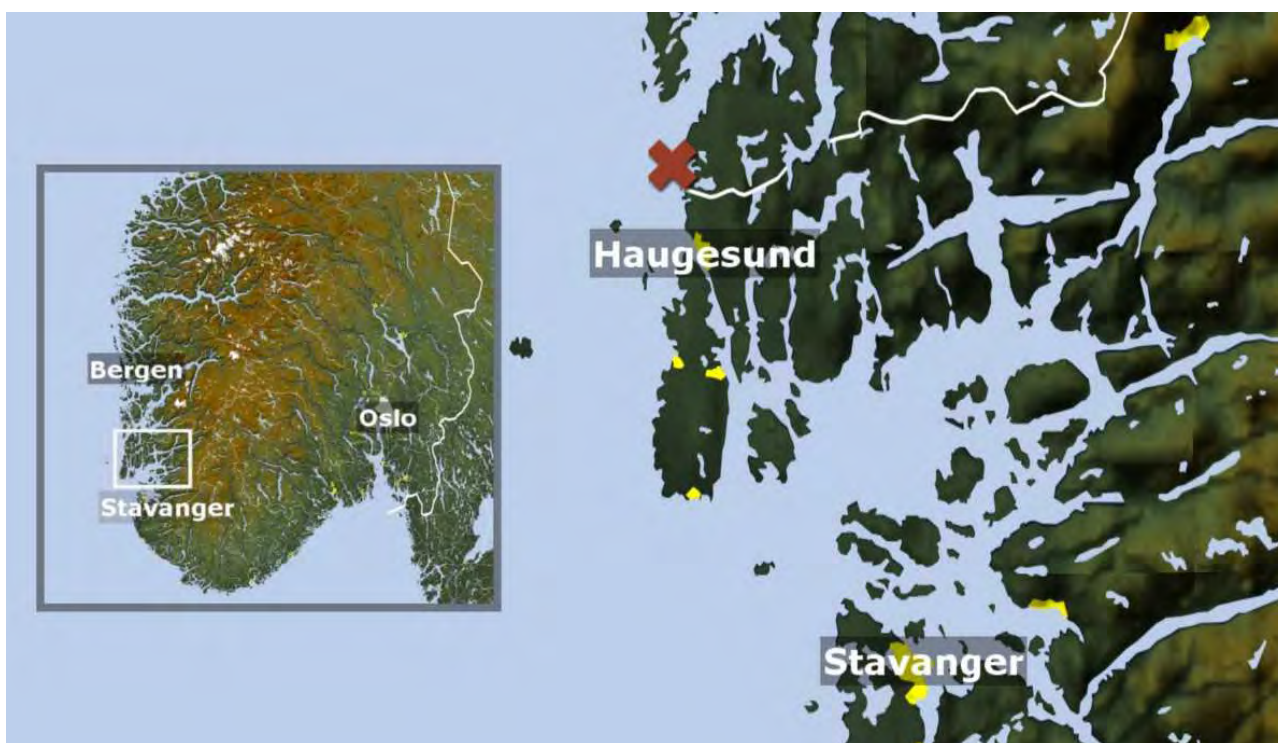
Figure 1: *Finnøyglimt* foundered at Sletta, north of Haugesund, at 23:40 local time on 7 October 2011. Source: AIBN

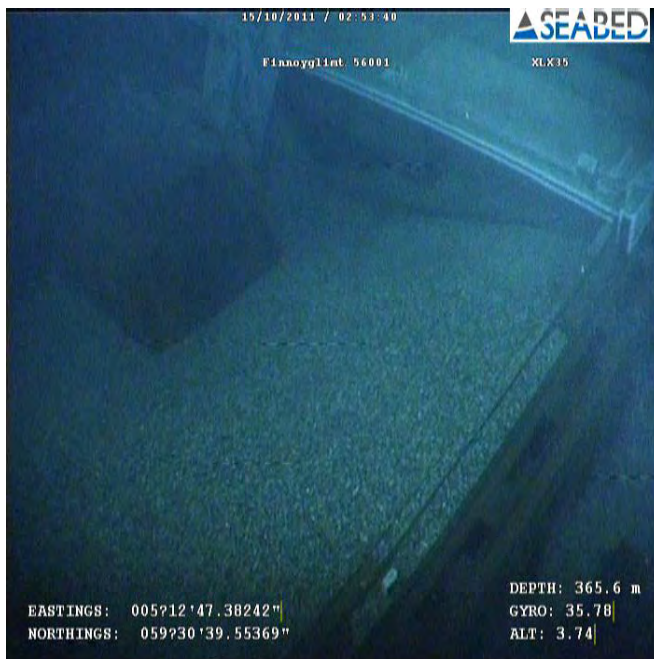
The sand in the aftmost part of the cargo hold has shifted to port. Towards the transverse bulkhead at the fore end of the hold, however, the sand was more evenly distributed across the width of the vessel. Forward of the transverse bulkhead, the aggregate had been thrown forwards towards the port side.

On the starboard side, the level of the cargo was some way under the deck. On the port side, the cargo was on level with the top of the hatch coaming. Some aggregate had been thrown over the coaming and had settled on top of the seabed sediments on deck.

Figure 10: The photo shows how the cargo has been ‘thrown’ (shifted) towards the port side. Source: Seabed Worker’s ROV

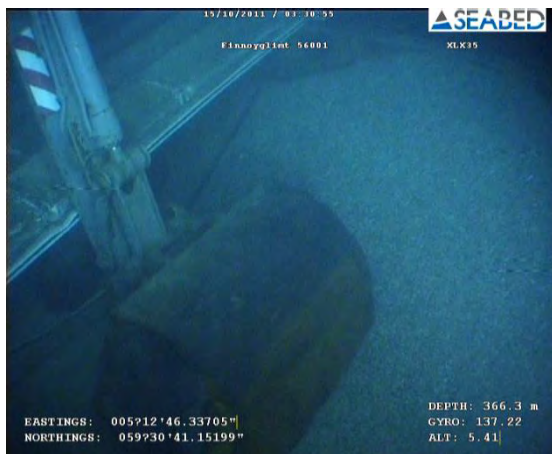
As described in section 1.3 on the chain of events, on this particular voyage, the excavator was parked at the aft end and secured with straps on the aft side. The arm pointed forward and the bucket rested on the hatch covers. The ROV video recording showed that the excavator was still located aft on deck with its arm extending forward. However, the excavator had tipped forward so that the arm extended into the cargo hold with the bucket resting on top of the cargo.

Figure 11: The photo shows the excavator bucket and arm dug into the aggregate in the cargo hold. The photo also shows how the cargo in the hold has been thrown towards the port side. Source: Seabed Worker's ROV

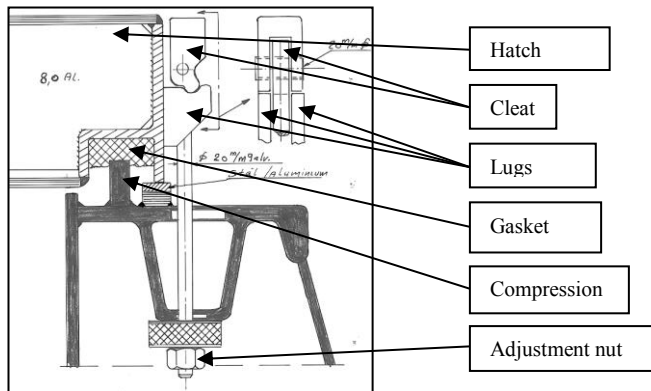
In the areas where the hatch covers were missing (nos 2 and 3), the jacks and securing devices were clearly visible. The aftmost securing device for hatch cover no 3 was missing on the starboard side. The jacks were down and the other securing devices lay unengaged in the steel frame to which they were attached.

In the areas where the covers were not missing, the jacks and securing devices were less visible. Observations of the hatch covers' sides showed, however, that none of the securing devices had been pulled up to the fastening lugs on the hatch covers and engaged.

It has not been possible to get hold of drawings of the hatch covers and securing arrangement on *Finnøyglimt* from the shipping company, the hatch manufacturer<sup>8</sup> or the Norwegian Maritime Authority. However, the hatch manufacturer gave the AIBN access to drawings for a vessel<sup>9</sup> having an arrangement corresponding to the one on *Finnøyglimt*. Figure 14 shows a detailed drawing of the securing arrangement.

Figure 14: Excerpt of drawing 0-1055 'Hatch cover assembly, M/S Solvind', corresponding to the hatch cover securing arrangement on *Finnøyglimt*. Source: Kopervik Slip AS

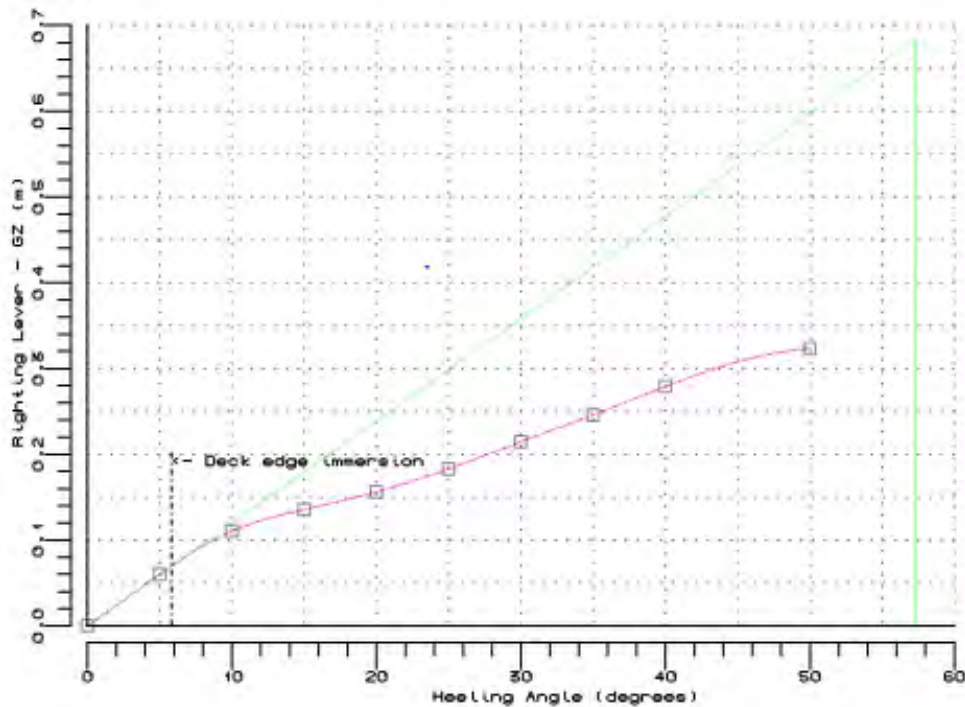
The calculations show that, on departure from Helle/Storasund, *Finnøyglimt* had a mean moulded draught of 3.588 m and a forward trim of 0.44 m; see load condition 8. The calculations show that the vessel's stability was satisfactory, see Figures 16, 17 and 18. The fact that the hatches were not secured was not taken into account.

Figure 17: Righting level curve (GZ) on departure from Helle/Storasund. Source: AIBN

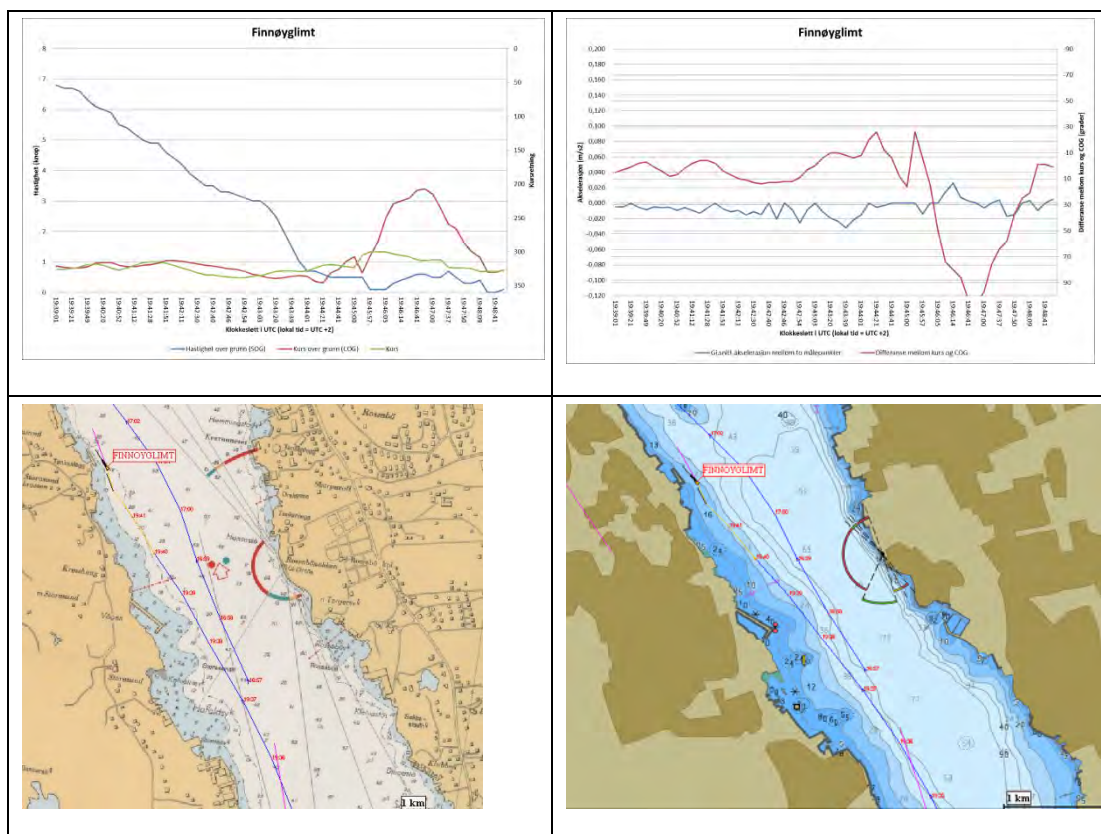
De større akselerasjonene og kursdifferansene oppstår etter at hastigheten har blitt redusert til under 3 knop. Det antas derfor at disse oppstår i forbindelse med at fartøyet legger til kai. De beregnede gjennomsnitt-akselerasjonene på opptil  $-0,032$  kan derfor oppstå når fartøyet legger til ved kai.

**Figur 9:**  
 Øverst venstre: Hastighet over grunn, kurs og kurs over grunn.  
 Øverst høyre: Beregnet gjennomsnittlig akselerasjon mellom to målepunkter, kurs og kurs over grunn.  
 Nederst venstre: Høyre strek angir Finnøyglimts seilas i tidsrommet over rasterkart. Fra AIS Utland  
 Nederst høyre: Tilsvarende som nederst venstre men med elektronisk kart.

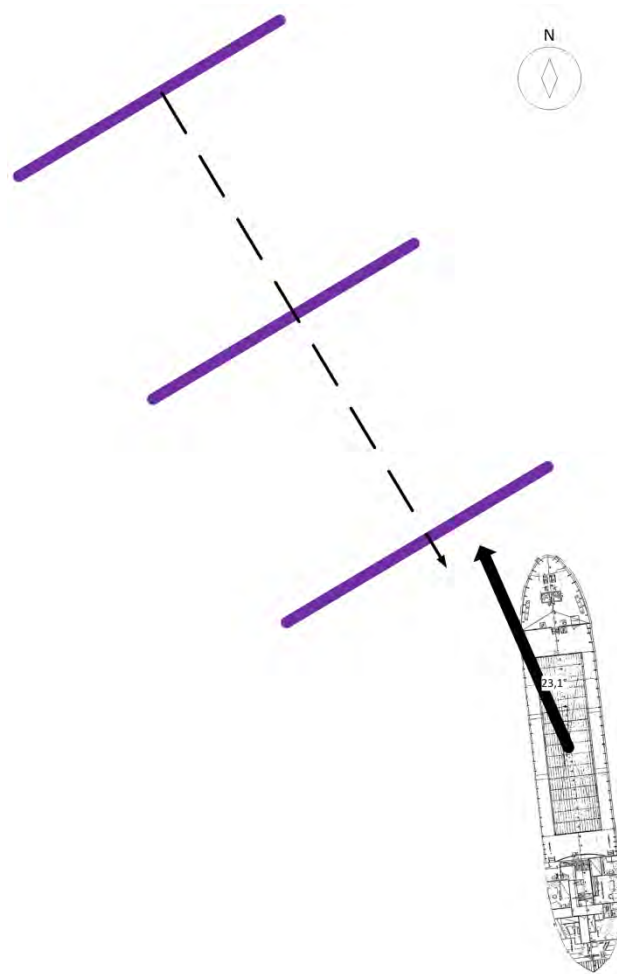
Fartøyet hadde noen akselerasjoner på  $0,017 - 0,034 \text{ m/s}^2$ . Dette var i et område der fartøyet seilte fra grunnere til noe dypere vann og med noe bråere endring i dybden. Det er vurdert til at vindsjøen forårsaket akselerasjonene på fartøyet sine bevegelser i dette tidsrommet.

Kl. 20:40:26 hadde fartøyet kurs 353 grader, COG 337 grader og hastighet 6,6 knop. På dette tidspunktet er det en beregnet akselerasjon på  $-0,051 \text{ m/s}^2$ . Posisjonen er ved vestlig side av 20-meters kotekant. Det oppgis to dybder innenfor kotekanten på hhv 15 og 12 meter. Som det fremgår av det elektroniske sjøkartet endrer bunntopografien seg raskere i dette området. I øst-vest retning endrer dybden seg fra 50 til 20 meter over en horisontal avstand på 40 meter.

Figur 11: Illustrasjon av fartøyets kurs, COG (svart heltrukken pil) og bølgenes retning kl. 20:40:26. Blå streker illustrerer bølgekammen til vindsjø. Avstanden mellom bølgekammene er ikke proporsjonalt med fartøyets størrelse.

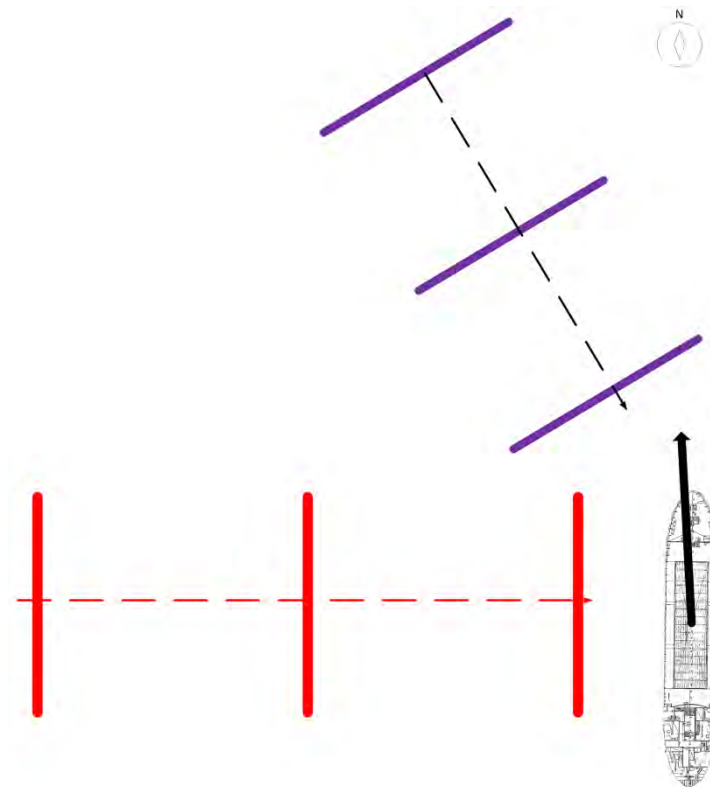
I dette området hadde fartøyet noe større forskjell mellom kurs og COG og med påfølgende akselerasjon på  $-0,051 \text{ m/s}^2$ .

Kl. 20:55:40 var fartøyet ved Tømmerflua og seilte over den syd-østre siden av 50-meterskoten. Kl. 20:55:40 var kurs 1 grad, COG 357 grader og hastighet 6,2 knop.

Like før dette tidspunktet var differanse mellom kurs og COG opp til 11 grader. Dette var omkring kl. 20:54:34. Kl. 20:55:40 var det en beregnet akselerasjon på  $-0,051 \text{ m/s}^2$ .

*Figur 13: Illustrasjon av fartøyets kurs, COG (svart heltrukken pil) og bølgenes retning kl. 20:55:40. Blå og rød streker illustrerer henholdsvis bølgekammen til vindsjø og dønninger. Avstanden mellom bølgekammene er ikke proporsjonalt med fartøyets størrelse. Det er usikkerheter om retningen til dønningene, men disse kan ha virket mot fartøyets babord baug og låring.*

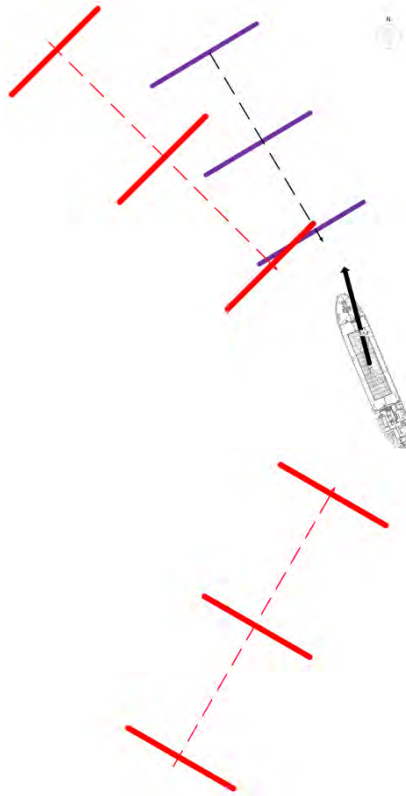
Kl. 21:00:32 er det en beregnet akselerasjon på  $-0,103 \text{ m/s}^2$ . Dette er en av de få maksimale akselerasjonene som har blitt observert. På dette tidspunktet var kurs 338 grader, COG 345 grader og hastighet 5,7 knop.

Figur 15: Illustrasjon av fartøyets kurs, COG (svart heltrukken pil) og bølgenes retning kl. 21:00:32. Blå og rød streker illustrerer henholdsvis bølgekammen til vindsjø og dønninger. Avstanden mellom bølgekammene er ikke proporsjonalt med fartøyets størrelse. Det er usikkerheter om retningen til dønningene, men disse kan ha virket mot fartøyets babord baug og låring.

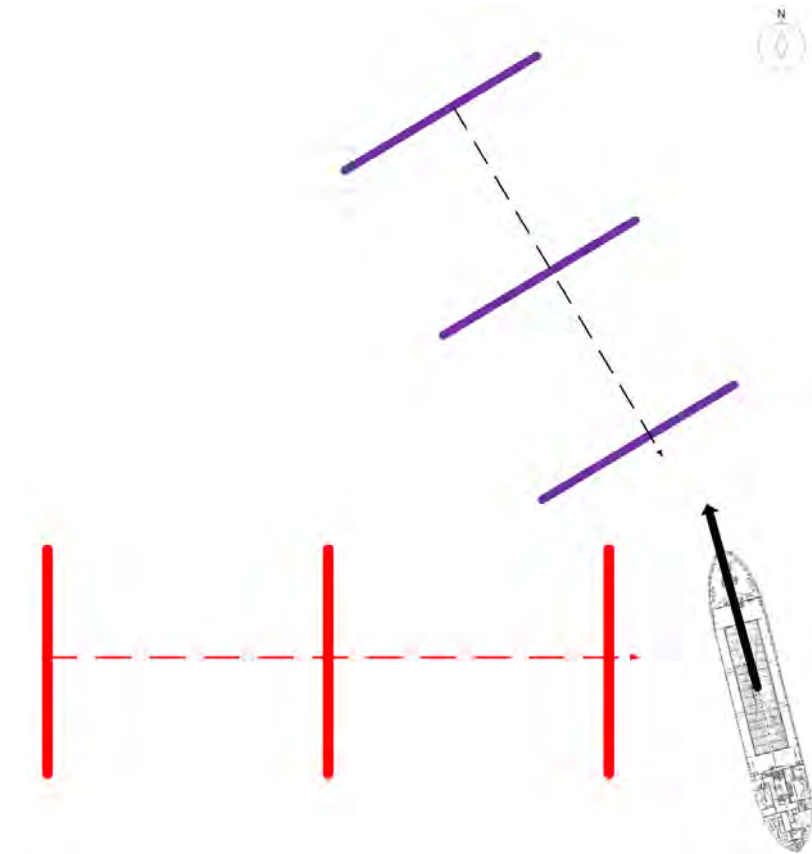
Kl. 21:07:11 var kurs 349 grader, COG 344 grader og hastighet 5,9 knop. Kl. 21:32:19 var kurs 9 grader, COG 15 grader og hastighet 5,7 knop.

*Figur 17: Illustrasjon av fartøyets kurs, COG (svart heltrukket pil) og bølgenes retning kl. 21:07:11. Blå og rød streker illustrerer henholdsvis bølgekammen til vindsjø og dønninger. Avstanden mellom bølgekammene er ikke proporsjonalt med fartøyets størrelse.*

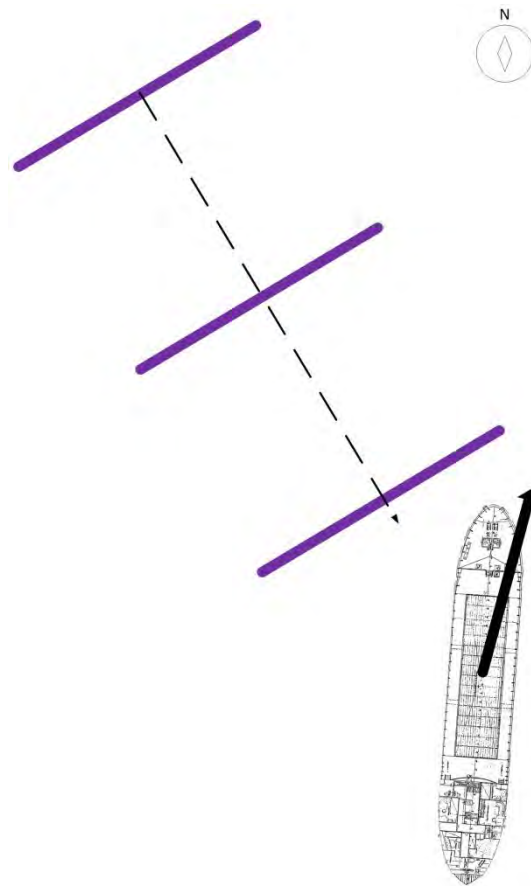
Omtrent kl. 21:32:30 påbegynte fartøyet babord sving. Kursen var da 4 grader, COG 15 grader og hastighet 5,7 knop.

Figur 21: Illustrasjon av fartøyets kurs, COG (svart heltrukken pil) og bølgenes retning kl. 21:32:30. Blå streker illustrerer vindsjøens bølgekam. Avstanden mellom bølgekammene er ikke proporsjonalt med fartøyets størrelse.

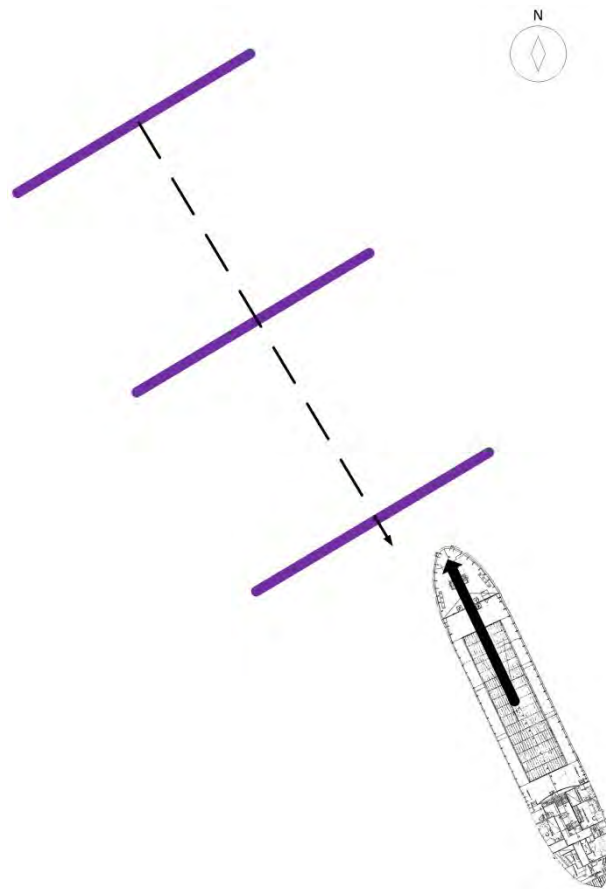
Kl. 21:33:16 oppstod det en større akselerasjon på  $-0,051 \text{ m/s}^2$ . På dette tidspunkt hadde fartøyet kurs 333 grader, COG 336 grader og hastighet 5 knop.

Figur 22 Illustrasjon av fartøyets kurs, COG (svart heltrukken pil) og bølgenes retning kl. 21:33:16. Blå streker illustrerer vindsjøens bølgekam. Avstanden mellom bølgekammene er ikke proporsjonalt med fartøyets størrelse.

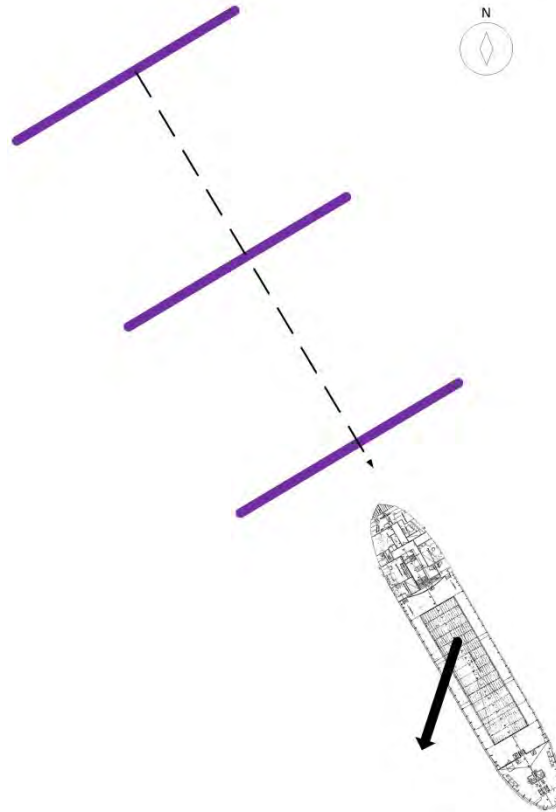
På dette tidspunktet fikk fartøyet vindsjøen på låringen. Ved at bølgene kom mot låringen kan bølgene ha løftet akterskipet slik at baugen gikk ned.

Figur 23: Illustrasjon av fartøyets kurs, COG (svart heltrukken pil) og bølgenes retning kl. 21:35:19. Blå streker illustrerer vindsjøens bølgekam. Avstanden mellom bølgekammene er ikke proporsjonalt med fartøyets størrelse.

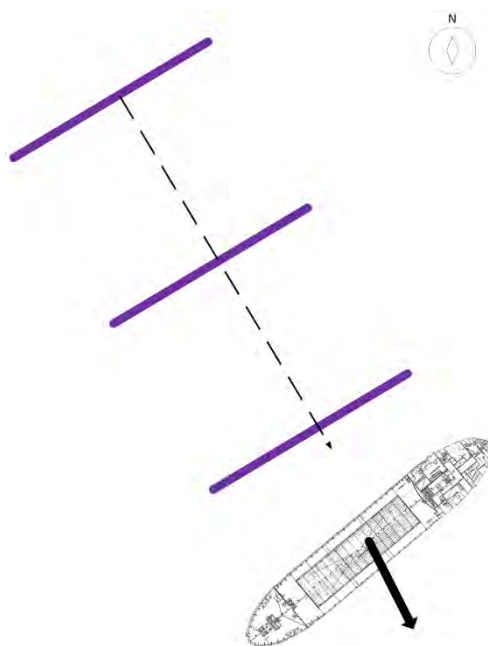
Tiden mellom akselerasjonene sammenfaller med bølgeperioden til vindsjøen. I løpet av denne tiden, 34 sekunder, ble fartøyet dreid tvers av vind og vindsjø slik at vindsjøen slo mot styrbord side.

Figur 24: Illustrasjon av fartøyets kurs, COG (svart heltrukken pil) og bølgenes retning kl. 21:37:07. Blå streker illustrerer vindsjøens bølgekam. Avstanden mellom bølgekamene er ikke proporsjonalt med fartøyets størrelse.

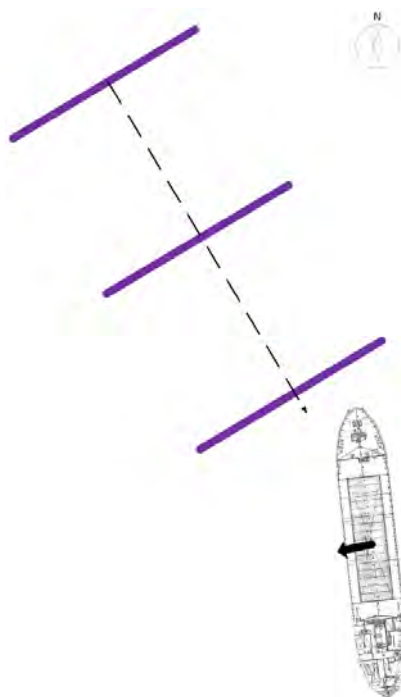
Figur 25: Illustrasjon av fartøyets kurs, COG (svart heltrukken pil) og bølgenes retning kl. 21:39:14. Blå streker illustrerer vindsjøens bølgekam. Avstanden mellom bølgekamene er ikke proporsjonalt med fartøyets størrelse.

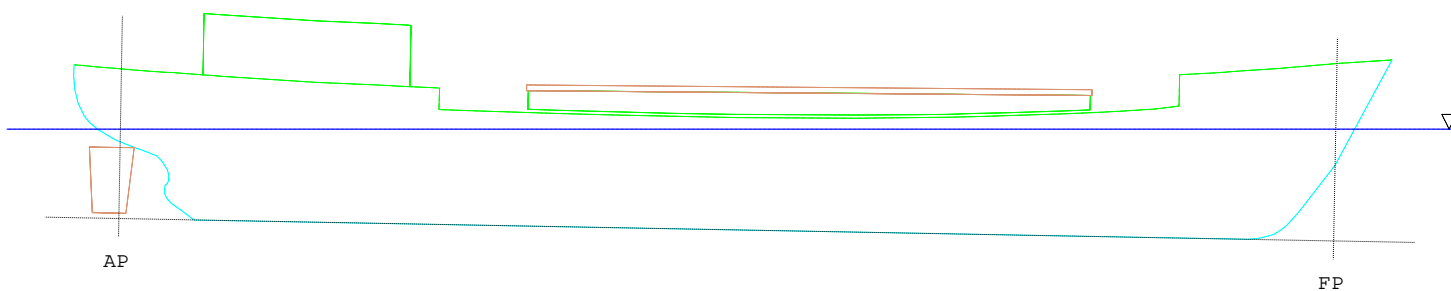
Loading Condition no. : 4

Stability Margin ..... : -0.099 m  
 Stability Conclusion . : NOT OK !!

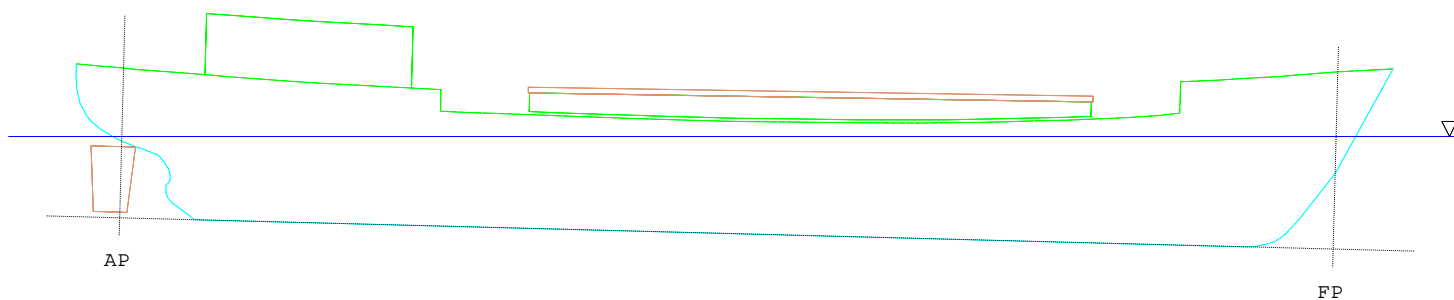
Loading Condition no. : 5

Stability Margin ..... : -0.139 m  
 Stability Conclusion . : NOT OK !!

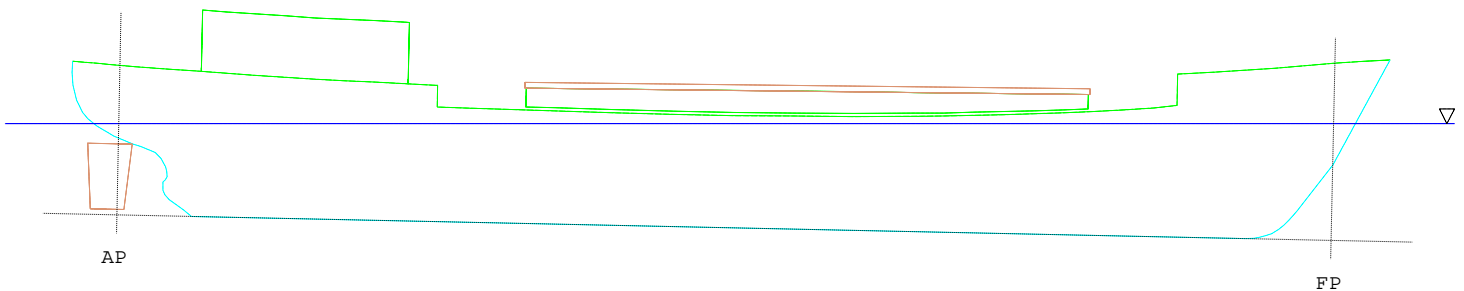
Loading Condition no. : 6

Stability Margin ..... : -0.128 m  
 Stability Conclusion . : NOT OK !!

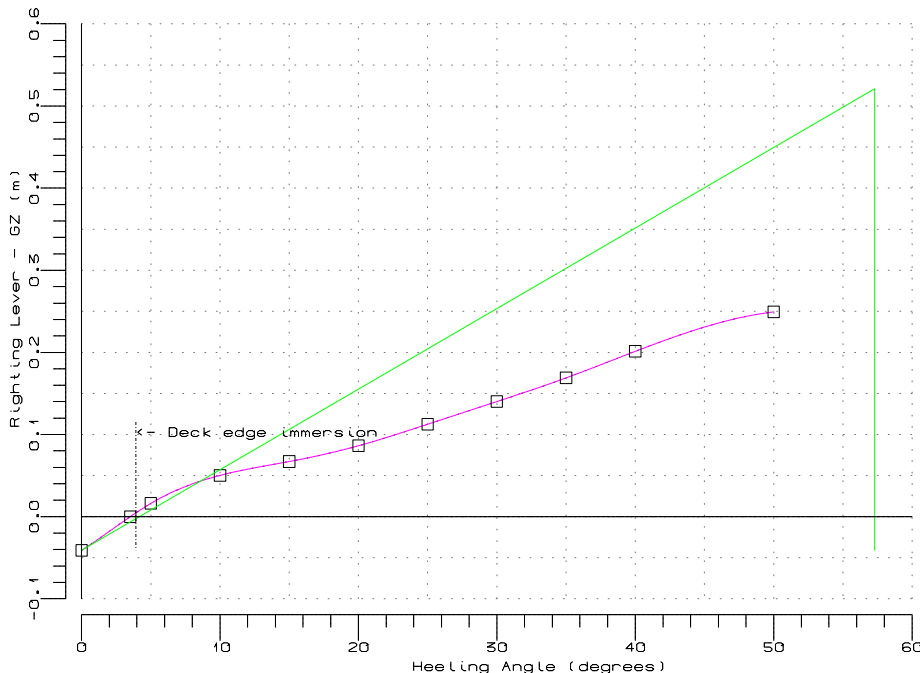
Loading Condition no. : 11  
Condition Id. text : Ved Tømmerflu FMP 71,46 t vann i last

Angle (degr.)	GZ (m)	Area (m*rad)
0.000	-0.041	-0.0013
3.519	0.000	0.0000
5.000	0.016	0.0002
10.000	0.050	0.0033
15.000	0.067	0.0085
20.000	0.086	0.0151
25.000	0.113	0.0237
30.000	0.140	0.0348
35.000	0.169	0.0482
40.000	0.201	0.0644
50.000	0.249	0.1043

Deck immersion : 3.926 °  
Maximum GZ at : 50.000 °  
Equilibrium at : 3.519 °  
Area, 0 - 30 : 0.0360 m\*rad  
Area, 0 - 40 : 0.0656 m\*rad  
Area, 30 - 40 : 0.0296 m\*rad  
Area, 0 - maxGZ : 0.1056 m\*rad  
GM : 0.562 m

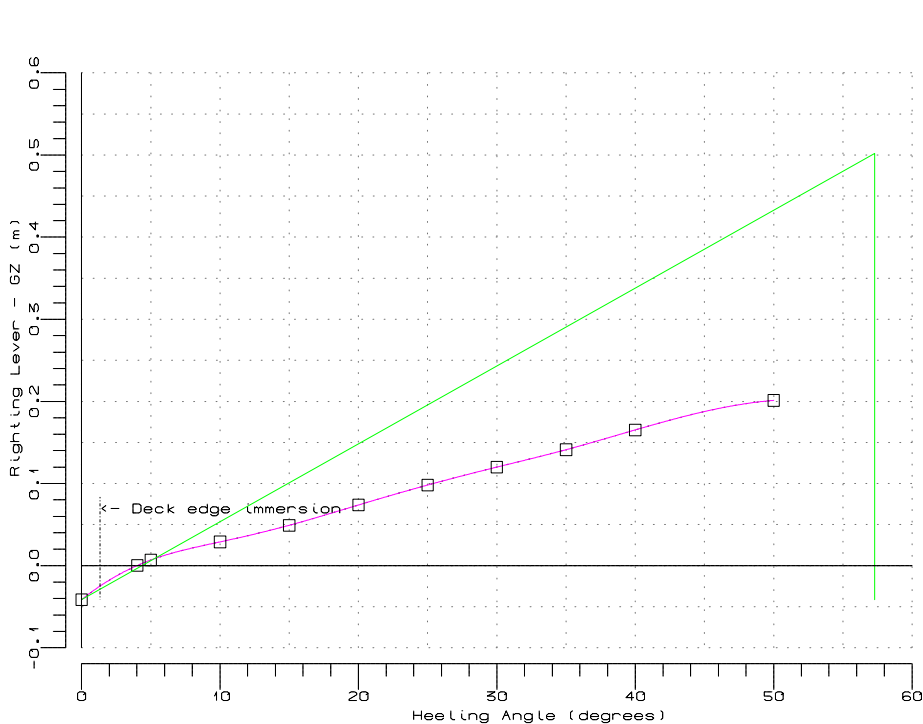
Loading Condition no. : 12  
Condition Id. text : Som 11 sand "mettet" 131,1 t vann i last

Angle (degr.)	GZ (m)	Area (m*rad)
0.000	-0.041	-0.0013
4.020	0.000	0.0000
5.000	0.007	0.0001
10.000	0.029	0.0017
15.000	0.049	0.0051
20.000	0.074	0.0104
25.000	0.098	0.0180
30.000	0.120	0.0275
35.000	0.141	0.0389
40.000	0.165	0.0522
50.000	0.201	0.0847

Deck immersion : 1.328 °  
Maximum GZ at : 50.000 °  
Equilibrium at : 4.020 °  
Area, 0 - 30 : 0.0288 m\*rad  
Area, 0 - 40 : 0.0535 m\*rad  
Area, 30 - 40 : 0.0247 m\*rad  
Area, 0 - maxGZ : 0.0860 m\*rad  
GM : 0.543 m

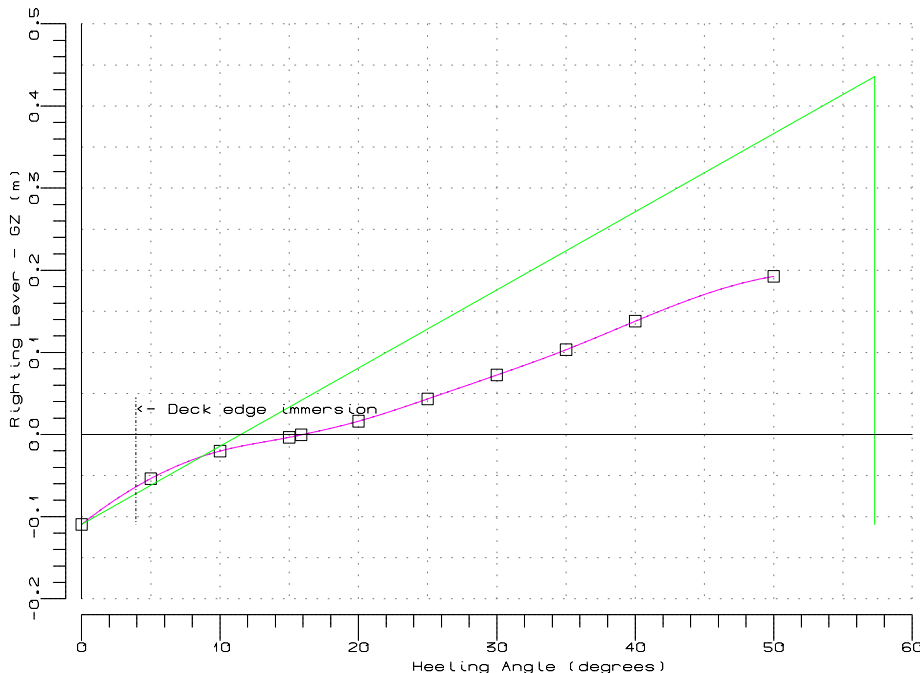
Loading Condition no. : 17  
Condition Id. text : Som 11 med kast i både sand og grus

Angle (degr.)	GZ (m)	Area (m*rad)
0.000	-0.109	-0.0110
5.000	-0.054	-0.0041
10.000	-0.020	-0.0010
15.000	-0.003	0.0000
15.869	0.000	0.0000
20.000	0.016	0.0005
25.000	0.043	0.0031
30.000	0.072	0.0081
35.000	0.103	0.0158
40.000	0.138	0.0263
50.000	0.192	0.0557

Deck immersion : 3.926 °  
Maximum GZ at : 50.000 °  
Equilibrium at : 15.869 °  
Area, 0 - 30 : 0.0192 m\*rad  
Area, 0 - 40 : 0.0373 m\*rad  
Area, 30 - 40 : 0.0181 m\*rad  
Area, 0 - maxGZ : 0.0668 m\*rad  
GM : 0.545 m

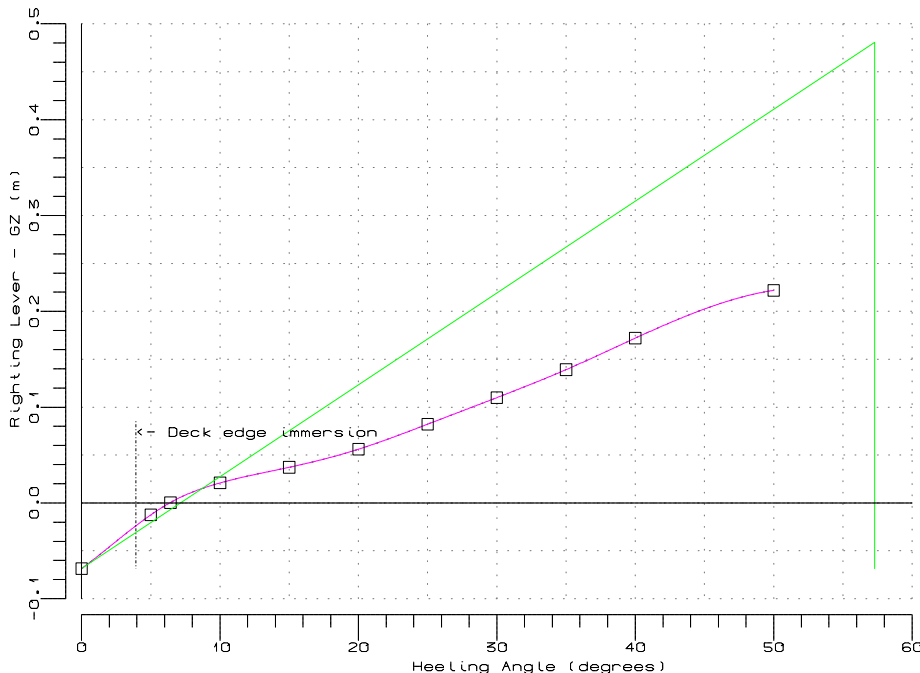
Loading Condition no. : 18  
Condition Id. text : Som 11 med kast kun i grus

Deck immersion : 3.926 °  
Maximum GZ at : 50.000 °  
Equilibrium at : 6.416 °  
Area, 0 - 30 : 0.0254 m\*rad  
Area, 0 - 40 : 0.0498 m\*rad  
Area, 30 - 40 : 0.0244 m\*rad  
Area, 0 - maxGZ: 0.0848 m\*rad  
GM : 0.549 m

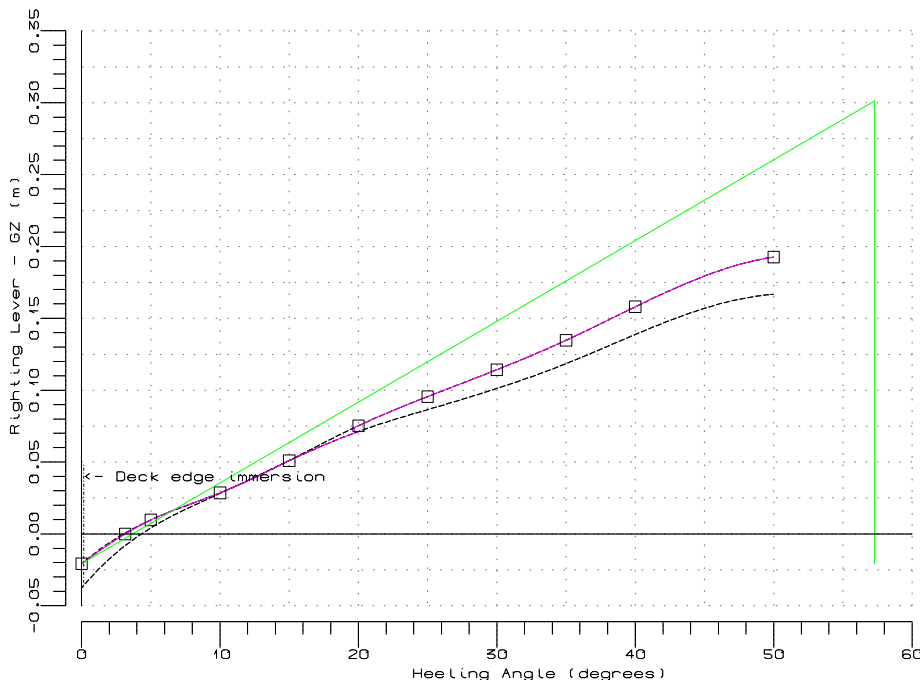
Loading Condition no. : 24  
Condition Id. text : Som 23 med "tank" over forsk. sand

Deck immersion : 0.156 °  
Maximum GZ at : 50.000 °  
Equilibrium at : 3.150 °  
Area, 0 - 30 : 0.0279 m\*rad  
Area, 0 - 40 : 0.0515 m\*rad  
Area, 30 - 40 : 0.0236 m\*rad  
Area, 0 - maxGZ : 0.0825 m\*rad  
GM : 0.322 m

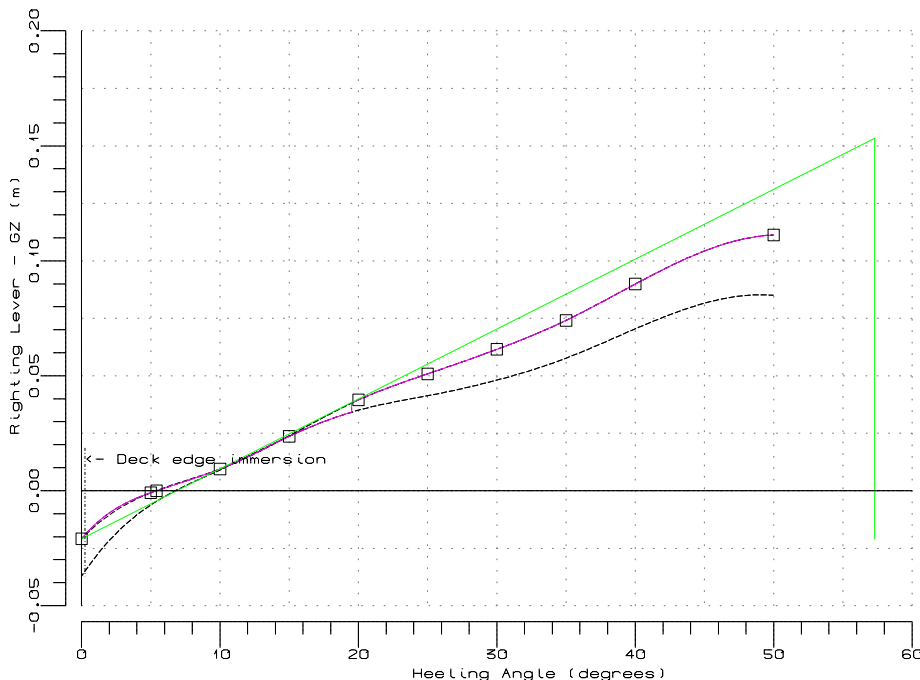
Loading Condition no. : 25  
Condition Id. text : Som 22 med "tanker" over forsk. sand og grus

Deck immersion : 0.234 °  
Maximum GZ at : 50.000 °  
Equilibrium at : 5.413 °  
Area, 0 - 30 : 0.0141 m\*rad  
Area, 0 - 40 : 0.0271 m\*rad  
Area, 30 - 40 : 0.0130 m\*rad  
Area, 0 - maxGZ: 0.0451 m\*rad  
GM : 0.174 m

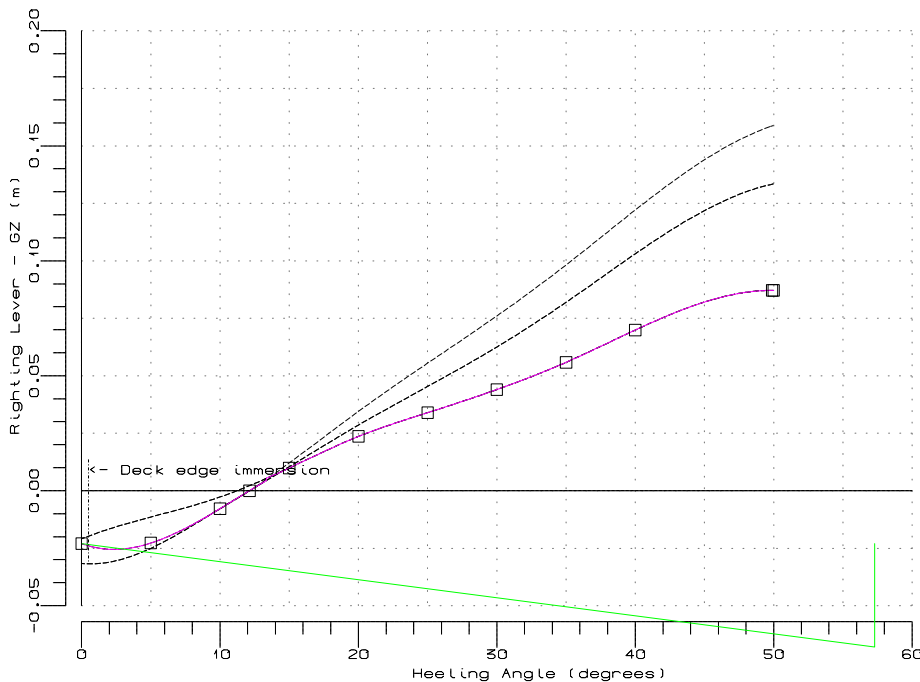
Loading Condition no. : 26  
Condition Id. text : Som 21 med "tanker" over forsk. sand og grus

Deck immersion : 0.508 °  
Maximum GZ at : 49.887 °  
Equilibrium at : 12.131 °  
Area, 0 - 30 : 0.0114 m\*rad  
Area, 0 - 40 : 0.0212 m\*rad  
Area, 30 - 40 : 0.0098 m\*rad  
Area, 0 - maxGZ: 0.0351 m\*rad  
GM : -0.045 m
