# REPORT

## MARINE 2016/05

## REPORT ON MARINE ACCIDENT – FOUNDING OF M/V ØSTBANKEN IN ØSTHAVET OUTSIDE BÅTSFJORD ON 9 JANUARY 2015

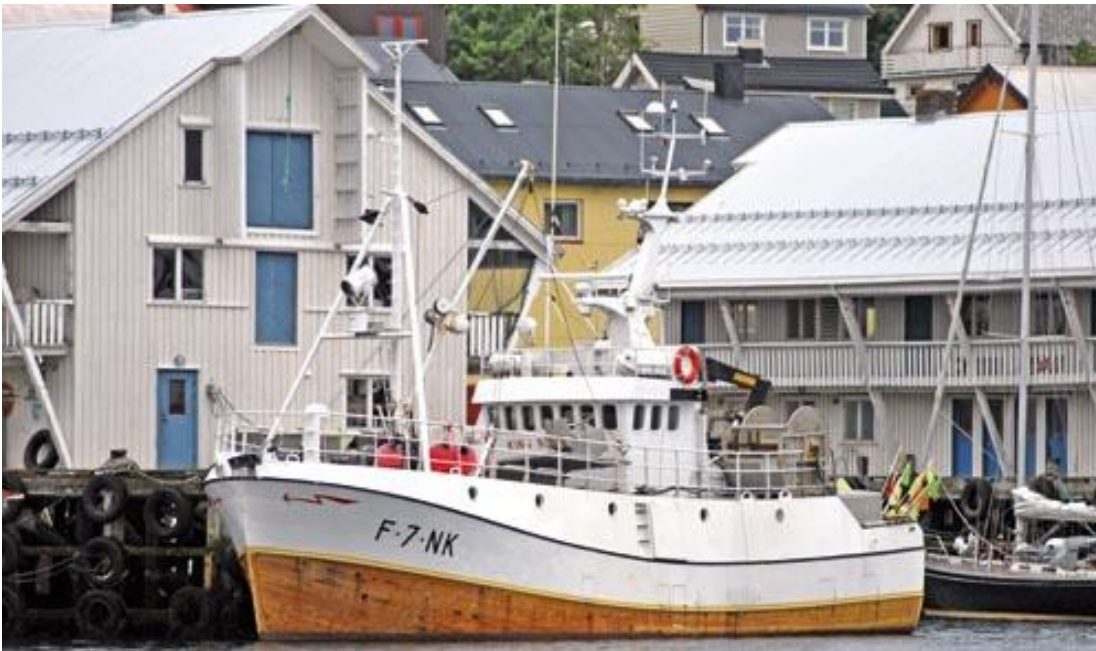
Figure 2: M/V Østbanken. The fishing vessel registration number is from before the vessel was taken over by the present owners. Photo: Tommy Lars Larsen

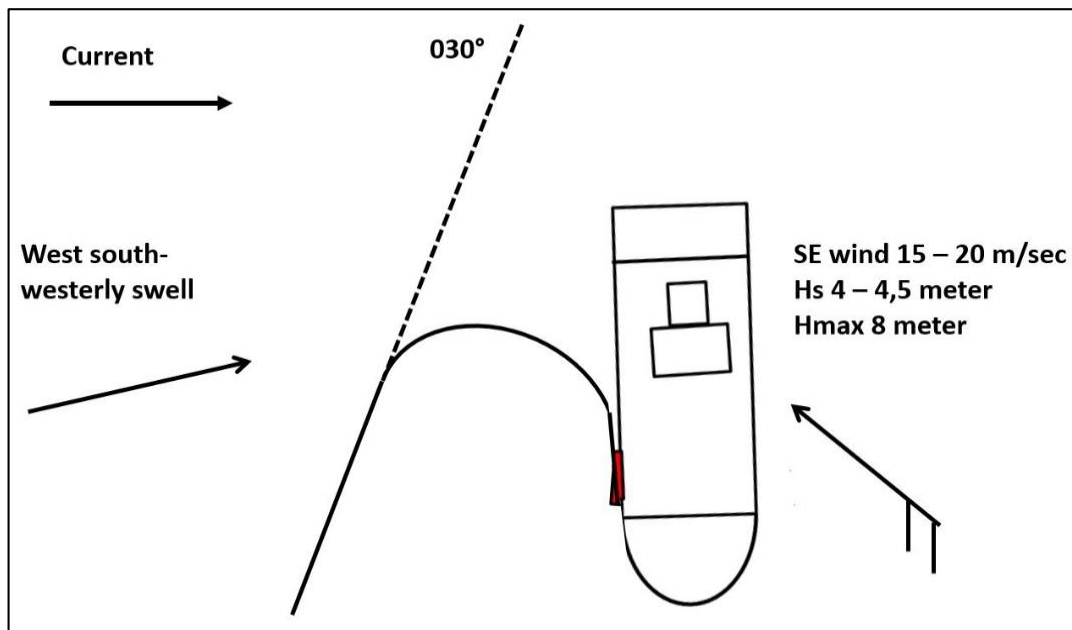
Figure 4: The positioning of the vessel in relation to the line during hauling. Illustration: AIBN

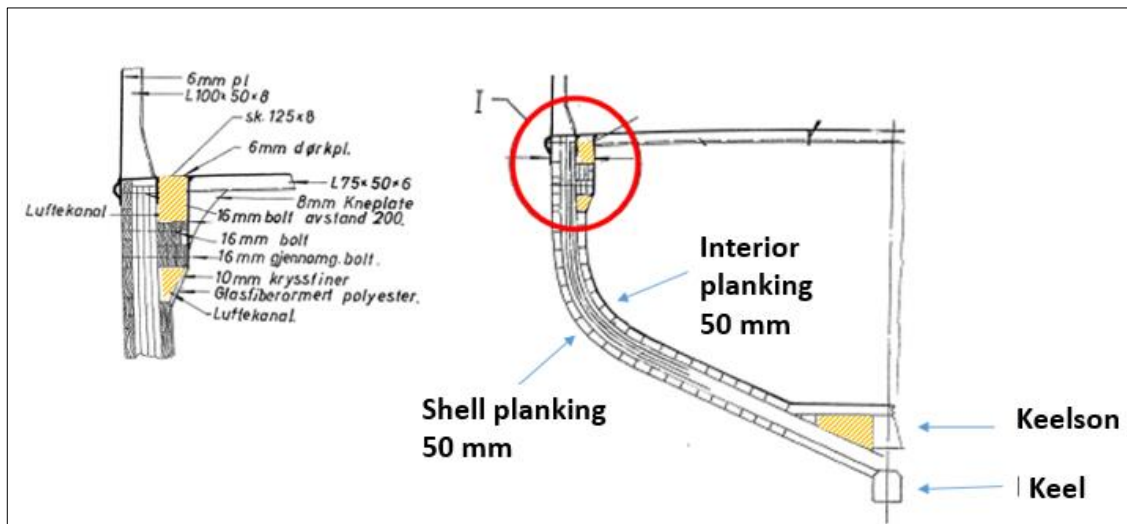
Figure 8: The hull and frame structure. The ventilation channels are highlighted in yellow.  
Source: Mjosundet Båtbyggeri AS. Illustration: AIBN

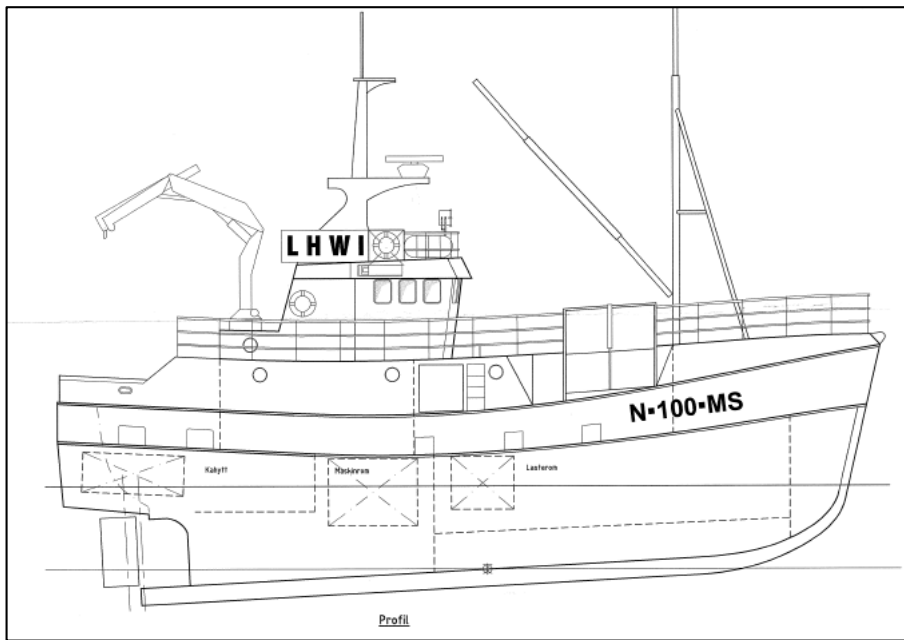
In 2008, the vessel was converted at Grovfjord Båtbyggeri AS. It was re-rigged for combined Danish seine/net fishing, and extended with a transom stern. The conversion increased the length of the vessel to 18.78 metres. In connection with the conversion, the double hull principle was abandoned for the aftmost part of the vessel.

Figure 9: General arrangement drawing of Østbanken after the conversion in 2008. Source: Grovfjord Båtbyggeri AS

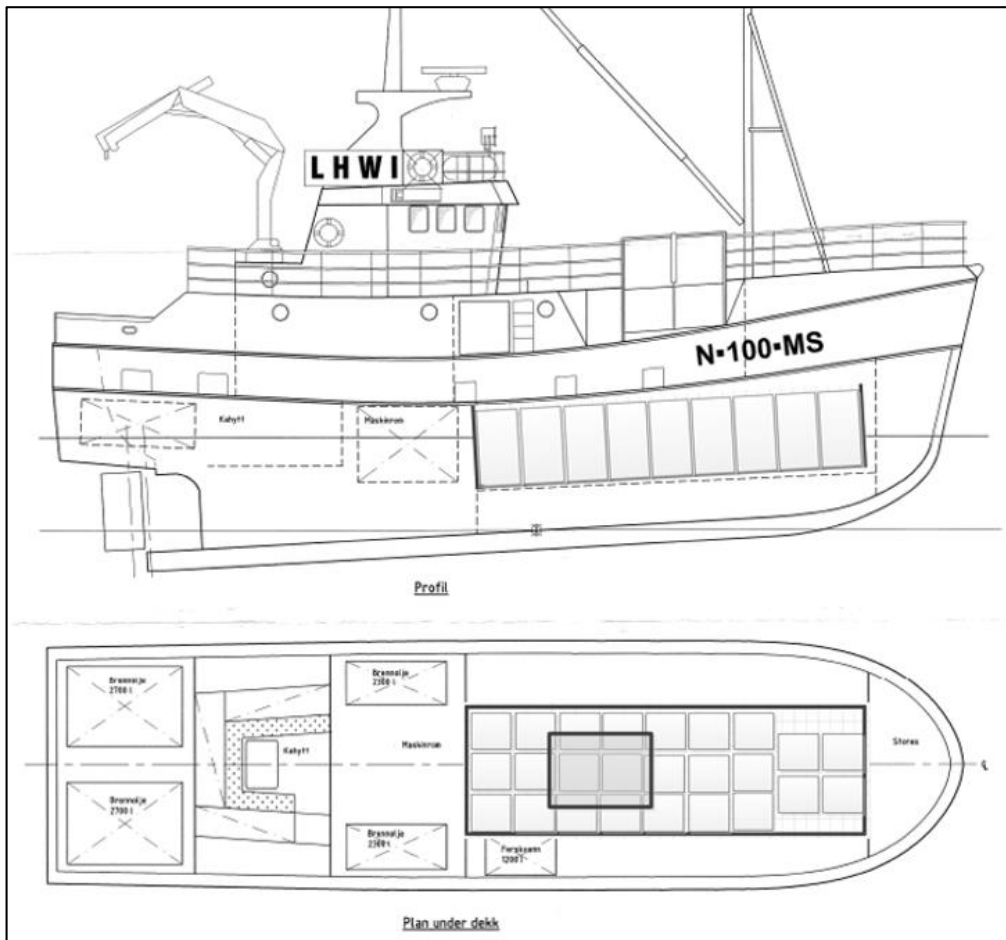
Aluminium angle bars had been installed in the hold, so that 25 containers of 1 m<sup>3</sup> each were held in place along the whole length of the room; see Figure 12.

Figure 12: The drawing shows how the containers were stowed in the cargo hold. Source: Vessel owners/Grovfjord Båtbyggeri AS/AIBN

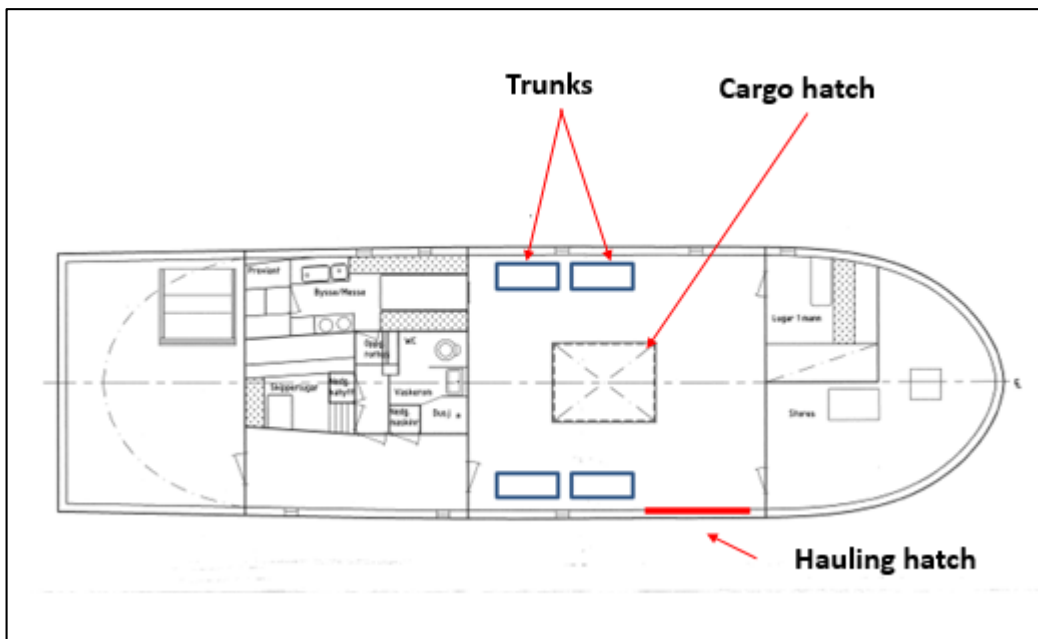
Figure 13: Position of trunks, cargo hatch and hauling hatch. Source: Grovfjord Båtbyggeri AS. Illustration: AIBN

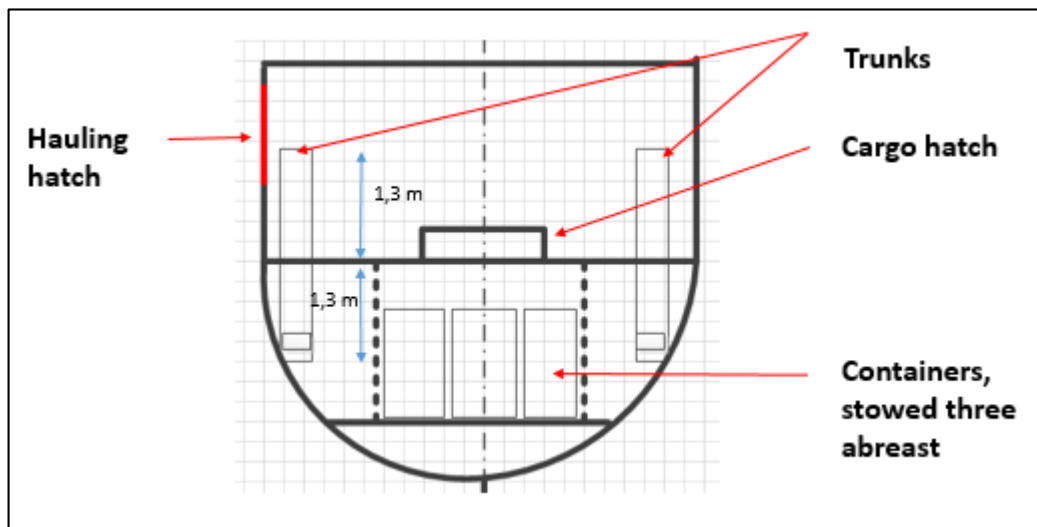
The trunks were open at the top and had a base of approximately 1.35 m x 0.73 m and a height of approximately 2.65 m. This meant that each trunk had a volume of approximately 2,6 m<sup>3</sup>. The trunks extended to approximately 1.3 m above the main deck and equally far into the vessel's hold at the sides; see Figure 14.

Figure 14: Section drawing showing where the trunks were located. Illustration: AIBN

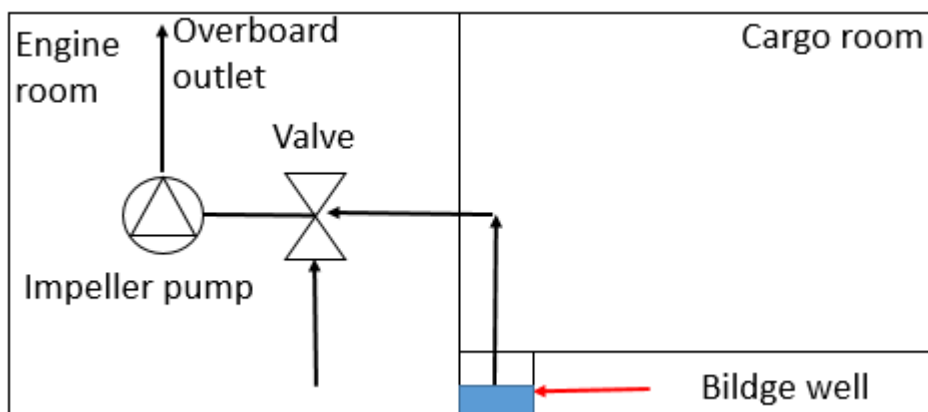
According to the vessel’s system drawing, which shows the bilge pump arrangement, the pumps were of the make Johnson (1 ½" (38 mm)). A review of the pump manufacturer’s brochure suggest that the pumps were of the model F8B and that the pumping capacity ranged from 87 l/min at 700 revolutions to 279 l/min at 2,000 revolutions. The normal rate of revolution during line hauling was approximately 900 r/min, and the manufacturer’s brochure indicates a pumping capacity of 114 l/min.

Figure 16: Simplified diagram of the bilge system. Illustration: AIBN

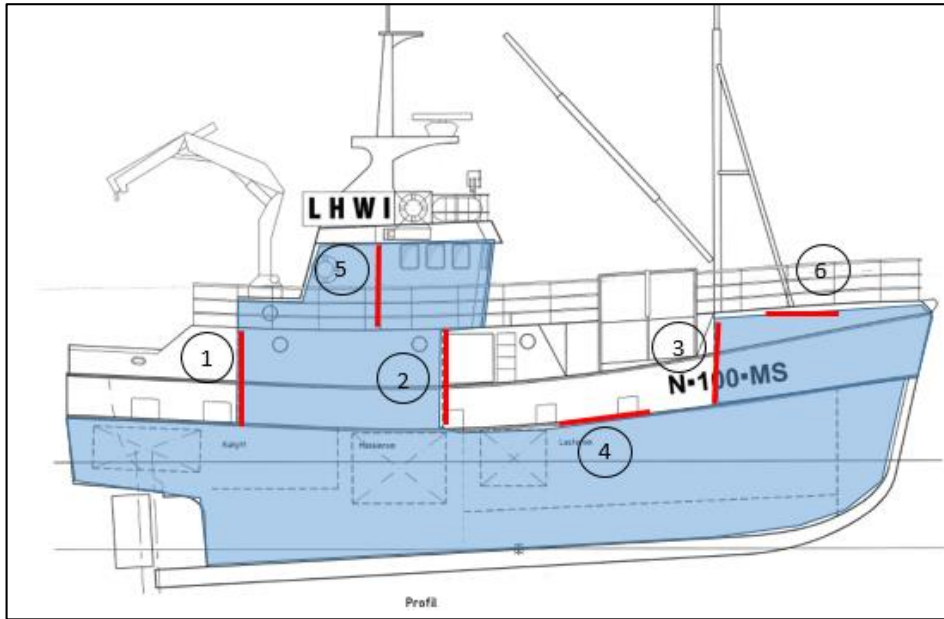
*Østbanken*'s stability and buoyancy depended on the hull (transom stern, cabin, engine room, cargo hold and forepeak tank) being watertight. According to the vessel's stability calculations, which are described in more detail in section 1.9.1, it was assumed that the baiting shed, the hydraulics room, the wheelhouse and the forecastle were also watertight. This meant that only the aft deck and working deck were not part of the vessel's total buoyancy; see Figure 17.

Figure 17: The area highlighted in blue shows Østbanken's buoyancy volumes. Source: Grovfjord Båtbyggeri AS. Illustration: AIBN

In the same figure, the openings that should be equipped with weathertight means of closing are marked in red. The relevant means of closing are listed below:
