Accident
Investigation Board
Norway

Marine 2017/06

REPORT ON MARINE ACCIDENT – RIB, FALL OVER BOARD IN OLDEN 22 JULY 2015

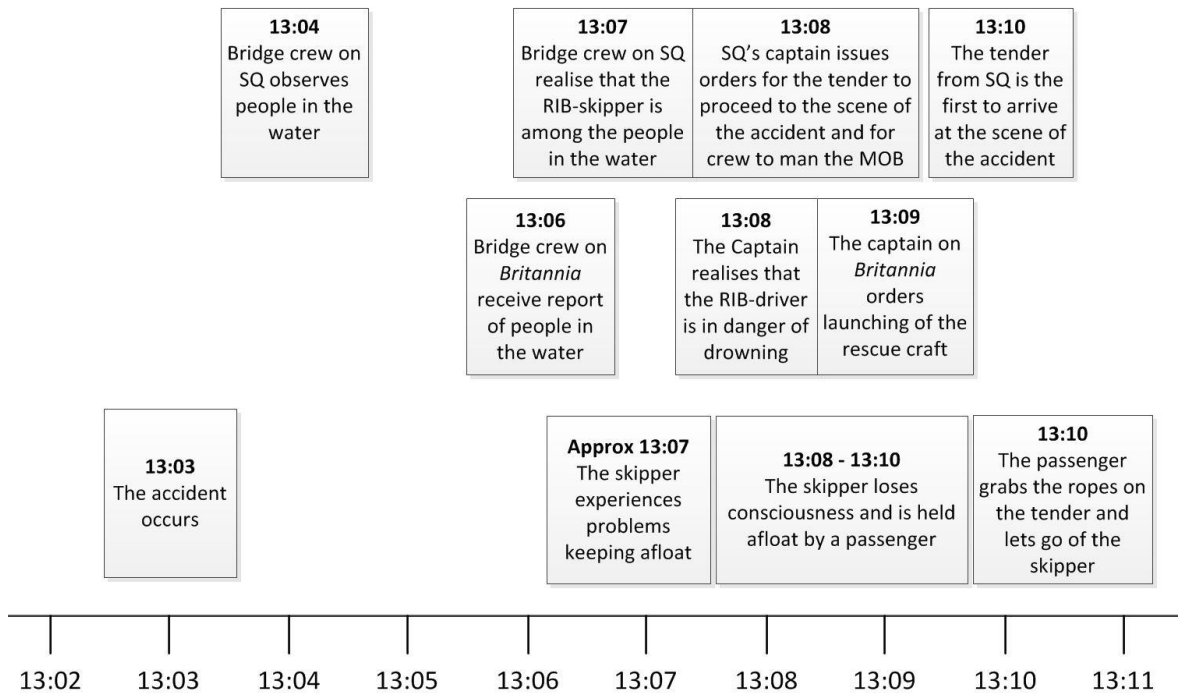
Figure 6: The time line illustrates when the bridge crews on ‘Seabourn Quest’ (SQ) and ‘Britannia’ became aware of the incident and their subsequent actions. Illustration: AIBN

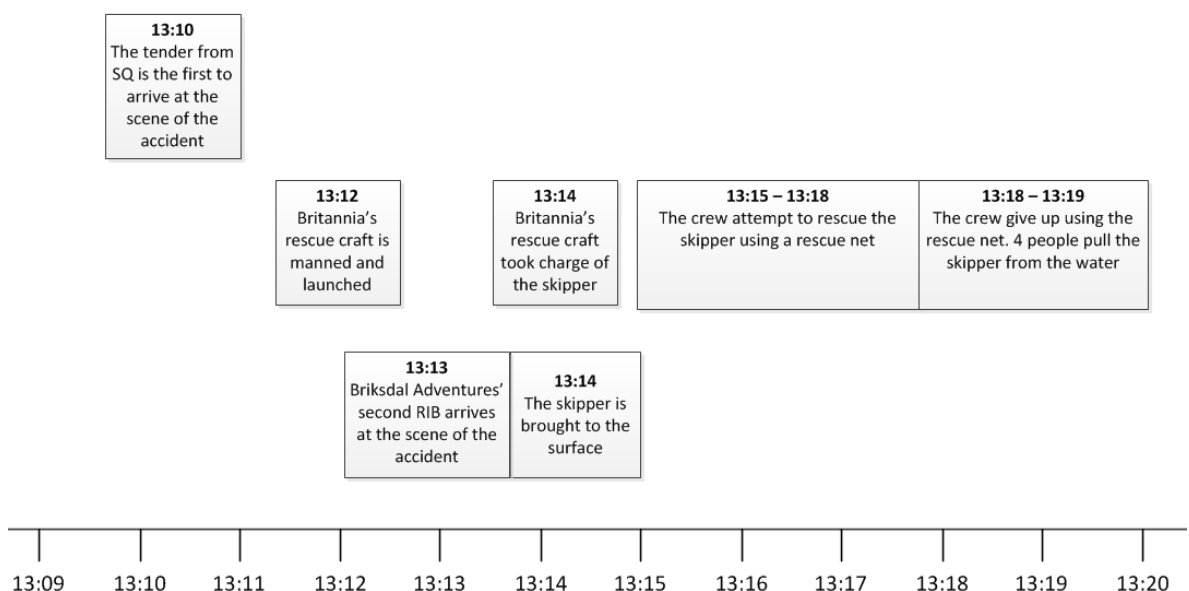
Figure 7: The time line illustrates relevant events during the rescue operation. Illustration: AIBN

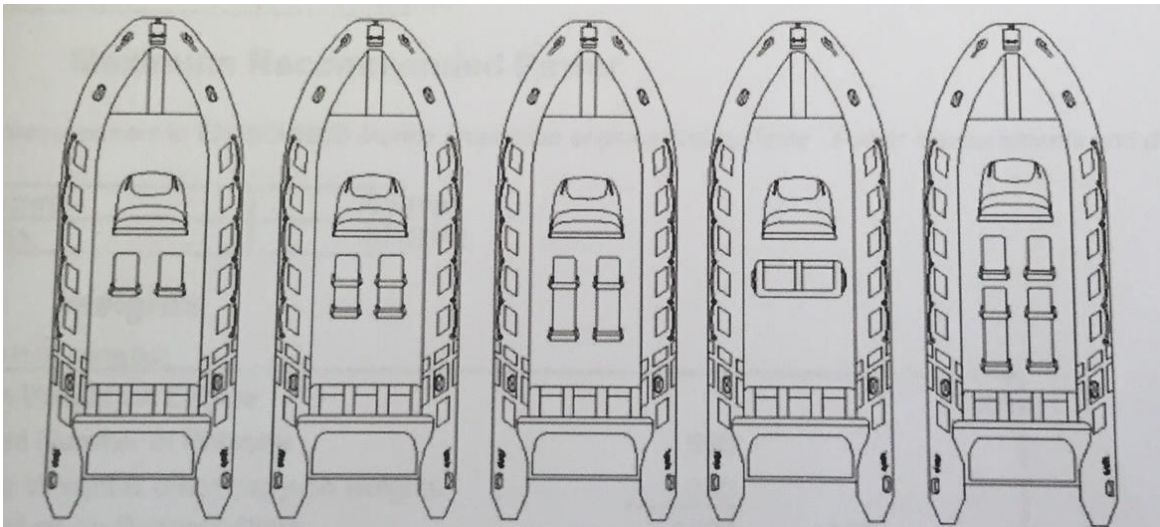
Figure 8: Seating configuration taken from the user manual that comes with the boat. Source: Ribeye Ltd.

The Norwegian importer bought quite a large number of boats of the RIBEYE 785 type, which were sold on to boat dealers in Norway. The importer estimates that around 30 boats of this type were imported, which were all delivered in flat-pack form. The importer explains that no assembly instructions accompanied the boats, but that he assisted the boat dealers with fitting out the boats according to the buyers' wishes and needs.
