## Marine 2018/02

## REPORT ON MARINE ACCIDENT – HUGIN, COLLISION IN HARSTAD ON 16 FEBRUARY 2017

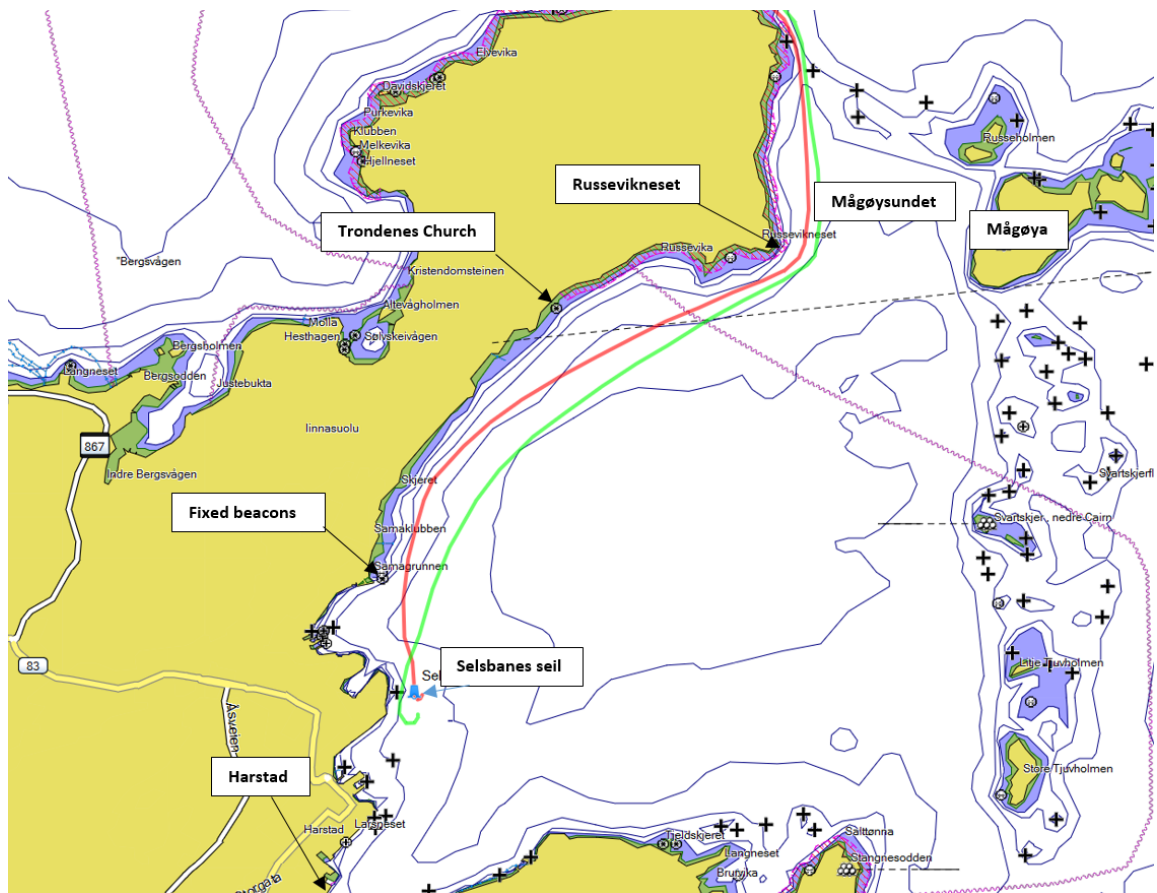
The RIBs travelled at an average speed of 30–35 knots for most of the trip, but increased the speed to between 40 and 50 knots for the final two minutes of the voyage after passing Russevikenet (see Figure 3). There was some small waves and wind. The passengers were holding on tight.

Figure 3: The figure shows the route the two RIBs took towards Harstad port. The green line represents Munin and the red line represents Hugin. Source: Garmin electronic chartplotter, Homeport

The skipper of Hugin (red line) was in his normal position astern of the lead boat on the starboard side and kept an eye on it, while switching between looking ahead and glancing at the chart plotter. He last checked his position on the chart approximately as they were passing the last two fixed beacons (see Figure 3 and the top of Figure 4).

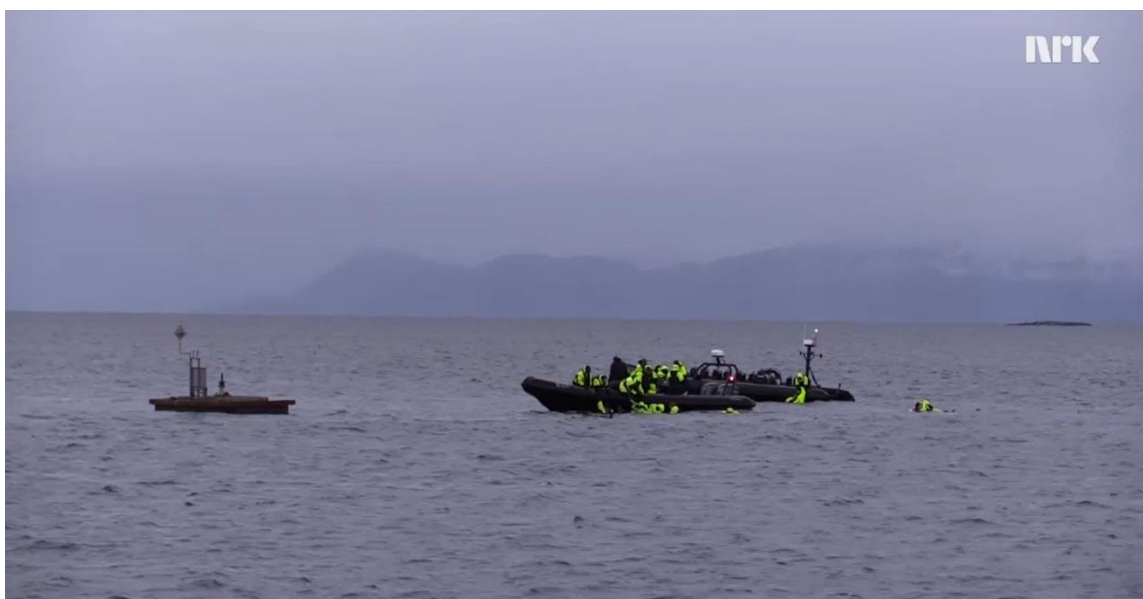
The weather was cloudy, mainly dry with occasional drizzle, but the total precipitation for the day was less than 1 mm. Air humidity was 88%, and visibility was good with no fog.

Figure 8: Visibility immediately after the accident. Photo: NRK

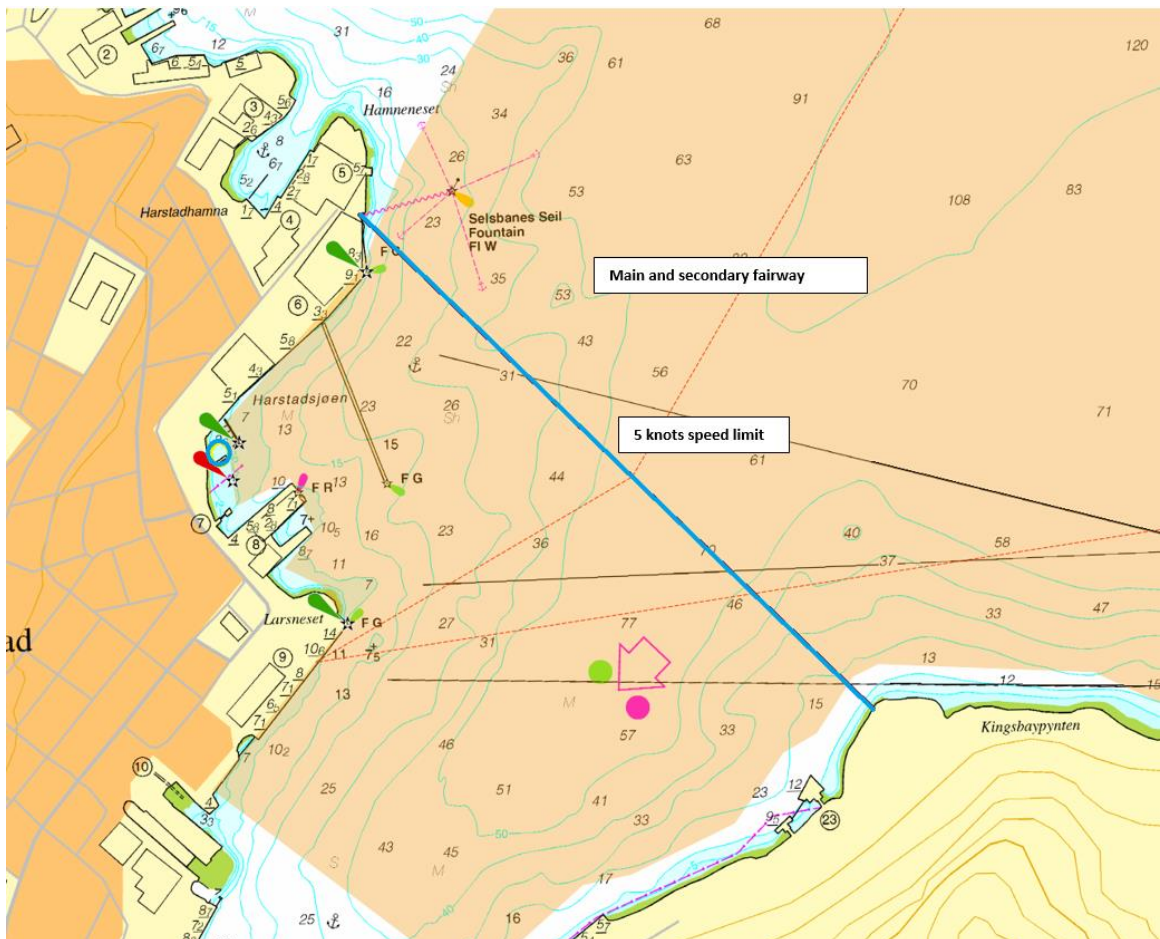
A speed limit of 5 knots applies when entering the port of Harstad, as shown in Figure 10. At the time of the accident, there was no sign showing this limit at the entrance to the port. According to Harstad Port Authority, the sign was temporarily removed in connection with a construction project around 2009. The skippers have stated that they knew where the 5-knot speed limit applies.

Figure 10: Selsbanes Seil is anchored at the position 68° 48.313' N, 16° 33.243' E. It is located about 120 metres north-east of the culture centre quay, in an area with no speed restrictions just outside the area where the 5-knot speed limit applies, but in the fairway. Source: Norwegian Coastal Administration, [kystinfo.no](http://kystinfo.no)

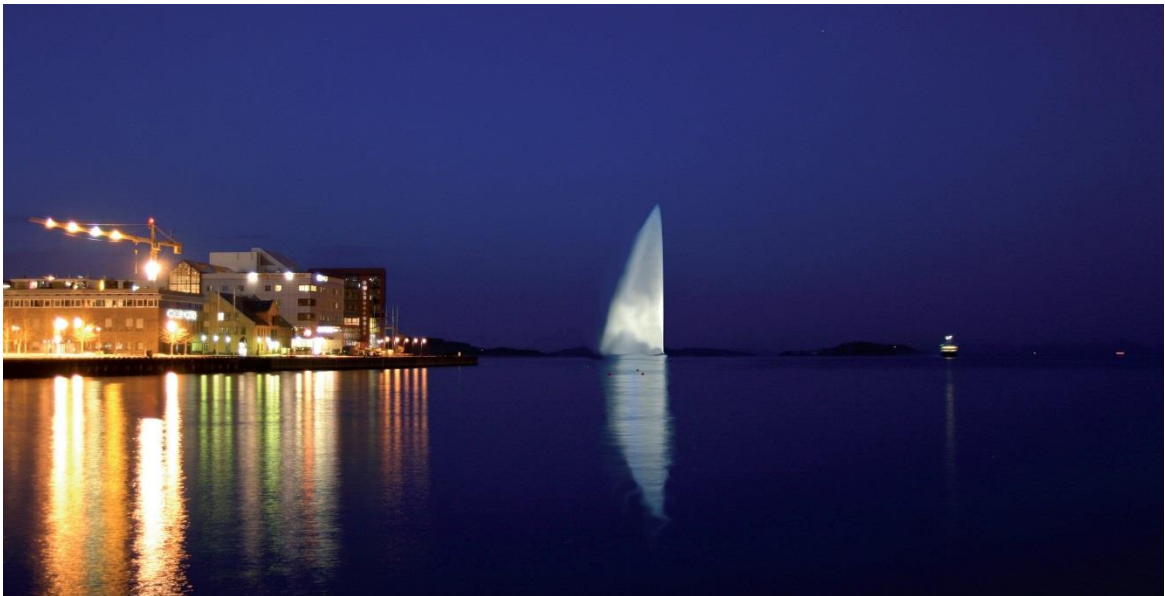
Figure 11: Selsbanes Seil. Photo: Geir Samuelsen

The fountain consists of a floating platform in reinforced concrete with a polystyrene core, and a pump that projects seawater approximately 50 metres into the air. Four projectors light up the water in ‘the colours of the northern lights’. The installation measures 3x3 m and extends 1.5 m below the surface of the water, while the platform deck is 0.5 meters above the sea surface and is surrounded by a wooden ‘fender’.

The fountain was equipped with a radar reflector and a Jotron Tron ML-300 marking light with a daylight sensor. Until after the day of the accident, the light was programmed to switch off in daylight. The light was mounted approx. 2.5 metres above the platform deck.

Harstad Port Authority has stated that the intention behind the condition for a marking light was that it was to flash around the clock, but this was not explicitly communicated. Until after the day of the accident, the installation was equipped with a photo sensitive marking light that did not flash during daylight.
