Issued November 2019

REPORT

Marine 2019/08

SUMMARY OF THE PART ONE REPORT ON THE COLLISION ON 8 NOVEMBER 2018 BETWEEN THE FRIGATE HNO MS HELGE INGSTAD AND THE OIL TANKER SOLA TS OUTSIDE THE STURE TERMINAL IN THE HJELTEFJORD IN HORDALAND COUNTY

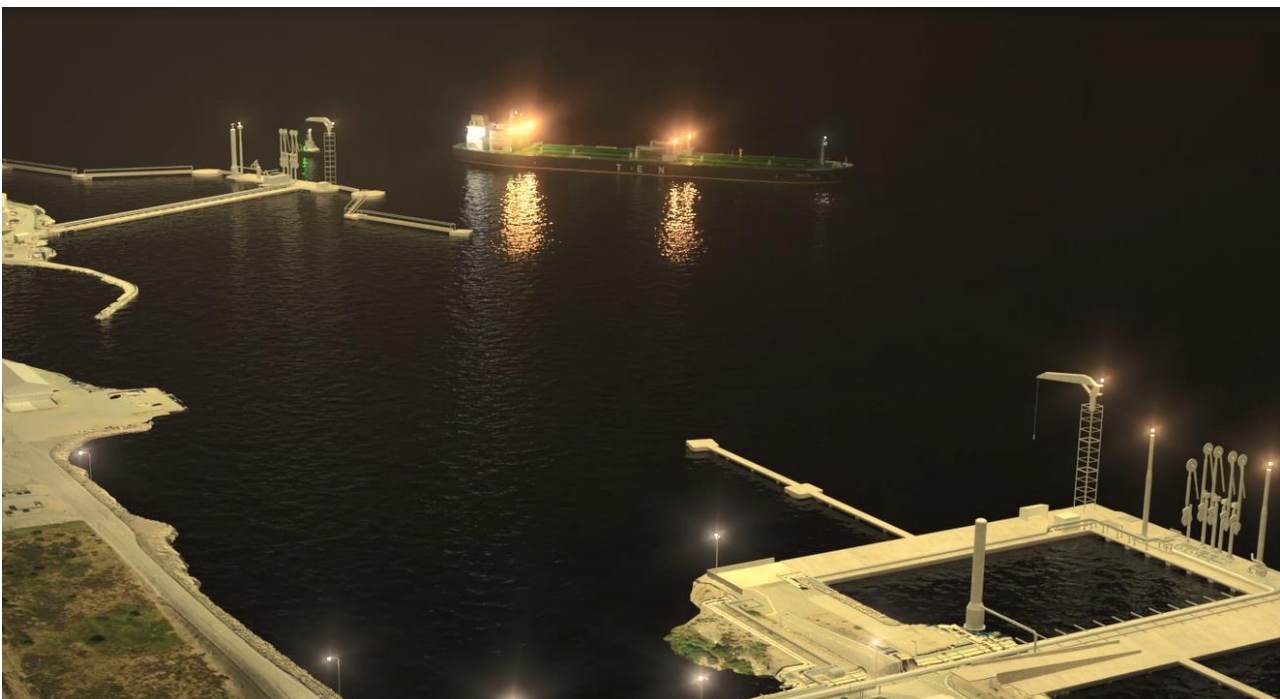
Figure 6: Sola TS departed the Sture Terminal at 0345. The tanker was assisted by the two tugs Tenax and Ajax during the departure. Illustration: AIBN

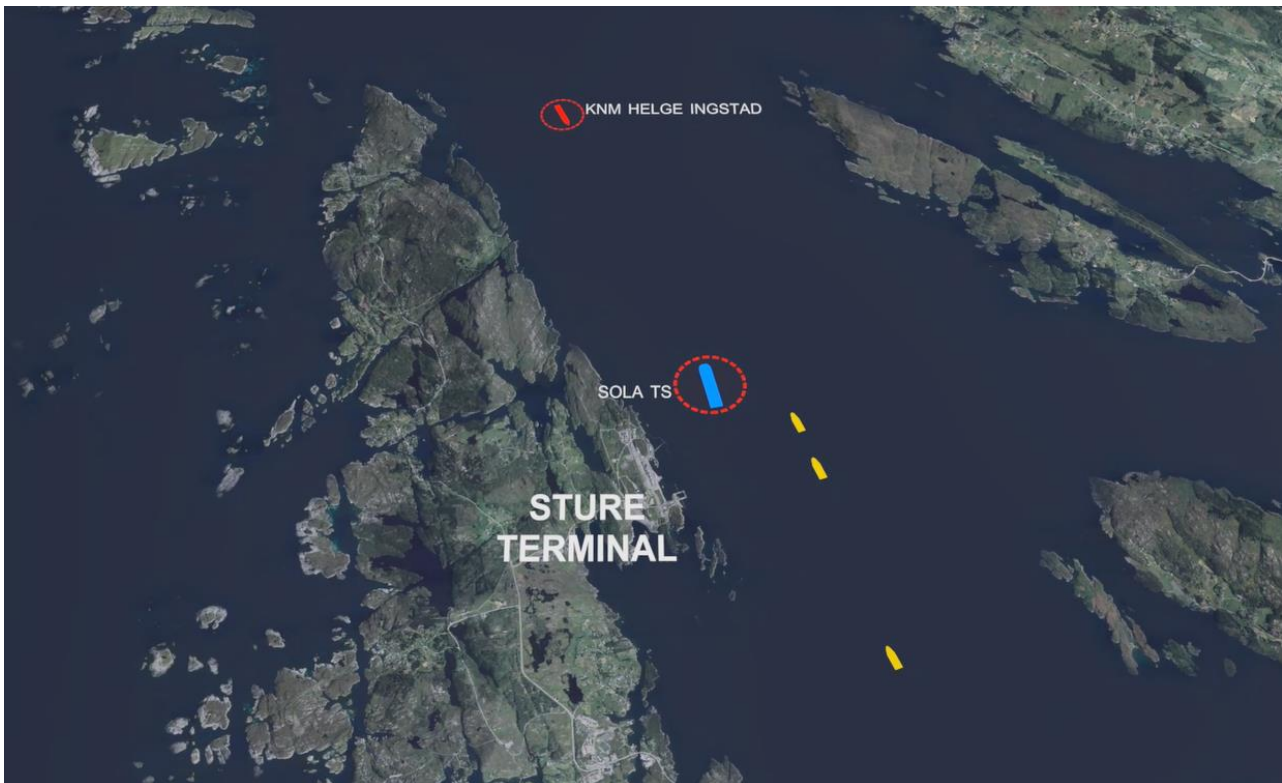
A while after setting course towards Fedje, the pilot reacted to the approaching vessel drawing closer without any indication of giving way. That was approximately four minutes before the collision, at which point the distance between the vessels was approximately 1.5 nm. As a consequence of HNoMS Helge Ingstad not transmitting AIS signals on this voyage, the name of the vessel that was approaching in the opposite direction was not presented on the displays on Sola TS.

The pilot requested information about the approaching vessel from Fedje VTS. The VTS operator had not monitored the passage of HNoMS Helge Ingstad after the frigate notified of entering the area, and was therefore unable to identify the vessel immediately.

Figure 11: The traffic situation in the Hjeltfjord approximately 3 minutes before the collision. Illustration: AIBN
