# REPORT MARINE 2023/04

***Capsizing of the pleasure boat Malmhella  
in the archipelago off Kragerø, Norway on  
25 October 2022***

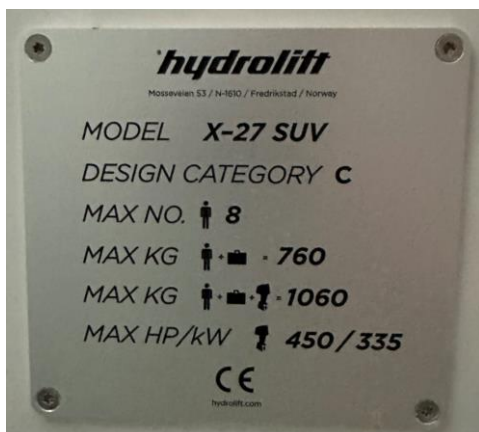
The boat was 8.11 metres long and 2.4 metres wide. It was CE marked for 8 persons, see Figure 7, and a pilothouse was fitted, offset to starboard, see Figure 8

Figure 7: CE label for Hydrolift X-27 SUV. Photo: NSIA

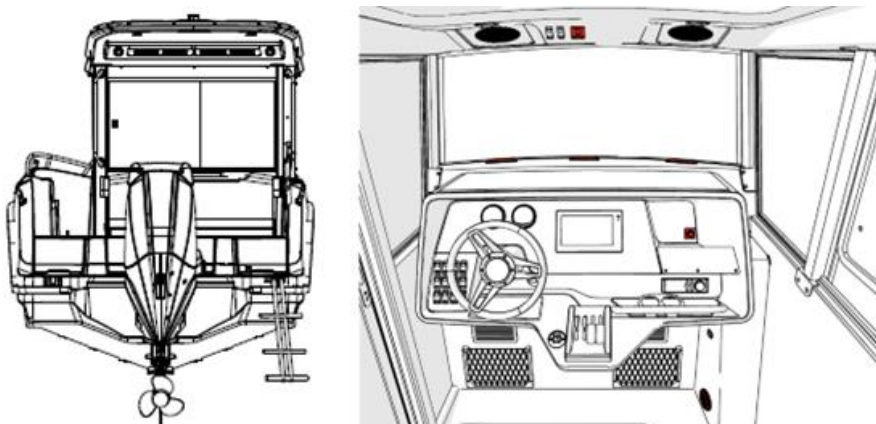
When the participants boarded Malmhella, it was remarked that the craft felt unstable with poor weight balance. The asymmetrical design with the pilothouse offset to starboard meant that the craft had a starboard list when they were all in the pilothouse. The instructor readied the craft, closed the pilothouse door and drove the vessel out the fjord. All the participants were then given the opportunity to familiarise themselves with the craft by testing it in slightly wavy conditions. The participants had to use the trim tabs before the craft had reached planing speed. This was done to avoid listing to starboard when applying throttle. Some of the participants pointed out that the craft also moved in an unusual way and felt wobbly and unstable when approaching planing speed compared with boat types they had experience of.

Figure 8: Illustration of the boat viewed from the rear and illustration of the control console in the pilothouse. The pilothouse is placed on the starboard side. Drawing: The manufacturer

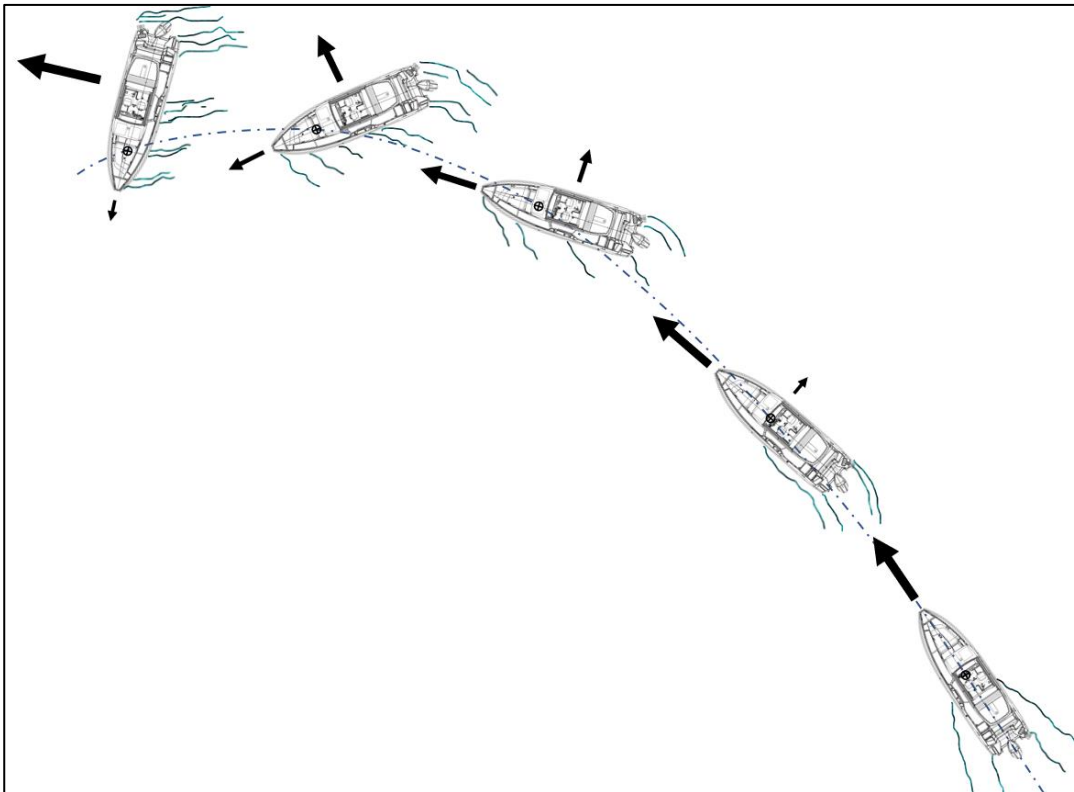
The reduction in speed caused the hull to lose hydrodynamic lift, and the bow was pushed down and forward by inertia forces. The bow of a stepped hull is already fairly low down compared with ordinary V-bottomed hulls, and when the throttle is reduced, this will cause the bow to sink even further.

The steps continued to provide air lubrication back under the hull. At the same time, the bow caught the water and became the craft's rotation point and point of attack for the lateral hydrodynamic forces. This caused the stern to lose contact with the water and rotate with the craft's movement, see Figure 21. The hull came to a sudden stop when it made contact with the water again.

Figure 21: The figure illustrates a craft that enters a turn resulting in a spinout. The arrows illustrate the velocity vector and show how the sideways speed gradually increases. When the forward speed of the craft decreases, the boat's point of rotation is shifted forward because the reduced speed lowers the bow. The point of rotation is indicated by the black dot that the dotted line runs through. Source: NSIA

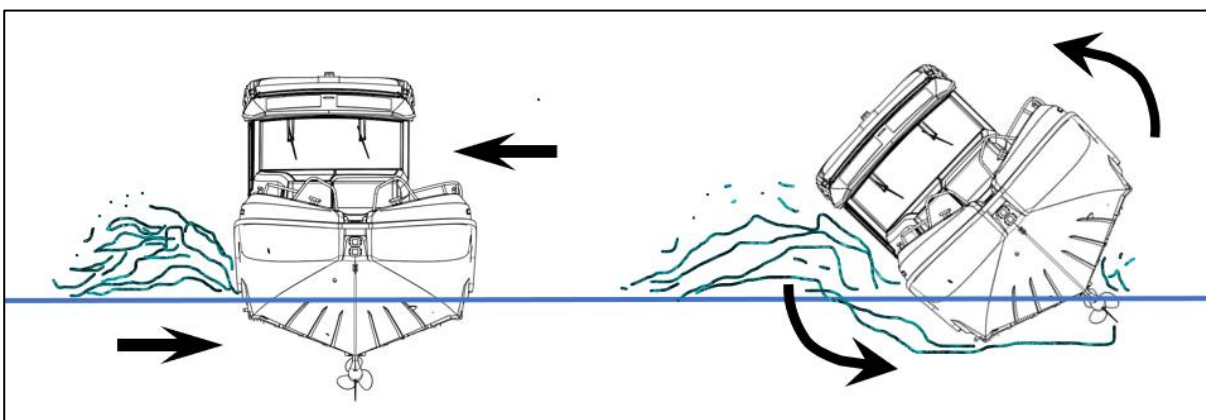
As the sideways movement suddenly stopped, the craft continued to list to starboard. This caused the starboard side of the pilohouse to make contact with the sea, and the window broke. The craft was unable to right itself and capsized. Findings on the craft, see section 1.4, indicate that great forces were at work on the outer side of the turning craft during the incident.

A high centre of gravity and poor stability increased the probability that the sum of inertia forces and hydrodynamic forces exceeded the righting moment, which in turn caused the craft to capsize, see Figure 22.

Figure 22: Illustration of a schematic drawing seen from ahead showing a vessel out of balance that capsizes.
