# INVESTIGATION REPORT

## VIKING POLARIS

### NSIA PROJECT NO 22/661

This report is translated by the Norwegian Safety Investigation Authority (NSIA)

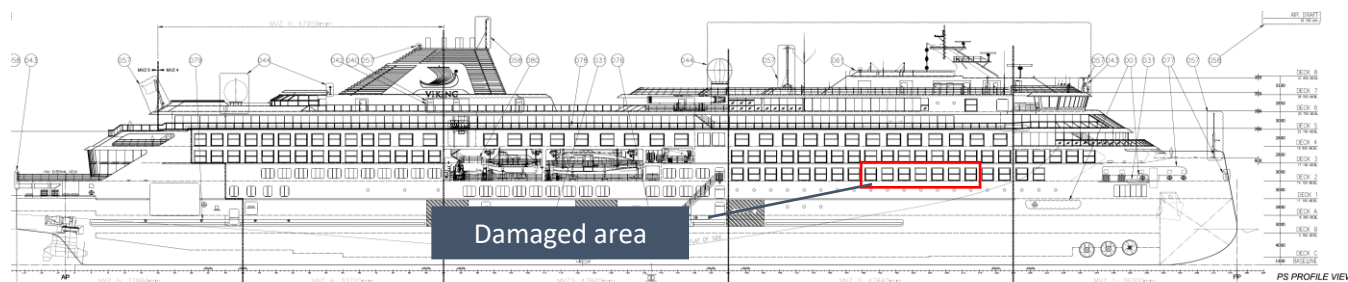
Figure 5-1: General arrangement and profile of starboard side where the damaged area is shown. Note that, although this figure shows the starboard side, the damage occurred on the port side, which has the same profile as the starboard side.

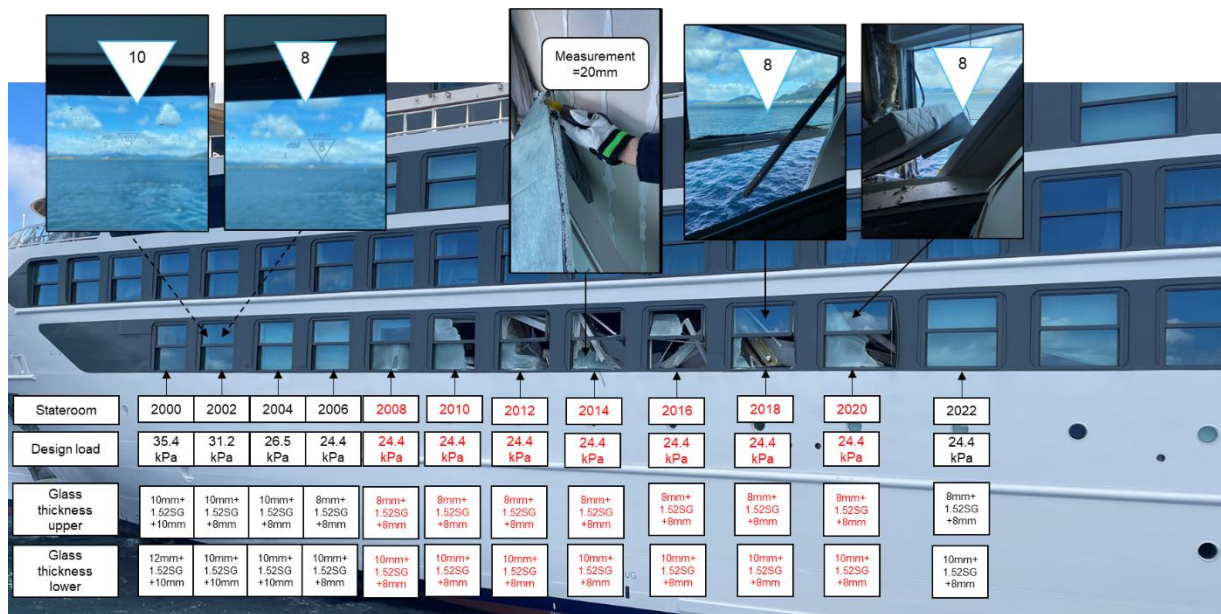
Figure 8-2 Design parameters for the windows.

The formula specify that pressure should be calculated for the sides of the superstructure and provide a static design pressure based on the vertical position (z) relative to maximum draught (Tsc), the shape of the ship (Cb), and the wave parameter (Cw) in the ship rules, where the latter is derived from the North Atlantic scatter with a 25-year return period. By superstructure is meant the parts of the structure that are located on the freeboard deck and extend from the starboard to the port side. The design pressure and other design parameters for the windows are given in Figure 8-2.

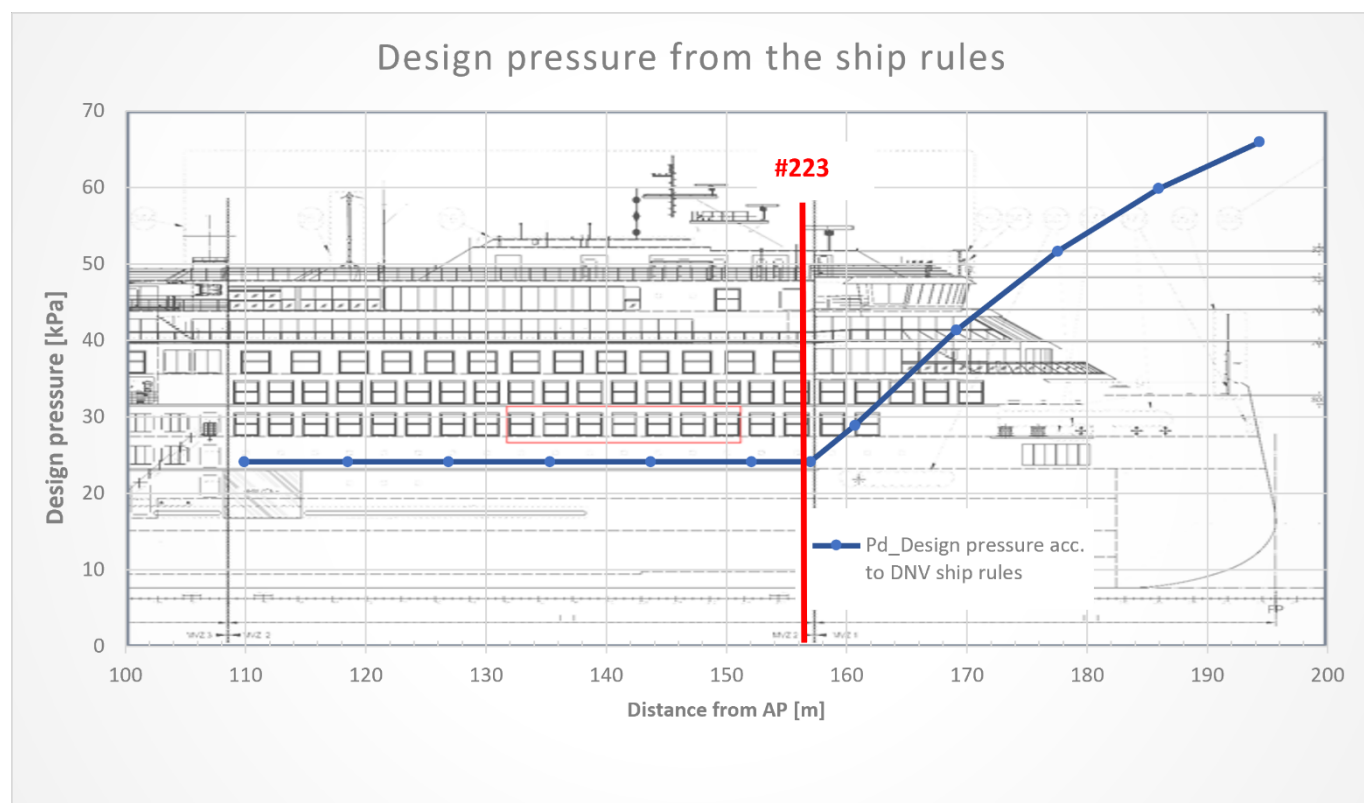
Figure 8-3 Rule pressure for the ship's side.

Forward of frame #223, the design pressure is calculated based on design waves for the oncoming sea, which results in increased design pressure requirements; see Figure 8-3. The results of the study are shown in Table 8-1 and show good correlation between the pressures. The study therefore concludes that the design pressure used for the design and testing of the windows and fixings were calculated correctly in accordance with the ship rules.

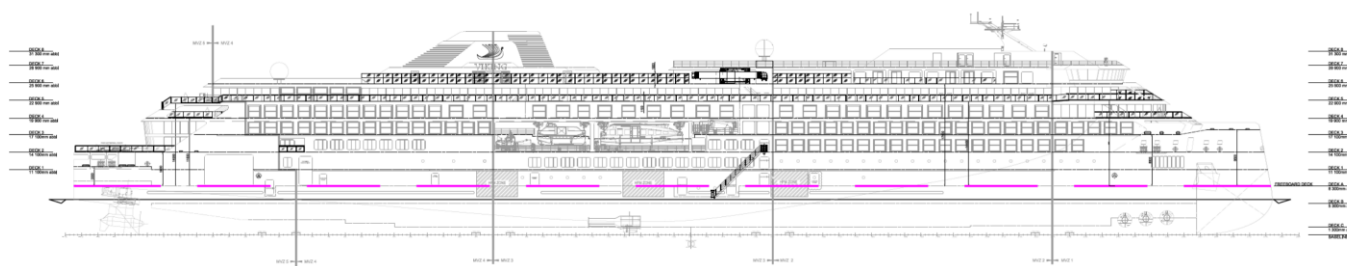
Figure 9-1 Freeboard drawing

ICLL and DNV's ship rules state that windows must not be fitted below the freeboard or on the superstructure that contributes to buoyancy on deck 1. The freeboard of 'Viking Polaris' is on deck A (8,300 mm above the keel), as shown in Figure 9-1, and deck 1 is 11,100 mm above the keel. The windows relevant to this investigation are located above the freeboard on deck 2 and thereby comply with DNV's ship rules.

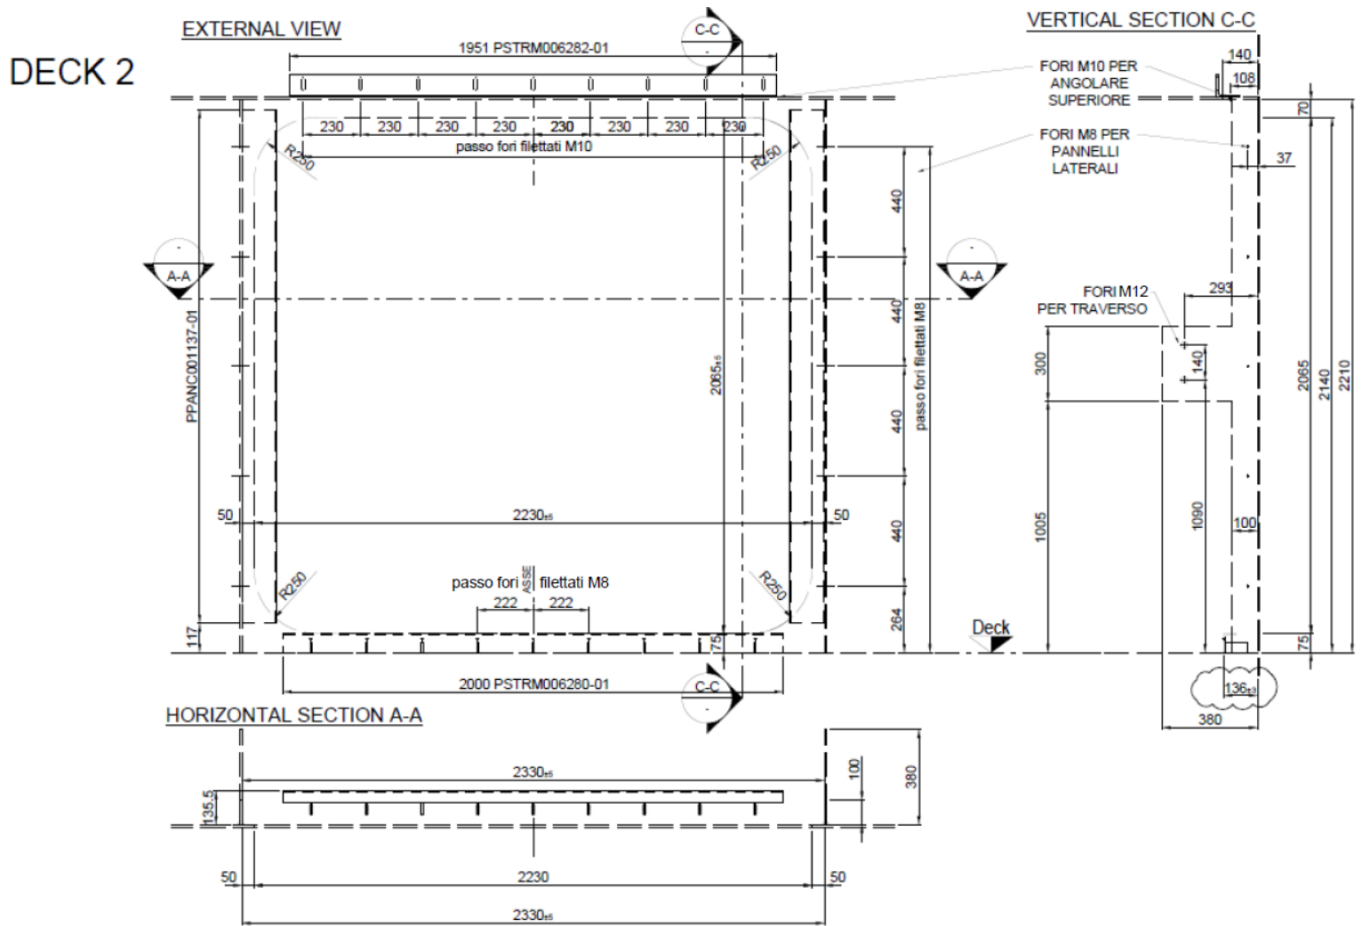
Figure 9-2 Screw fixing, deck 2

The spacing between the screws fastening the window frame to the ship structure must not exceed 150 mm. The windows in question were attached with different types of screws that were also spaced at different intervals. The spacing between the load-bearing screws varied between 222 mm and 230 mm. The capacity of the window fixings, including frame, bolts and stiffeners, are evaluated by class society to be in accordance with the applicable rules through the equivalence principle stated in Pt.1 Ch.1 Sec.1 [2.5.9], by performing a strength test of the complete installation. The fixing of the screws is shown in Figure 9-2 and Figure 9-3. The load-bearing screws are highlighted in Figure 9-3. The remaining screws hold a thin aluminium profile with low load-bearing capacity and are therefore not considered load-bearing.

No damaged or broken load-bearing screws were found for the windows studied in this report. It can therefore be concluded that the load-bearing screws were of sufficient strength. This has also been verified by a full-scale pressure test as explained in section 10.2.

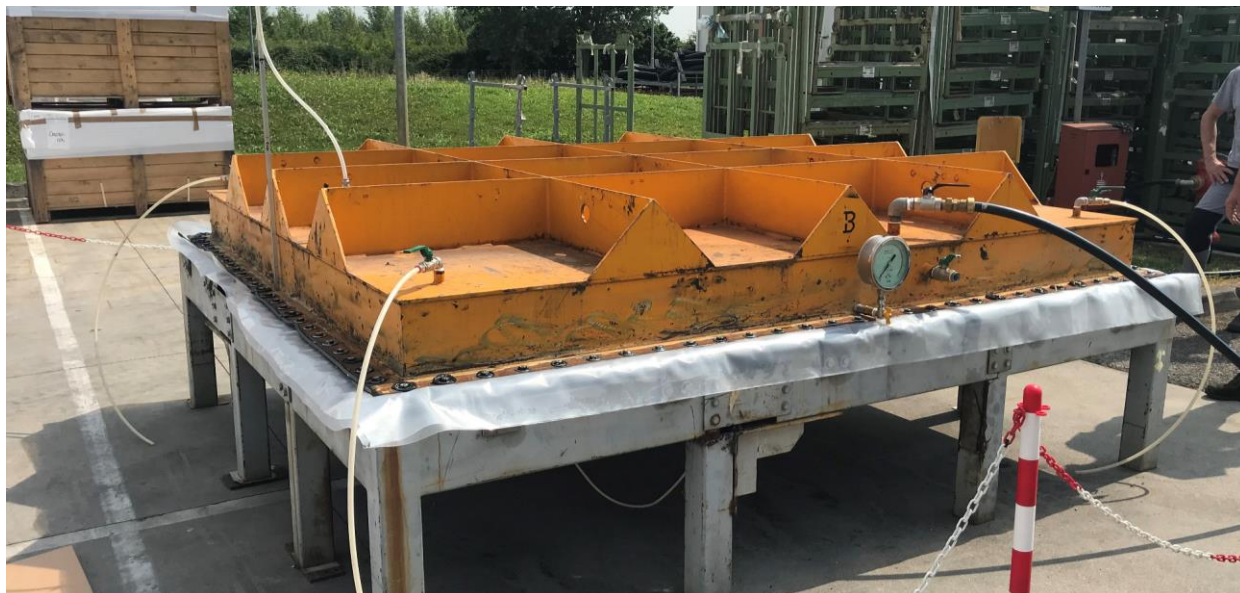
The test was performed in accordance with the ship rules Pt. 3 Ch. 12 Sec 6 [6.2] items 1–3. The test was performed on a hydrostatic test bench by statically applying the design pressure (35.4 kPa) over a period of 5 minutes. This corresponded to the design pressure of the forward window in stateroom 2000, which was also the strongest on deck 2. Figure 10-1 shows a photo from the test.

SOMEK has, on its own initiative, increased the pressure applied during the test to 40 kPa in order to test the windows' residual capacity [10]. The test was positive, as no visible damage or deformations were registered.

Figure 10-1 Static pressure test. Photo from window manufacturer SOMEK

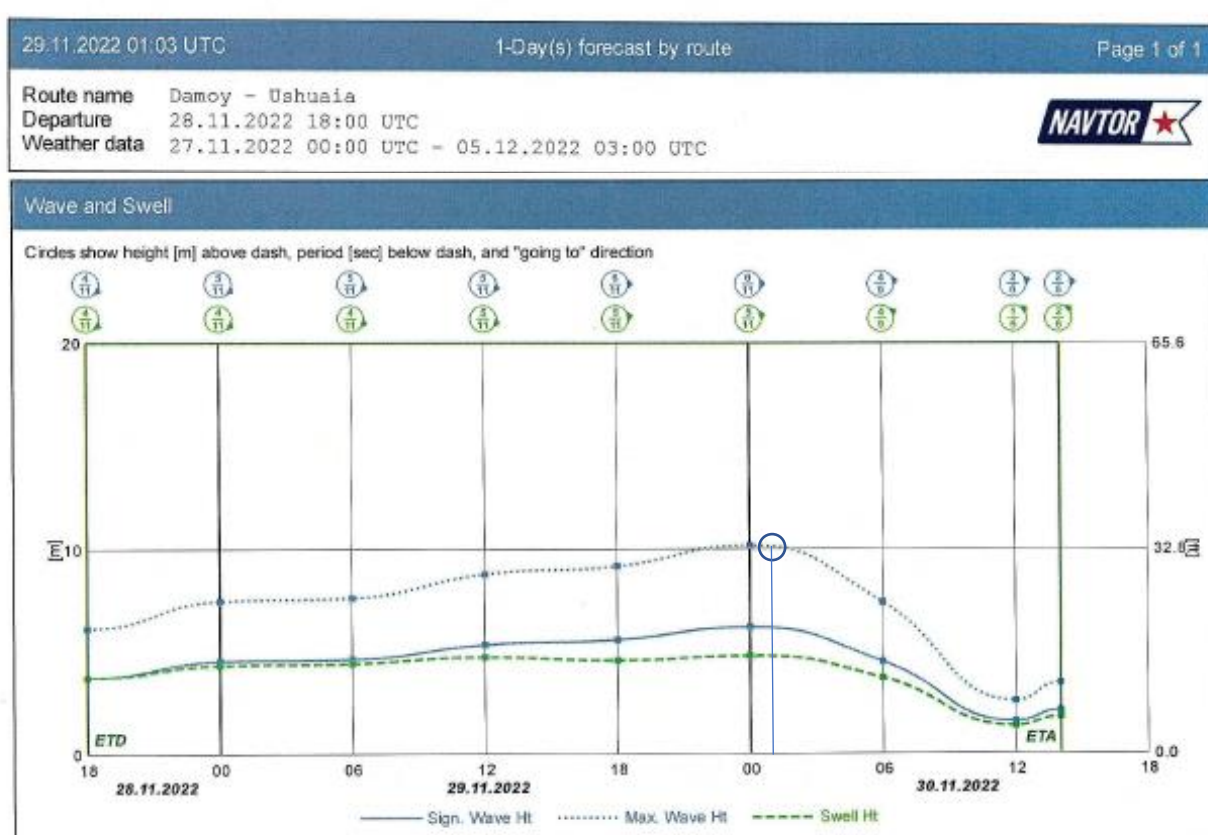
Based on the weather forecast [16], the wave state at the time of the accident was characterised by the following significant and maximum wave height and associated wave period ( $H_s = 6$  m,  $H_{MAX} = 10$  m,  $T_p = 11$  s). Figure 11-1 shows a transcript from the ship's route planning station.

Figure 11-1 Transcript from the ship's route planning station for the voyage Damoy-Ushuaia [16]. The blue circle shows the time when the accident occurred (01:35 UTC)

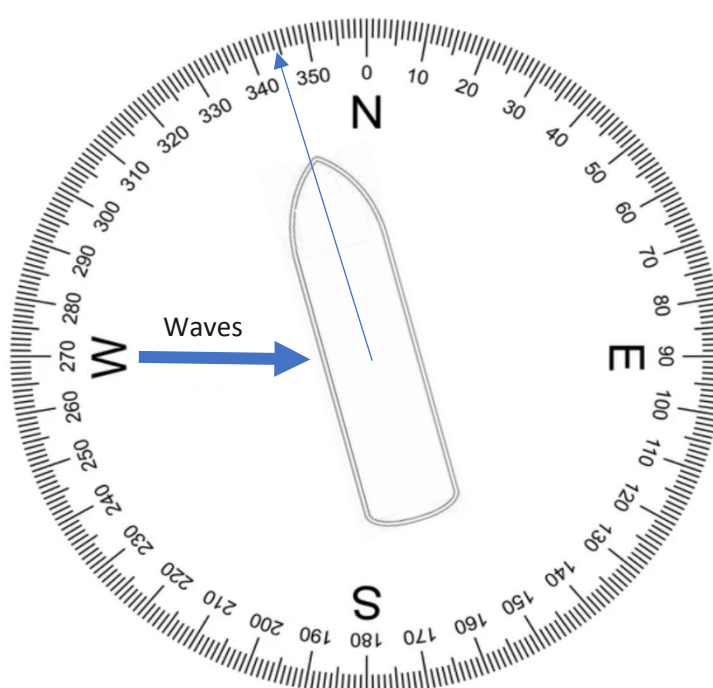
Figure 11-2 Relative wave direction

The weather forecast at the time of the accident predicted waves from 270 degrees (from the west). According to the Voyage Data Recorder (VDR), the ship’s heading was 344 degrees immediately before the accident. This gives a wave direction relative to the sea state of 74 degrees to port relative to the ship length; see Figure 11-2. This wave direction is supported in part by observations from the CCTV cameras shown in Figure 11-3. However, the footage appears to show a somewhat smaller angle, and the relative wave direction is therefore estimated to approximately 60–80 degrees to port, which means beam sea.

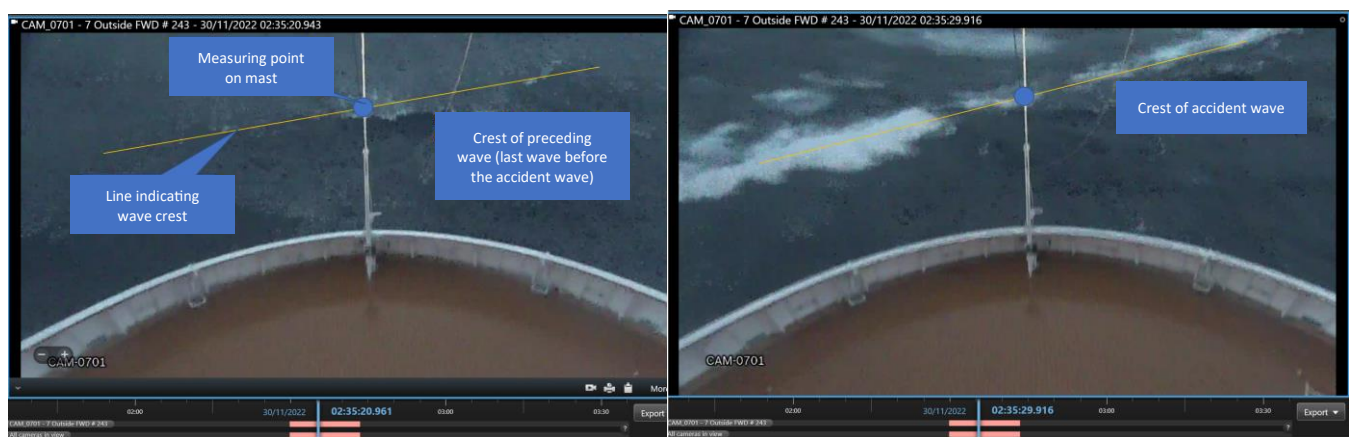
Figure 11-4 CCTV footage from the bridge showing the time interval between the preceding wave and the accident wave, measured from the bow mast.

Figure 11-4 shows the crest of the preceding wave passing approximately at the measuring point of the bow mast at 2:35:20:9 and the crest of the accident wave passing approximately the same point at 2:35:29:9, which gives a wave encounter period of 9.0 seconds.

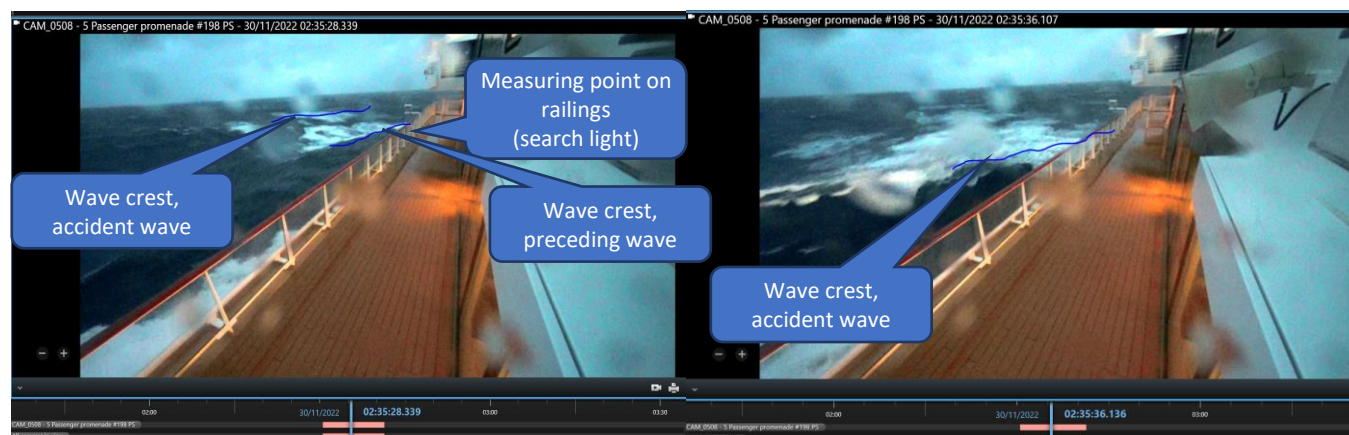
Figure 11-5 CCTV footage from frame #198, deck 5, port side. The measuring point is the search light mounted on the railing.

Figure 11-5 shows the crest of the preceding wave passing the area around the rack at 2:35:28:3 and the crest of the accident wave passing approximately at the measuring point at 2:35:36:1, which gives a wave encounter period of 7.8 seconds.

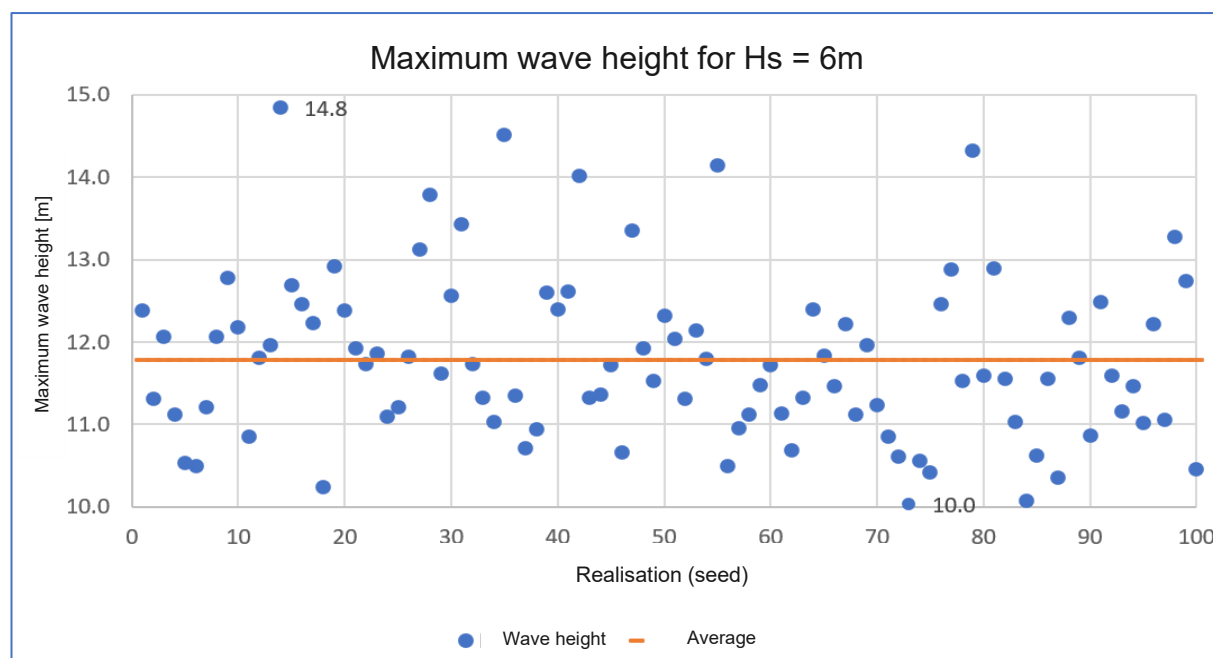
The results of the simulations for  $H_s = 6$  m are shown in Figure 11-7. The results of the simulations are given in Table 11-1.

Figure 11-7 Maximum wave height from wave simulations for  $H_s = 6$  m

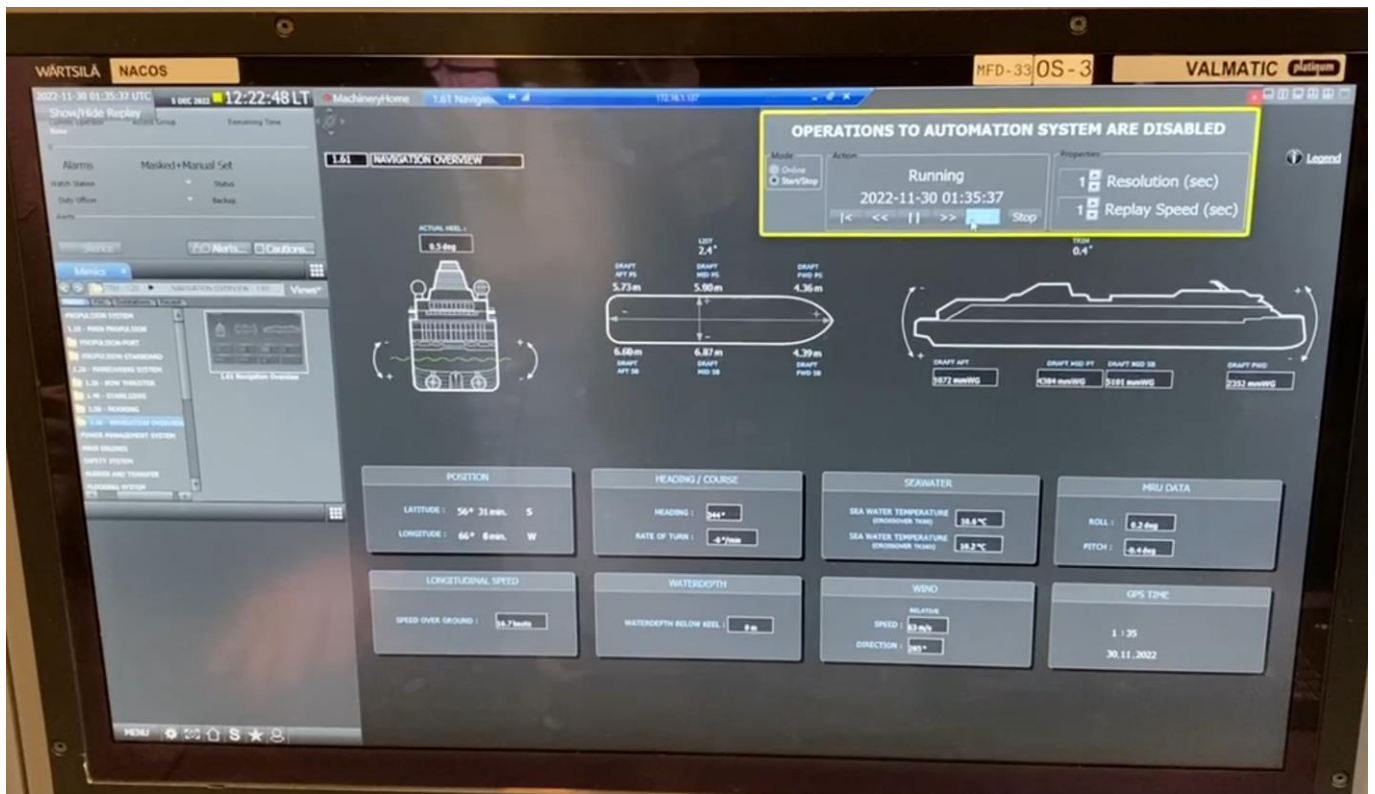
Figure 12-1 Machinery log.

There has been uncertainty about the coordinate system used for the roll angles. Based on CCTV footage and the roll response in Figure 12-2, we conclude that a positive angle of heel means that the ship lists to starboard and that the starboard side inclines. This is the opposite of the coordinate system shown under 'actual heel' in the machinery log in Figure 12-1.

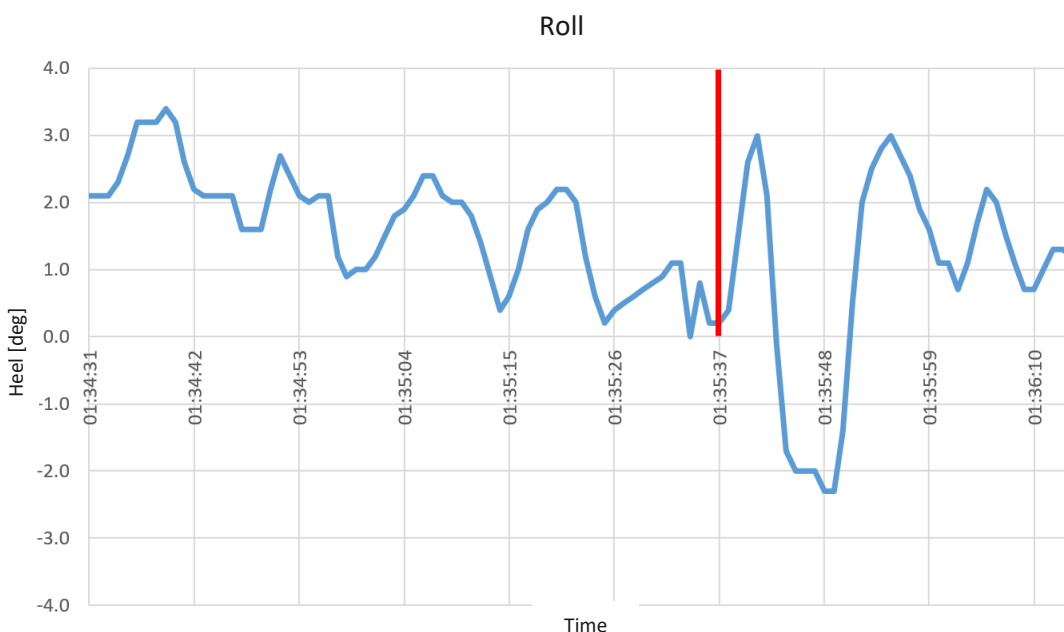
'Viking Polaris' is equipped with stabiliser fins that dampen the roll motion, and we see that these fins dampen most of the roll motion after 30 seconds.

Figure 12-2 Roll movement after the accident. The wave strikes at 01:35:37. The positive angle is a starboard heel.
