# REPORT MARINE 2023/06

***Marine casualty involving the cruise ship  
'Viking Polaris' south-east of Cape Horn,  
29 November 2022***

*The Norwegian Safety Investigation Authority (NSIA) has compiled this report for the sole purpose of improving safety at sea.*

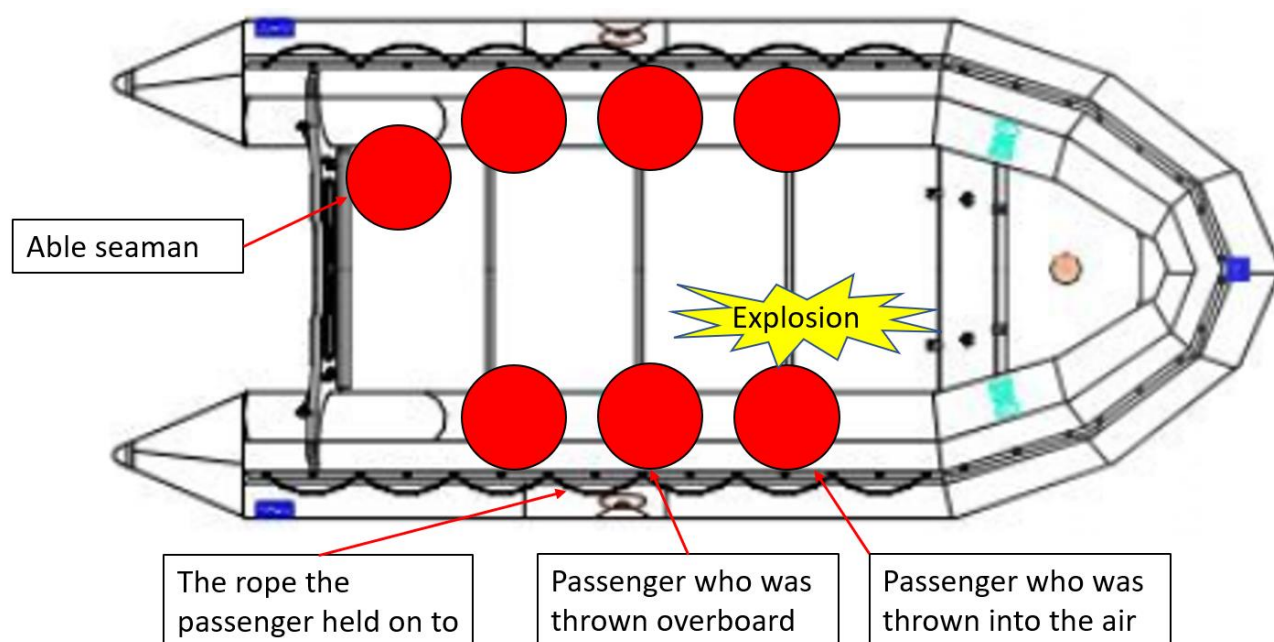
Suddenly some sort of explosion occurred on board the Zodiac. One of the passengers, who was seated forward on the starboard side of the boat, experienced to be thrown into the air and fell down into the Zodiac. The passenger sustained fractures in both legs. Another passenger, who was seated in the middle position on the starboard side and holding on to the rope running along the tube with one hand, was thrown overboard by the explosion. He did not let go when he fell overboard and was therefore pulled along by the Zodiac for a few seconds until the boat came to a stop. His lifejacket did not inflate. Two of his fellow passengers grabbed him and tried to pull him up with his back against the tube. As the expedition clothing was wet and slippery, it took two or three attempts before they finally succeeded in pulling him back on board with the help of the able seaman. See Figure 5 for an overview of where the passengers were seated on the Zodiac.

Figure 5: Overview of the positions of the passengers and the able seaman on board the Zodiac.  
Illustration: Supplier/NSIA

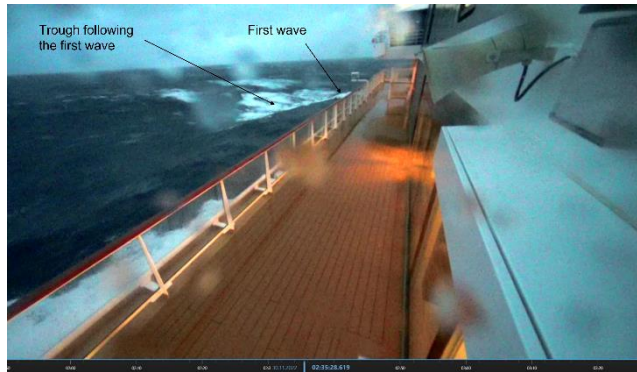
Figure 7: The first wave hitting the side of the ship. White foam is visible in the trough that follows at 22:35:28. Source: CCTV

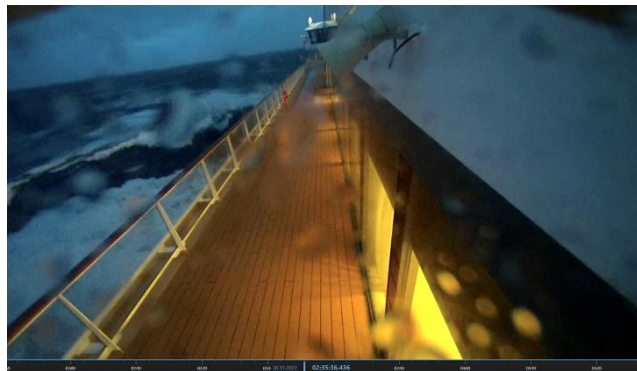
Figure 9: The second wave approaching the side of the ship at 22:35:36. Source: CCTV

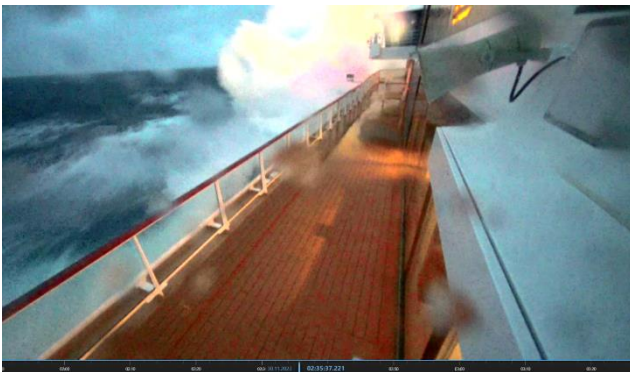
Figure 10: The wave hits the side of the ship at 22:35:37. View from the forward camera on deck 5. Source: CCTV

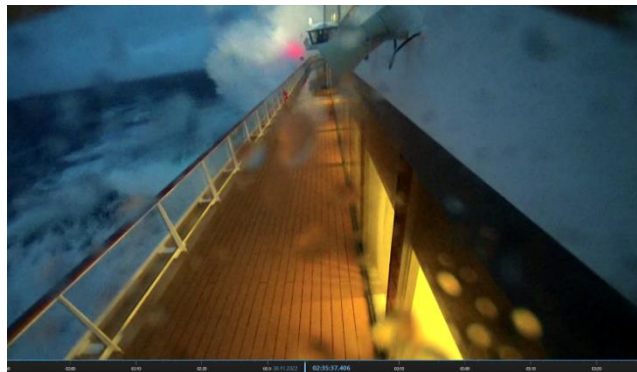
Figure 11: The wave hitting the side of the ship at 22:35:37. View from a camera further aft on deck 5. Source: CCTV

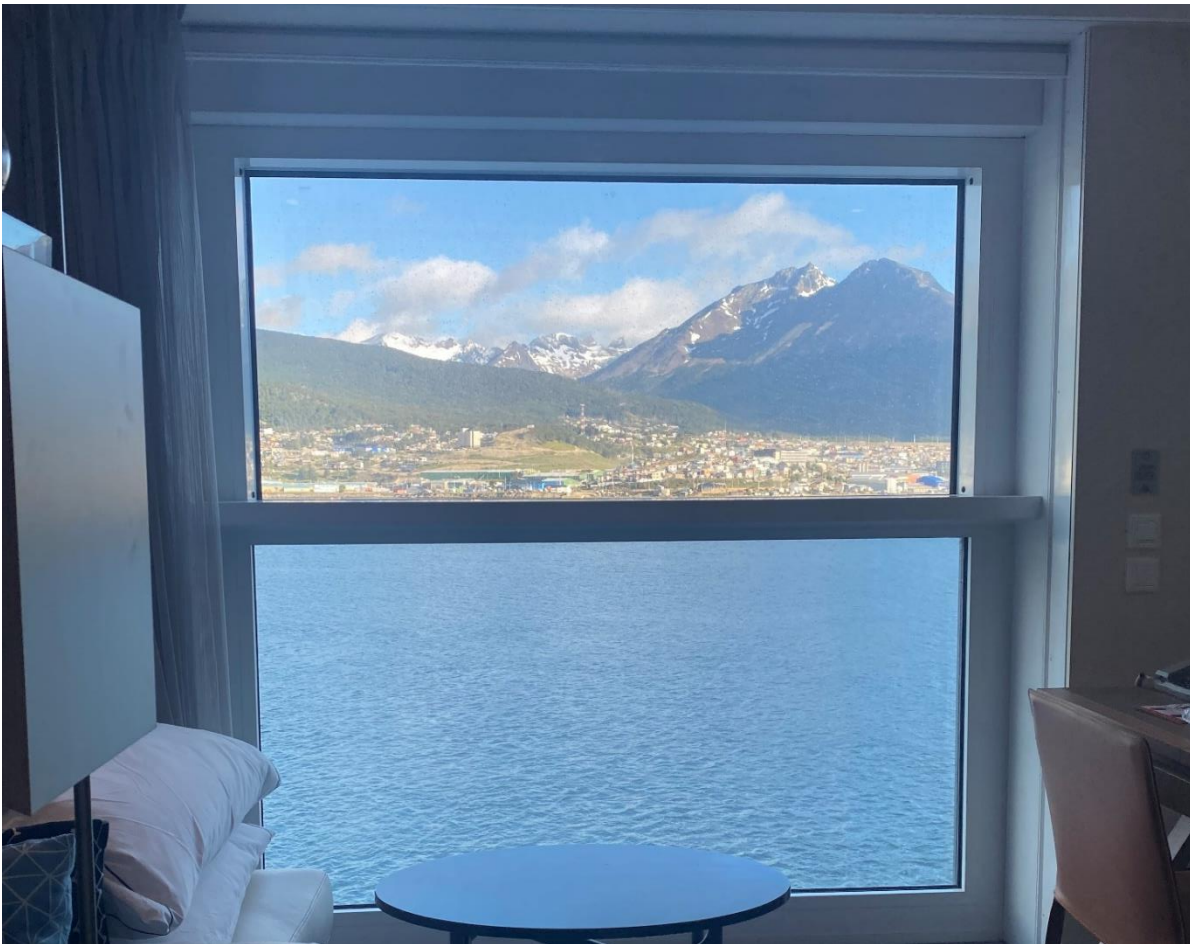
The windows consisted of two sections, where the upper part could slide up and down to open to the surroundings; see Figure 59. The operable part of the window opened and closed with the use of a switch beside the stateroom window, or could be closed automatically from the bridge. The window could also be operated manually in the event that the power supply to the system was disrupted.

Figure 59: Window of the same type as on deck 2. This photo was taken on deck 4. Photo: NSIA

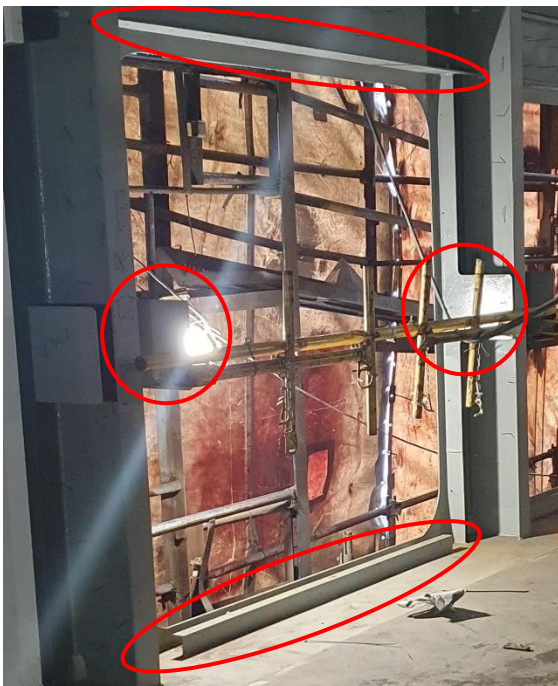
A stiffener was fitted in the window frame between the upper and lower part of the window, fastened to the side of the cutout. The window frame was made from aluminium and fastened to the hull with bolts on the top and bottom, but not on the sides; see Figure 61 and Figure 62.

Figure 61: Photo: The window frame was fastened with bolts on the top and bottom. The stiffener was fastened to the plates on either side; as indicated by the red circles. Photo: Shipyard / modified by NSIA

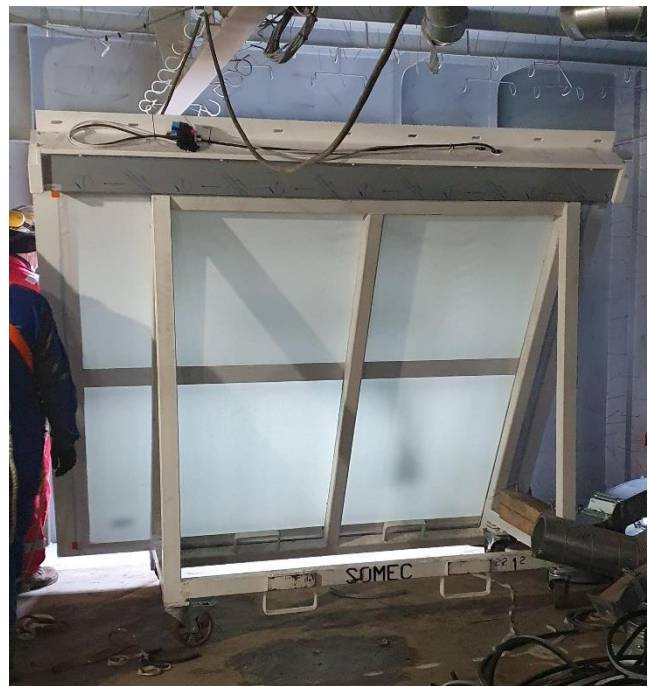
Figure 62: Window ready to be installed. Note the bolt holes on top of the frame and the horizontal stiffener in the middle of the window. Photo: Shipyard

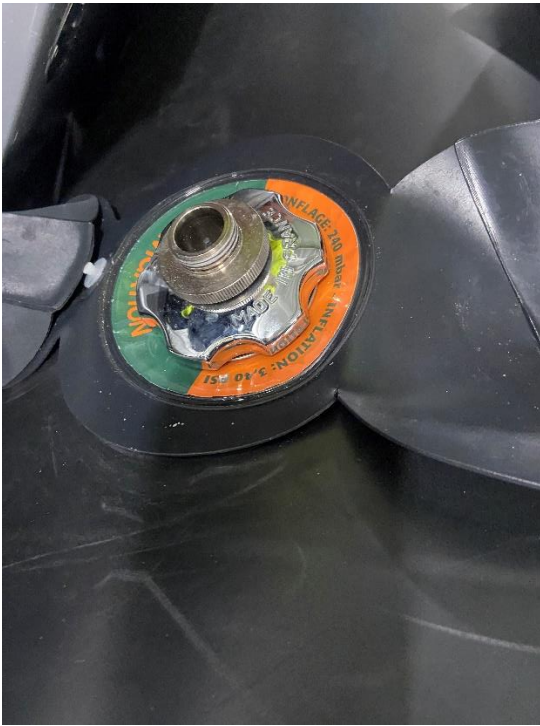
The main tubes of the boat consisted of five air chambers in total. Each chamber had a combined inflation and overpressure relief valve; see Figure 64. The valves on the main tubes showed the prescribed air pressure. The chambers could be opened to allow for free passage of air between them, and only one inflation valve needed to be used to inflate the boat. This allowed for the pressurised air to be checked by means of a manometer fitted to another inflation valve; see Figure 65. Once the correct pressure had been achieved, the bypass valves were to be set to navigation mode. That would isolate each chamber from the others as a precaution against leaks.

Figure 64: Inflation valve with overpressure relief.  
Photo: NSIA

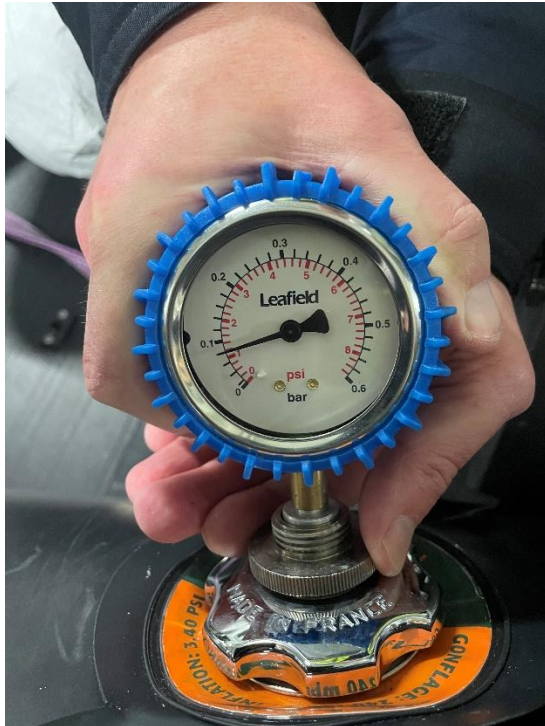
Figure 65: Manometer fitted to inflation valve.  
Photo: NSIA

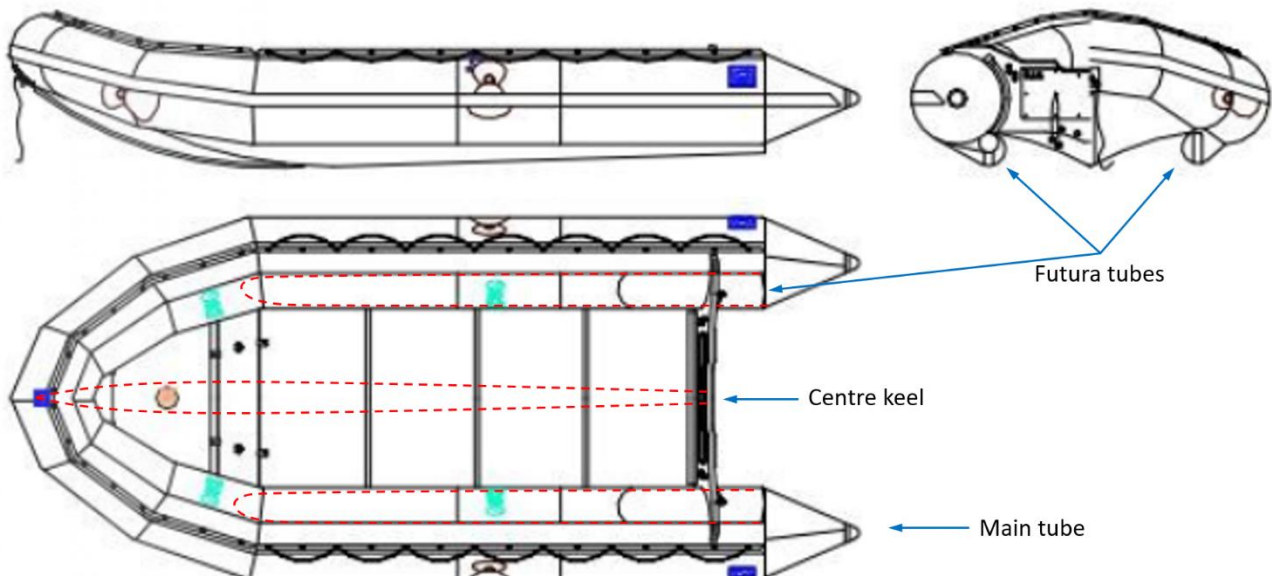
The boats were delivered with a futura tube below each main tube, as well as an inflatable centre keel; see Figure 66. Neither of these were equipped with overpressure protection. The futura tubes were cylindrical and intended to improve buoyancy and manoeuvring characteristics at speed. The inflatable keel was cylindrical and located at the centre, below the floorboards, and extended from the stern the all the way to the bow. The centre keel was intended to tighten the fabric at the bottom of the boat and create a V-shaped design to improve its seagoing properties. The keel also pushed the floorboards up and made them stable to walk on, in addition to stiffening the boat. The futura tubes were inflated at the stern, where an extension hose was installed from both sides, and the inflatable keel was filled from the valve placed in the aluminium box at the bow.

Figure 66: Overview illustration of Zodiac. Illustration: Manufacturer / text and dotted lines by the NSIA

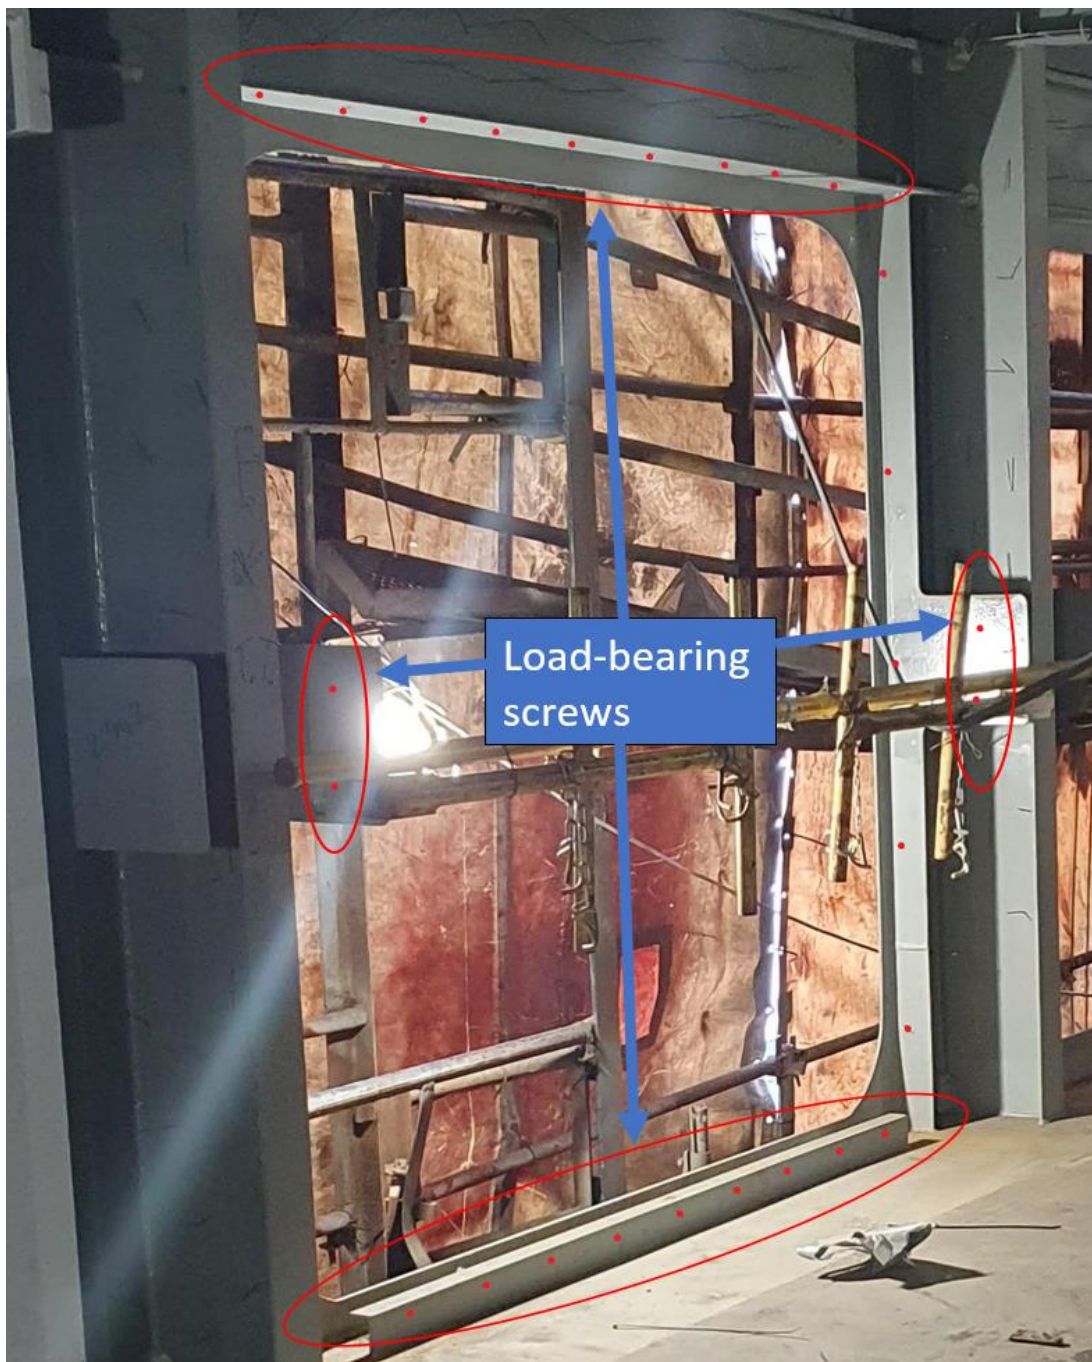
The spacing between the screws fastening the window frame to the ship structure must not exceed 150 mm. The windows in question were attached with different types of screws that were also spaced at different intervals. The spacing between the load-bearing screws varied between 222 mm and 230 mm. The capacity of the window fixings, including frame, bolts and stiffeners, are evaluated by class society to be in accordance with the applicable rules through the equivalence principle stated in Pt.1 Ch.1 Sec.1 [2.5.9], by performing a strength test of the complete installation. The load-bearing screws are highlighted in Figure 73. The remaining screws hold a thin aluminium profile with low load-bearing capacity and are therefore not considered load-bearing.

Figure 73: Screws fastening. The red dots show the location of the screws. The load-bearing screws are highlighted. Photo: Window supplier / modified by the consultant

No damaged or broken load-bearing screws were found for the windows studied in this report. It can therefore be concluded that the load-bearing screws were of sufficient strength for the windows in question.

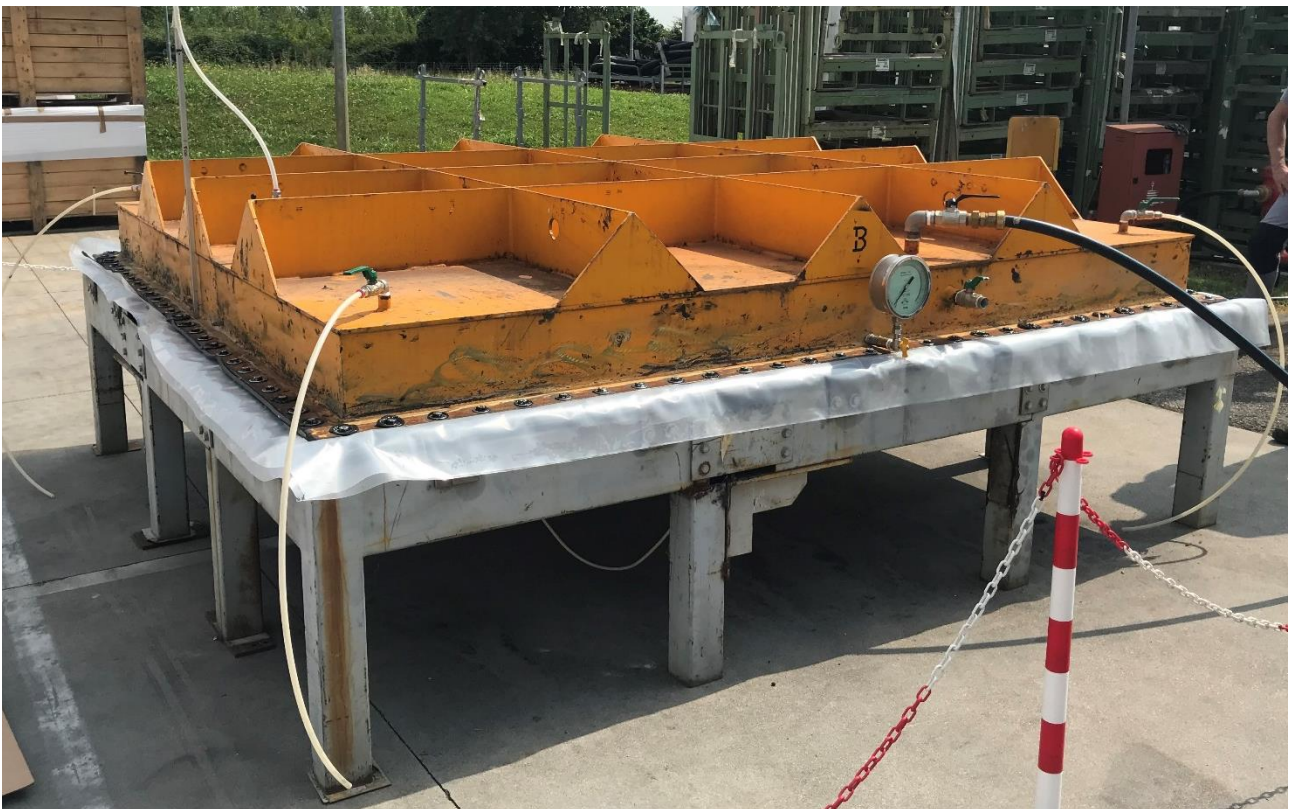
The full-scale test was performed in accordance with the Rules for Ships Pt. 3 Ch. 12 Sec 6 [6.2] items 1–3. The test was performed on a hydrostatic test bench by statically applying the design pressure (35.4 kPa) over a period of five minutes; see Figure 78. This corresponded to the design pressure of the forward window in stateroom 2000, which was also the strongest on deck 2.

The purpose of the test is to verify that the window, including the frame and fixings, is able to withstand the design pressure. This means that the test is performed with an arrangement identical to how it was installed on the ship. The test was performed by the window supplier and observed by class society.

The window supplier has, on its own initiative, increased the pressure applied during the test to 40 kPa in order to test the windows' residual capacity. The test was positive, as no visible damage or deformations were registered.

Figure 78: The hydrostatic test bench used in the full-scale test. Photo: Window supplier
