# REPORT MARINE 2024/01

***Fall overboard from the fishing vessel  
'Hunter' (LKUA) in the Barents Sea on  
30 January 2023***

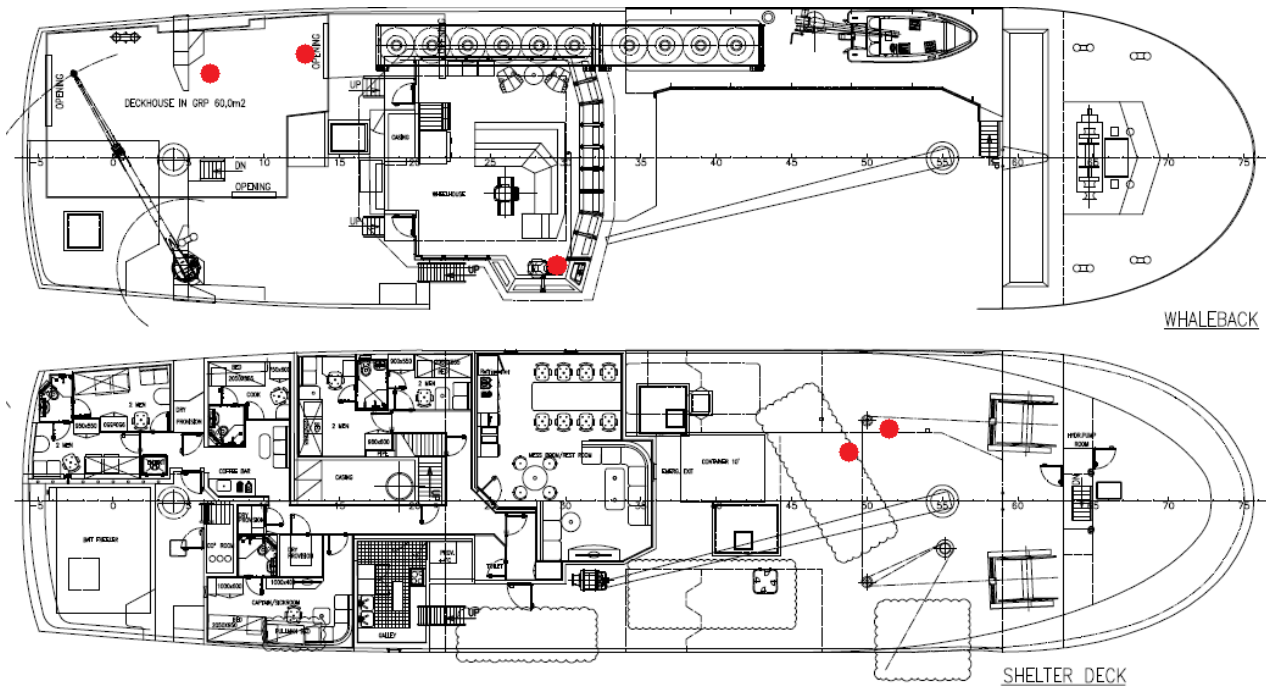
At about 17:00, the crew started the preparations process of deploying the pots and at 17:28 they began to set out pots. As usual, there were two fishermen on the foredeck and two on the afterdeck; see Figure 2. One fisherman on the foredeck and one on the afterdeck could communicate directly with the wheelhouse using the intercom in their helmets. Video surveillance from the wheelhouse was supposed to give the crew member on watch an overview of the work operations, but the system had stopped working on the way out to the fishing grounds. The CCTV camera had recently been replaced as the previous system had broken down on the previous voyage.

Figure 2: Red markings indicate the locations of crew on the deck and in the wheelhouse just before the accident. Source: Shipping company. Illustration: NSIA

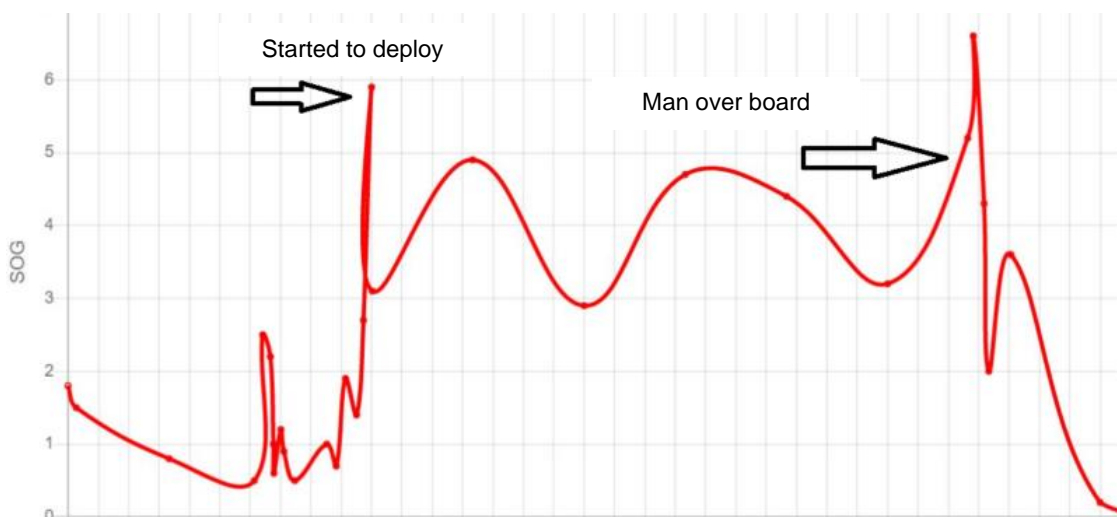
The vessel's speed during deployment of the gear was stated to ordinarily be within the range of 3.5–4 knots, depending on the weather conditions. The speed graph shows that the speed was somewhat higher on the day of the accident; see Figure 3.

Figure 3: Speed graph from deploying the pots and at 17:28 and man overboard at approximately 17:58 on 30 January 2023. Left arrow shows the time when they started to deploy pots and the right arrow is the time when the fisherman fell overboard. Source: Norwegian Coastal Administration AIS. Illustration: NSIA

At a speed of four knots, there was about a 10-second gap between each pot to be hooked to the set line every 20 metres. Since the point of attachment on the line was only two metres long, it gave the fisherman about one second to attach the hook. The fishermen have stated that the work

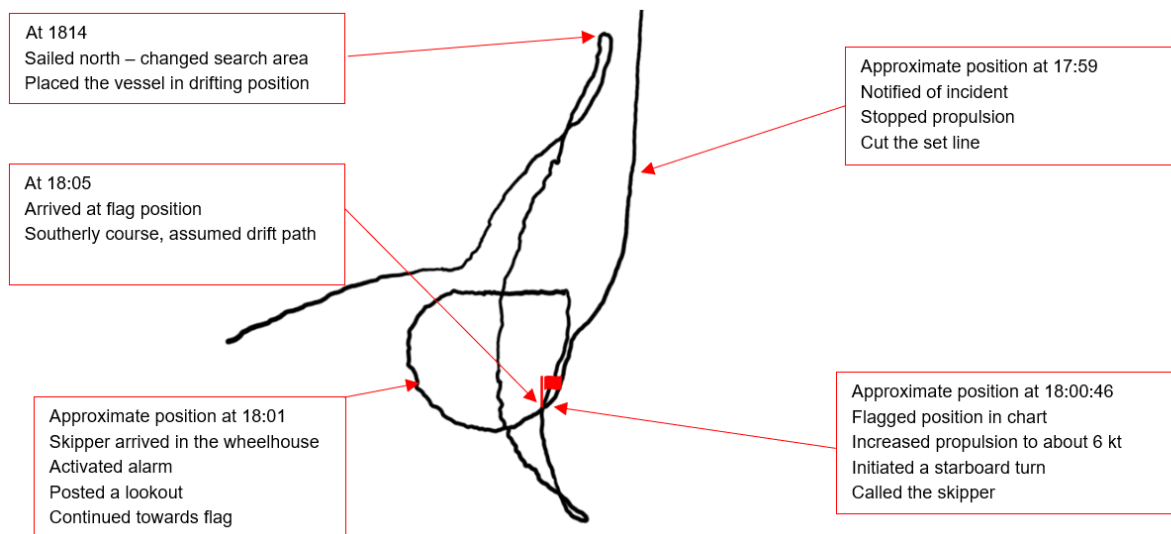
The fisherman on the foredeck first tried to pull the set line back with the winch to see whether the fisherman in the water had managed to cut it, but the line was still tight, so he cut the line as the chief officer had told him to do. The fisherman then ran far aft on the starboard side to look for the fisherman who had fallen overboard, but it was difficult to see anything in the dark through heavy sleet. One fisherman later informed that he heard three distinct cries from abaft the midship on the port side and tried to identify exactly where they came from. The fisherman then went to the other side to see whether he could see or hear anything, but visibility was too poor and he heard no more cries. See Figure 5 for an overview of key events at the time of the accident.

Figure 5: Overview of activities on board and the vessel's movements around the time of the accident. Source: Vessel chart system. Illustration: NSIA

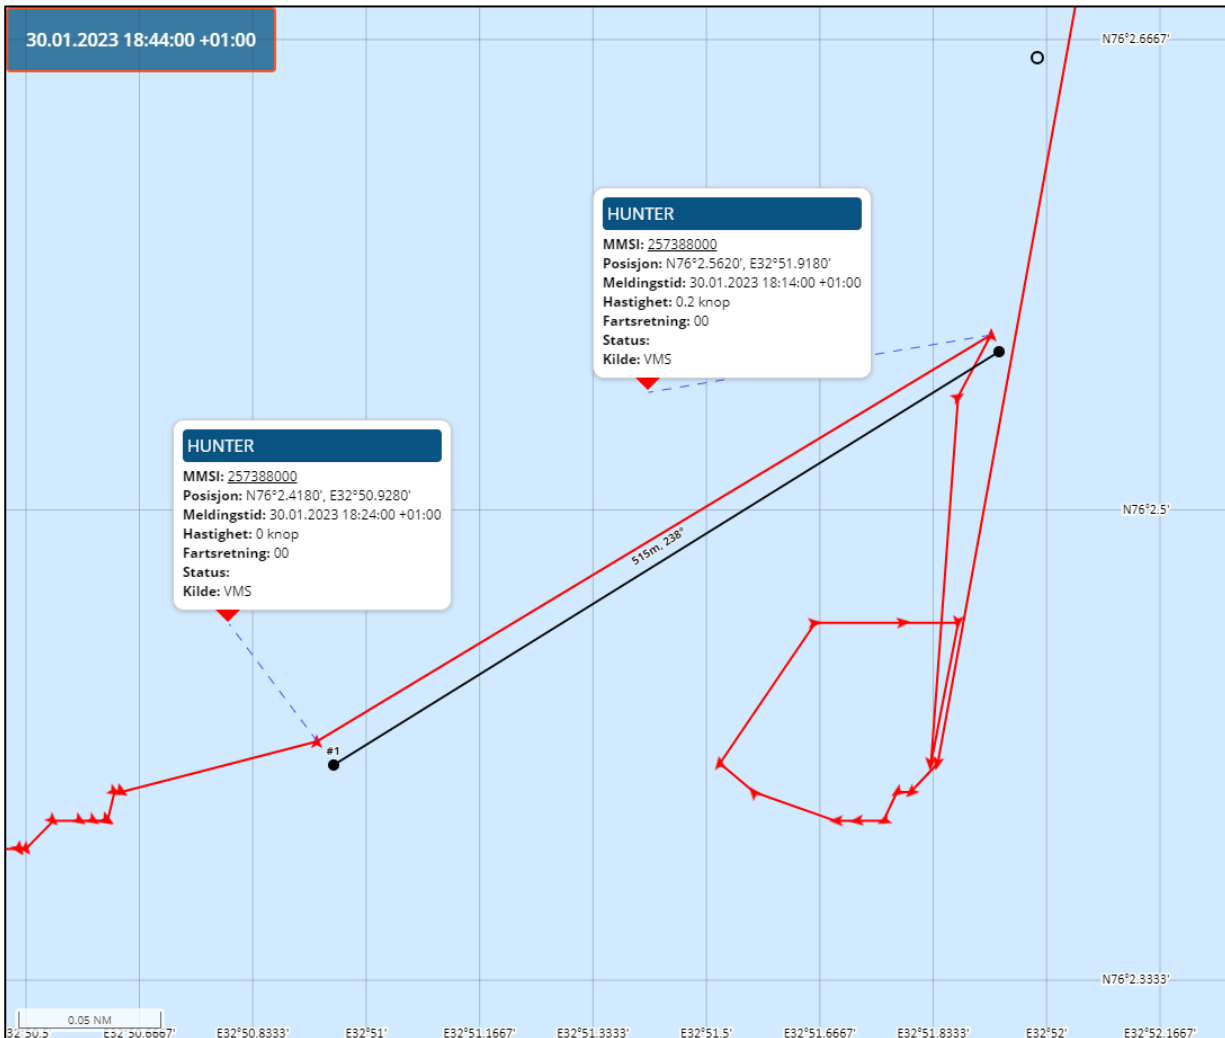
At 18:14, the vessel had reached the position where they assumed the fisherman had fallen overboard; see Figure 6. The vessel was then placed in a drifting position against the weather while they proceeded with a visual search. The drifting position was maintained for about 10 minutes, covering a distance of about 515 metres.

Figure 6: The different positions of the vessel during the search process.  
Source: Norwegian Coastal Administration AIS. Illustration: NSIA
