Issued April 2026

REPORT MARINE 2026/03

Marine accident involving a rental vessel north-east of Kråkenes Lighthouse in Vestland County, 4 May 2025

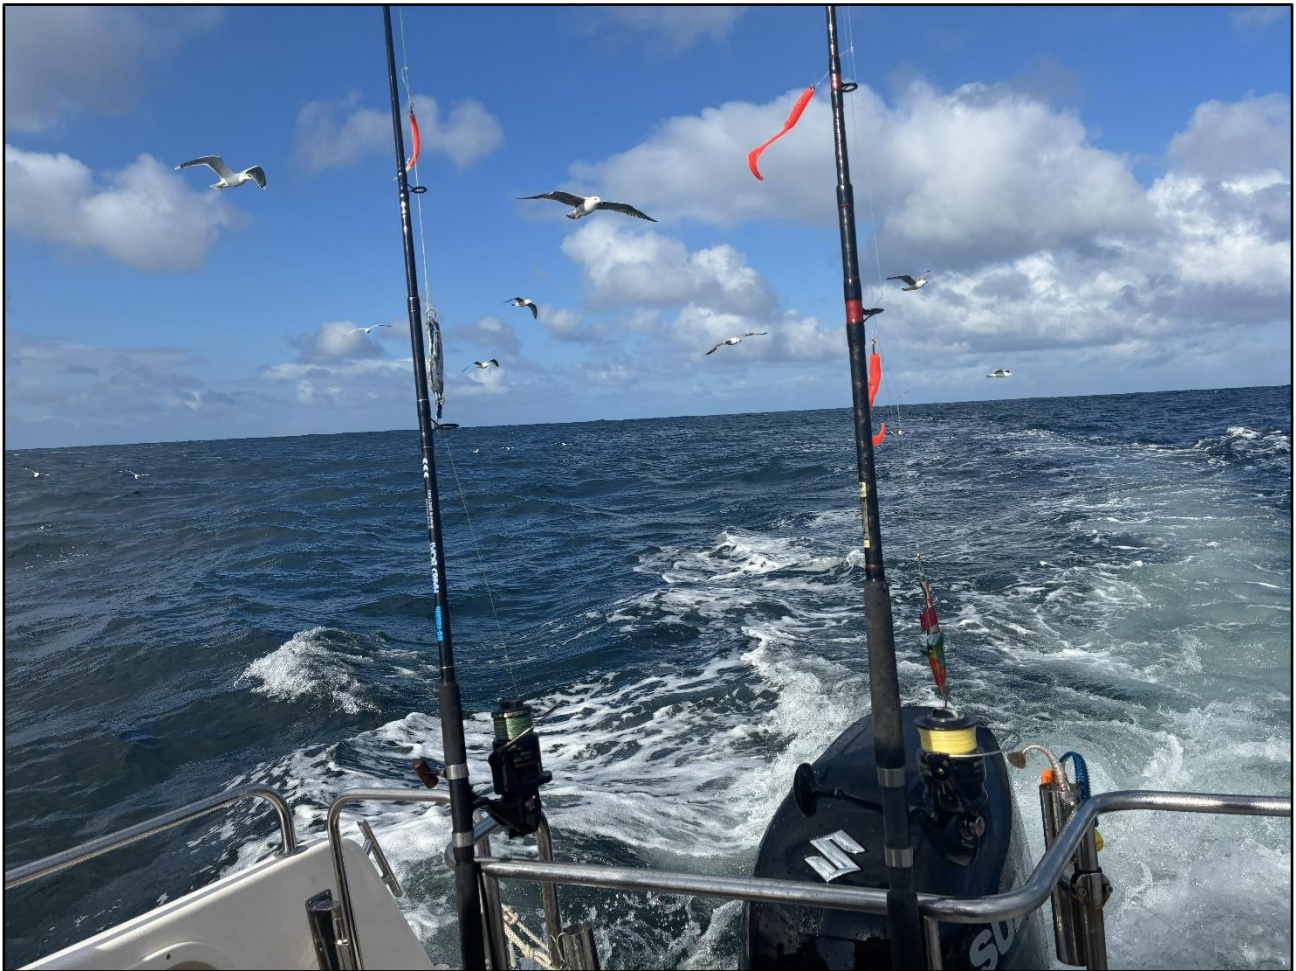
Figure 8: Photo sent from one of the anglers to a family member at 10:24 on the day of the accident. Photo: Private

One of the tourist anglers sent a photo to a family member approximately one-and-a-half hours before the accident. The image shows the weather conditions at that time (see Figure 8).

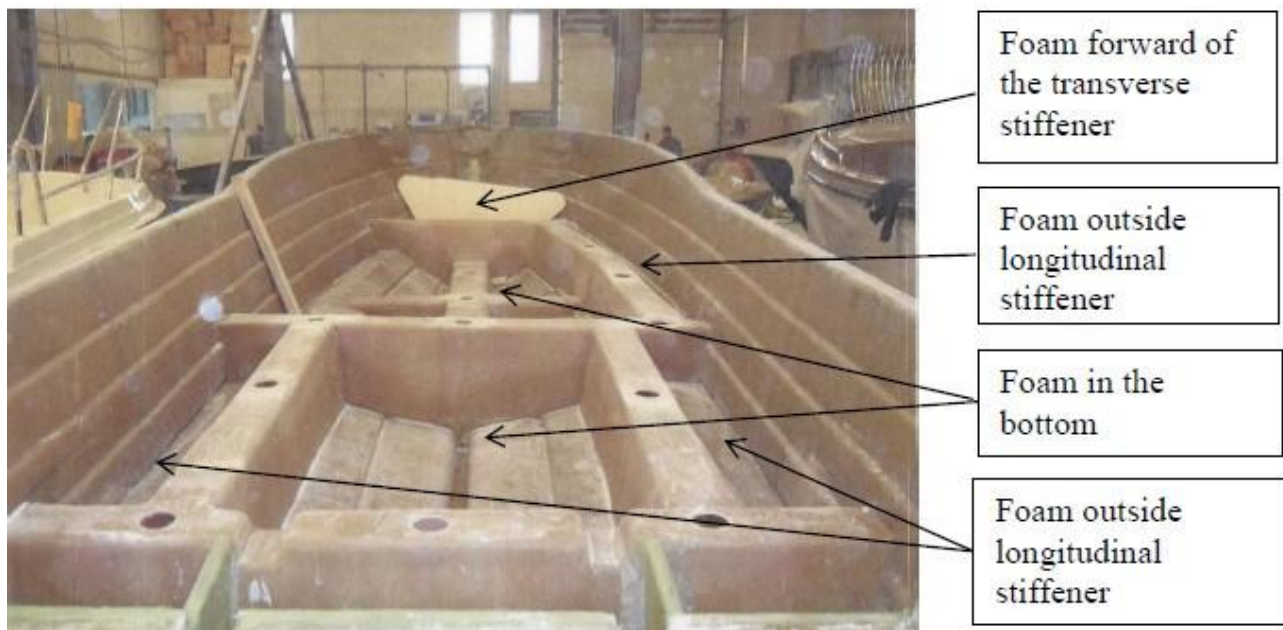
Figure 18: The image shows foam-filled areas of the hull. Source: NSIA (Report Marine 2016/10)

Most of the voids between the hull and the inner liner were filled with foam, (see Figure 18).

A comparison between the accident vessel and Viking 7 shows that they were foam-filled in the same areas, and the boats appeared nearly identical.

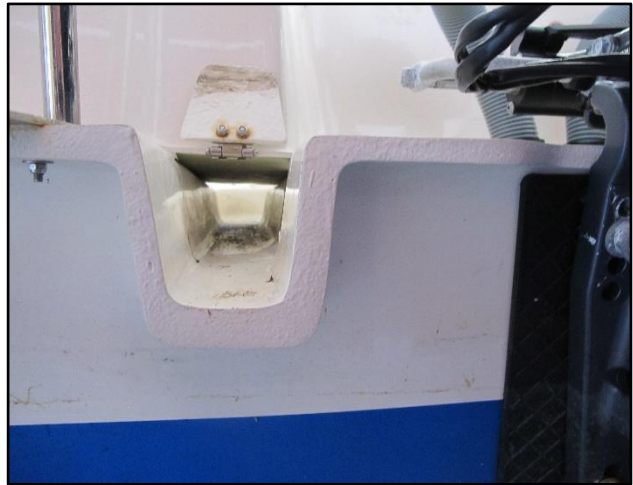
Figure 20: Port side drain opening from the Viking 7 investigation. Photo: NSIA

The design of the drain openings had been somewhat modified following the accident involving Viking 7 in 2014. The accident vessel featured external flaps (see Figure 19), whereas the drain openings on Viking 7 were positioned further inside the drainage channel (see Figure 20).

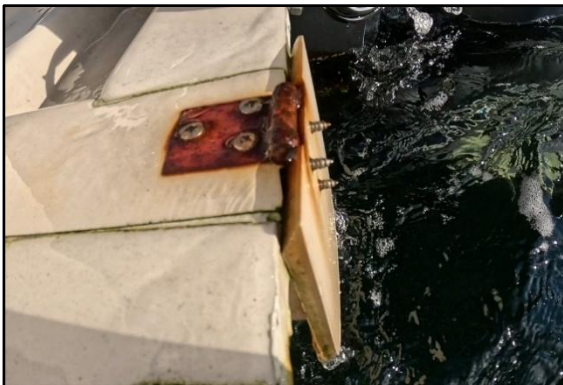
Figure 25: Port drain opening in closed position.
Photo: NSIA

The drain openings had the same design as those on the accident vessel and were externally mounted aft of the drainage channels from the aft deck. The drain openings remained closed by gravity when the vessel was stationary and when the vessel was making sternway through the water (, see Figure 25).

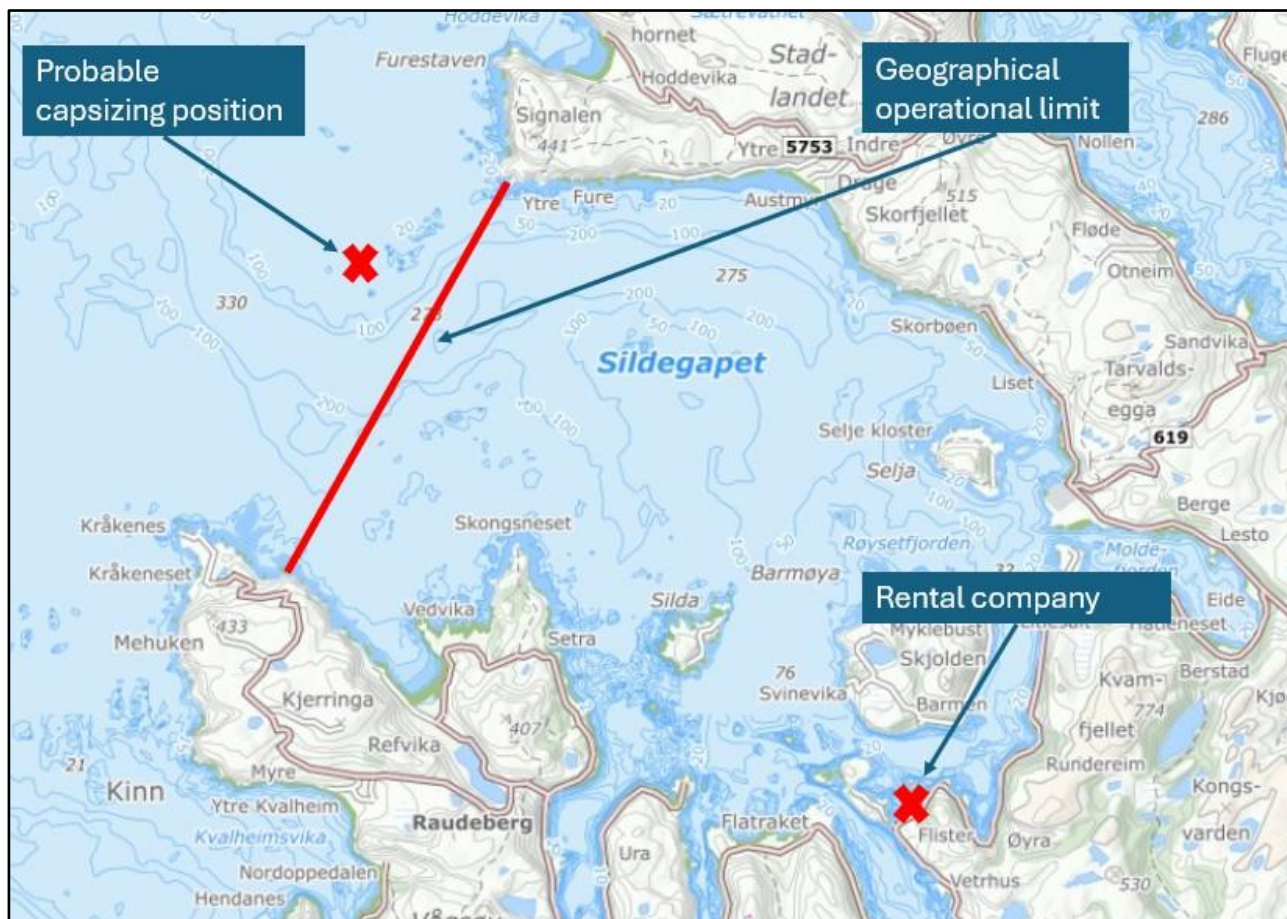
Figure 28: Location of the rental company, the position where the vessel likely capsized and geographical operational limit provided by the rental company. Map: Kystinfo. Norwegian Coastal Administration / NSIA

The company had also demarcated a geographical operational limit on a chart, which was presented to renters. The rental vessels were not to operate west of the line indicated in Figure 28.

A review of the chart plotter track showed that the anglers had fished outside the geographical operational boundary on 30 April, 3 May and 4 May. On 1 and 2 May, they remained inside the boundary.
