Issued May 2026

REPORT MARINE 2026/04

***Marine accident involving a rental vessel
in Bergsfjorden in Loppa municipality,
19 May 2025***

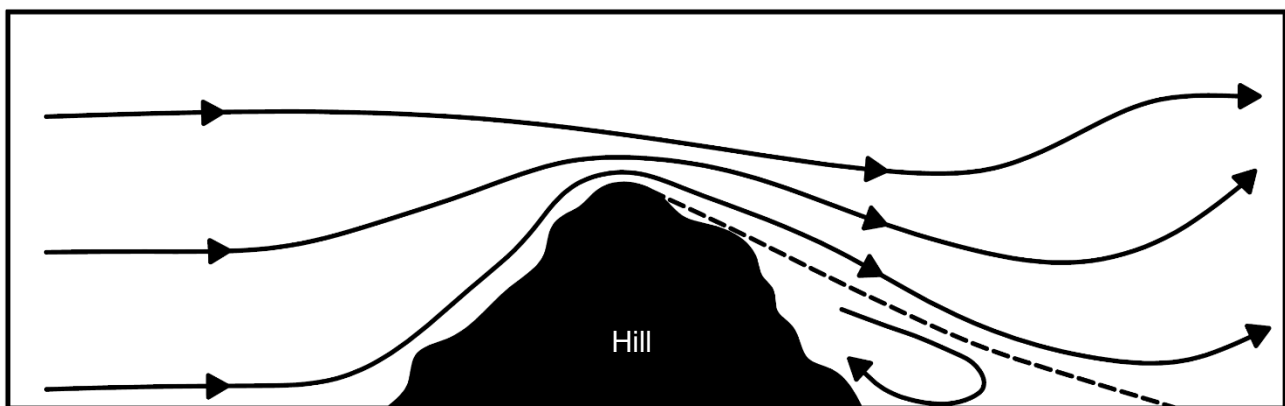
Figure 5: Cavitation and chaotic wind patterns on the lee side. Source: Stull, 1988 – An introduction to boundary layer meteorology. Illustrated by NSIA

According to the Great Norwegian Encyclopedia, mountain waves⁴ are a specific type of atmospheric gravity wave that occurs when an air flow passes over a mountain or mountain range. Mountain waves are often the source of strong and sometimes unexpected downslope winds along the ground or sea surface. They can produce chaotic wind patterns and significant turbulence (see Figure 5).

High-resolution models from the MET showed that the area on the lee side of the island experienced chaotic wind conditions during the period when the accident occurred. According to MET, this may have resulted in winds from several different directions, as well as gusts descending from higher altitudes. Mini-tornadoes were also observed. The formation mechanism of such mini-tornadoes is not known in detail, but they have been reported in various contexts in connection with mountain waves and downslope winds on the lee side of mountains, both in the United States and in Norway. Local topography and changes in horizontal wind with altitude are likely to play an important role in the formation of such vortices. An unstable temperature stratification in the lower atmosphere may also intensify such vortices.

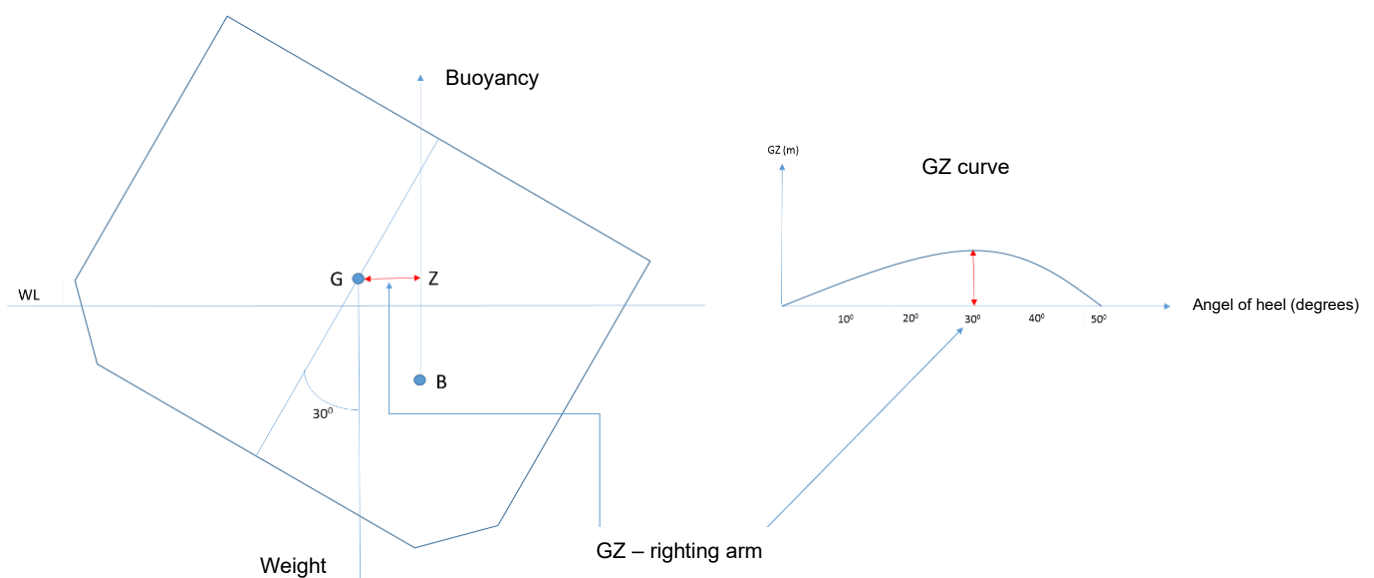
Figure 8: Explanation of the GZ curve. Illustration: NSIA

Stability is traditionally expressed using GZ curves, and stability requirements are normally linked to characteristics of a craft's GZ curves. GZ is the horizontal distance between a craft's centre of gravity (G) and its centre of buoyancy (B) at a given angle of heel and makes up a righting arm, see Figure 8. The righting arm multiplied by the weight of the craft is the righting moment.

Figure 8 shows that the illustrated craft's capacity to resist heeling is greatest at approx. 30° (highest GZ value), and at approx. 50° the craft is no longer capable of resisting heeling (GZ = 0) – in other words, it will capsize at this angle of heel.

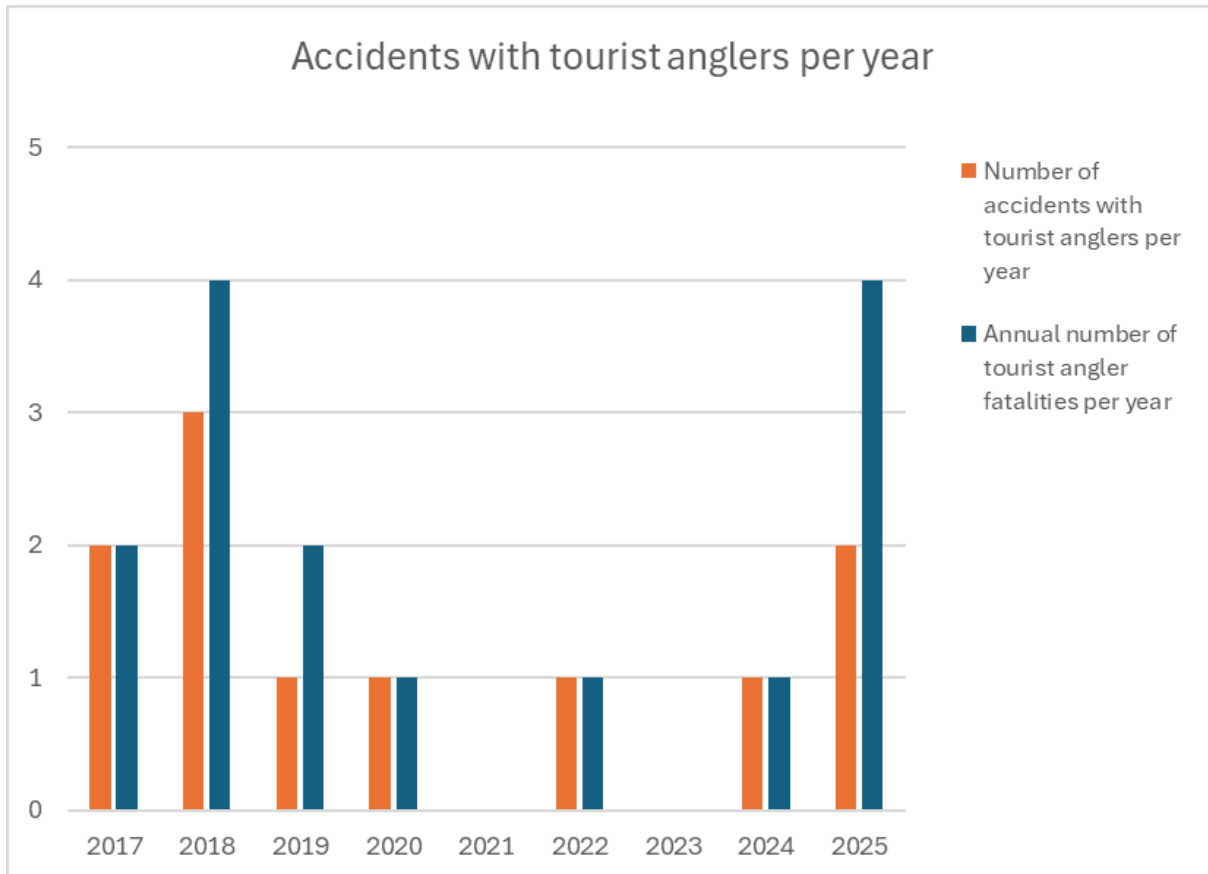
Figure 12: Accidents involving tourist anglers per year. Source: Norwegian Maritime Authority. Graph: NSIA

The information showed that there have been eleven accidents involving tourist anglers who had leased a vessel from a rental enterprises. These accidents resulted in a total of fifteen fatalities. On average, this corresponds to slightly more than one accident and just under two fatalities per year. The number of accidents involving tourist anglers and the number of fatalities among tourist anglers per year are shown in Figure 12.

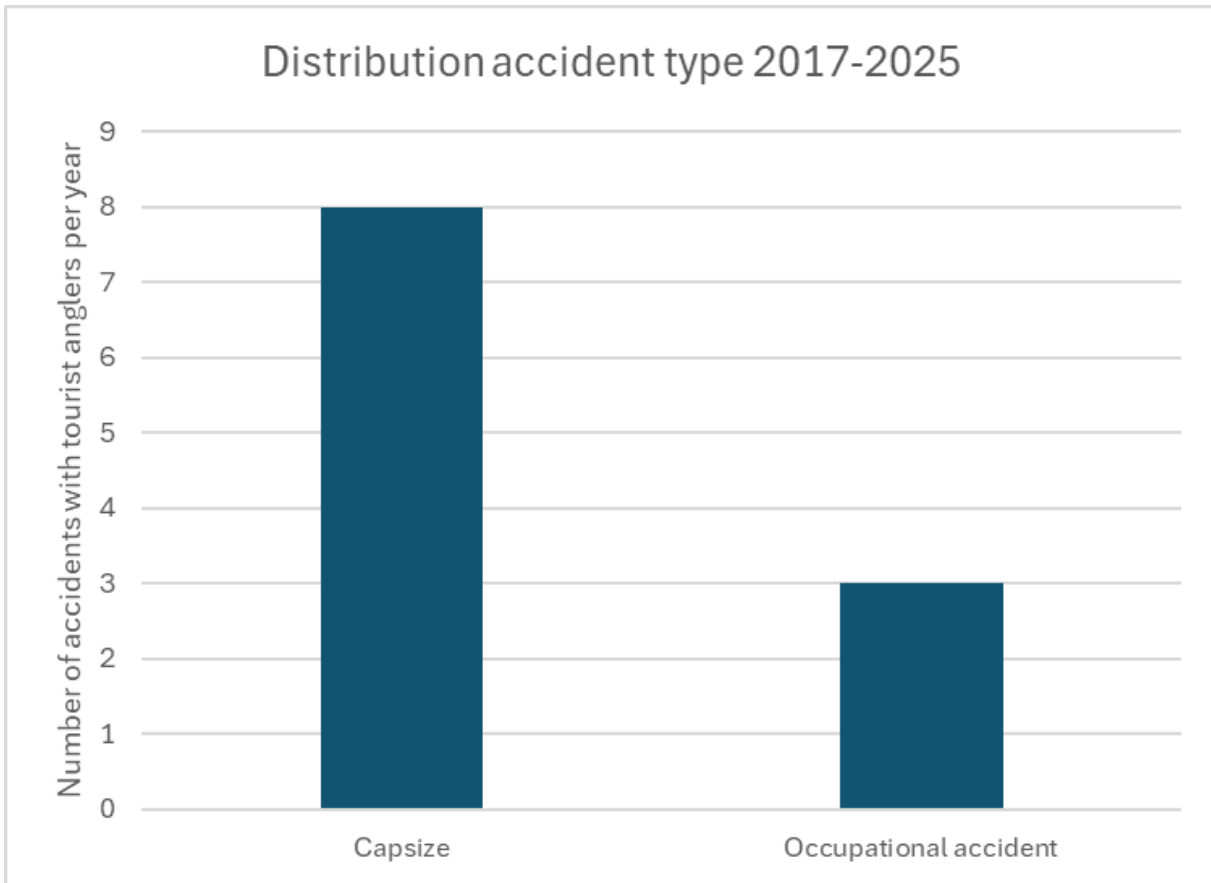
Figure 13: Overview of accidents by type. Source: Norwegian Maritime Authority. Graph: NSIA

The information showed that capsizing accidents dominate the statistics (see Figure 13). The three accidents that were categorised as occupational accidents were man-overboard incidents.

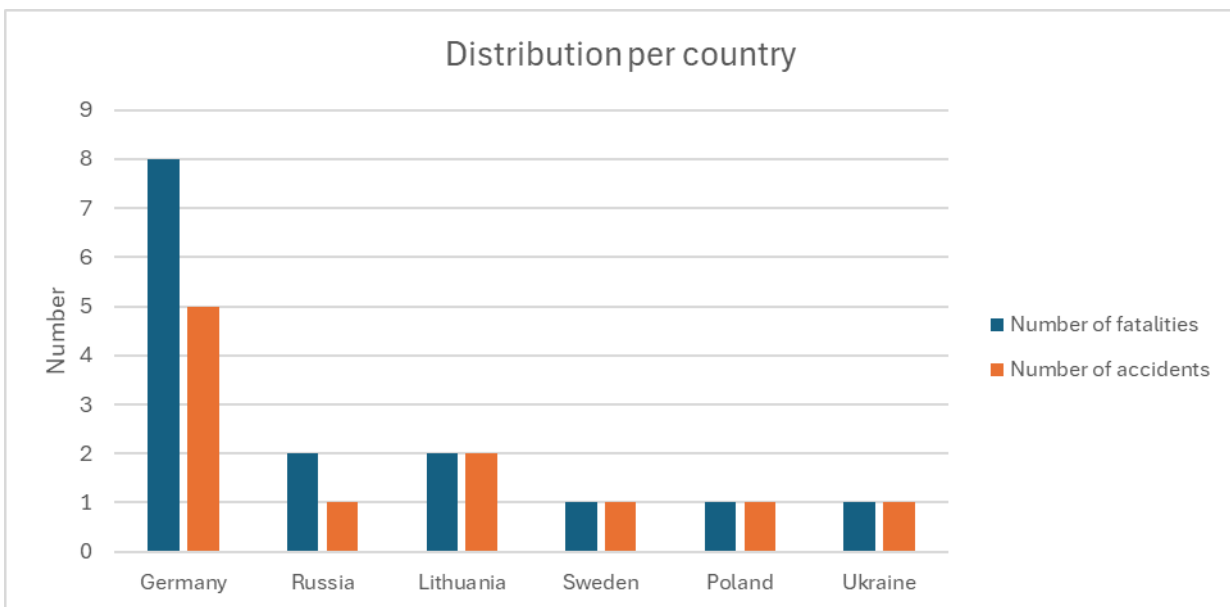
Figure 14: Number of tourist angler fatalities by citizenship in the period 2017–2025. Source: Norwegian Maritime Authority. Graph: NSIA

The information also showed that all the tourist anglers who perished during this period were foreign nationals (see Figure 14).
