# REPORT

JB 2013/02

## REPORT ON DERAILMENT NEAR NYKIRKE STATION, THE VESTFOLD LINE, ON 15 FEBRUARY 2012, TRAIN 12926

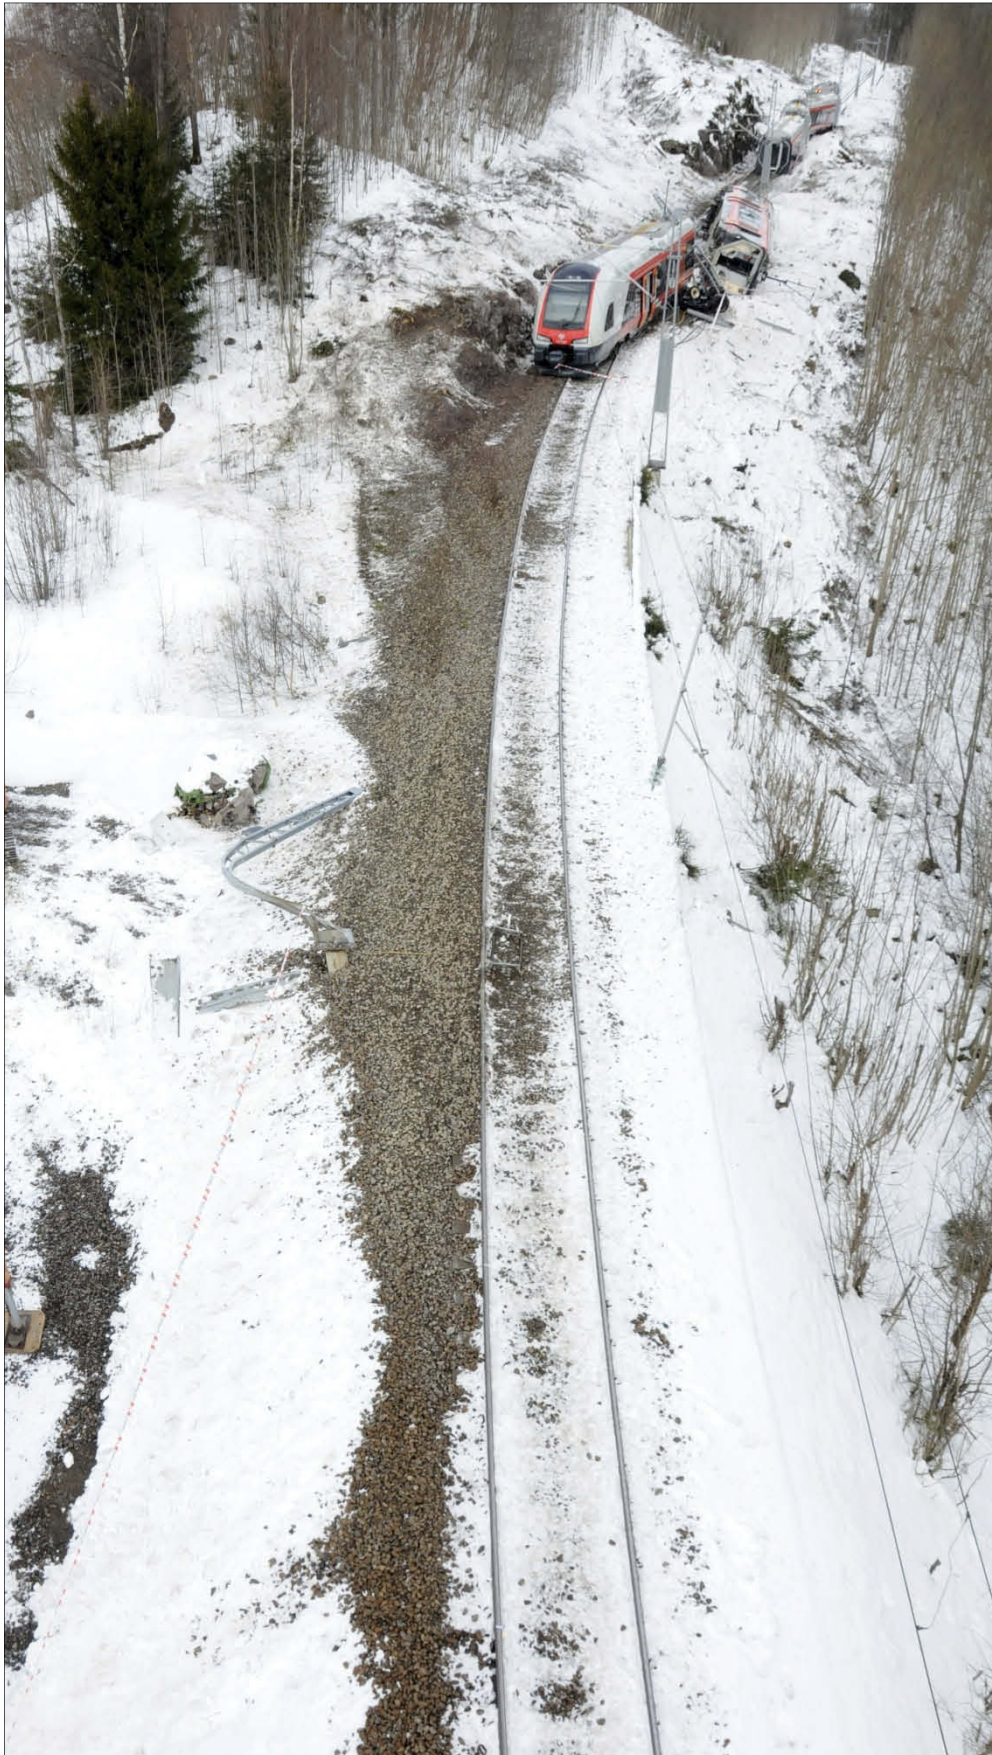
Figure 10: The scene of the accident (photo: the police).

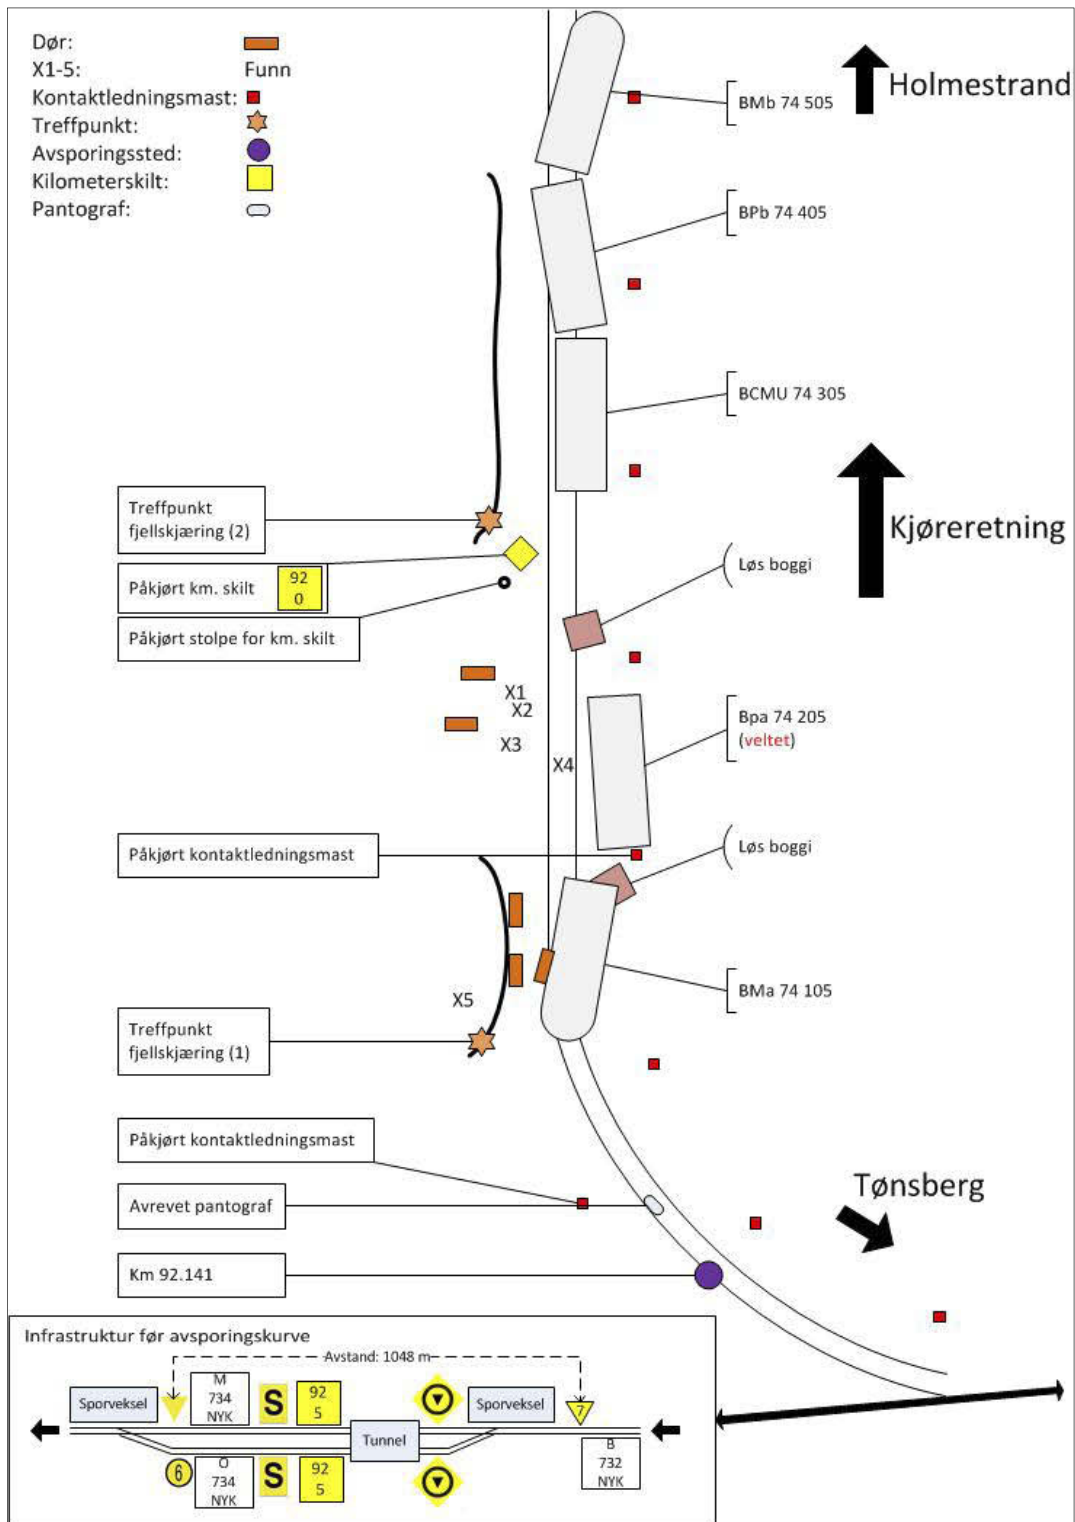
Figure 11: Diagram of the scene of the accident.

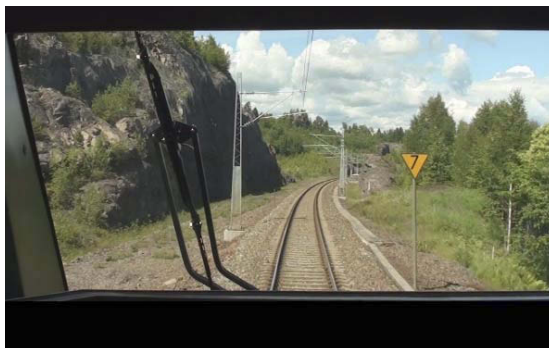
During the inspection on 6 June 2012, the section was filmed from the driver's perspective. Figure 18 and Figure 19 shows the speed signal that was overlooked and the speed reduction marker at the site.

Figure 18: The speed signal for 70 km/h (photo: the AIBN).

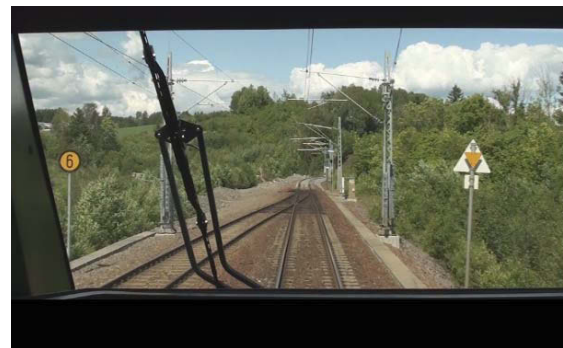
Figure 19: Speed reduction marker (photo: the AIBN).

The marker from which the speed reduction applies was correctly located, but is not intended to be sufficient to warn the driver to brake if braking has not already been initiated.

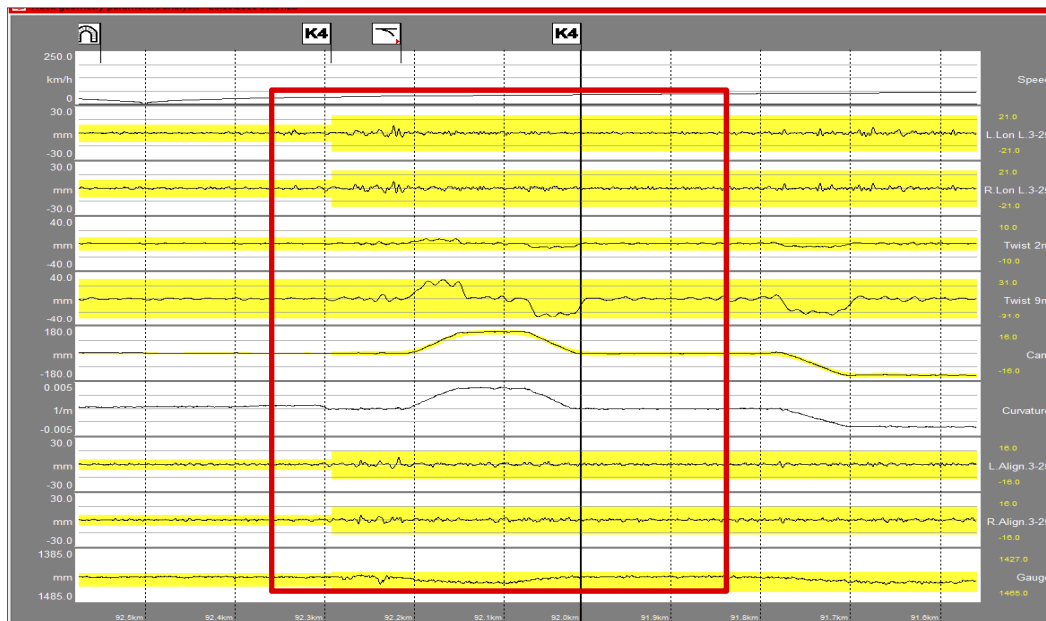
The investigation has not uncovered any technical faults or defects in the track or substructure that are deemed to have had a bearing on the accident. The NNRA's track geometry car carried out line measurements of the site on 26 October 2011, and these measurements found no defects at the derailment site (see Figure 20). The area highlighted in yellow represents the requirements. No places fail to meet the requirements. The area outlined in red covers the derailment track, and goes from kilometre point 91.830 to kilometre point 92.350.

Figure 20: Rail diagram from the analysis tool used for measurements by the track geometry car (source: the NNRA).

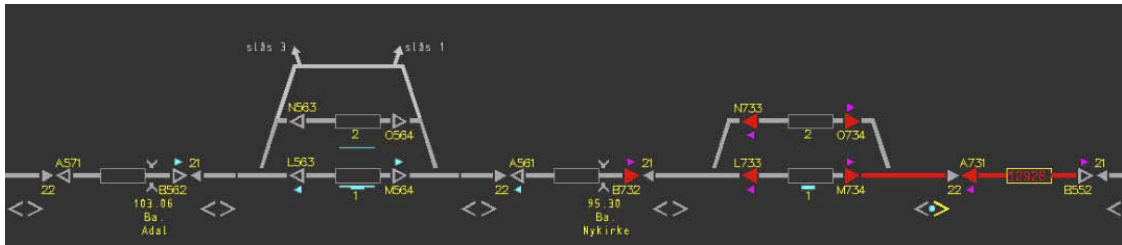
Figure 22: Shows the indication in the traffic control centre after the derailed train had cut the cables (source: the NNRA).

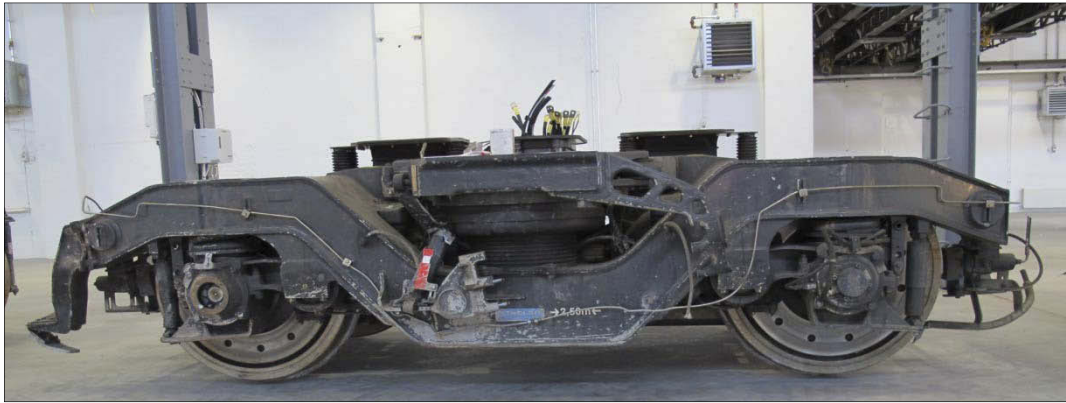
Figure 23: Leading bogie (photo: the AIBN).

The inspection was carried out without dismantling components. The condition of the bogies were documented by photos, and any damage observed was recorded. A decision was made to measure the wheel profiles of the wheels in the bogie denominated MB7 (first bogie in the direction the train was travelling). A visual assessment of the wheel profiles of the other bogies during the inspections on 23 and 24 April concluded that they did not deviate significantly from the profiles of MB7.

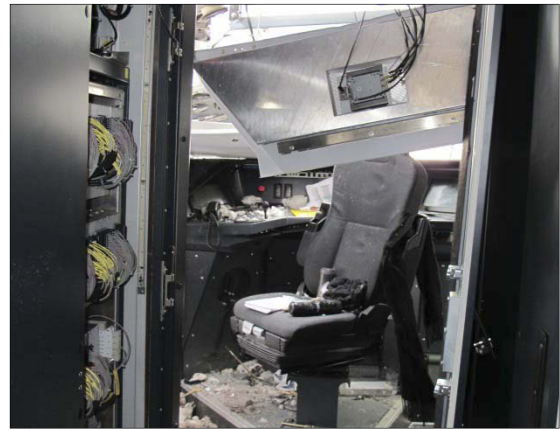
The photos below illustrate how much damage was done to the driver's cab in the incident.

Figure 28: The driver's cab after the incident (photo: the AIBN).

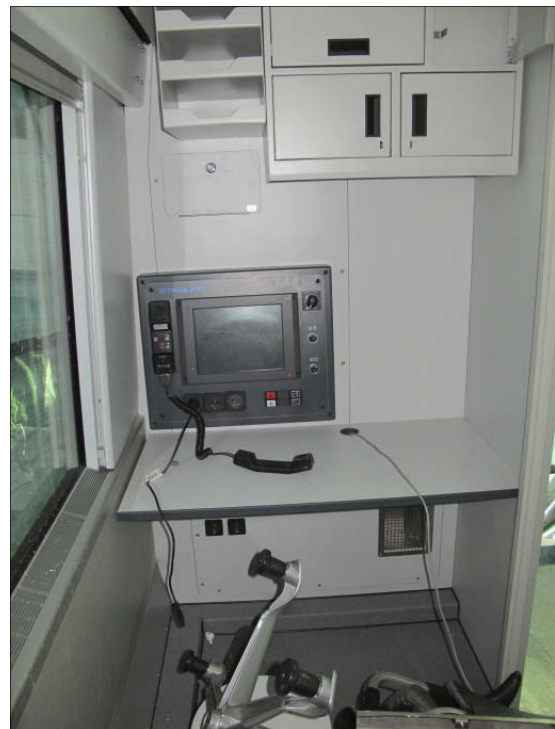
Figure 30: The room where the Stadler representative was (photo: the AIB).

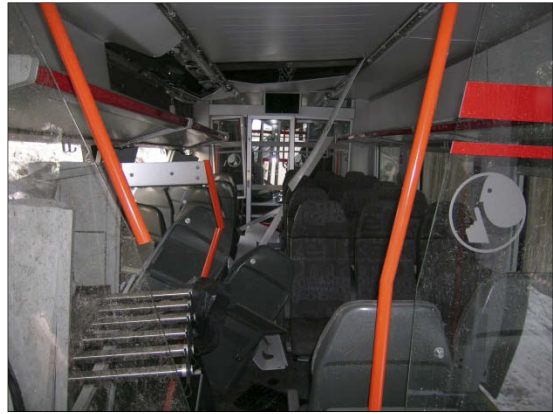
There was extensive damage to the side of compartments and passenger areas closest to the cliff. Also, some fixtures and fittings came loose from ceilings as well as from technical cabinets. As is known, there were no passengers or luggage in the train. Had there been, the situation would have been considerably worse.

Figure 32: Compartment after the incident (photo: the AIBN).

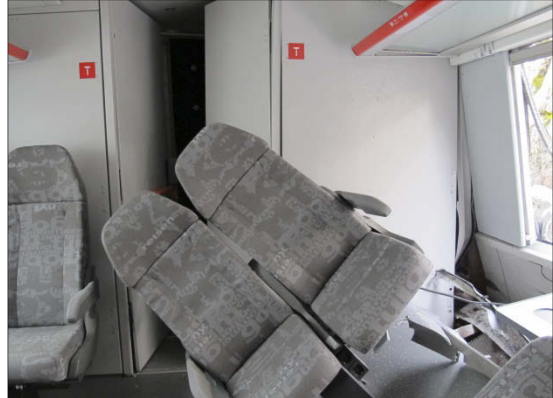
Figure 34: Compartment after the incident (photo: the AIBN).

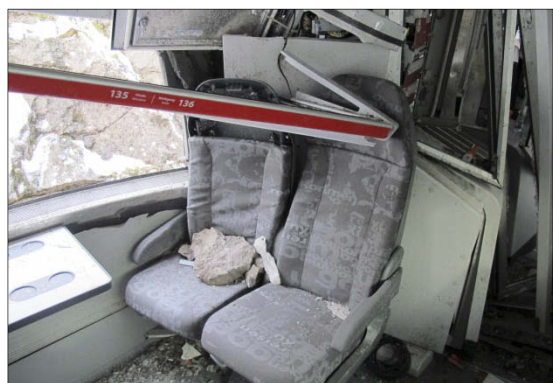
Figure 36: Compartment after the incident (photo: the AIBN).

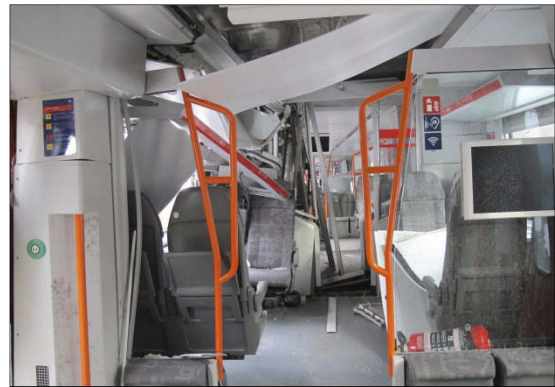
Figure 38: Compartment after the incident (photo: the AIBN).

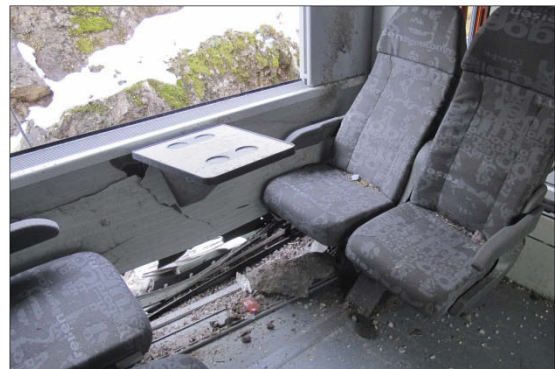
Figure 40: Compartment after the incident (photo: the AIBN).

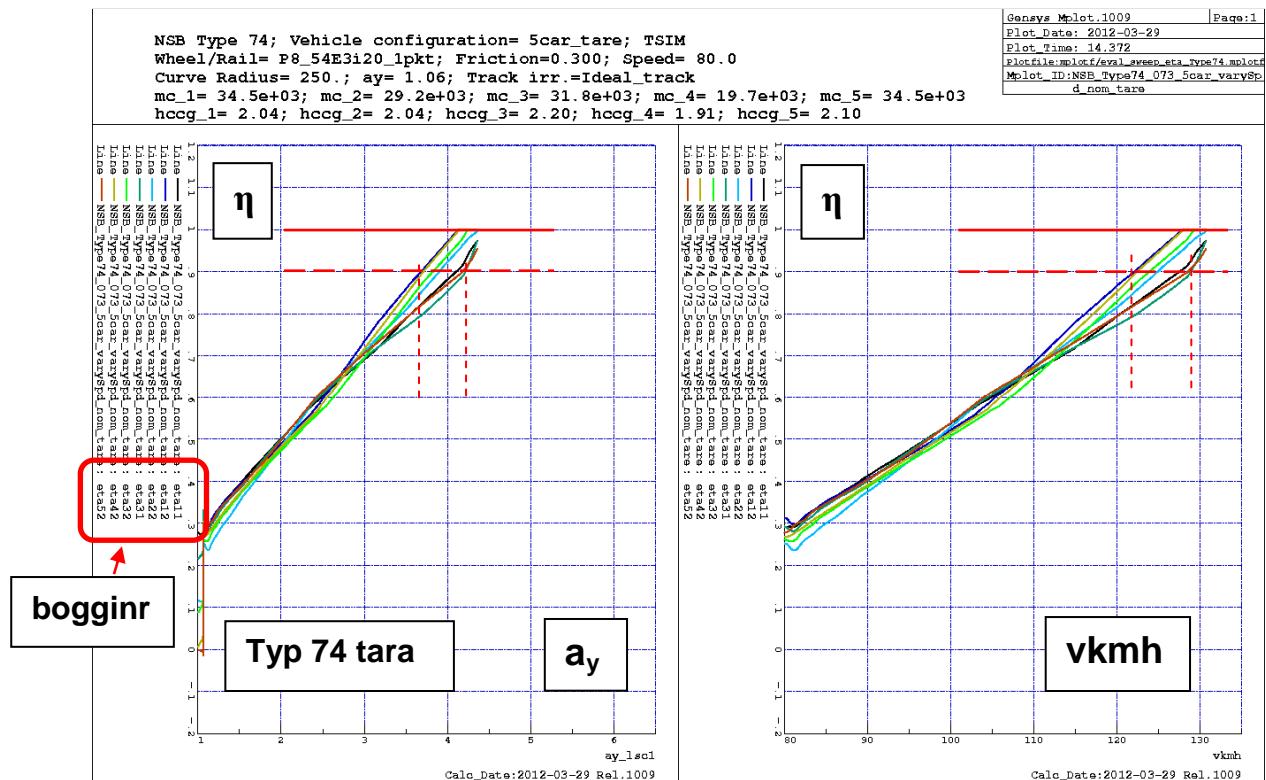
Resultaten sammanfattas från diagrammen genom att ge spannet mellan spårplansaccelerationen då den sämsta och den bästa boggin når  $\eta$ -värdet 0.9 motsvarande 90 % avlastning redovisas. Dessa värden är indikerade med lodräta streck i Figur 6.

Figur 6. Diagram av  $\eta$  per boggi som funktion av spårplansacceleration (vänster diagram) och hastighet (höger diagram) för typ 74, tara. Gränsvärdet  $\eta=1.0$ , d.v.s. total hjulavlastning, samt  $\eta=0.9$ , vilket har använts i de redovisade tabellerna, är inritade i diagrammen. De vertikala strecken visar spannet mellan sämsta och bästa boggi vid  $\eta=0.9$ .

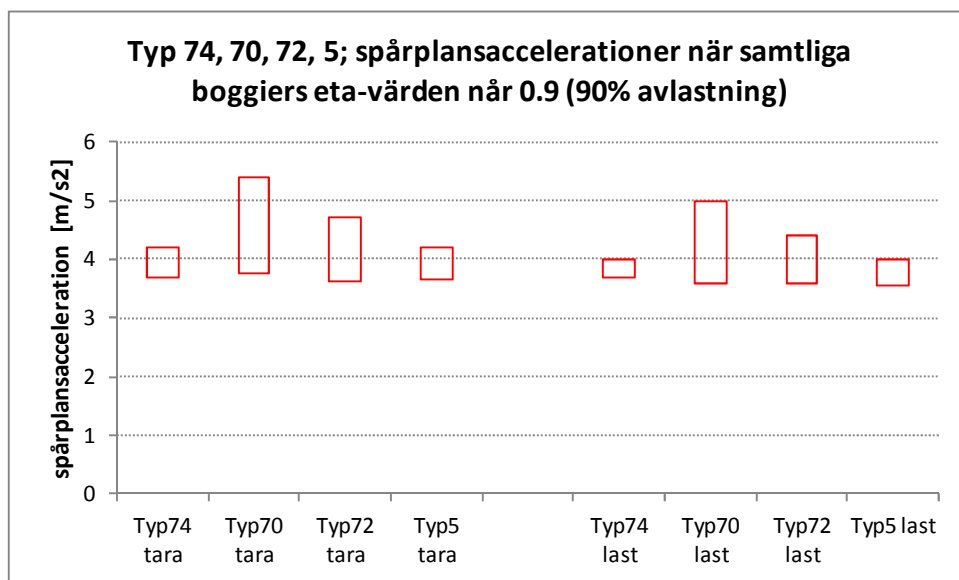
Figur 7. Översiktligt diagram av spårplansaccelerationen då  $\eta = 0.9$  för de studerade fordonstyperna.

Som framgår av figuren skiljer sig inte de sämsta värdena för de olika fordonstyperna nämnvärt. En förklaring är att man vid dessa höga sidoaccelerationer ligger i hård kontakt med både lateral- och vertikalstoppen hos vagnskorgarna, vilket är det som begränsar rörelsen. Individuella skillnader i löpverken har därför mindre betydelse. Att de bästa värdena för typ 70 och 72 blir högre än för de andra fordonstyperna beror till stor del på den förhållandevis låga tyngdpunkten i ändvagnarna för dessa fordon.

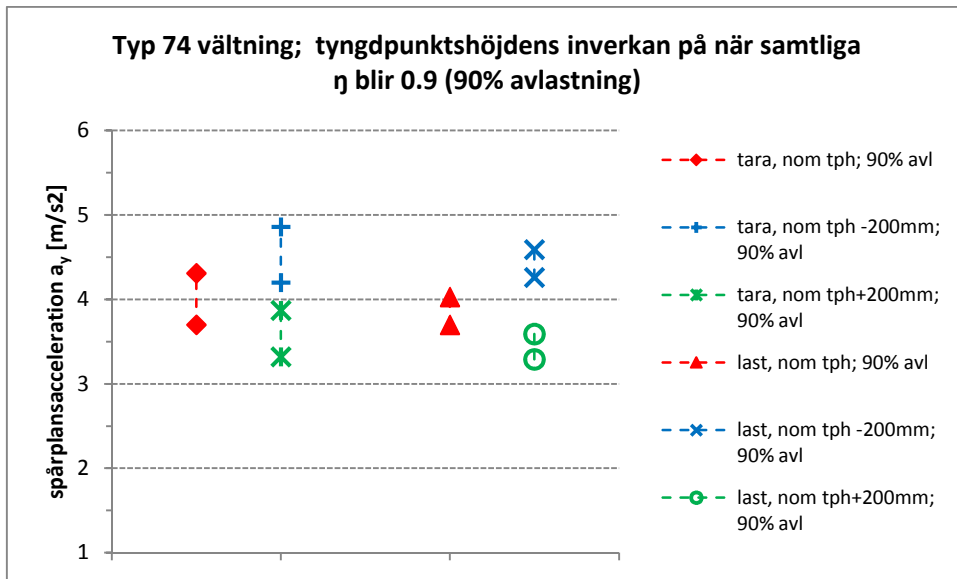
I Figur 8 visas spannen i spårplansacceleration [ $\text{m/s}^2$ ] för  $\eta = 0.9$ , dels för den nominella tyngpunktshöjden och dels för en ökning respektive minskning med  $200\text{ mm}$ . Värdena avser typ 74 tara och lastad.

Figur 8. Inverkan av tyngdpunktens höjd på spårplansaccelerationen för  $\eta = 0.9$  för typ 74.

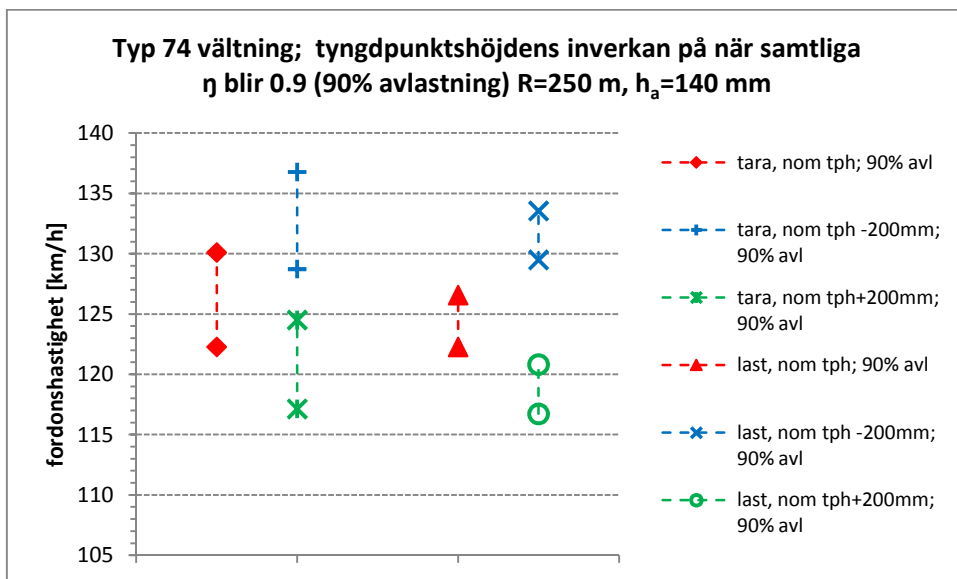
Figur 9. Motsvarande diagram som Figur 8, men uttryckt i fordonshastighet för en kurva med kurvradie 250 m och rälsförhöjning 140 mm.

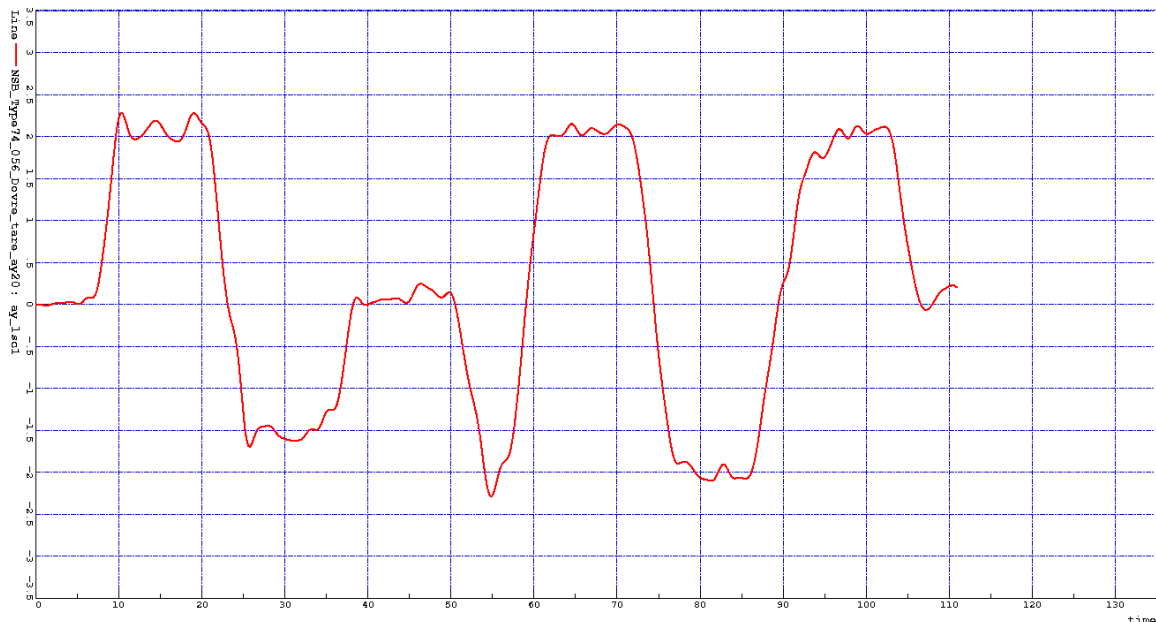
Hastigheterna är anpassade så att spårplansaccelerationerna i de undersökta kurvorna motsvarar värdena ovan. Eftersom den aktuella geometrin varierar mellan kurvorna kommer också den verkliga accelerationen att variera, se Figur 10. Men accelerationen 2.0 m/s<sup>2</sup> i det aktuella fallet stämmer ändå rätt bra i fem av kurvorna. Det är bara i dessa fem kurvor från avsnitt 2 och motsvarande fyra kurvor från avsnitt 1 som bedöms med avseende på dynamiken.

Figur 10. Aktuell spårplansacceleration, med riktvärdet 2 m/s<sup>2</sup>, i hastigheten 98 km/h på banavsnitt 2.

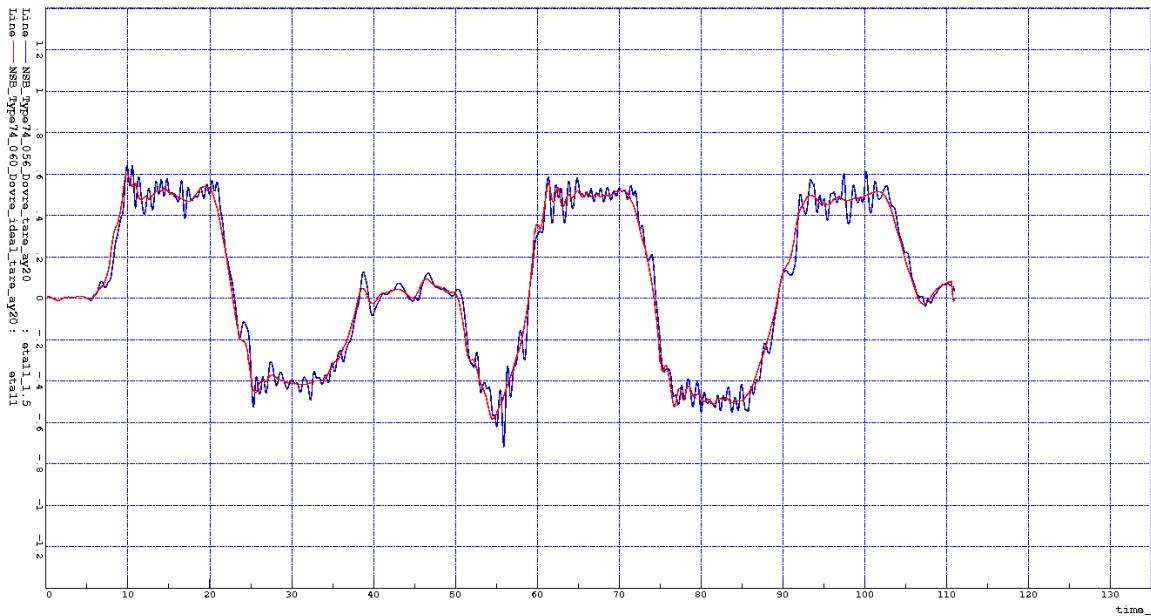
Figur 11. Dynamiskt  $\eta$  för typ 74, boggi 11, med spårplansaccelerationen  $2 \text{ m/s}^2$  på banavsnitt 2 (Dovrebanan). Röd kurva avser simulering i idealt spår och blå kurva simulering med verkligt spåräge.

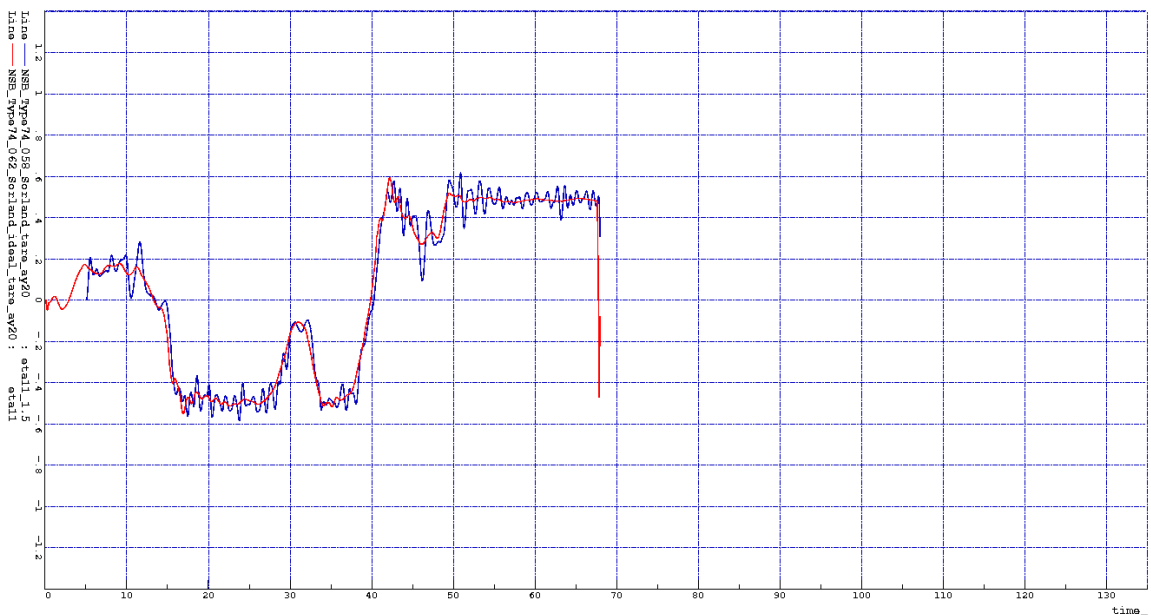
Figur 12. Dynamiskt  $\eta$  för typ 74, boggi 11, med spårplansaccelerationen  $2 \text{ m/s}^2$  på banavsnitt 2 (Sörlandsbanan). Röd kurva avser simulering i idealt spår och blå kurva simulering med verkligt spåräge.

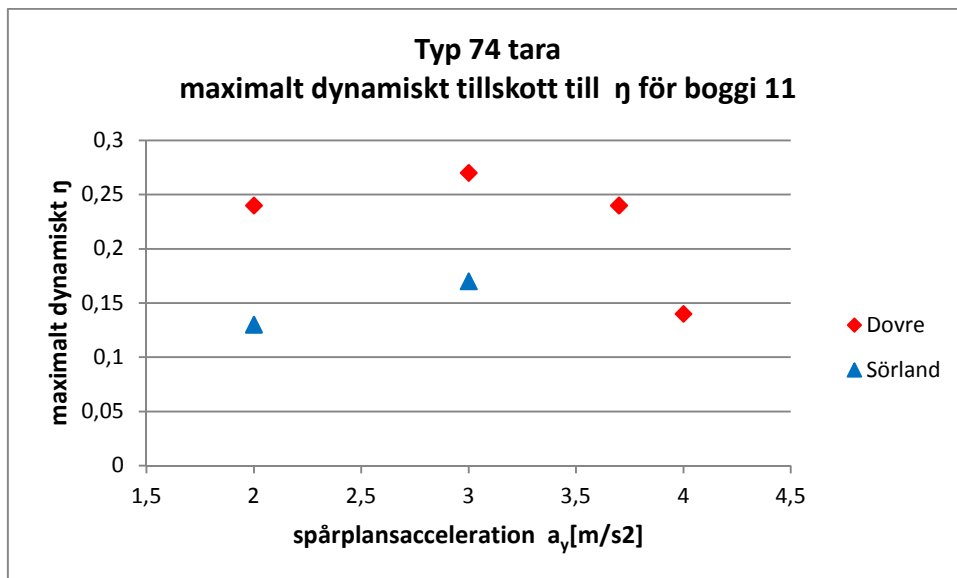
Figur 13. Maximalt dynamiskt  $\eta$  för boggi 11 i de studerade kurvorna.

Som synes minskar det dynamiska  $\eta$  för de extrema spårplansaccelerationerna. Detta beror dels på att de mekaniska stoppen kommer i ingrepp i ökad grad och dels på, för 4 m/s<sup>2</sup> fallet, att innerhjulen på den aktuella boggin redan är fullt avlastade momentant, d.v.s.  $\eta = 1$  är en fysikalisk gräns. Det krävs dock uppenbarligen ytterligare hastighetsökning innan vältning inträffar.

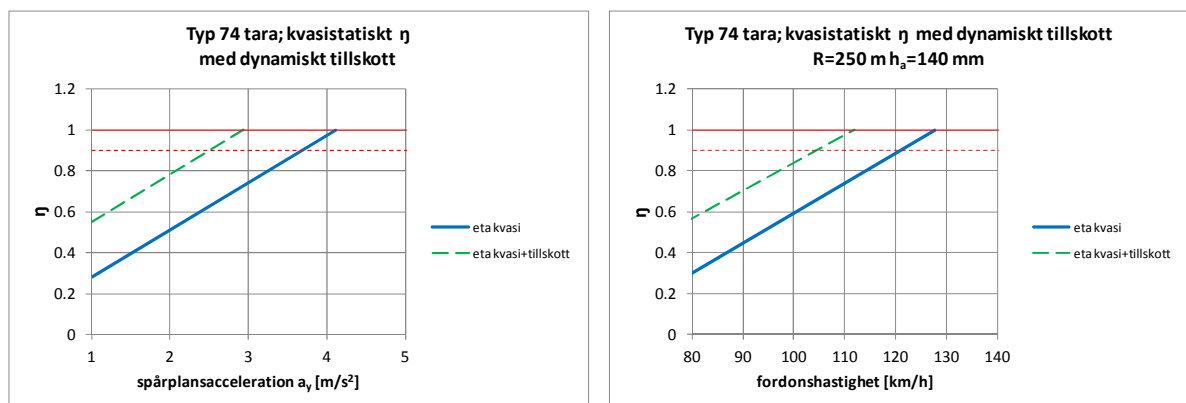
En illustration av effekten av att addera ett dynamiskt tillskott till det kvasistatiska  $\eta$  visas i Figur 14. I dessa diagram har det maximala dynamiska tillskottet för boggi 11, se Figur 13, adderats till det kvasistatiska  $\eta$  för den sämsta boggin enligt Figur 6. Observera att de simuleringar som är gjorda pekar på att det kan finnas en betydande konservatism i att göra på detta sätt. Värdet  $\eta=0.9$  uppnås vid spårplansaccelerationen 2.6 m/s<sup>2</sup>, medan vältning i simuleringarna på detta spåravsnitt skedde mellan 4.0 och 4.2 m/s<sup>2</sup>.

Figur 14. Illustration av effekten av att addera ett dynamiskt tillskott till det kvasistatiska  $\eta$ . Typ 74 tara, med det största dynamiska  $\eta$  från Figur 13.
