Issued December 2022

# REPORT RAIL 2022/08

***Faulty interlocking system at Jar metro station on the Kolsås line, 27 November 2021***

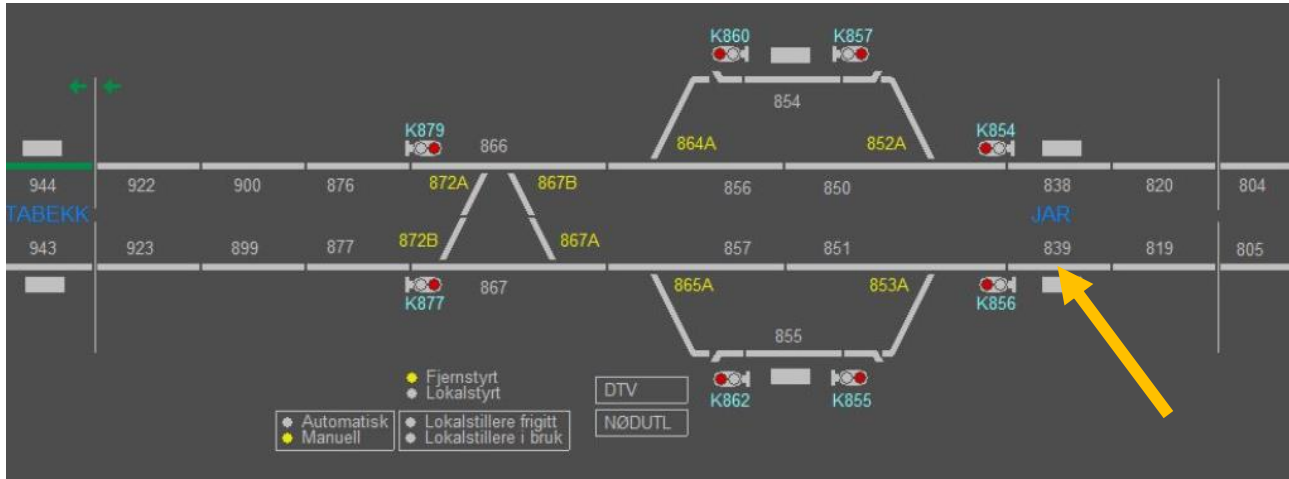
At 07:56 on Saturday 27 November 2021, Sporveien T-banen AS's traffic controller observed that train no 1316, an SL95 type tram, was presented in the traffic control system as being 'Lost at track'. The traffic controller completed the established troubleshooting procedures, and received confirmation that the subsequent train no 303, an MX metro train, was also presented as not occupying the track section. Track circuit 839 covers the track section along the platform for incoming metro trains at Jar station (Figure 1).

Figure 1: Schematic track diagram showing track sections at Jar station (the relevant track section is marked). Source: Sporveien T-banen AS

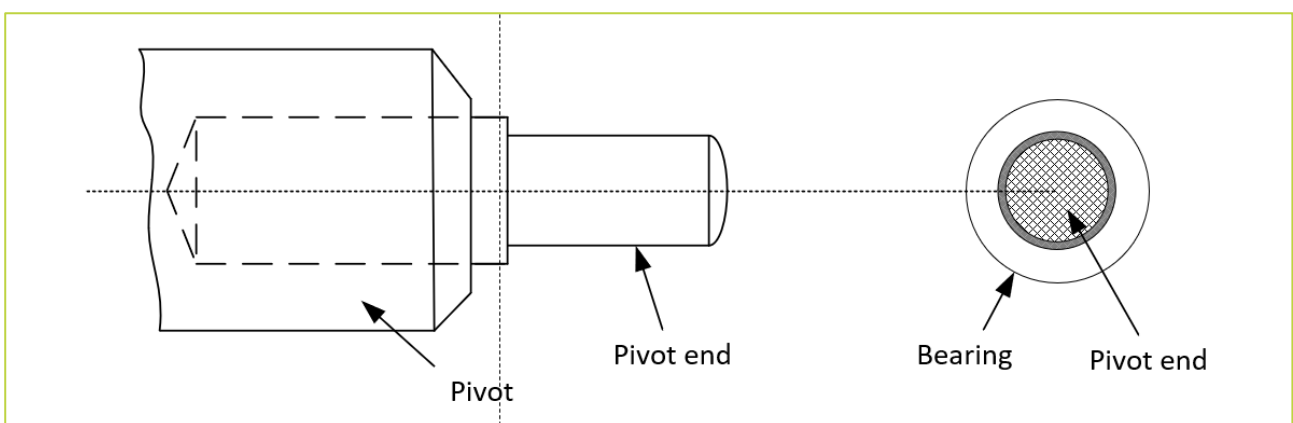
Figure 3: Schematic drawing of pivot and bearing. Illustration: NSIA

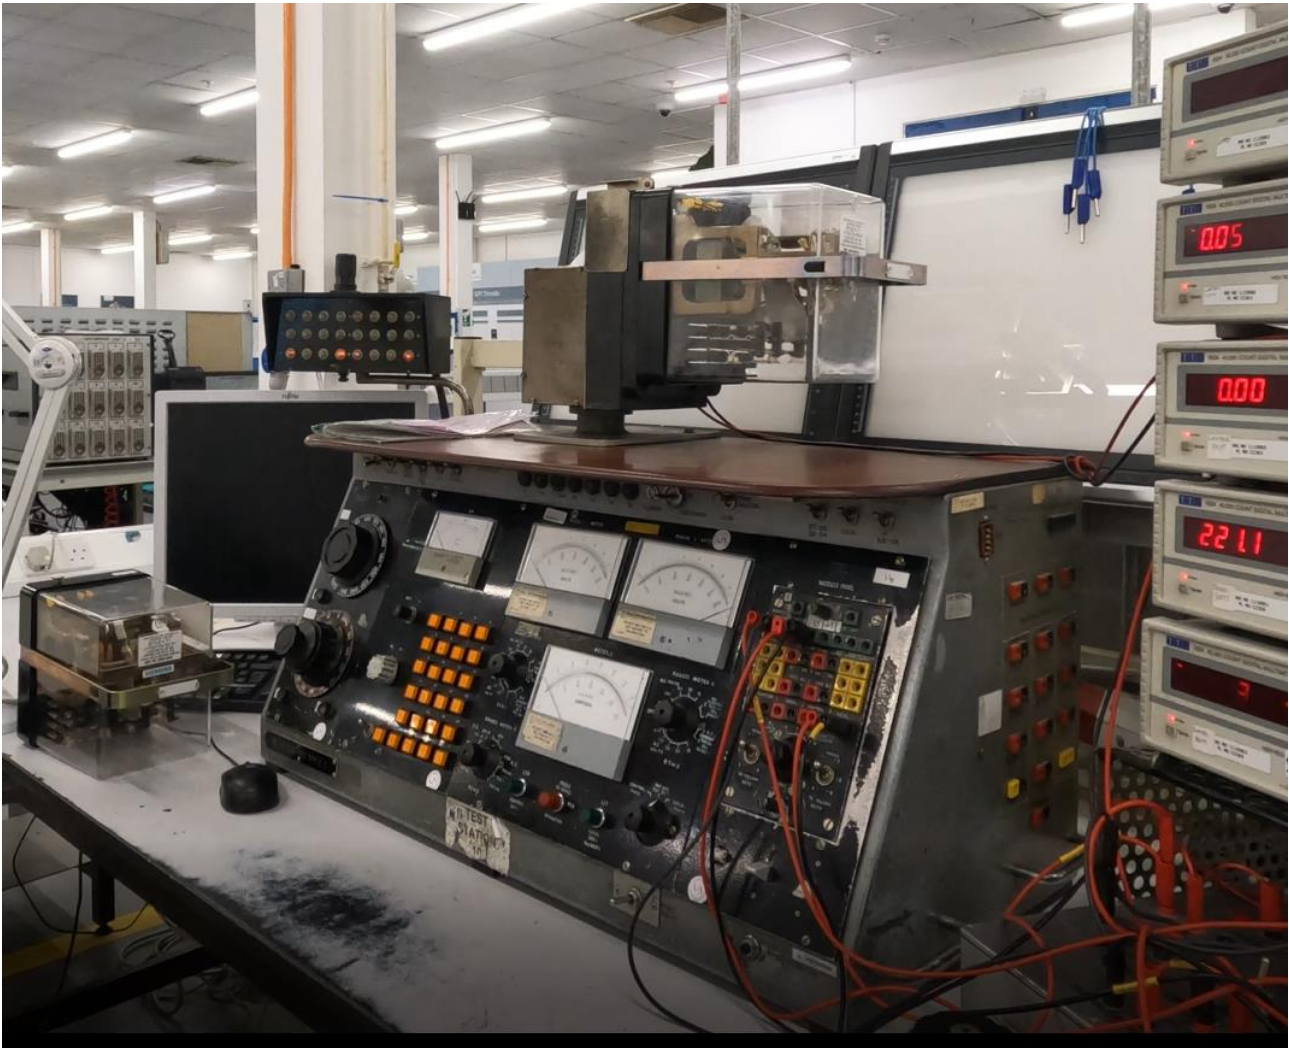
Figure 4: Comparable relay mounted on top of test bench. The relay involved in the incident can be seen on the left-hand side of the worktop. Photo: NSIA

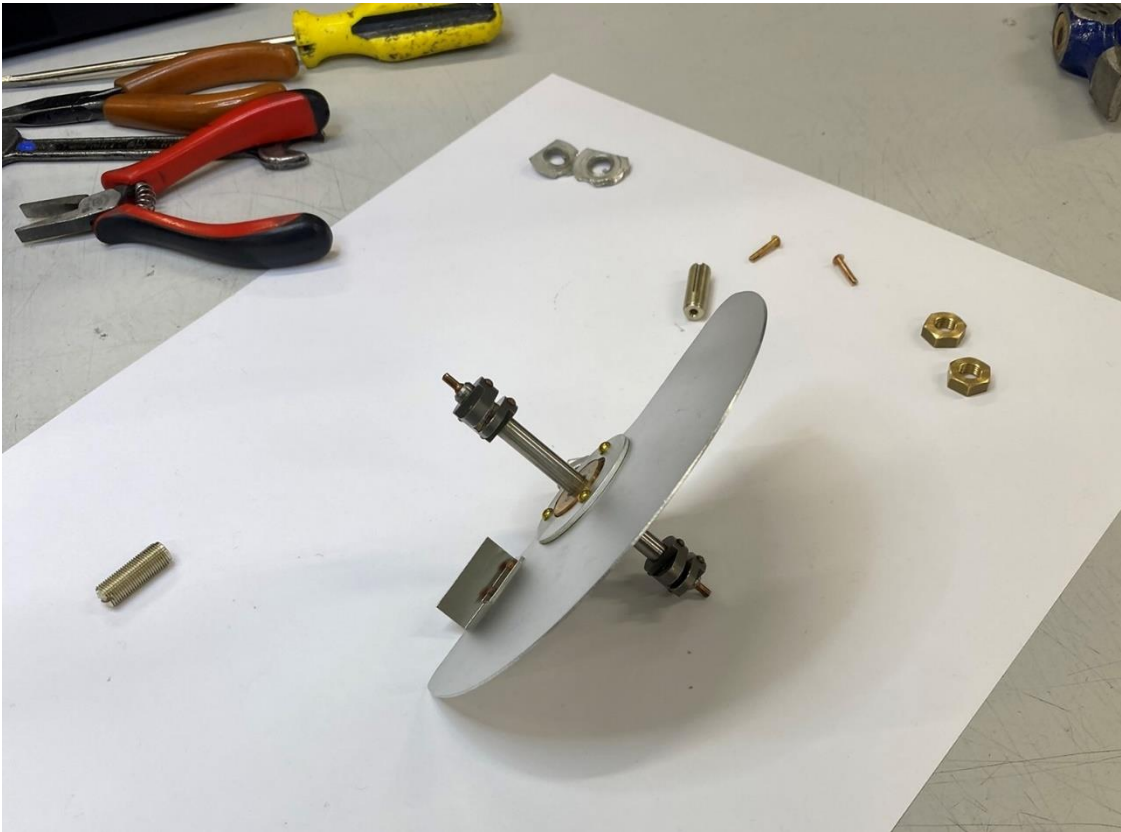
The NSIA has been unable to come to a definitive conclusion as to why the relay did not open when the track circuit was short-circuited by the vehicles, but it is likely that vane rotation was prevented by small metal fragments found in the bearings of the relay's vane.

1. When the relay was checked in relation to the specifications for final testing and inspection, the vane was found to have been displaced laterally by 1/1,000 inch.
2. When the relay was disassembled, particles were found inside the vane bearings (Figure 6, Figure 8).

Figure 7: Vane. Photo: NSIA
