REPORT

ROAD 2016/03

REPORT ON COACH FIRE IN THE GUDVANGA TUNNEL ON THE E16 ROAD IN AURLAND ON 11 AUGUST 2015

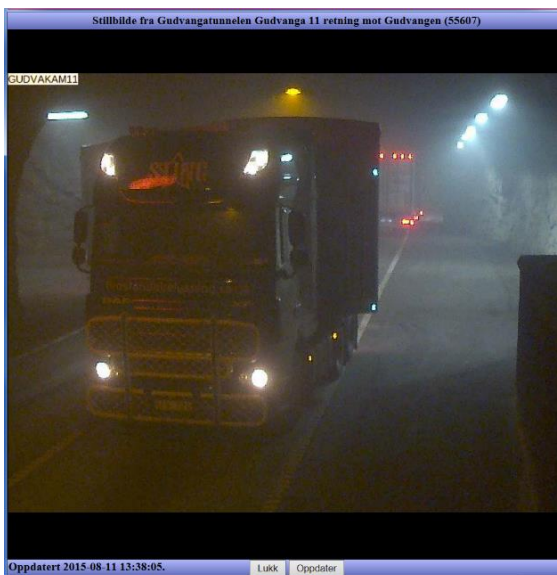
The coach driver managed to proceed 300 m into the tunnel from the scene of the fire before the smoke reached him. The coach driver sought refuge in a heavy goods vehicle that was parked in the direction of Flåm and remained there together with the driver. Figure 2 and Figure 3 show visibility inside the tunnel at a distance of 3.5 km from the Flåm exit at 13:38 and 13:39, respectively.

Figure 2: At 13:38, the heavy goods vehicle turned around after travelling 3.5 km into the tunnel towards Gudvanga. Photo by NPRA

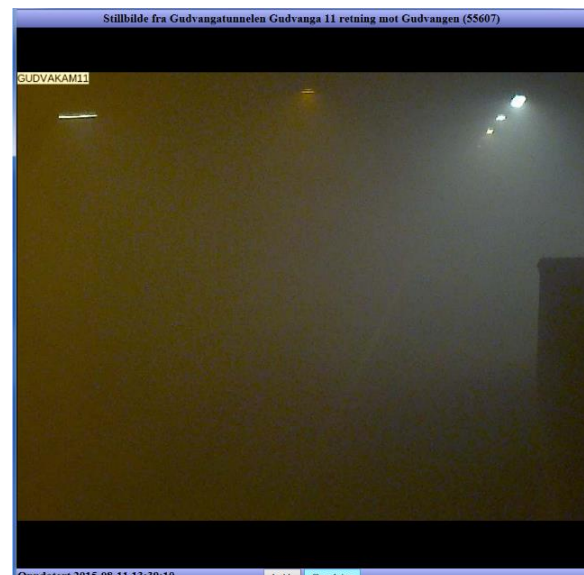
Figure 3: Visibility in this location became very poor at 13:39. Photo by NPRA

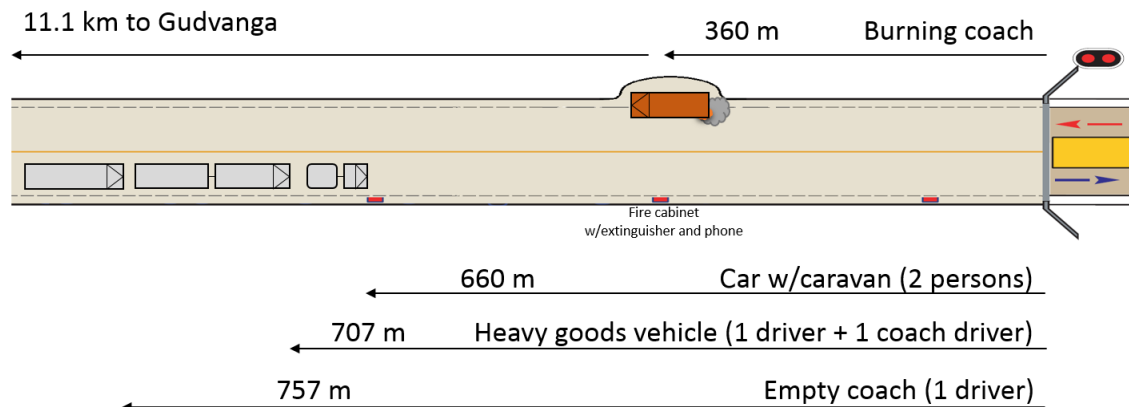
the smoke approximately 700 m from the exit on the Flåm side of the 11.4-km-long tunnel. See Figure 4.

Figure 4: Overview showing the position of vehicles and road users trapped in the smoke.
Source: The police/AIBN

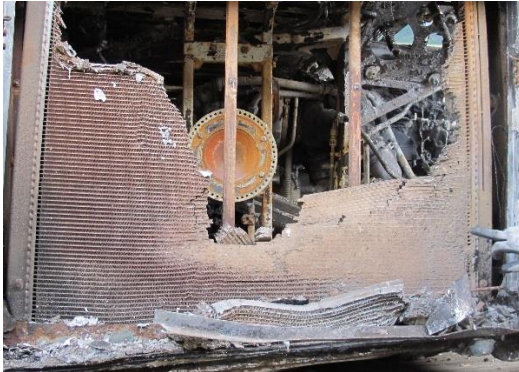
Figure 9: Radiator and fan pump (behind the round disc). Photo: AIBN

The radiator was partially burnt out and soiled. The AIBN took samples of the deposited material, which consisted mainly of mineral and salt particles. This suggests that there may have been deposits in parts of the radiator before the fire occurred. This may have affected the cooling performance of the engine's radiator, which is an important component in the cooling system.

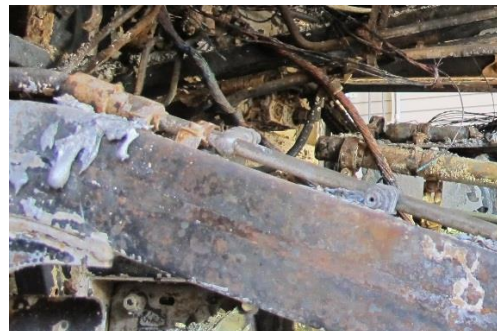
Figure 12: Nozzles from the fire extinguishing system located at the back of the engine compartment. Photo: AIBN

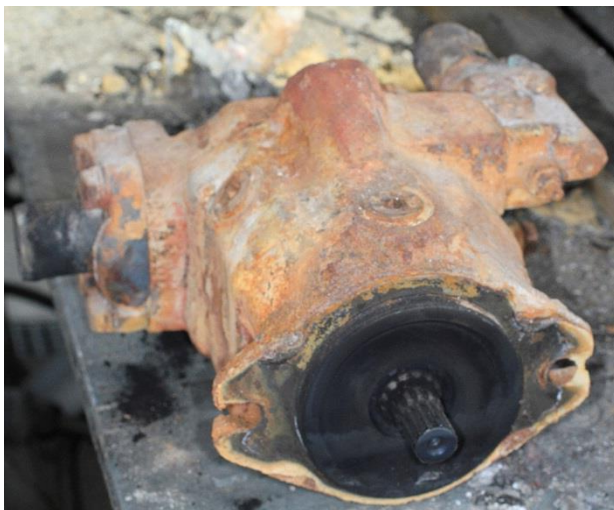
Figure 20: Disconnected hydraulic pump. Photo: AIBN

No damage was found on the pump to suggest internal pump failure, but the drive shaft splines were completely worn down. This may have caused the pump to stop working at some point while the engine was running for the last time.

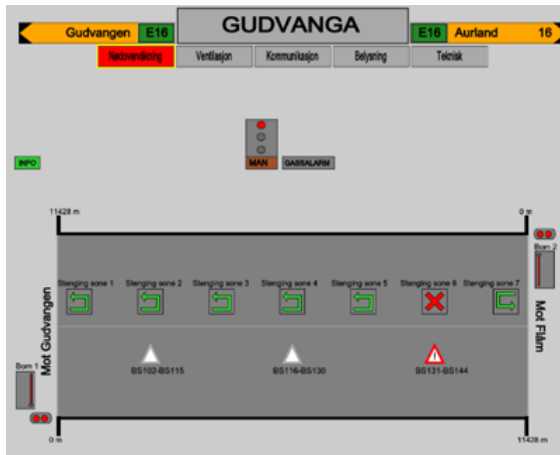
Figure 22: Screenshot from the VTS's monitor showing the entire Gudvanga tunnel on 11 August 2015. The U-turn symbol marks the position of the sign bearing the text 'Snu og kjør ut/Turn and exit'. Zone 6 should also have been closed to traffic from Gudvangen. Photo: NPRA

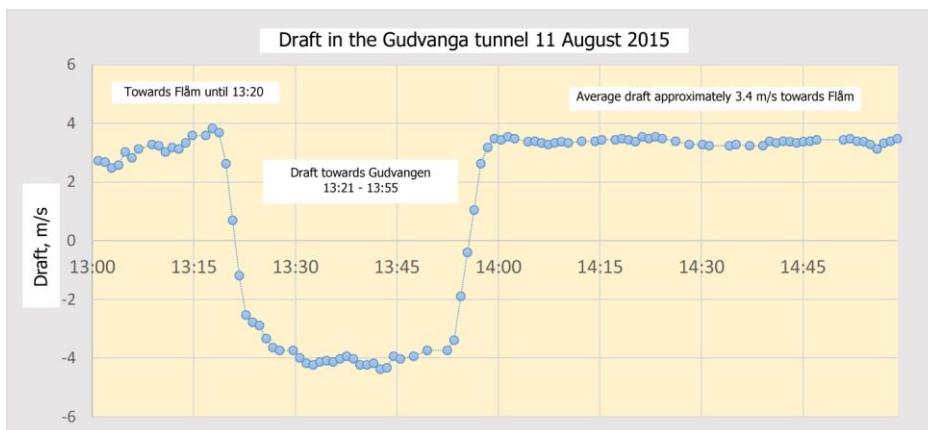
Automatic increases in the ventilation rate level were observed at 13:21 and 13:30. At 13:53, the VTS operator manually changed the direction of ventilation at the request of the fire service. On both occasions when the direction of ventilation was changed, the system responded quickly. The set direction and rate of ventilation were achieved in the course of approximately three minutes (see Figure 24).

Figure 24: Direction and rate of ventilation in the Gudvanga tunnel on 11 August 2015. Source: NPRA
