# REPORT

## Road 2016/04

## SPECIAL REPORT II ON SAFETY-CRITICAL FACTORS RELATING TO HOOKLIFT CONTAINER TRANSPORT

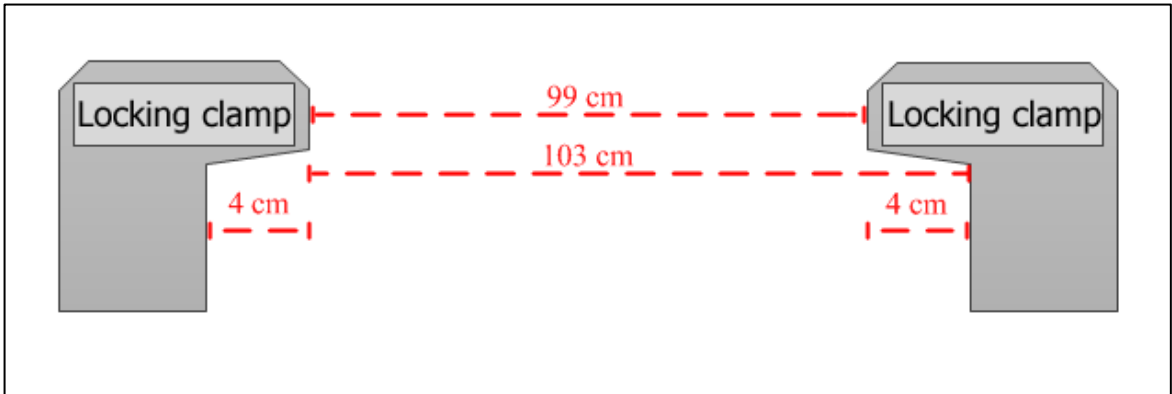
The clamps are designed to lock the hooklift container to the truck by holding down the container's bottom side rails during transport. When the AIBN examined the truck after the accident, measurements were taken of the locking system. The measurements are reproduced in figure 8 and show a total distance of 103 cm (99 cm + 4 cm) from the tip of the clamp one side to the neck of the clamp on the opposite side.

Figure 8: Locking clamps and relevant measurements. Illustration: AIBN

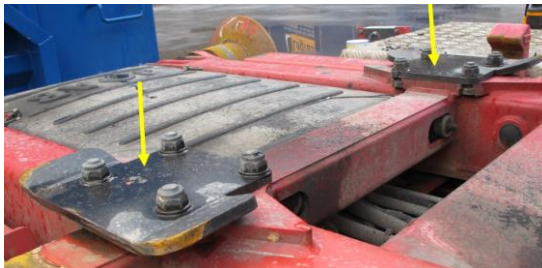
*Figure 13: Retrofitted plates (black in colour, indicated by the yellow arrows) for mechanical locking of the container to the truck from the inside. The photo shows the plates installed as part of a JOAB hooklift system. Photo: AIBN*

Following the accident, the transport company has installed additional equipment on its hooklift containers for the purpose of improving safety. The trucks have been equipped with an inside mechanical locking mechanism for the container in addition to the outside factory-installed locking mechanism. This is a relatively simple mechanism consisting of a steel plate and four bolts on the inside of the hydraulic locks, see Figure 13 and Figure 14.

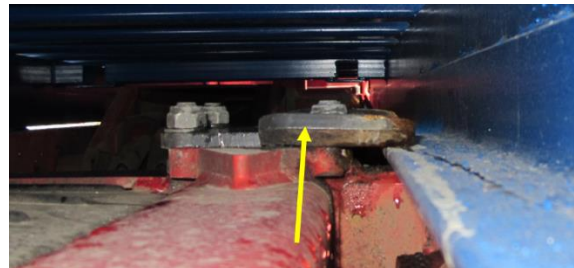
*Figure 14: The plates (black/grey/brown, indicated by the yellow arrow) lock the hooklift container (blue) to the hooklift system (red) and the truck. Photo: AIBN*

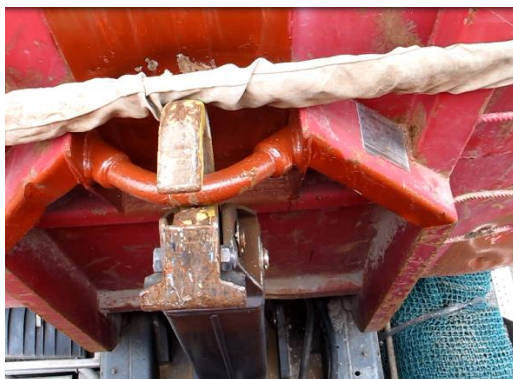
Figure 17: Hooklift arm and lift bar on container without lateral load. Photo: AIBN

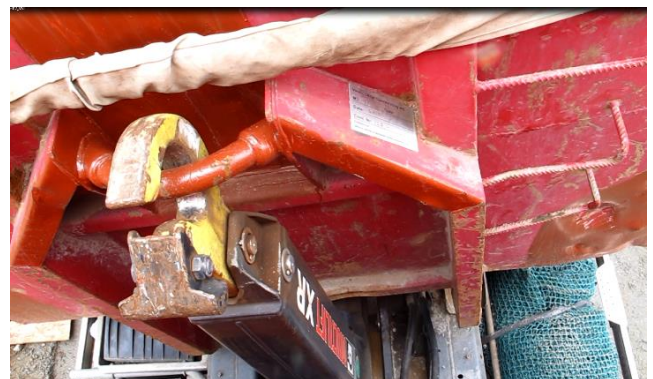
Figure 18: Hooklift arm and lift bar on container exposed to a lateral load of approximately 0.5 G. Photo: AIBN

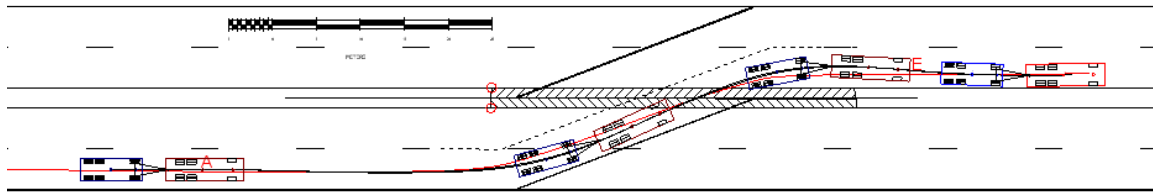
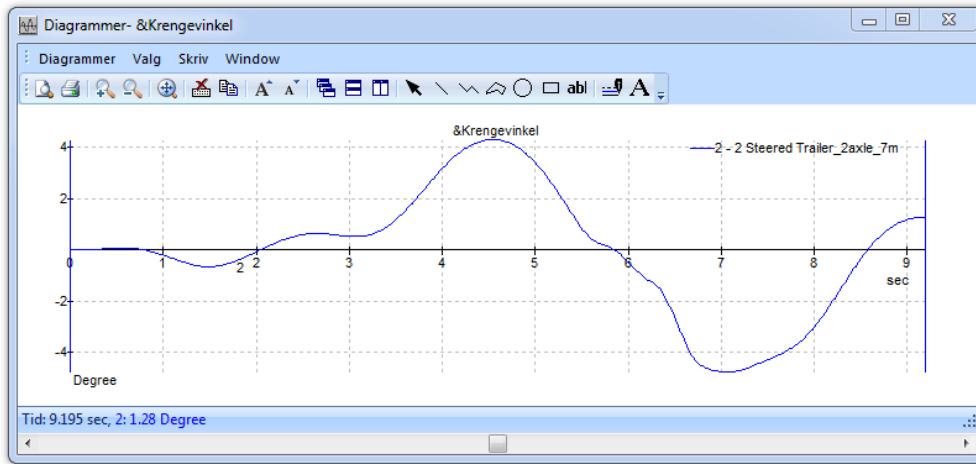
**Illustration 1:** Shows the start and end position for the simulation. The diagram shows the development of the trailer’s tilt angle. The positions for maximum tilt angle to either side are drawn in.

The simulations show a maximum tilt angle of 4.75 degrees in the right curve before the vehicle combination is brought to the upright position, a maximum lateral acceleration of  $3.6 \text{ m/s}^2$  in the same place and that the vertical forces acting on the right wheels are low in the same area.

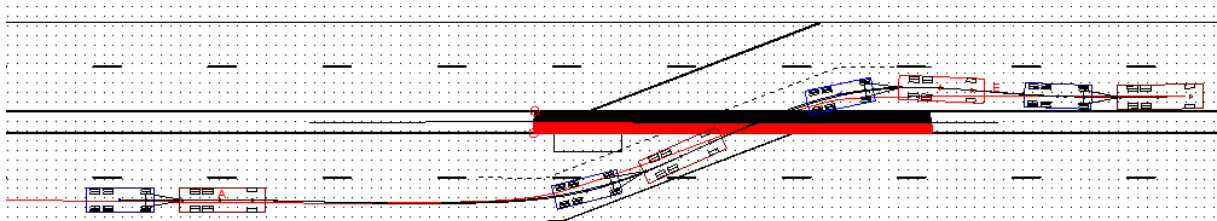
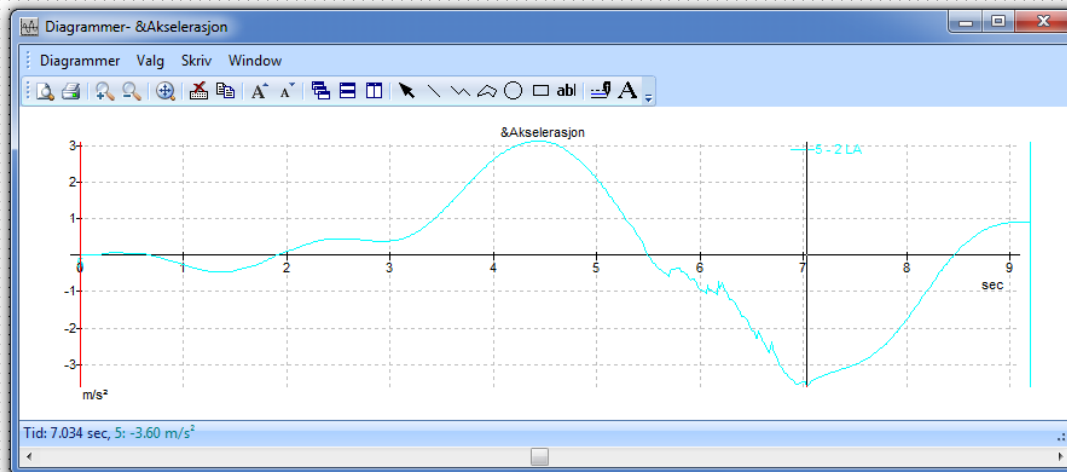
**Illustration 2:** Shows the start and end position for the simulation. The diagram shows the development of the lateral acceleration at the trailer’s centre of gravity. The positions for maximum lateral acceleration to either side are drawn in.

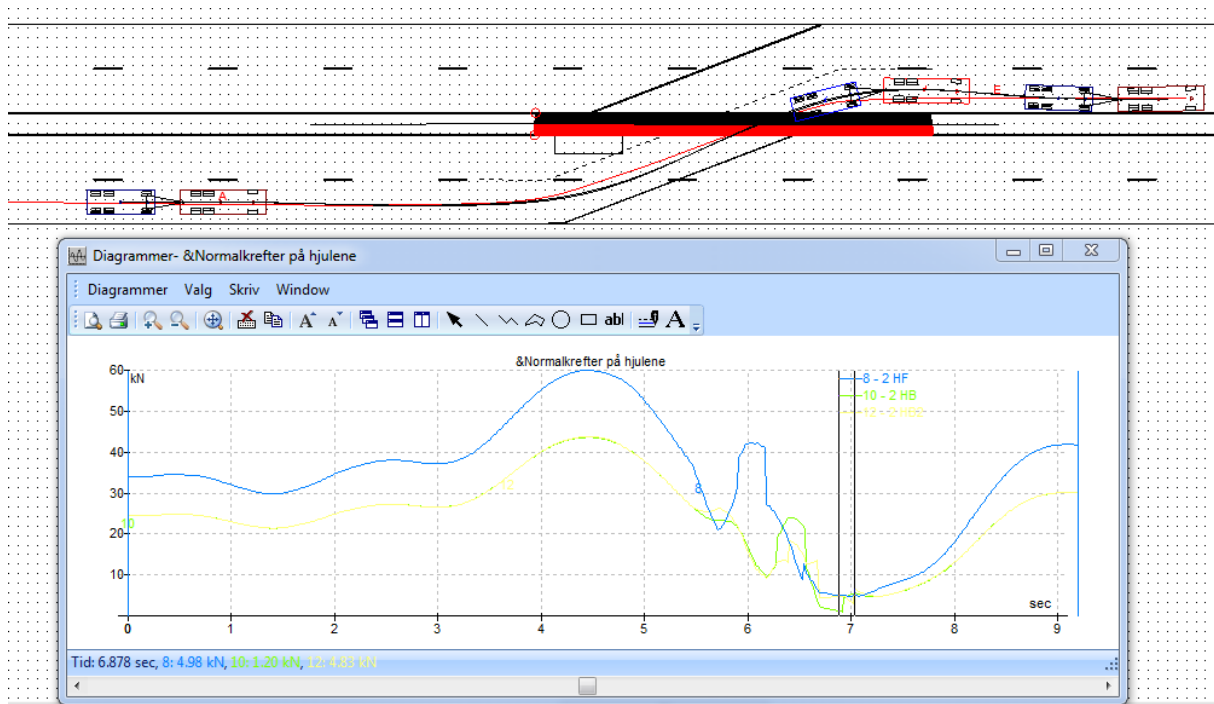
**Illustration 3: Shows the start and end position for the simulation. The diagram shows the development of the normal forces acting on the trailer's right wheels. The position for minimum normal forces in the right curve is drawn in.**

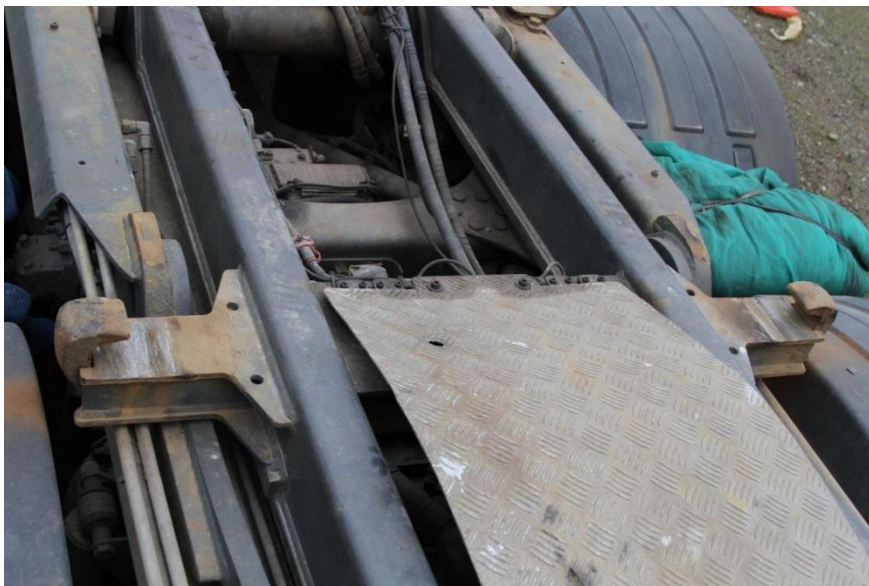
Photo 5. The two external securing hooks in the aft part of the loading deck.

It was also observed that the hydraulic securing devices on the truck were not able to be moved to their inner position because of dirt in the mechanism, 10 mm remained to move to inner position. This clearly indicates the risk that the securing device can be stuck in their outer position without the driver noticing.

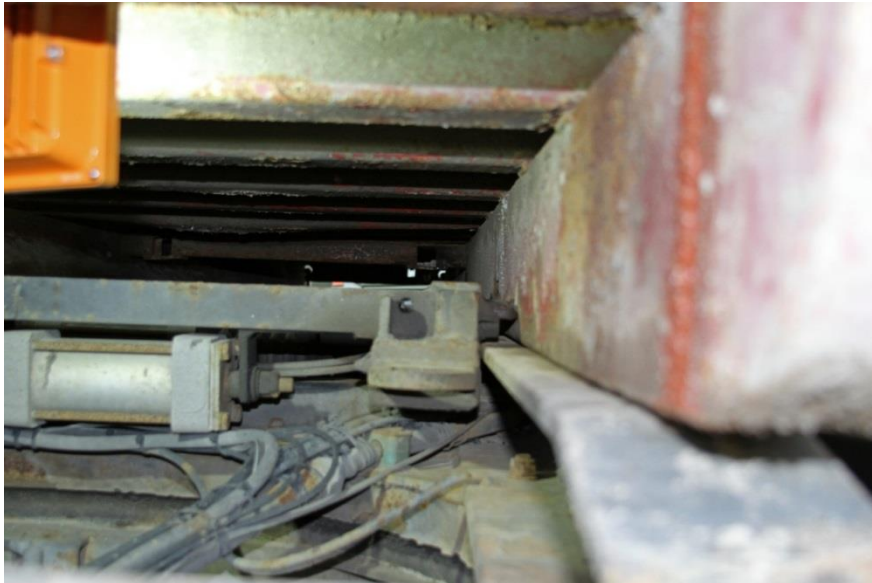
Photo 10. Trailer with hooklift container, observe that the front pair of securing devices do not have any holes to fit into in the container frame. The aft pair fits into holes in the frame of the container.

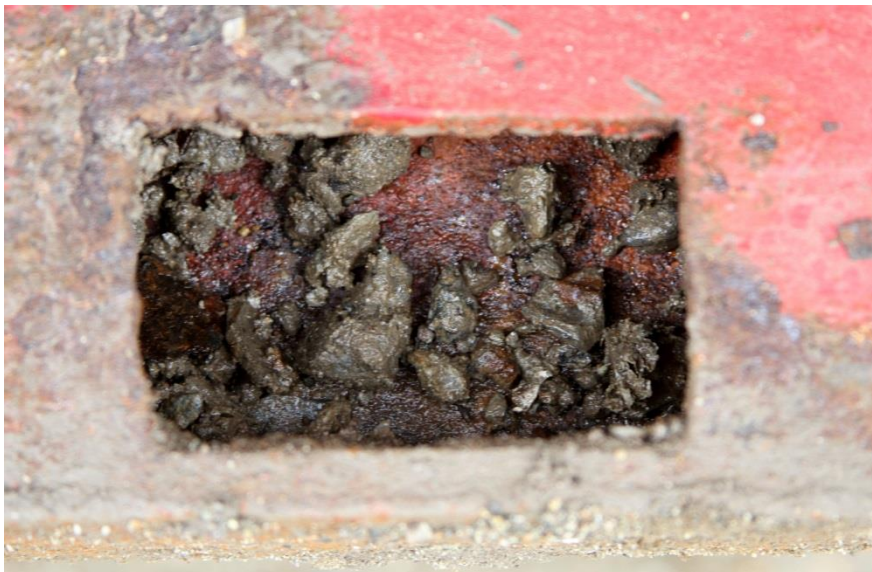
Photo 11. The hole in the fram of the hooklift container into which the securing devices fitted. Observe that the hole was filled with gravel and dirt.

The securing device of the trailer was designed in another way. They were locking in holes in the inside area of the bottom rail of the hooklift container, see photo 8 to 12. The mechanism of these pneumatic securing devices was so dirty that the function was affected. Equipment to measure the force they were able apply to the bottom rail was lacking but a person using an iron-bar level had difficulties to move the locks when pneumatic pressure was released. This shows that also this type of securing devices can easily be fastened in unlocked position. Reduced force can also result making it impossible to lock in the hole of the bottom because of it being filled with dirt and ice.

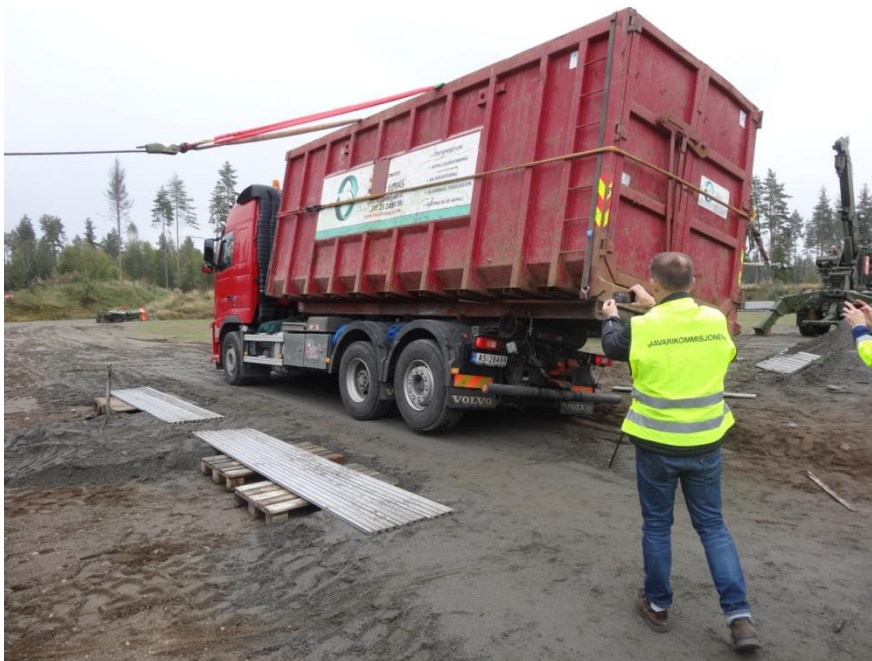
- 1) *The horizontal movement depended on the fact that the hooklift container slid on the load deck until it stopped against the side supports. No remaining deformations could be observed after the tests.*
- 2) *The aft wheels of the truck was lifted from the ground and any increasing of the lateral force was possible see photo 15 and 16. The hooklift container had no contact with the load deck in the front of the container, see photo 17 and 18 .*

Photo 17. Force level equivalent to 0.5 g

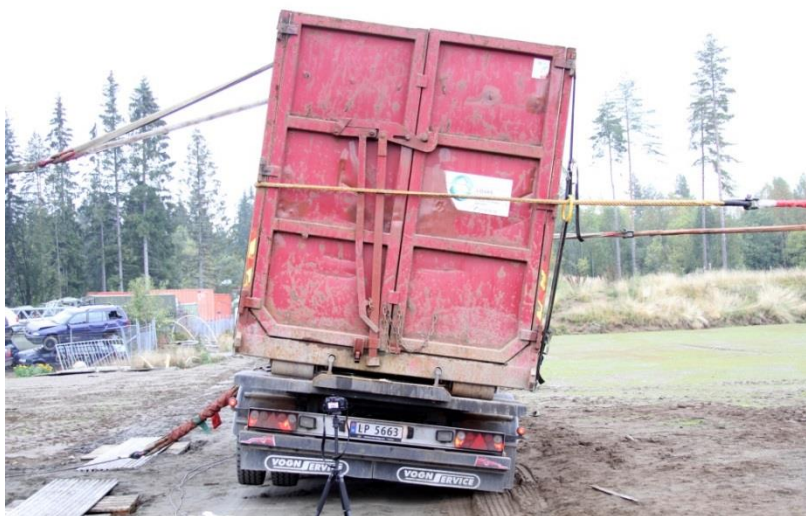
- 1) *The wheels of the trailer lost its contact with the ground and further increasing of the lateral force was impossible, see photo 19 and 20 . The hooklift container was still fixed to the tilting frame of the trailer but a big distance between container and the load deck of the trailer had occurred, see photo 21. After each load step the container returned to the position it had when the test started. This shows that no remaining deformations had occurred during the tests. The distance between the hooklift container and the load deck of the trailer was so big that it was not possible to measure.*

Photo 20. The wheels of the trailer lost contact with the ground at a force equivalent to an acceleration of 0,38g.

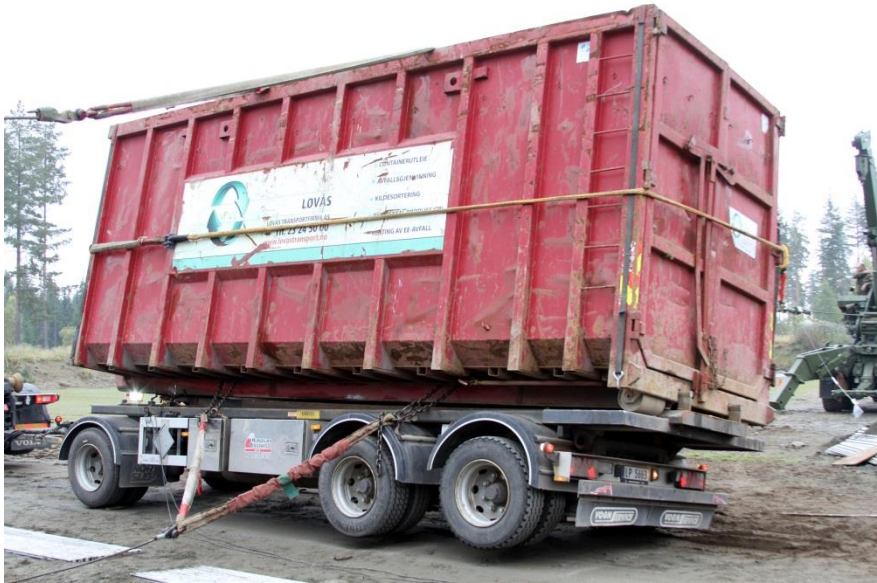
Photo 21. Force level equivalent to 0,38g.

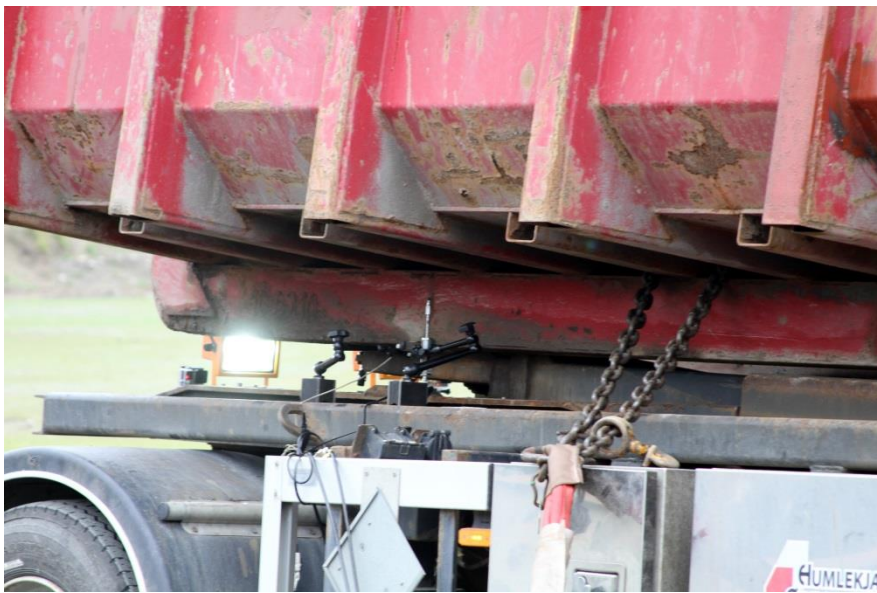
Photo 22. Observe that the hooklift container has left a big distance between its underside and the load deck. It is the tilting device that is holding it on the trailer but the tilting device has no support from the frame in its frontal part and is subjected to a unfavorable angle between tilting device and trailer frame. This angle may make it possible to deform the tilting device and subsequently make the hooklift container slide off the load deck. Observe also that all measuring equipment has lost contact with the container.

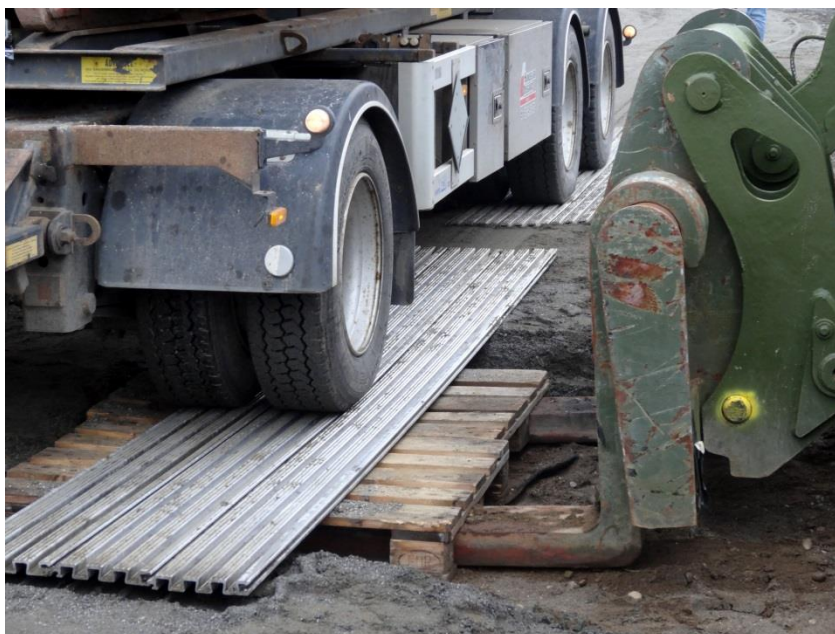
Frontal securing devices fixed	Difference in height between front wheels mm	Distance between container and load deck mm
Fixed	0	0
	100	0
	200	11
Not fixed	0	0
	100	0
	200	11
	300	27

Photo 23. Lifting of the left front wheel of the trailer in order to simulate a turn over a bump between two lanes.

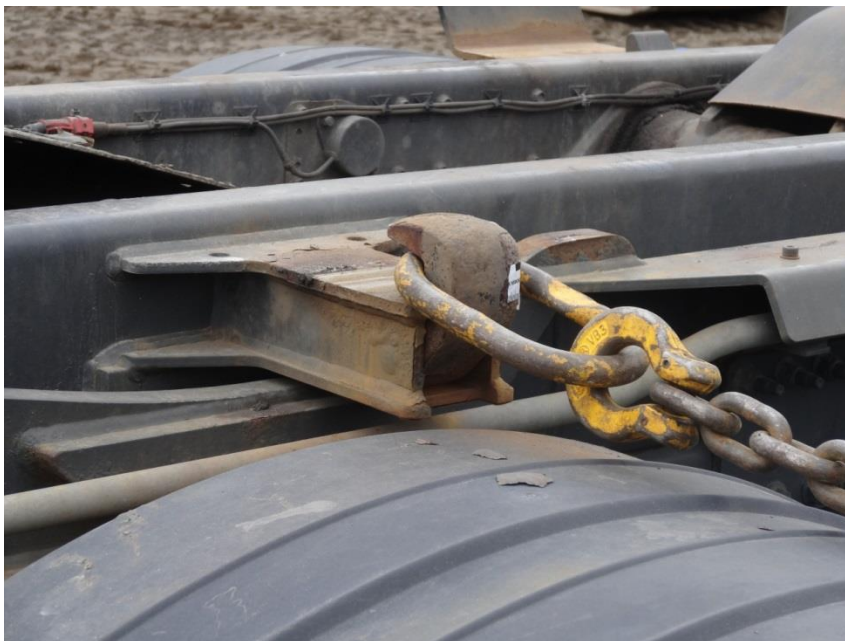
Photo 24. Measuring of the force when the securing device of the truck opens.

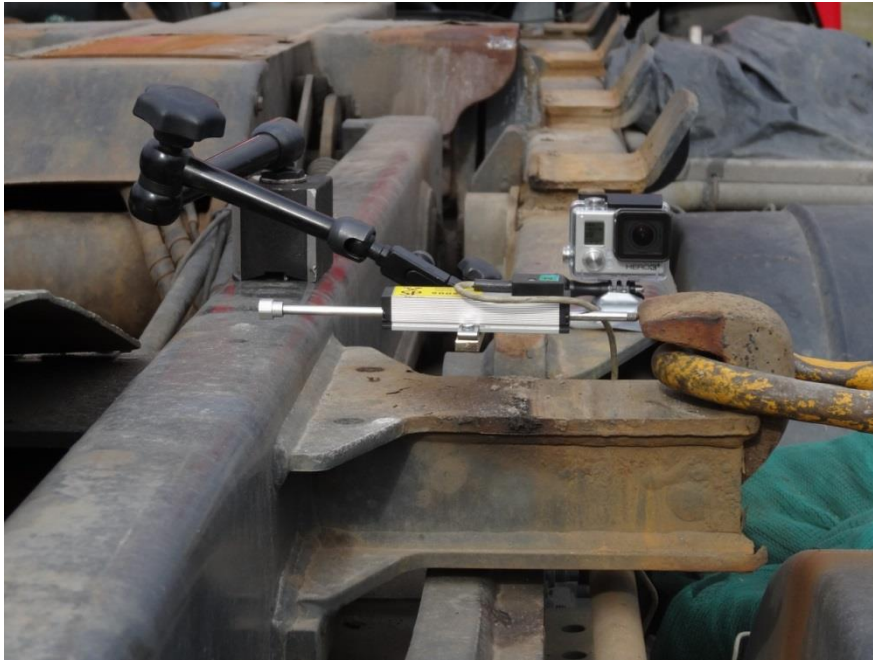
Foto 25. Position of indicator for measuring of the movements of the locking hooks on the right side of the truck.

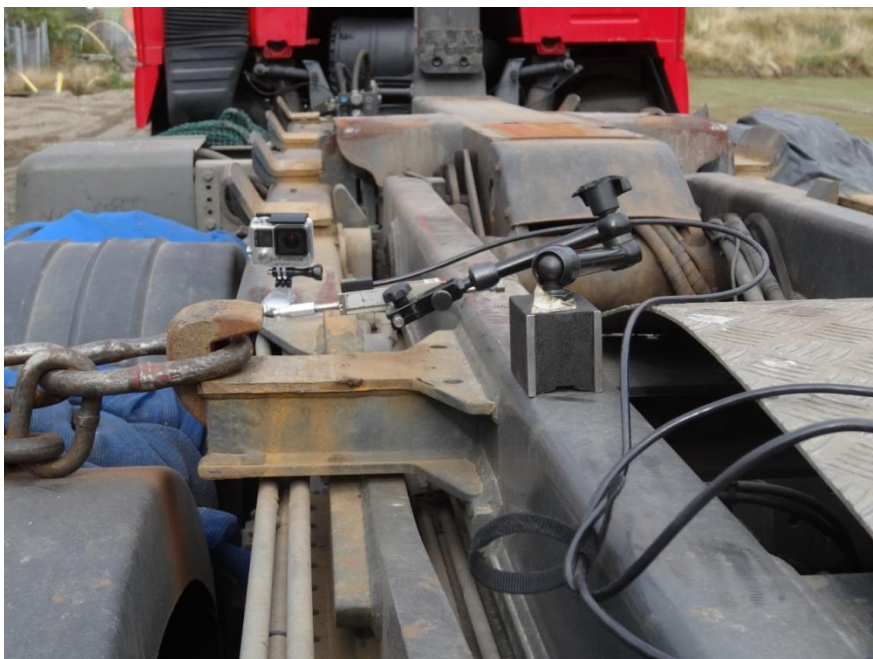
Photo 26. Position of indicator for measuring of the movements of the locking hooks on the left side of the truck.

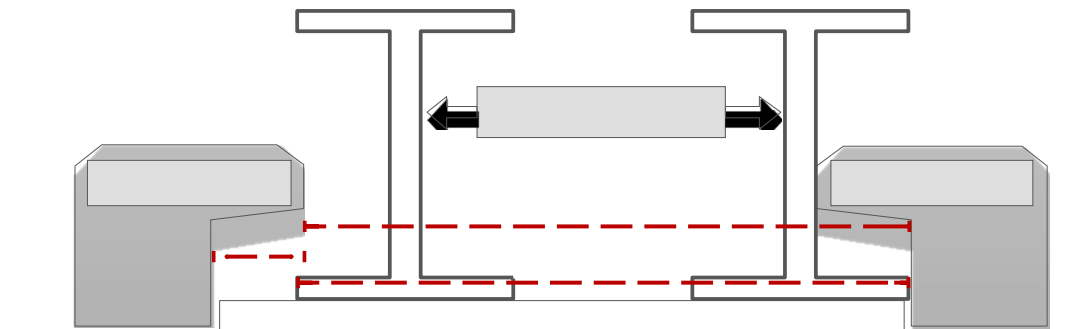
The outer securing devices on the truck had in open position a gap of 1083 mm and in inner position a gap of 901 mm. This means that they could get a good grip in the two bottom rails of the container since the outer dimension of the bottom rails, measured over the flanges, may vary between 1055 and 1060 mm and was 1057.5 to 1059.5 on the container tested on the truck. They were also not dependent of holes in the bottom rails since they could grip anywhere along the bottom rails.

Figure 1. Sketch showing the securing device on the truck and the bottom rails of the hooklift container. Observe that I-Beams are shown but the container on the truck was equipped with U-beams with the flange outwards.

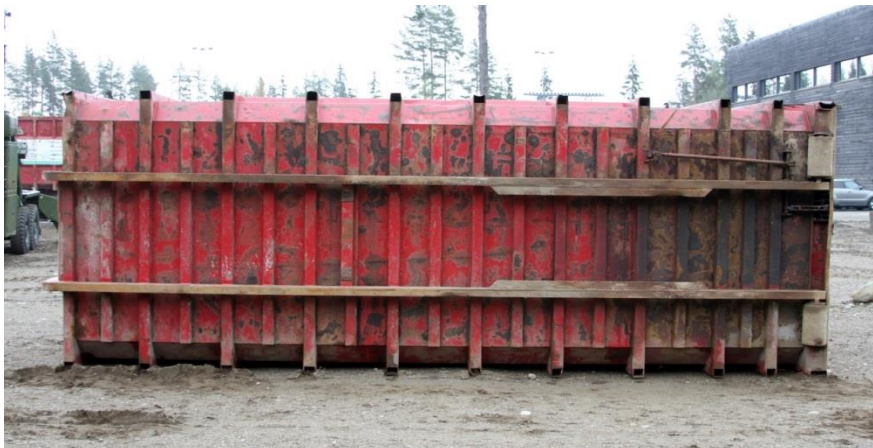
After the tests the hooklift containers were emptied and inspected. It was obvious that they are subjected to hard wear and damages are sometimes only barely repaired. Following photos show the condition of the containers.

Photo 27. The hooklift container used on the truck.

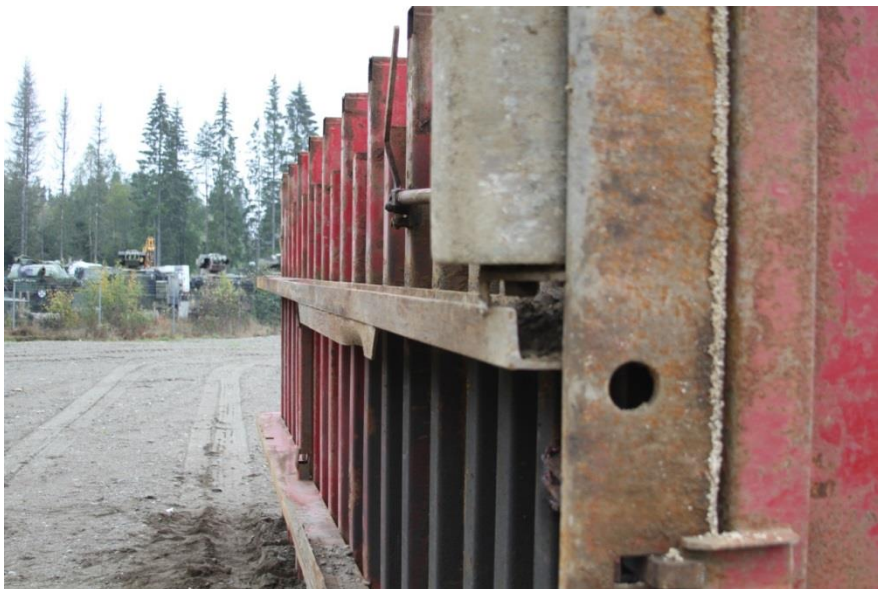
Photo 29. Hooklift container used on the truck.

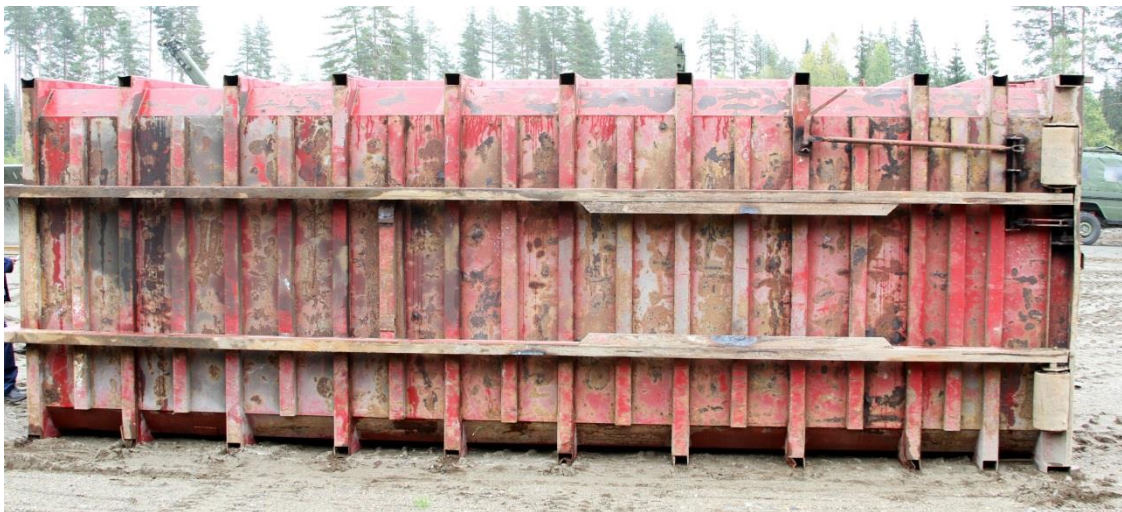
Photo 31. The hooklift container used on the trailer.
