REPORT

Road 2019/04

REPORT ON HEAD-ON COLLISION BETWEEN TWO BUSES ON COUNTY ROAD FV 450, AT NAFSTAD IN ULLENSAKER ON 17 NOVEMBER 2017

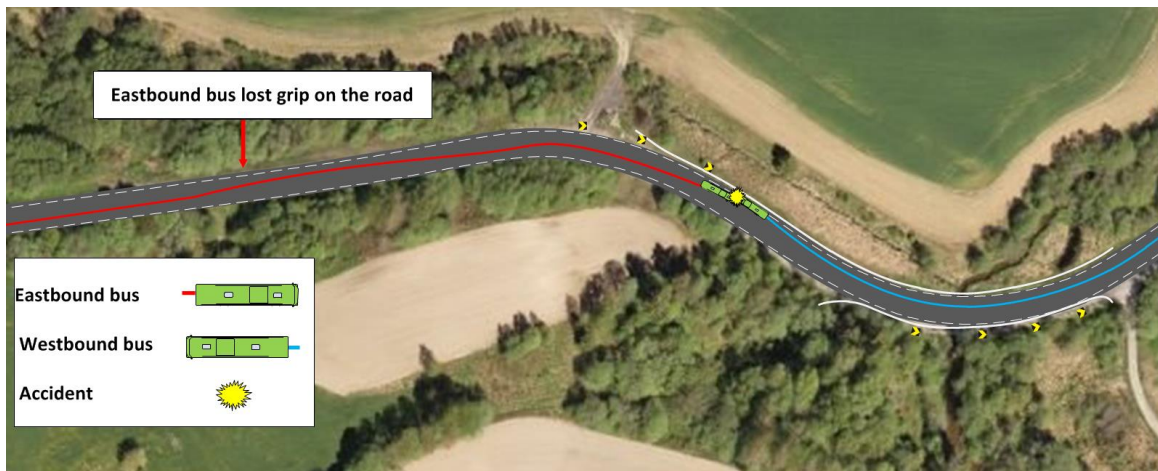
The eastbound bus was on schedule and was descending a hill leading to a double bend shaded from the sun by a copse of trees. The road was bare on the section before the hill, but on the hill and in the double bend, a layer of rime frost and film of ice had formed on the road. Speed data downloaded from the tachograph on the bus showed that the driver of the eastbound bus braked as it approached the bend (see section 1.11). Halfway down the hill, the bus lost its grip on the road and veered into the opposite lane as it was leaving the bend. At that moment, the westbound bus was entering the same bend.

The buses collided head-on with an overlap of approximately half the width of the front of the buses, and each bus penetrated the other in the driver's cab area. According to the downloaded speed data, both buses were travelling at a speed of approximately 33-34 km/h at the moment of impact.

Figure 2: Sequence of events for the head-on collision between eastbound and westbound buses on Fv 450. Map: © Norwegian Mapping Authority. Illustration: AIBN

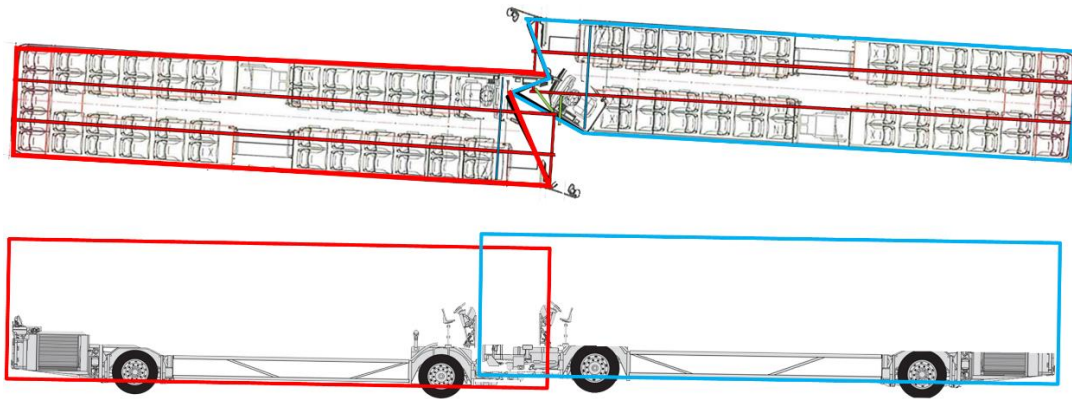
There was also little survival space in the westbound bus, but the side wall on the driver's side collapsed in towards the centre in the collision, which meant that the driver was pushed almost as far back as the driver of the eastbound bus and slightly towards the centre; see Figure 11.

Figure 11: Illustration of the penetration between the eastbound bus and westbound bus.
Illustration: AIBN

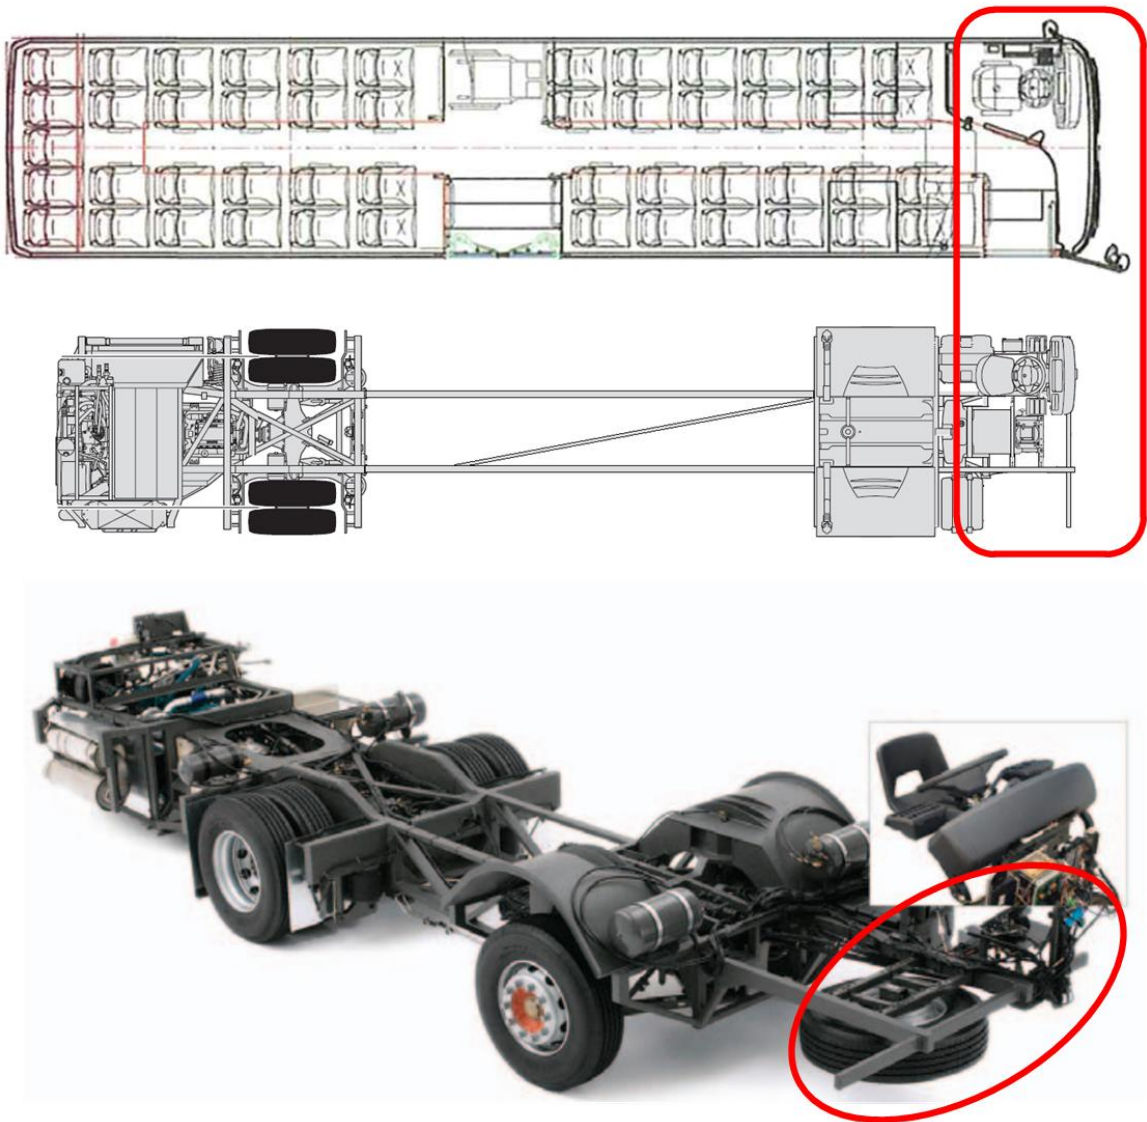
The driver's cab on the buses was built on the outside of the load-bearing chassis, and was located on the left hand side of the bus at the very front. Volvo has informed the AIBN that there is no regulatory requirement to provide either structural collision protection for the driver's cab or underrun protection on these buses. The chassis was made of conventional steel, and the front structure had a generally low level of energy absorption, shown in Figure 17.

Figure 17: Volvo B12B chassis and body structure. The cross-beams in the front are circled in red. Illustration/photo: Volvo Bus

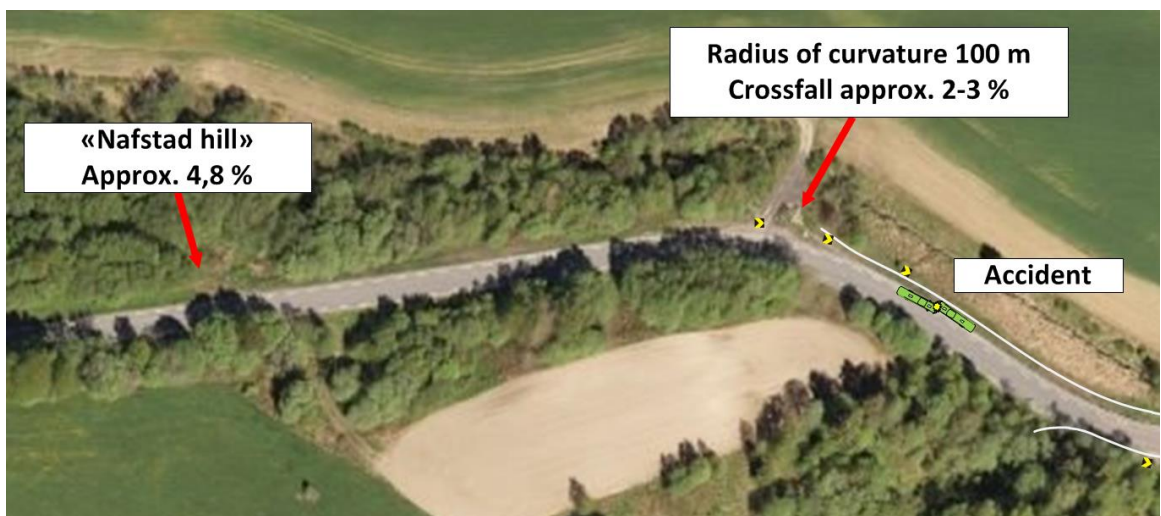
Adjacent to the entire hill and accident site is a copse of trees in the side terrain on the north and south sides.

Figure 19: Overview photo of ‘Nafstad hill’. Map: © Norwegian Mapping Authority. Illustration: AIBN

The copse of trees on the south side of the hill has not always been there. Aerial photos show that trees have grown alongside Nafstad hill since 1986. The trees have gradually led to an increase in shade on the roadway, which has resulted in an increased risk of rime and frost formation in certain weather conditions. In the AIBN's view, this also affects safety on this section.

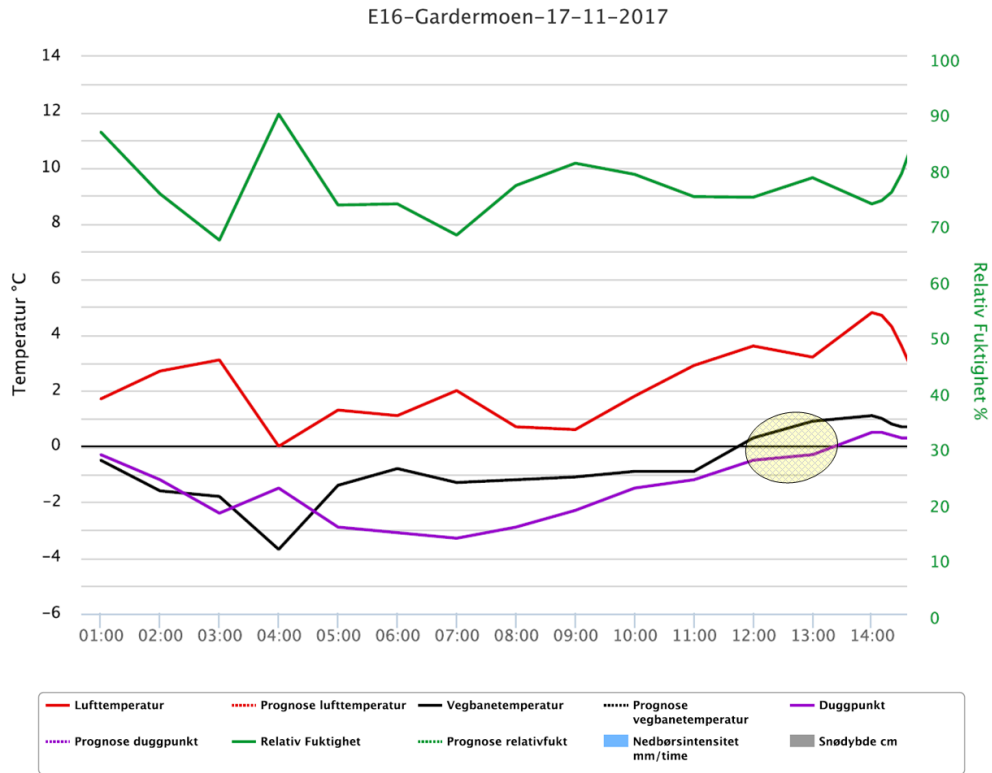
Figure 22: Meteorogram for E16 Gardermoen weather station, 17 November 2017. Source: Vegvær.no/AIBN

At Gardermoen, the road surface temperature rose throughout the morning and exceeded zero degrees at around 12:00. At Ulvesund, on the other hand, the road surface temperature did the reverse, falling from above zero at 12:00 to below zero at around 12:30, while the dewpoint rose and exceeded the road surface temperature. This is shown in the shaded area in Figure 22 and Figure 23. The conditions at Ulvesund bru would allow rime frost to form, as described in section 1.15.1.

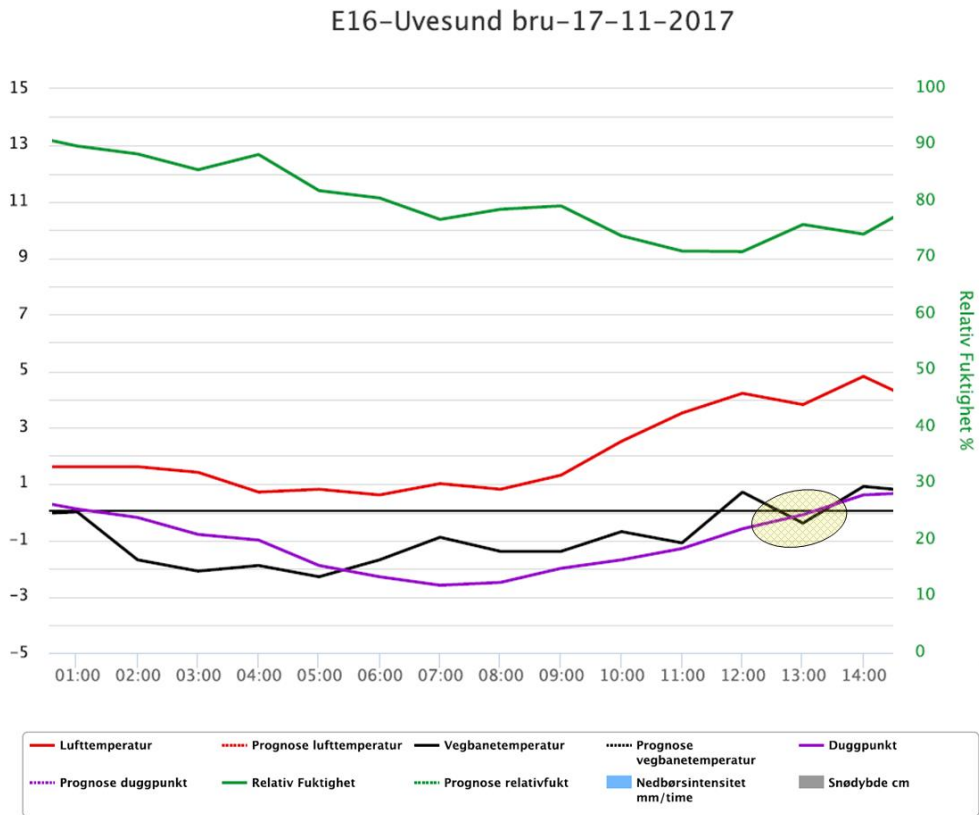
Figure 23: Meteorogram for E16 Ulvesund bru, 17 November 2017. Source: Vegvær.no/AIBN

The meteorogram from Ulvesund bru shows that the roadway temperature dropped below the dewpoint and that both temperatures were below zero degrees just before 13:00 at this location. This situation can result in rime frost on the roadway. In the AIBN's assessment, this was also the case in the shaded area down Nafstad hill in the interval between 12:30 and 13:00, and a layer of rime frost formed. Photos from the site of the accident taken after the accident support this. People who were at the scene also described that there was a film of ice on the roadway.

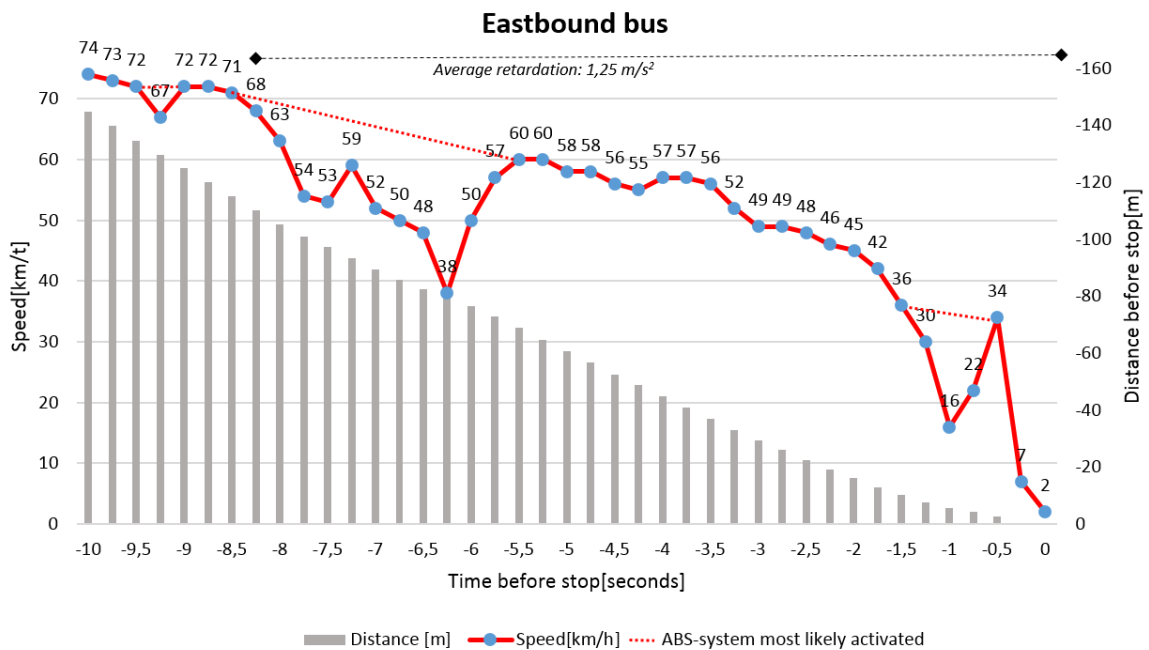
The eastbound bus was travelling at just under 80 km/h on the flat section west of Nafstad hill. As shown in Figure 24, the bus had reduced its speed to approximately 74 km/h on the slope, approximately 150 metres before the site of the accident. Halfway down Nafstad hill, there is a noticeable change in the curve of the speed graph 8.5 seconds before the accident. This is probably because the ABS system was activated and blocked the rear wheels. This indicates emergency braking for approximately 2.5 seconds (marked with a dotted red line). Approximately 60 metres before the collision, the bus entered the right-hand bend at a speed of approximately 58 km/h. Through the bend, the braking was stable, until approximately 1 second before the collision, until there are again signs of emergency braking. Based on the recordings, it is estimated that the eastbound bus collided at approximately 34 km/h.

Figure 24: Recorded speed and distance data for the eastbound bus for the 10 seconds leading up to the collision. Illustration: AIBN

After the accident, the friction value on the road was calculated by the Norwegian Public Roads Administration to be $\mu=0.19$. Average retardation of the eastbound bus during the 7.5 seconds leading up to the collision was 1.25 m/s^2 (see Figure 24), which gives a friction value of just under $\mu=0.1$.

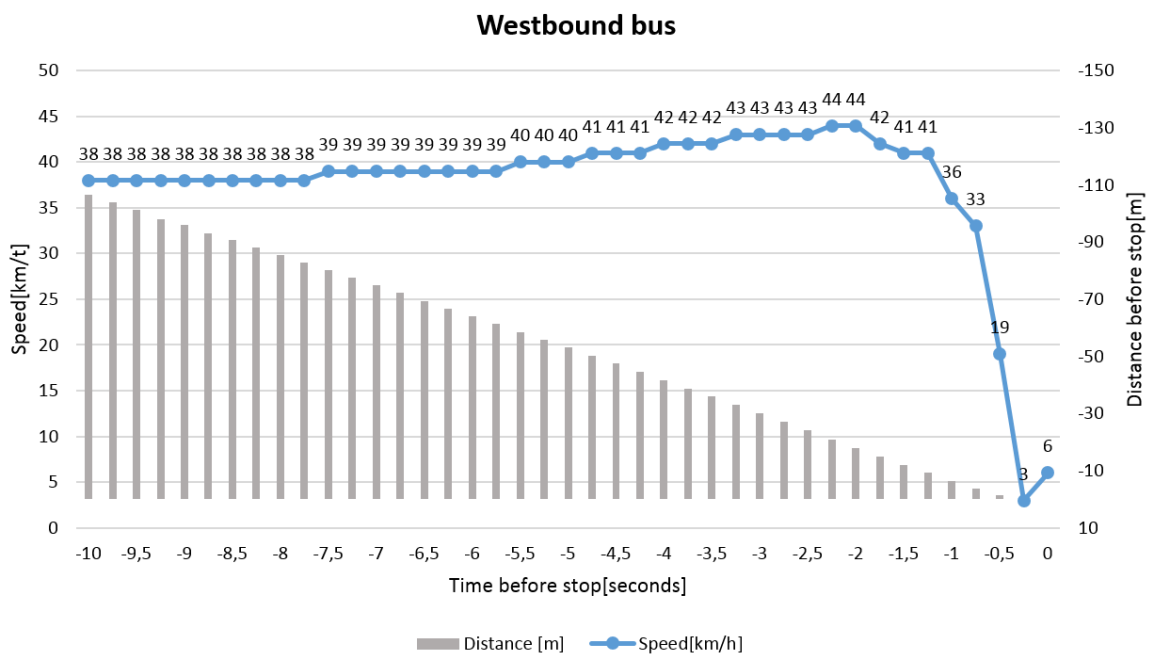
The westbound bus was driving at a steady speed of around 40 km/h until approximately 1 second before the collision. Based on the recordings, it is estimated that the westbound bus collided at approximately 33 km/h.

Figure 25: Recorded speed and distance data for the westbound bus for the 10 seconds leading up to the collision. Illustration: AIBN

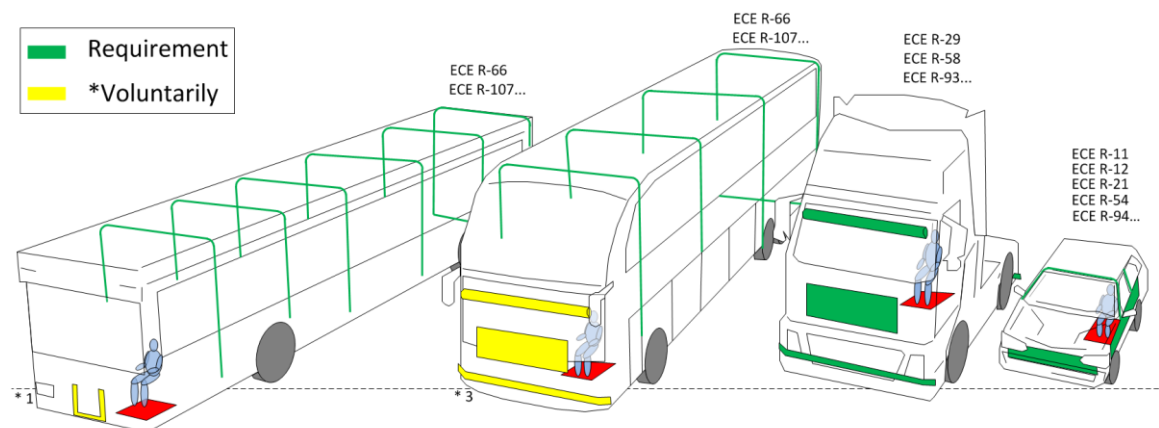
Figure 26: Collision protection requirements for various vehicle groups. Illustration: AIBN

The AIBN believes that the severity of the injuries was greatly affected by the buses' weak collision protection in the drivers' cabs. This is connected to the fact that current regulations do not address the crashworthiness of buses in the same way as for passenger cars or heavy goods vehicles (see Figure 26 and Table 3). In the AIBN's assessment, there are several ways to introduce improved crash protection for bus drivers, and this is described in more detail below.
