Road 2019/06

## REPORT ON RUN-OFF-THE-ROAD ACCIDENT ON THE FV 651 ROAD, SVINEROIVEGEN, NEAR RJUKAN, TINN MUNICIPALITY, 2 SEPTEMBER 2018

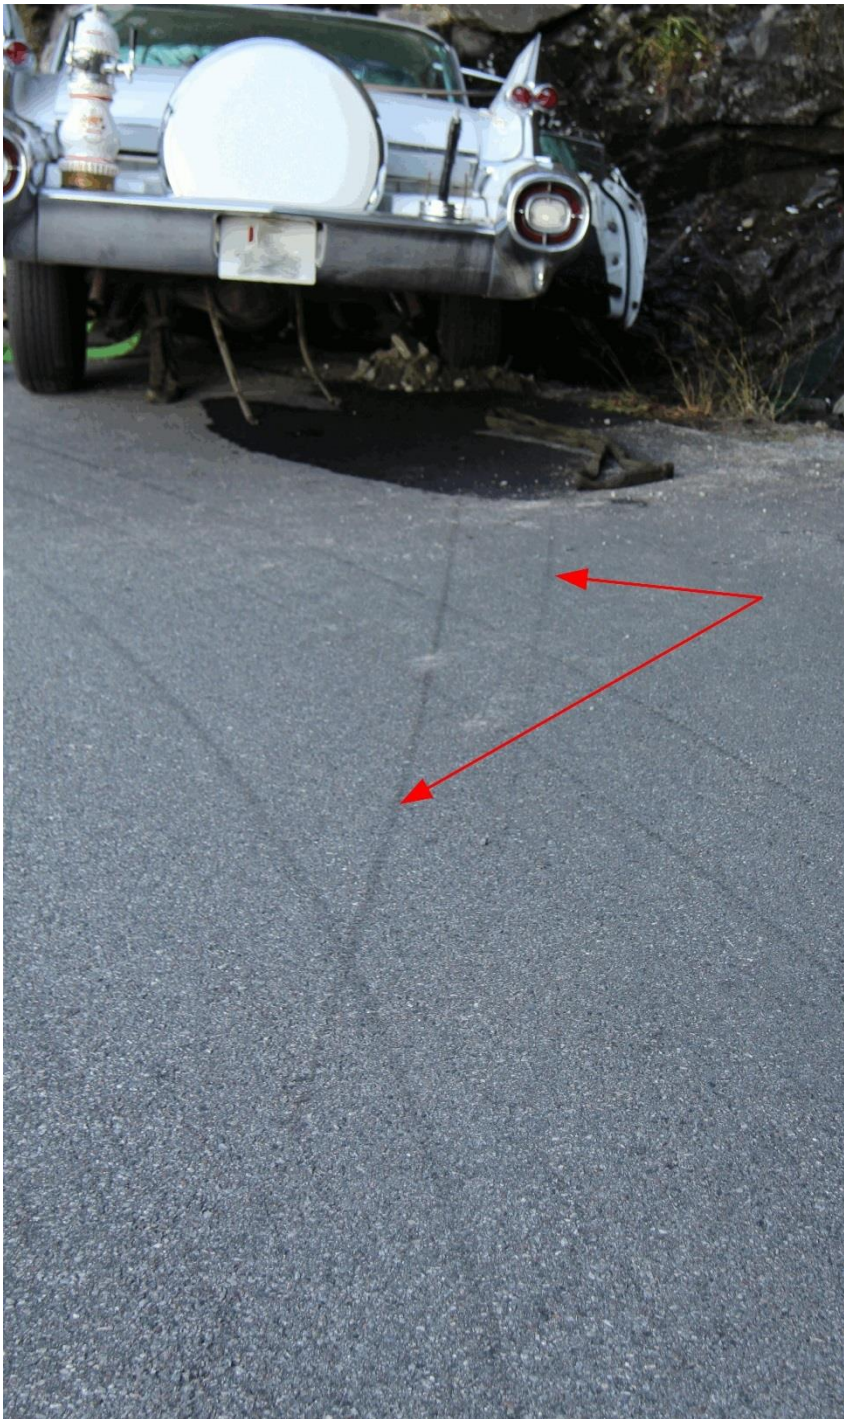
On-scene observations were recorded by representatives of the police and the NPRA on the day of the accident. Tire tracks were registered from the car's right-hand wheel pair, which, according to the NPRA, measured 6.4 m from the rear corner of the car; see Figure 9. The AIBN inspected the scene of the accident on the following day. Several other tire tracks were found on and near the accident site, but the investigation showed that they were not left by the accident car.

*Figure 9: Tire tracks from the right-hand wheel pair at the scene of the accident. Photo: NPRA*

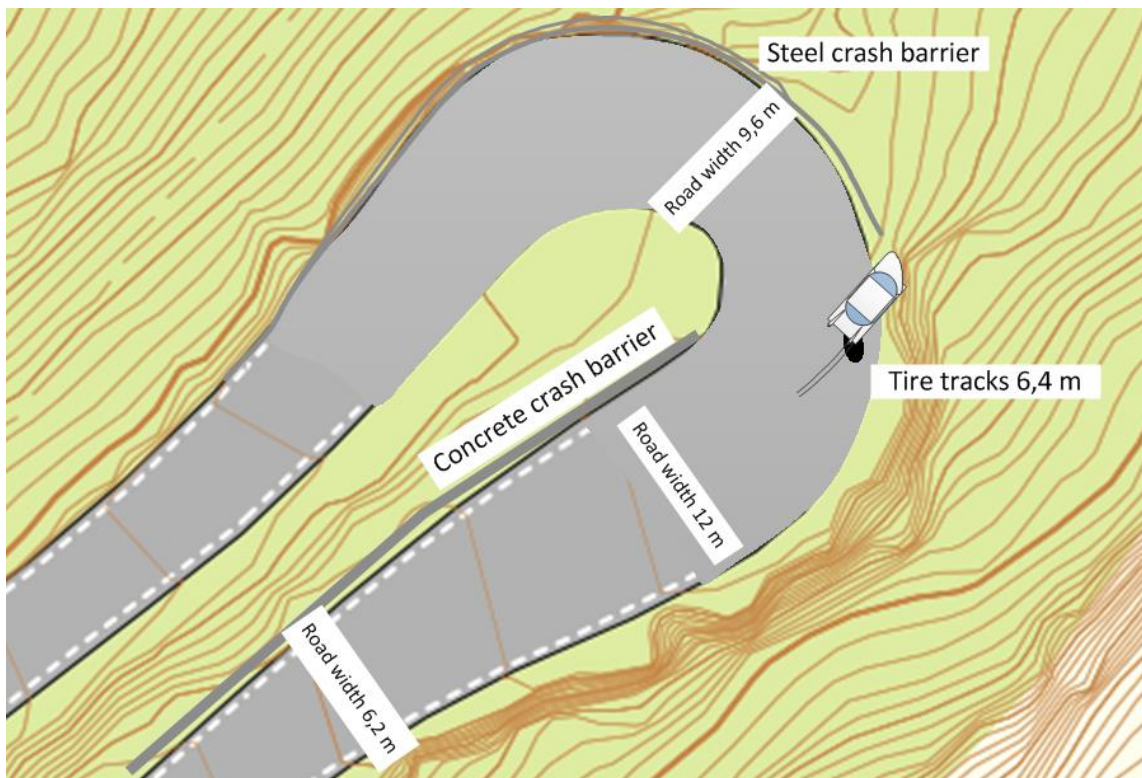
Figure 10: Schematic drawing of the accident site. Illustration: AIBN

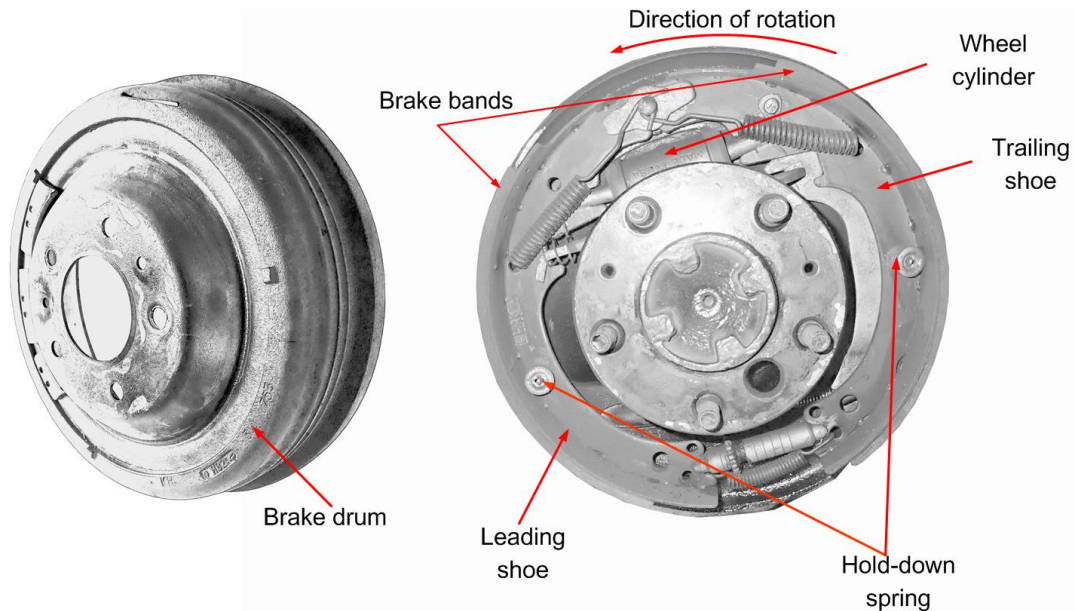
The car was equipped with a single-circuit brake system with drum brakes at both the front and rear. The brake force was more or less evenly distributed between the front and rear axle. The parking brake was operated by a foot pedal that engaged the back wheels' drum brakes.

Figure 12: Overview of drum brake components (left back wheel) with the drum removed.  
Illustration: AIBN

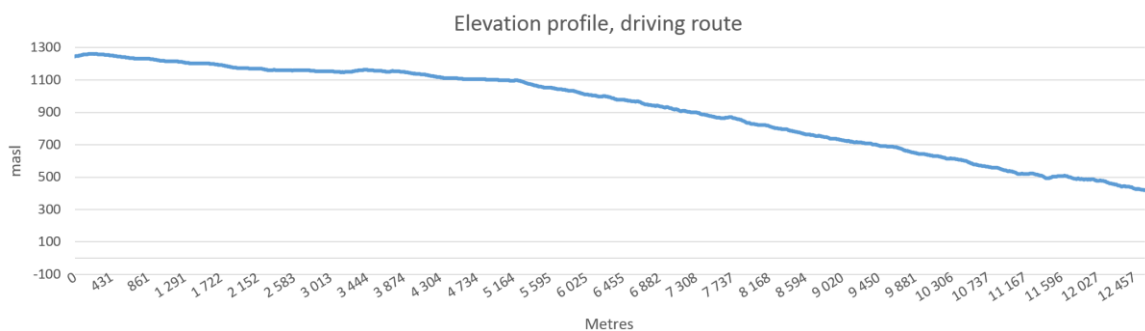
Approximately 7.4 km from the accident site, there is a 'Steep slope' (downhill) warning sign (sign no 104.2), with a text below indicating a gradient of 10% and 'Low gear 0–9 km'.

Figure 24: Elevation profile from the highest point at Flisetjønn down to the accident site. The average gradient of the final 7.5 km of road down to the accident site is 9.6%. Illustration: © Norwegian Mapping Authority

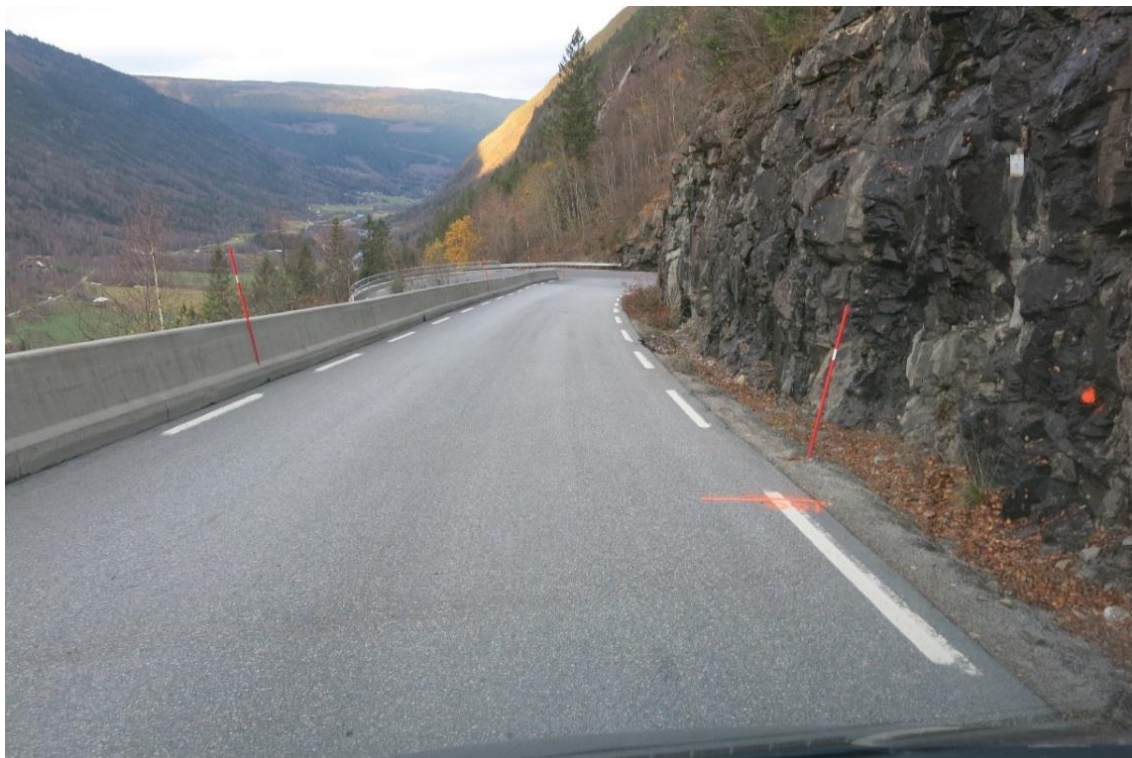
A barrier had been erected against the sloping terrain, consisting of steel railings on wooden posts along the first part of this stretch from the penultimate hairpin bend to approx. 750 metres from the accident site, where it was relieved by a 90 cm high concrete crash barrier. The width of the shoulder between the edge line and the concrete barrier varied, but was for the most part 30 cm.

Figure 26: Road shape and roadside terrain approx. 100 metres from the accident site. Photo: AIBN

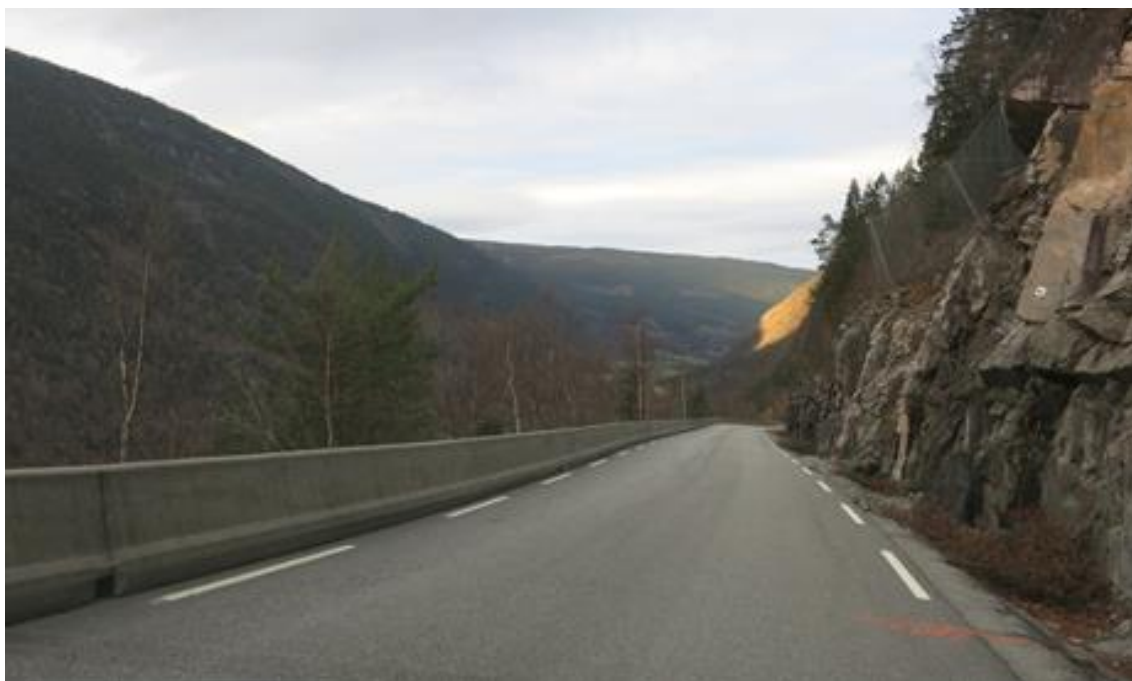
Figure 27: Road environment 400 metres from the accident site. Photo: AIBN

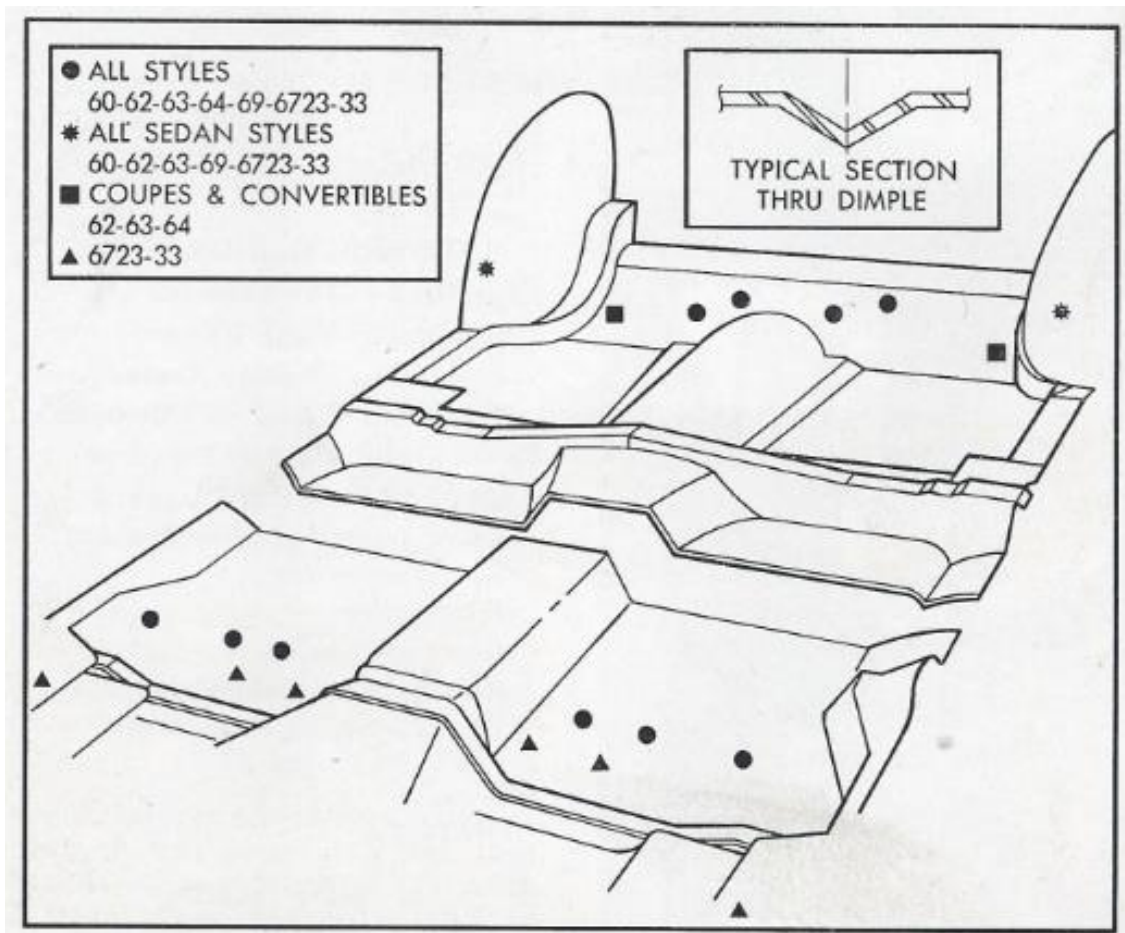
According to *The Cadillac Serviceman*, a magazine published by the General Motors factory on a regular basis that contained information not covered by the factory shop manual, it was possible to install seatbelts in the car. According to the issue published in November 1959, the service procedure for installing seatbelts had been simplified by making recesses in the floor and body to indicate where the seatbelt installation bolts should be located (General Motors, 1959).

Figure 28: The points on the figure show where the seatbelt installation bolts were to be located. Source: *The Cadillac Serviceman*, November 1959
