REPORT

Road 2020/07

REPORT ON A HEAD-ON COLLISION BETWEEN A PASSENGER CAR AND A VAN ON THE E39 AT AUSTEFJORDEN, VOLDA, MØRE OG ROMSDAL ON 20 OCTOBER 2019

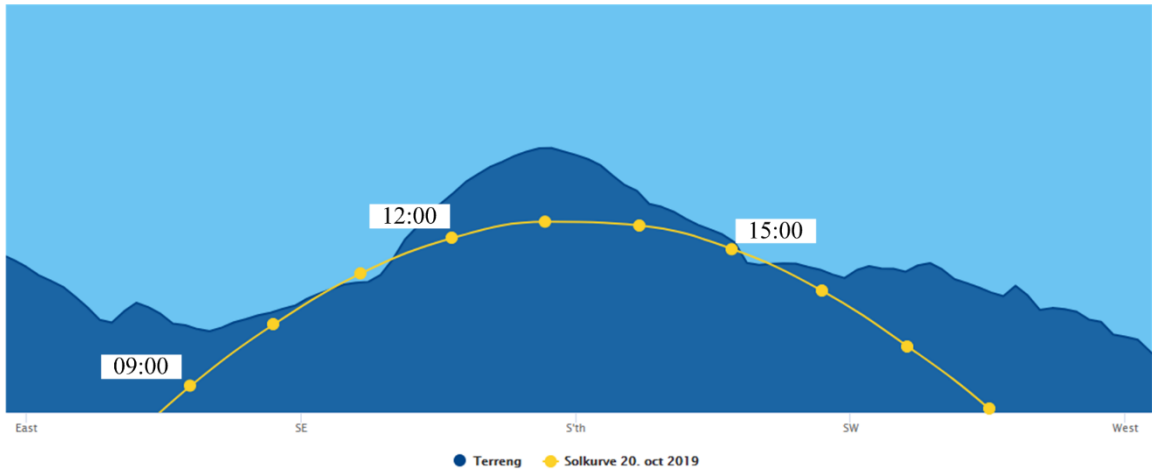
Figure 9: Sun conditions at Kvivsvegen, looking SE towards the mountains. Source: Suncurves

At the time of the accident, the area had mist from Storvatnet lake, and there was hoar frost on the ground beside the road. Both the persons involved and the response personnel at the scene described the road conditions as very slippery. Descriptions of the road surface at the accident site included 'like a skating rink', and it was so slippery that several of them had to hold on to one another to avoid falling.

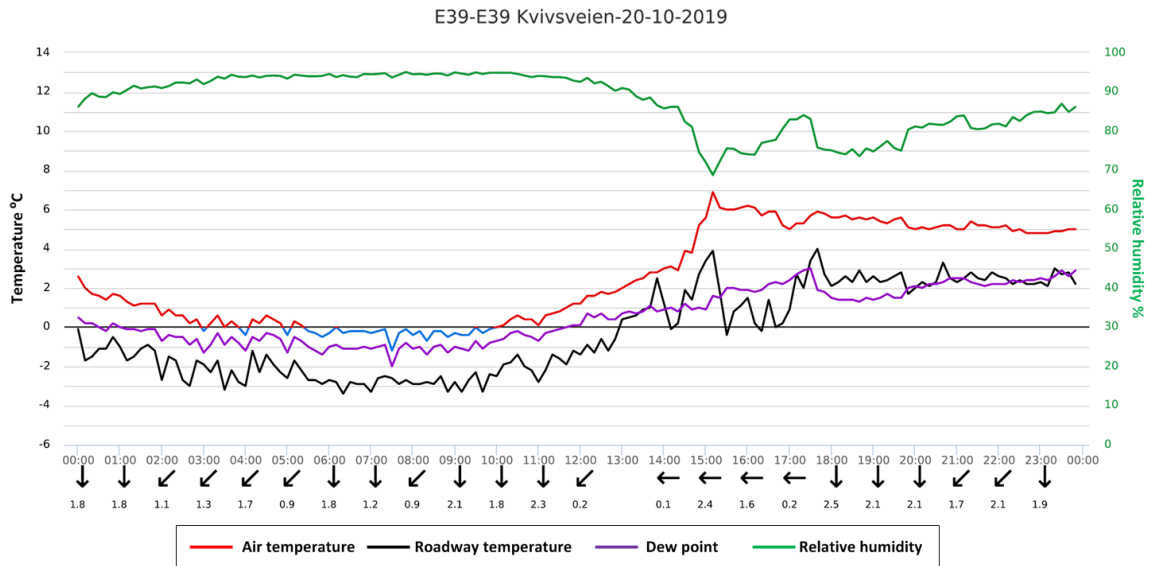
There was light cloud cover, no precipitation, and the air temperature in Volda in the early hours of Sunday 20 October 2019 was above zero. During the night and up to 09:00, the cloud cover at altitude cleared. The nearest weather station to the accident site that measured roadway temperature was E39 Kvivsvegen, approx. 3.5 km from the site. This showed that the road temperature was below 0 °C, the dew point was higher than the road temperature and the air temperature was around 0 °C at the time of the accident, see Figure 10. It is well-known that in these weather conditions a film of ice is likely to form on the road surface as the moisture freezes.

Figure 10: Measurements from the E39 Kvivsvegen weather station for 20 October 2019. Source: NPRA

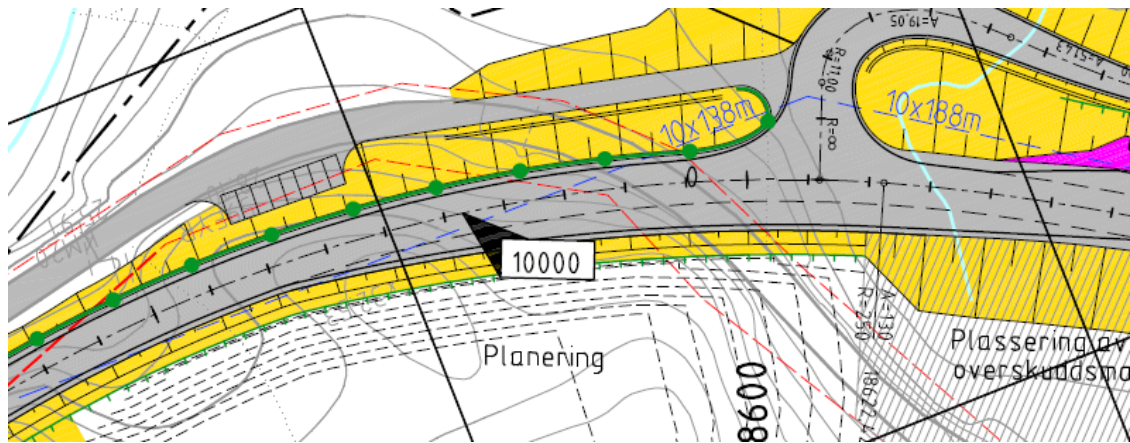
Figure 11: Map of the bend where the accident happened and the nearside passing bay by the exit road. Illustration: NPRA

The NPRA measured the camber of the road to 6.1% in the inner lane in the area where the van probably lost its grip. N100 stipulates that the camber through a bend on road type H1 with a radius of 250 m shall be 8%, which was the plan for this bend. The NPRA has informed the NSIA that, according to the road designers, the camber was reduced to 6% during development, in order to provide room for a nearside passing bay in the planned road junction area immediately south of the tunnel.

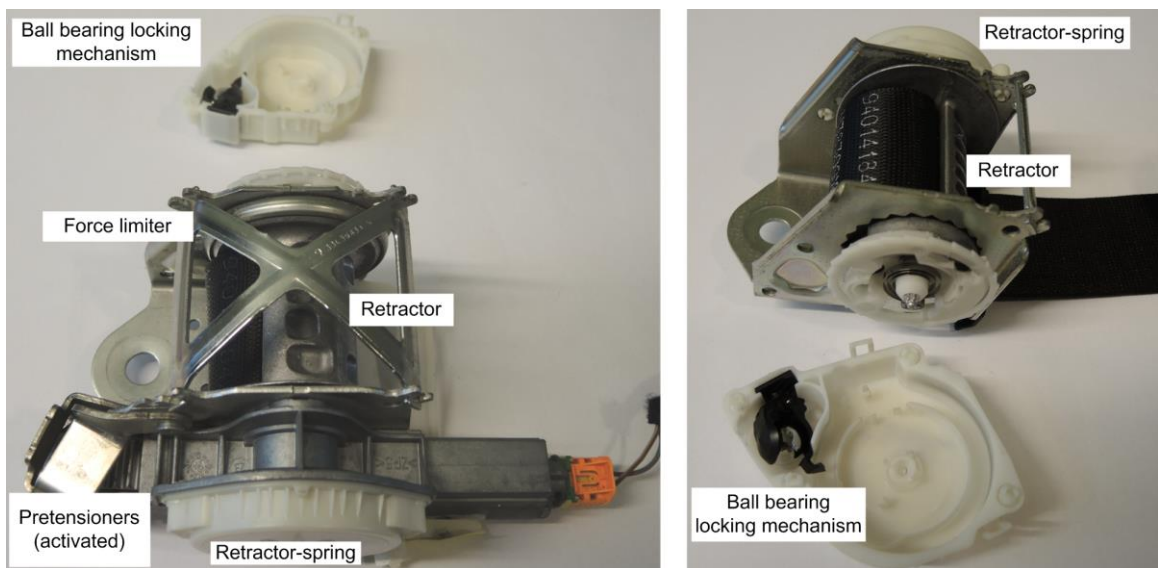
Figure 12: Rear seat belt functions at the sides (left) and the rear middle seat belt (right).
Illustration: NSIA

The seat belt in the middle rear seat did not have a pretensioner and force limiter, and it locked with a ball bearing locking mechanism. The belt was anchored to two points on the body of the vehicle beneath the seat squab and to one point integrated into the front side of the rear seat-back. This seat belt was the only seat belt where the shoulder belt was not anchored to the vehicle's body, B or C pillar. The passive safety of the middle rear seat is described in more detail in Section 1.13.2, and all the seats are analysed in Section 2.4.

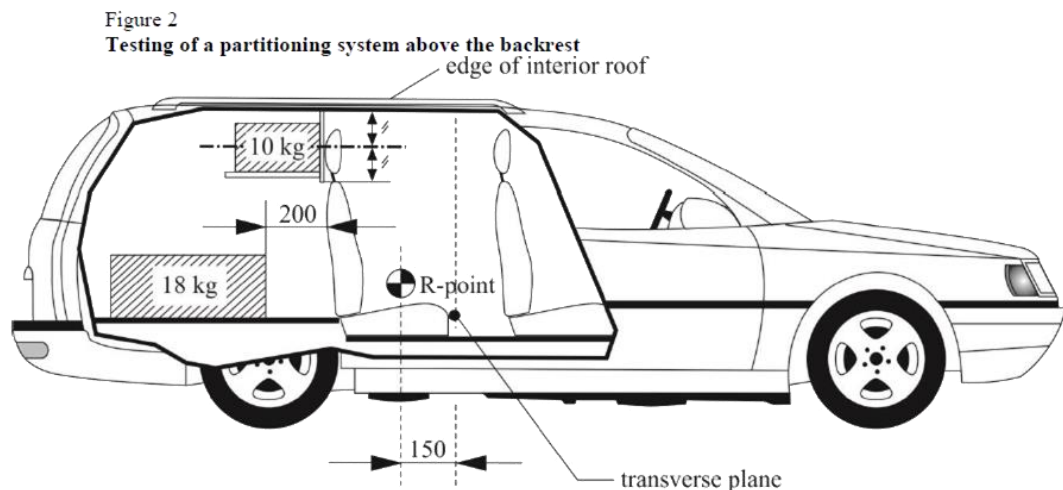
Figure 19: Test of seat-back with 2 x 18 kg luggage and 10 kg against the head restraint in a sled test at 50 km/h. The minimum requirement for forward deformation of the seat-back is described below. Source: UN-ECE R17

This test was carried out without crash-test dummies in the rear seat and does not describe how the seat belts in the rear seat shall be designed. No requirement is specified for the way in which a seat-back can or should be deformed, nor for oscillation of the seat-back.

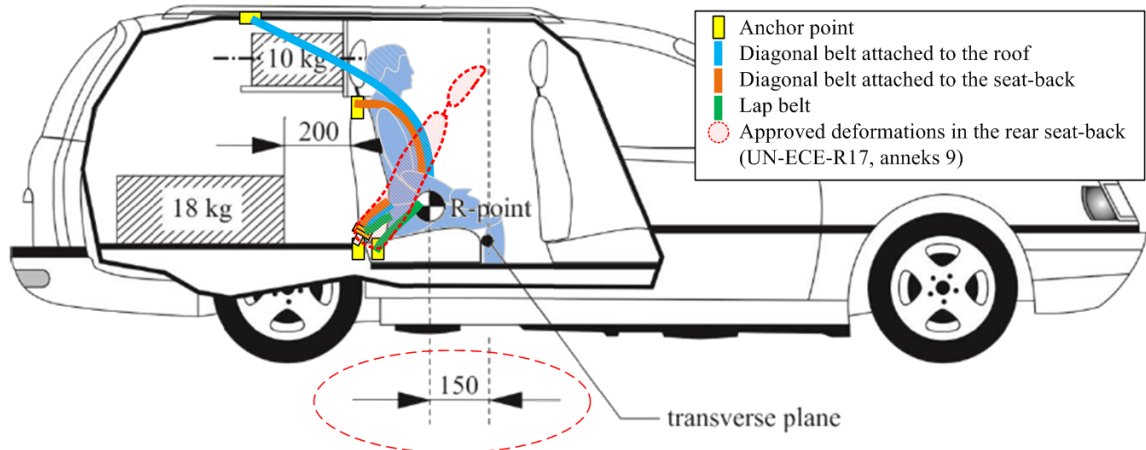
Figure 25 illustrates a passenger in the middle rear seat with alternative anchorages for the shoulder belt; in the roof, and integrated into the rear seat-back. The approved deformation is also shown, in red.

Figure 25: Strength requirements for rear seat-backs - showing middle rear passenger and seat belts with alternative shoulder belt anchorages. (Note: R-point is determined by the car manufacturer and will vary). Illustration: NSIA

In the context of this test, the alternative middle rear seat belt anchorages present different problems in relation to deformation of the rear seat-back. When the shoulder belt anchorage is in the roof, the rear seat-back must be strong enough for a deformation not to jam the passenger between the shoulder belt and the rear seat-back. When the shoulder belt anchorage is integrated into the rear seat-back, the movement of a secured passenger's body will be determined by the movement of the rear seat-back and the configuration of the belt, described in Figure 15.
