REPORT

Road 2021/02

REPORT ON HEAD-ON COLLISION ON THE E6 ROAD NEAR HAMMER IN SNÅSA MUNICIPALITY ON 2 FEBRUARY 2020

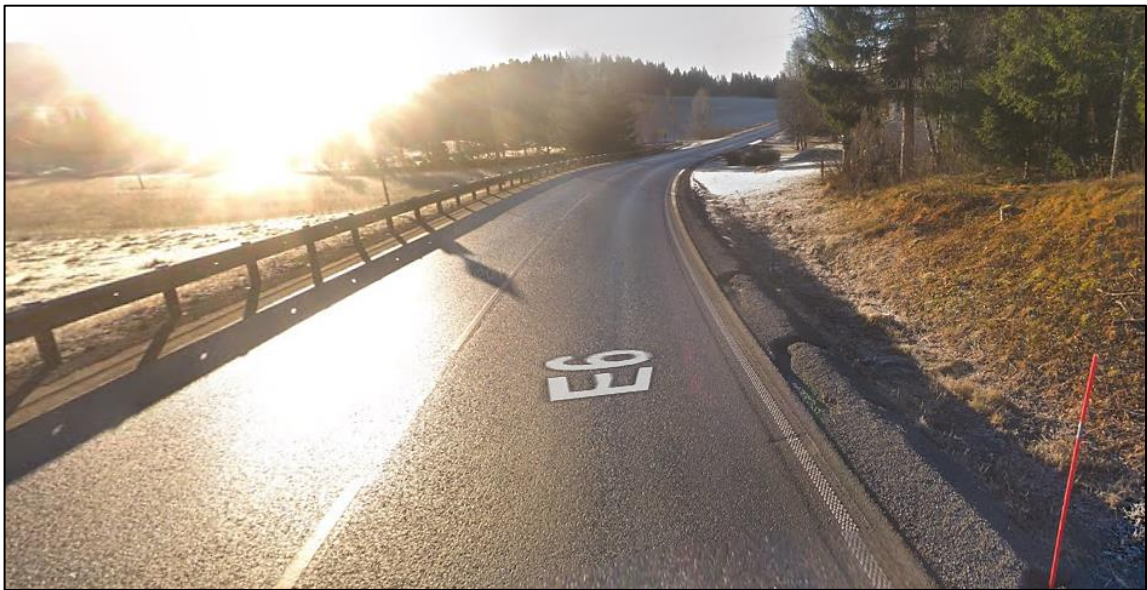
On Sunday 2 February 2020, at approximately 10:40, a Polish heavy goods vehicle was heading south on the E6 road with a trailer carrying a cargo of fish. The heavy goods vehicle had left Gartland at 10:05 (see Figure 1) and was bound for Maryport, England. In a downward slope towards a right-hand curve before the exit to Østvika, the driver lost control of the Polish heavy goods vehicle, which crossed into the opposite lane (see Figure 2). The vehicle collided head-on with a Norwegian heavy goods vehicle travelling north on the E6 road carrying foods (see Figure 3). This heavy goods vehicle had left Trondheim that morning and was bound for Brønnøysund.

Figure 2: North-to-south view of the section of road where the heavy goods vehicles collided.
Photo: Google Maps

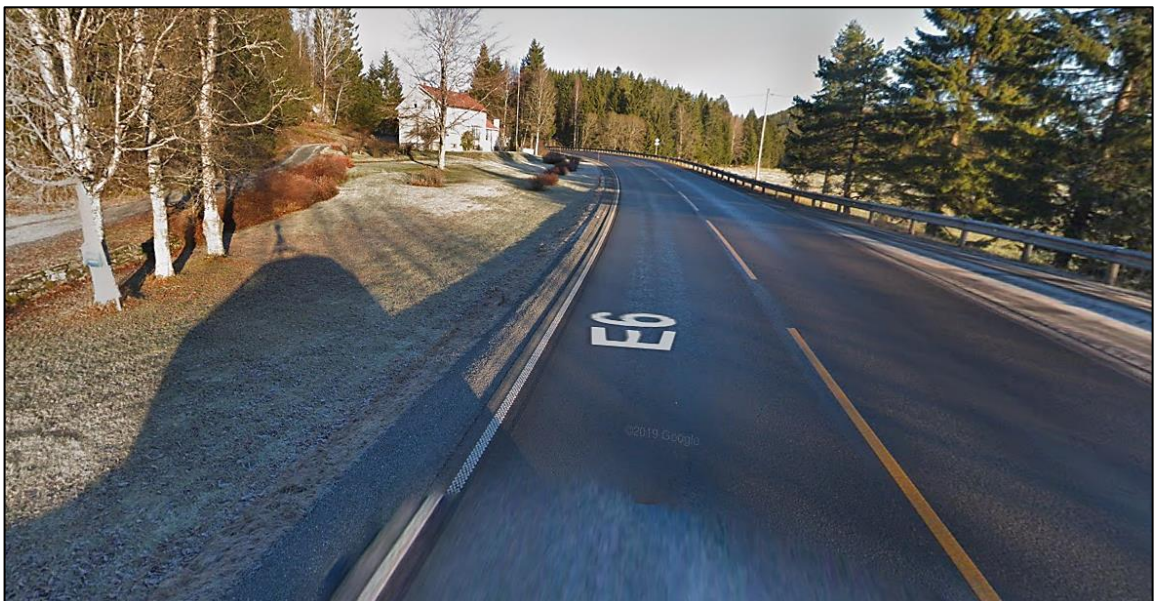
Figure 3: South-to-north view of the section of road where the heavy goods vehicles collided.
Photo: Google Maps

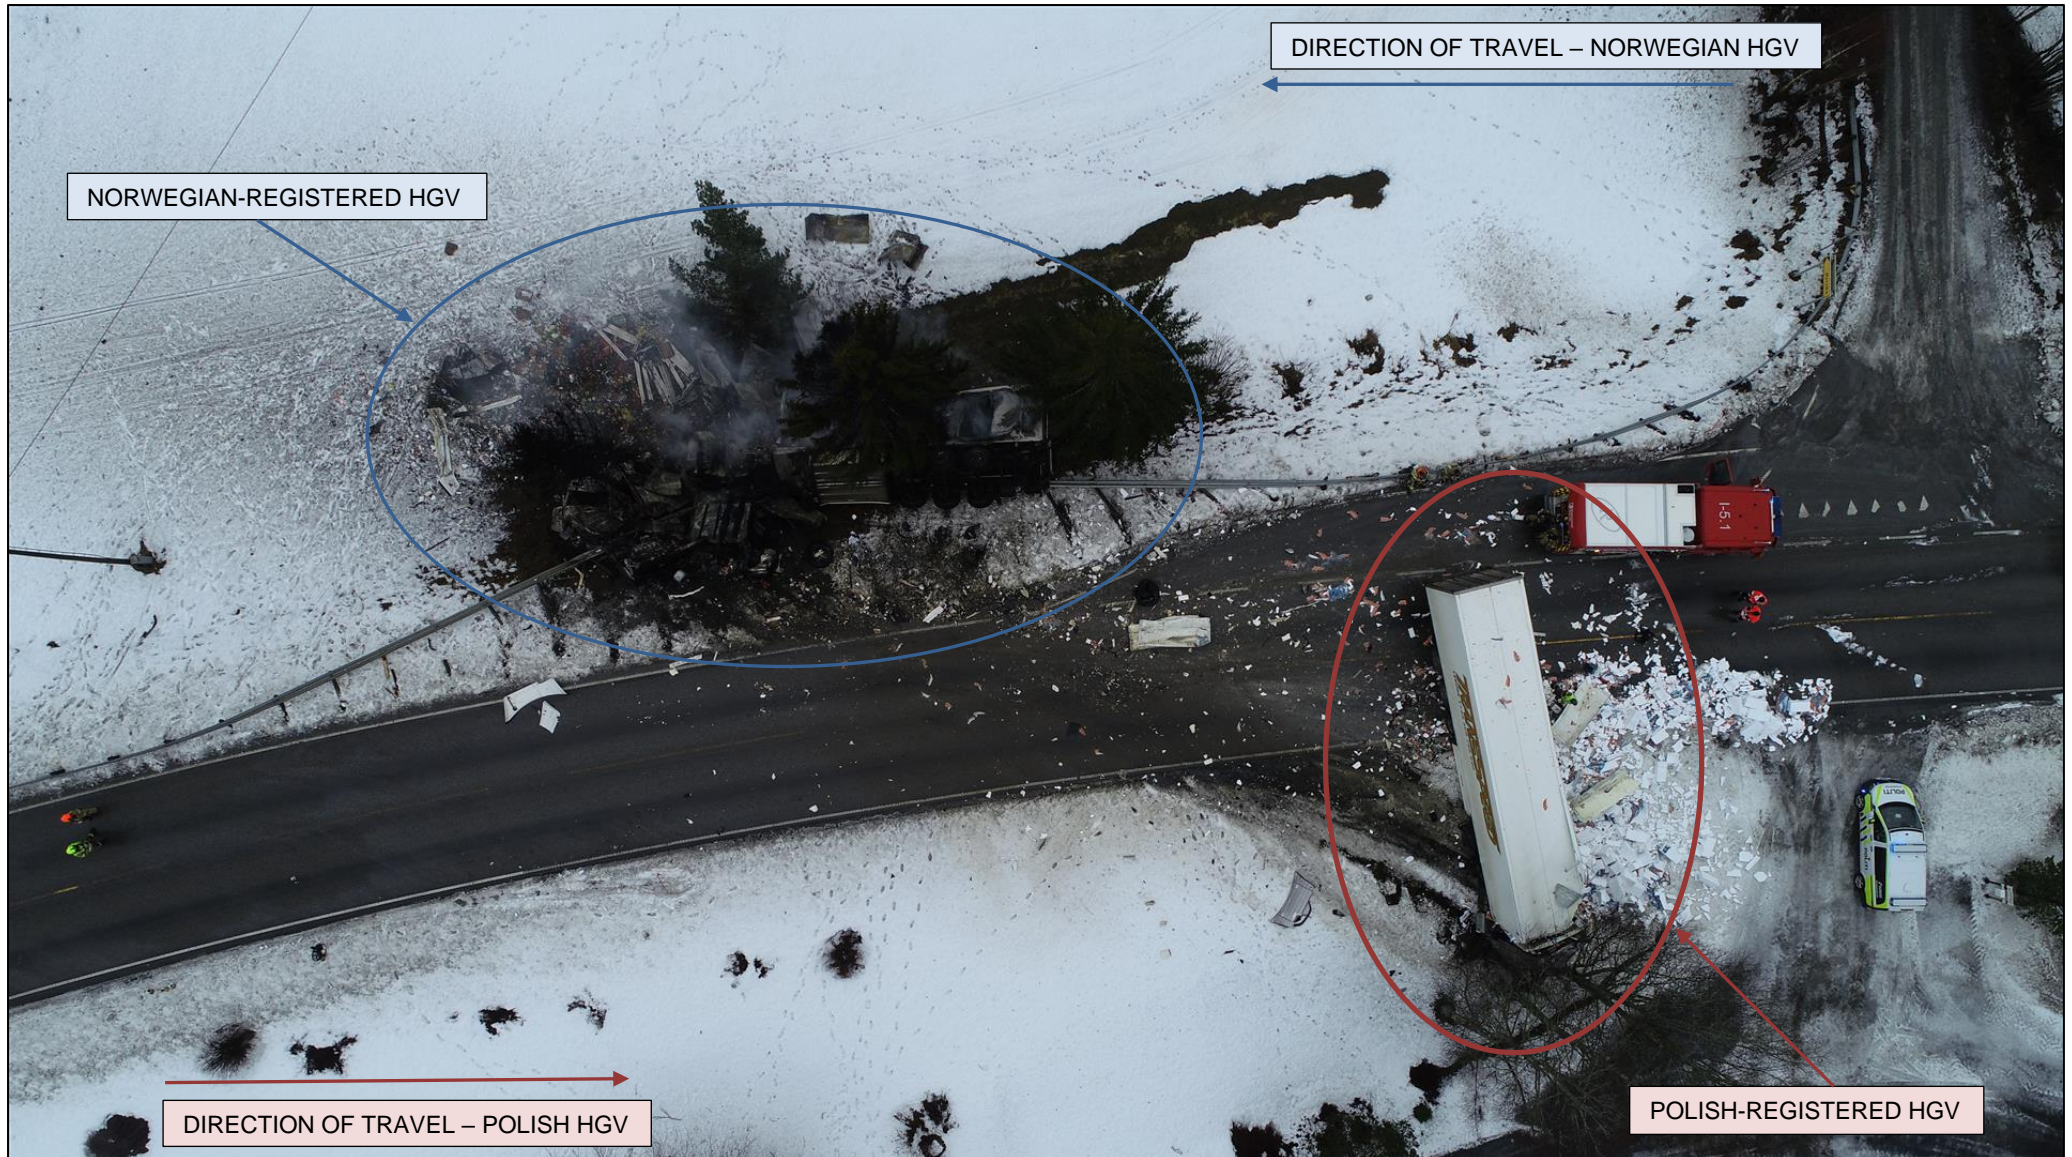
Figure 4: The scene of the accident. The two heavy goods vehicles involved and their respective directions of travel are shown. Photo: NPRA. Illustration: NSIA

After the collision, the Polish heavy goods vehicle ran off the road from its lane. The tractor unit came to a stop with its front against some trees, and the semi-trailer ended up at an angle of approximately 90° across the road. The Norwegian heavy goods vehicle ran off the road from its lane after the collision, before it overturned and came to rest against some trees in a slope. Both tractor units sustained extensive material damage in the accident. The driver's cab of the Norwegian vehicle caught fire immediately after the collision.

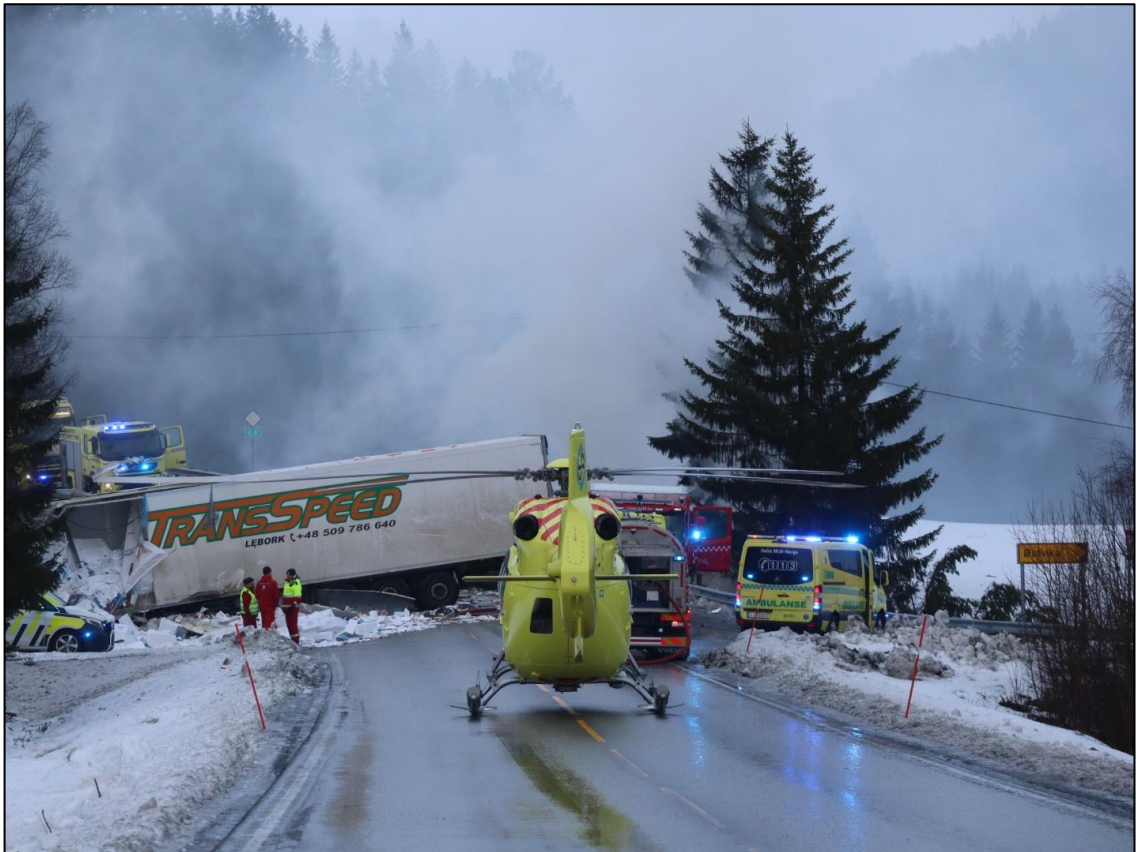
Figure 6: Firefighting and rescue work in progress at the scene of the accident. Photo: Lars Lilleby Macedo

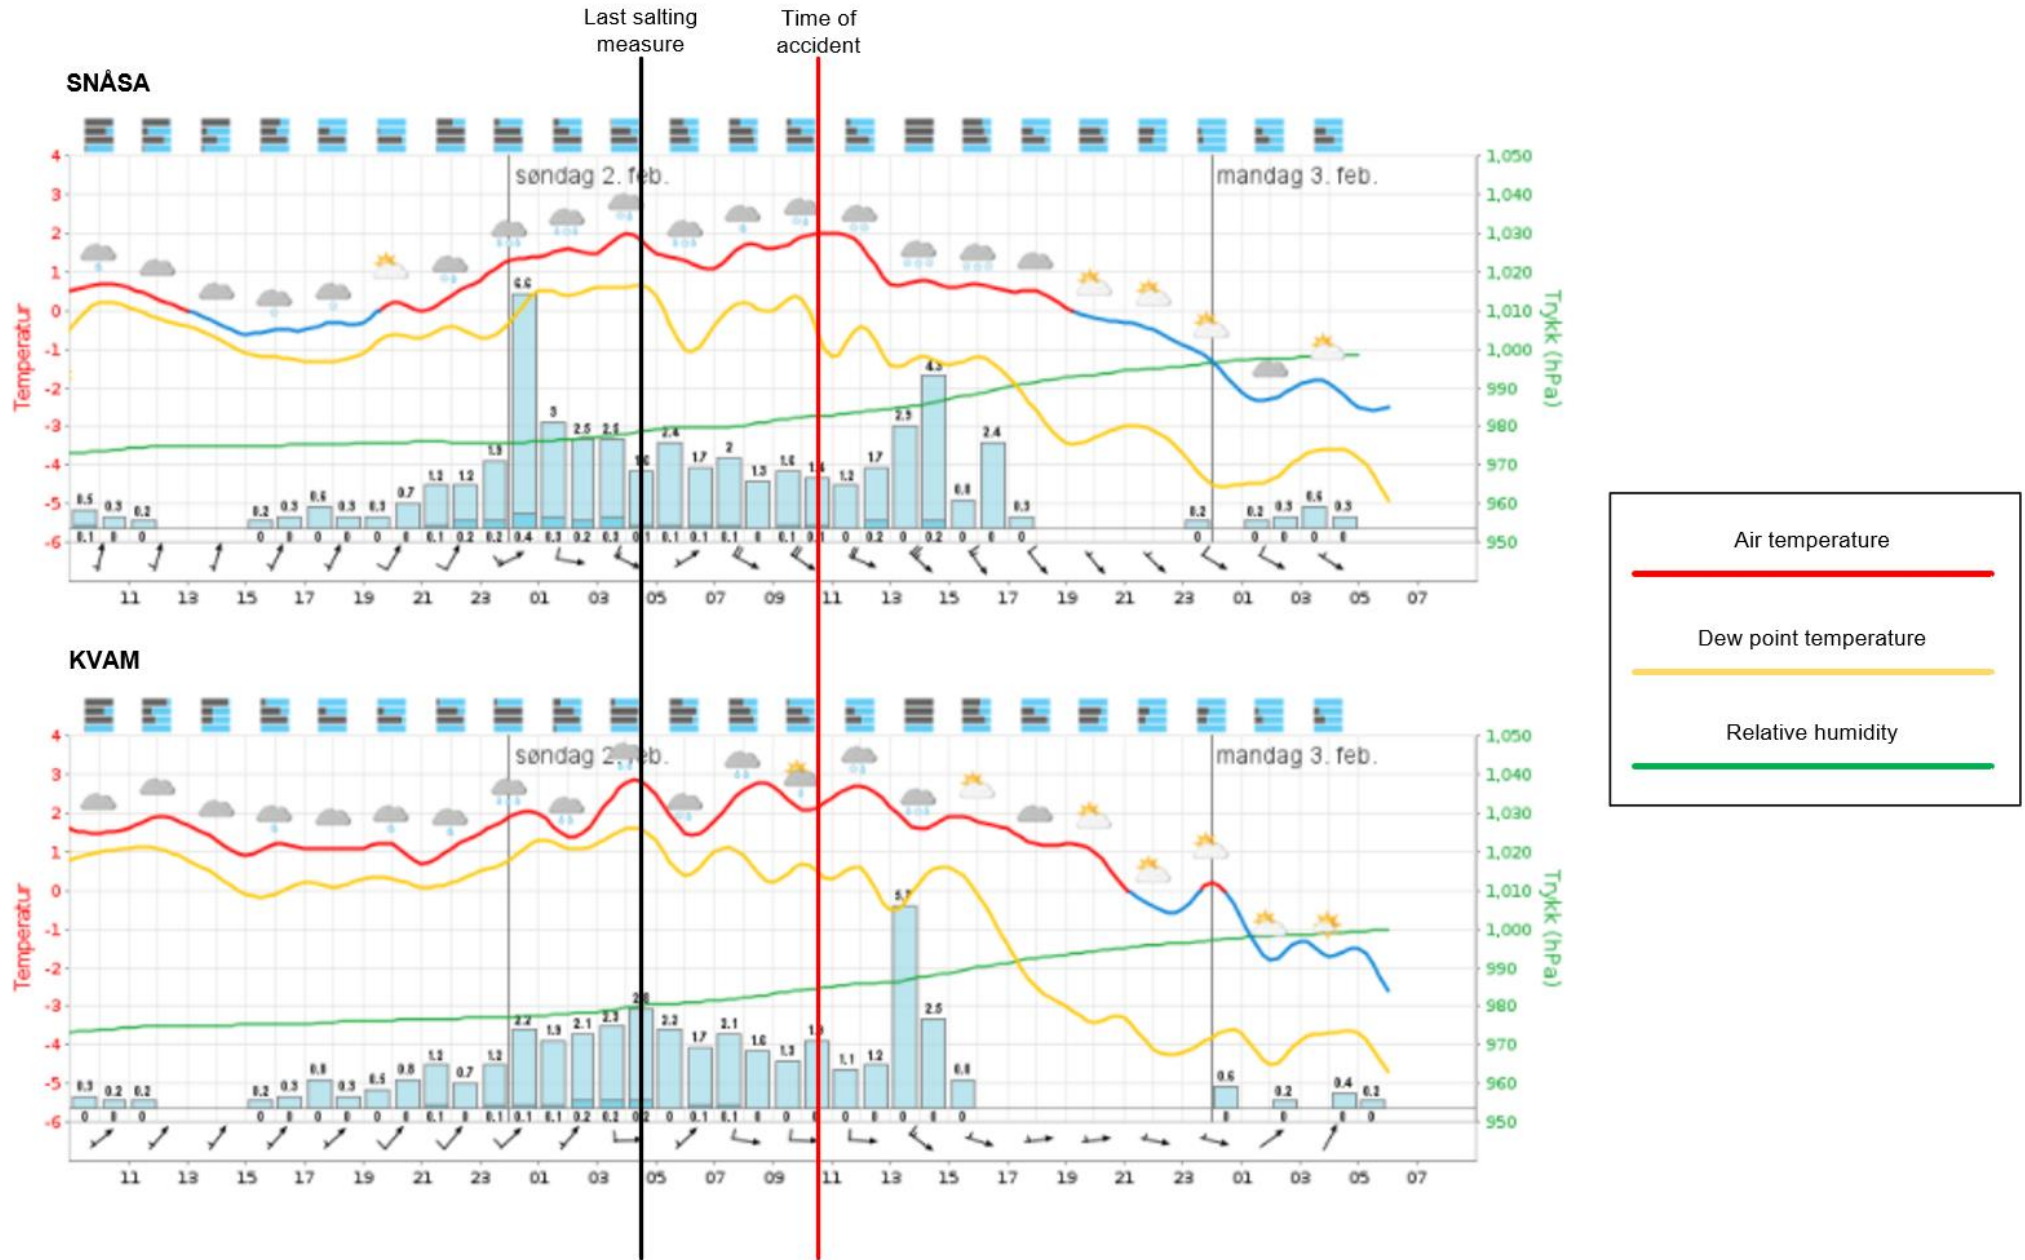
The air temperature was forecast to be 1–3 °C through the night and in the morning of 2 February. The forecast dew point temperature was minus 1–1.5 °C.

Figure 18: Meteograms for Snåsa and Kvam with the time of the last salting and the time of the accident indicated. Source: Norwegian Meteorological Institute
Illustration: NSIA

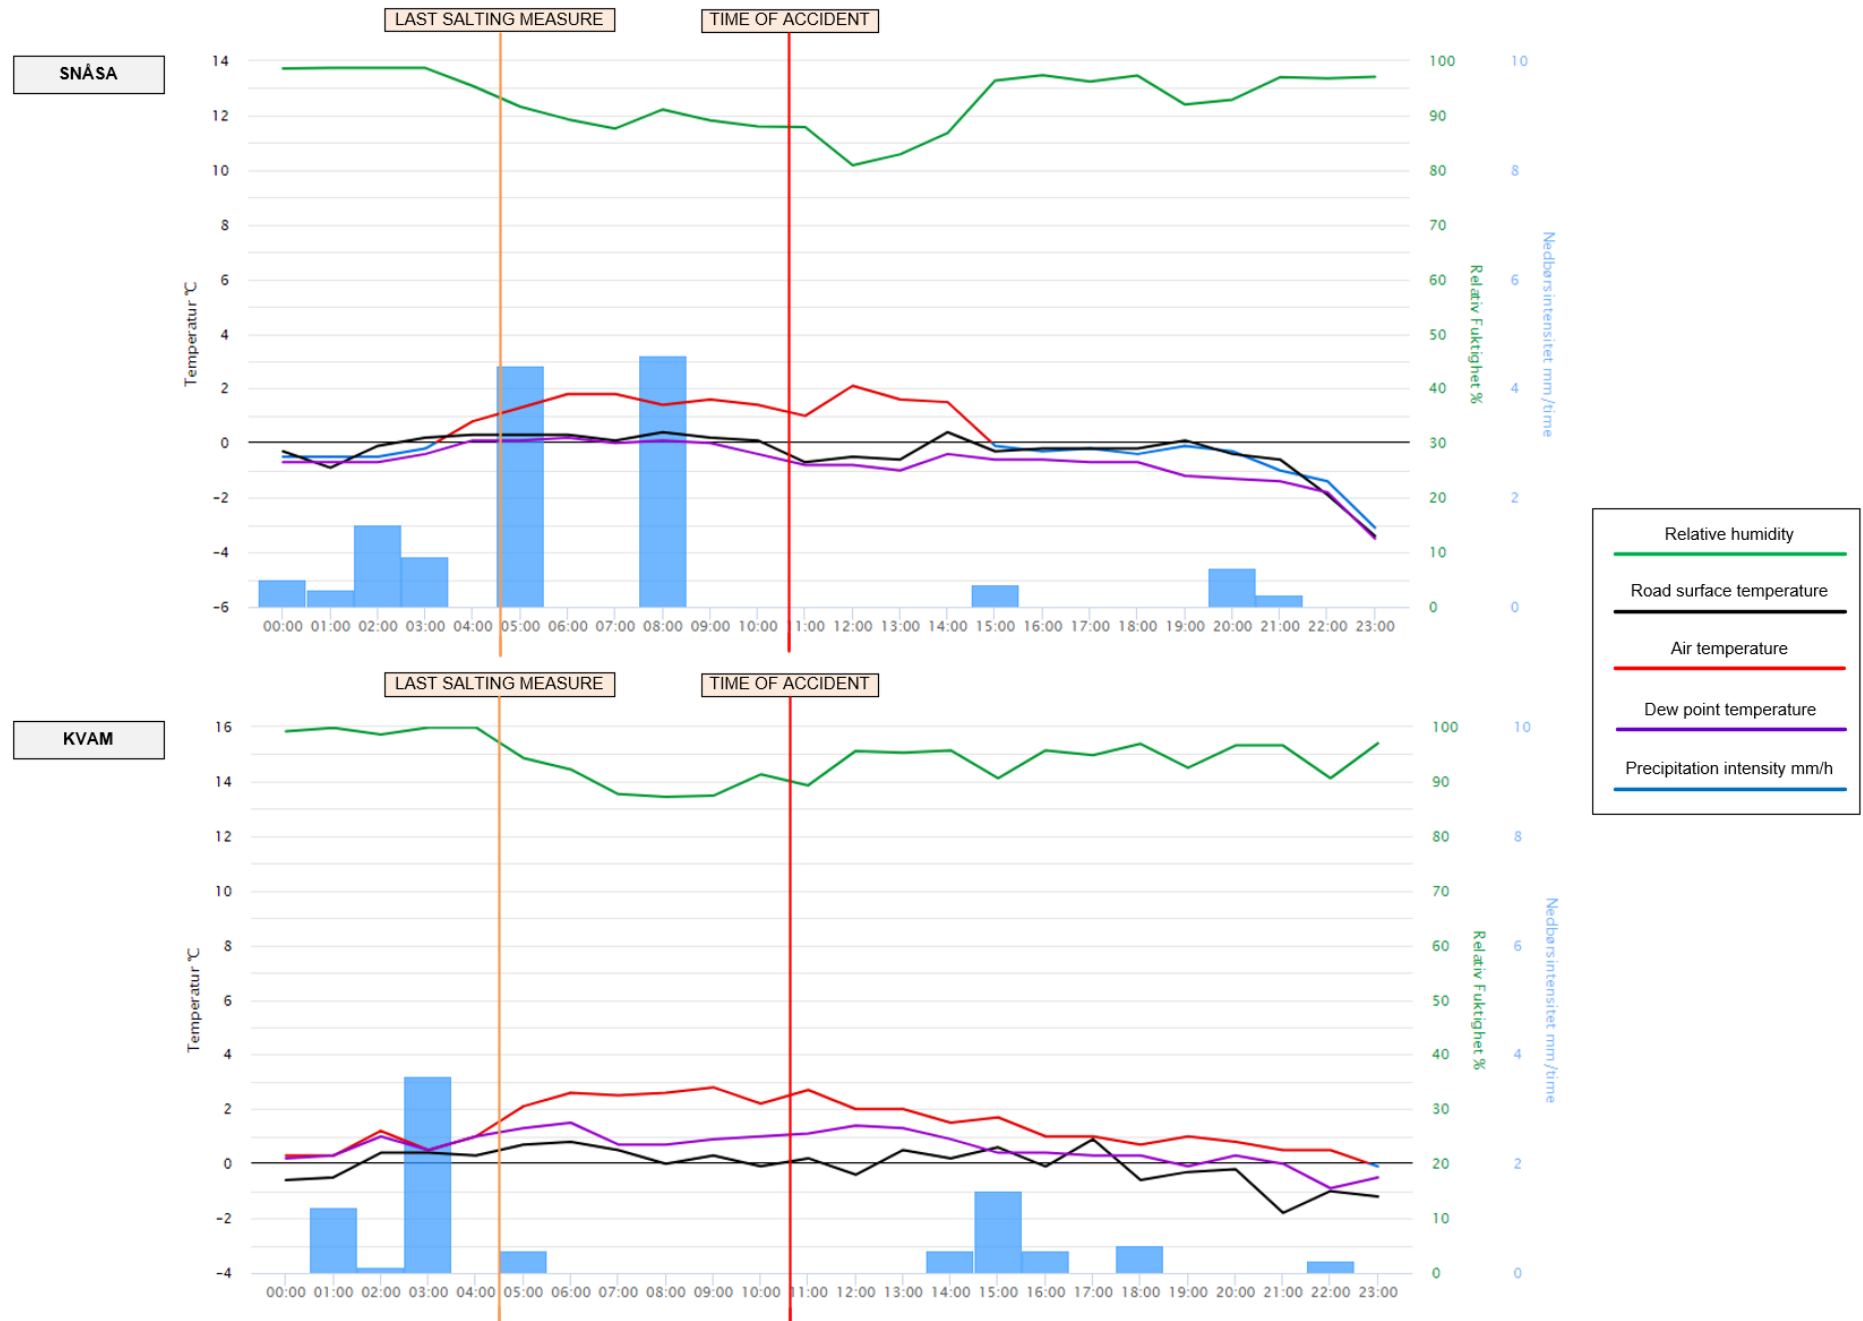
The 'E6 Snåsa' station has recorded dew point temperatures above 0 °C from 04:00 until 09:00, after which the temperature dropped below 0 °C. The 'E6 Kvam' station has recorded dew point temperatures above 0 °C from midnight until 19:00. At the time of the accident, the two weather stations recorded a road surface temperature of 0.4 °C and 1.0 °C, respectively.

From 04:00 until 11:00, the 'E6 Snåsa' station recorded air temperatures of 0.8–1.8 °C. The 'E6 Kvam' station recorded air temperatures of 1.0–2.8 °C during the same period. At the time of the accident, the two weather stations recorded air temperatures of 1.2 °C and 2.5 °C, respectively.

Figure 19: Data from the weather stations 'E6 Snåsa' and 'E6 Kvam' showing the relevant weather developments on 2 February 2020. Source: Vegvær.no. Illustration: NSIA

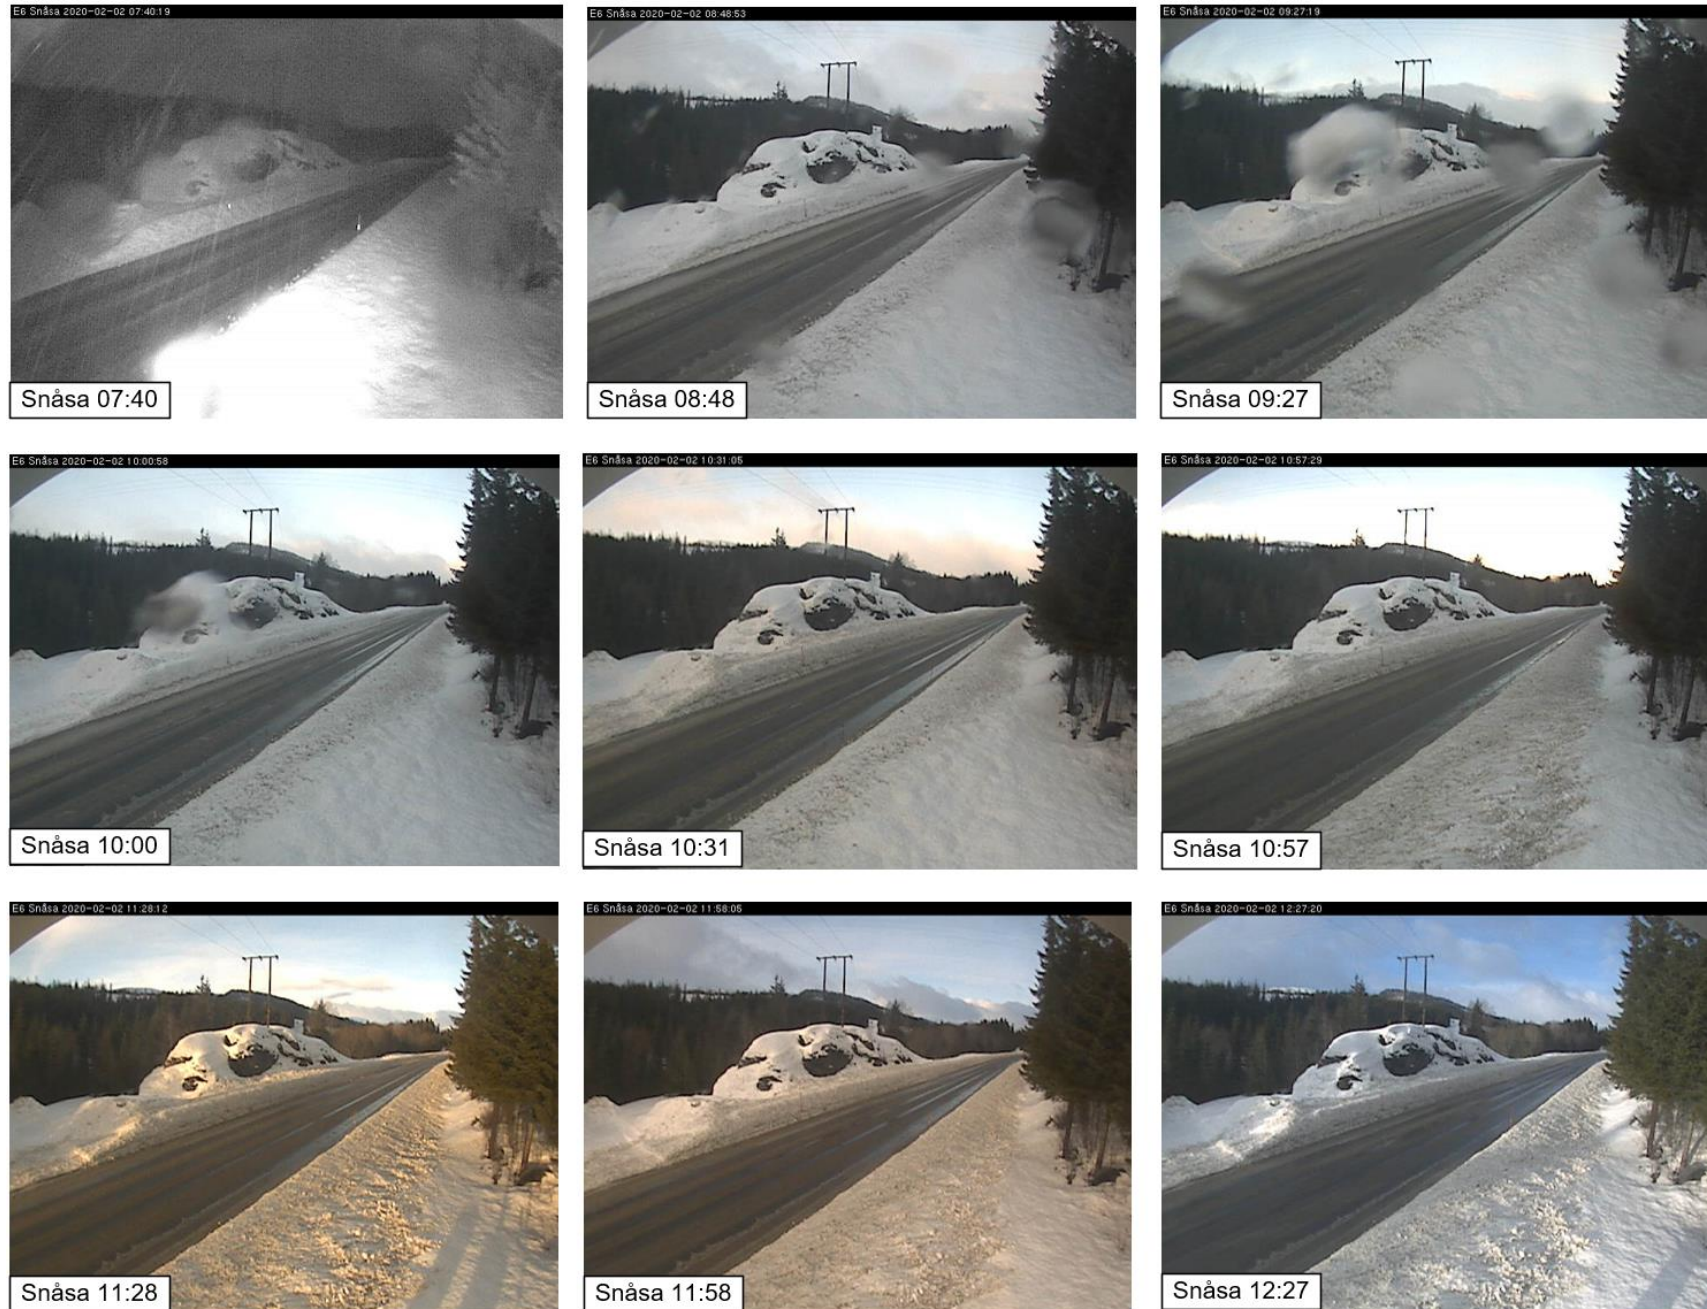
Figure 21 shows web camera images from Snåsa from the time between 06:00 and 13:00 on 2 February. The images clearly show precipitation from 07:30, followed by the cloud cover clearing up from approx. 08:40. The images show clear weather at the time of the accident. The clear weather continued until 13:00, after which the sky clouded over and a period of precipitation followed from 14:10.

Figure 21: Web camera images from the weather station 'E6 Snåsa' from the period between 07:40 and 12:27. Source: NPRA

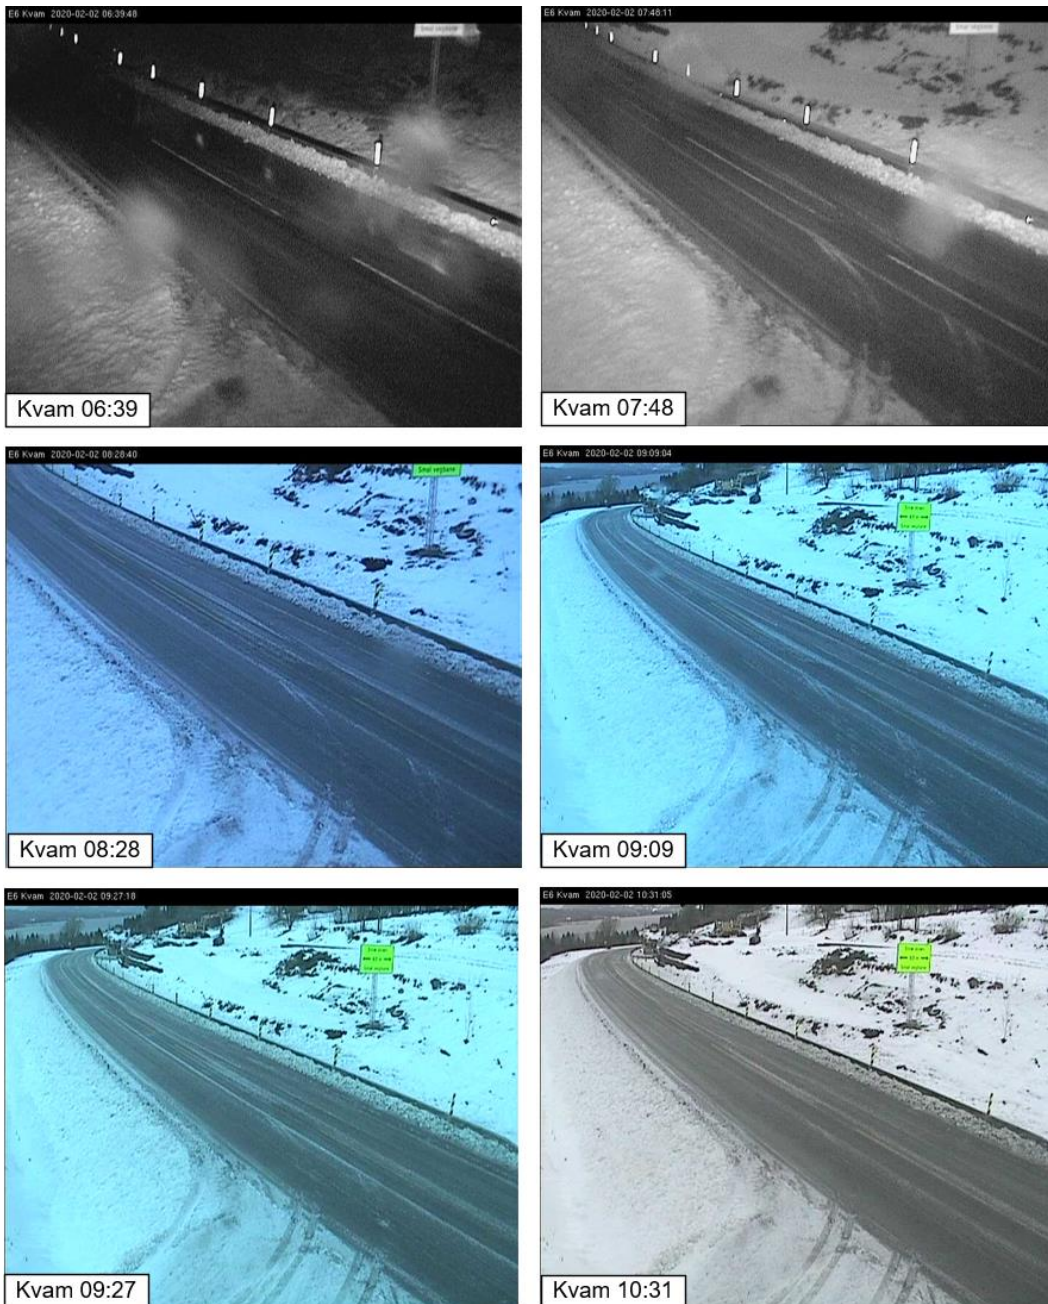
Figure 22 shows web camera images from Kvam from the time between 06:00 and 13:00 on 2 February. The images show that there was precipitation at Kvam in the morning, followed by a period of dry weather until 10:10. The images then show precipitation again at Kvam at 10:10, about half an hour before the accident occurred. The images show dry weather at the time of the accident. There was precipitation from 11:10 to 12:00, followed by a dry period lasting until 13:00.

The camera at Kvam does not show the sky, only the road. The images show small amounts of ice and/or snow in the road from approx. 07:30 and as the morning progressed.

Figure 22: *Web camera images from the weather station 'E6 Kvam' from the period between 06:39 and 10:31. Source: NPRA*

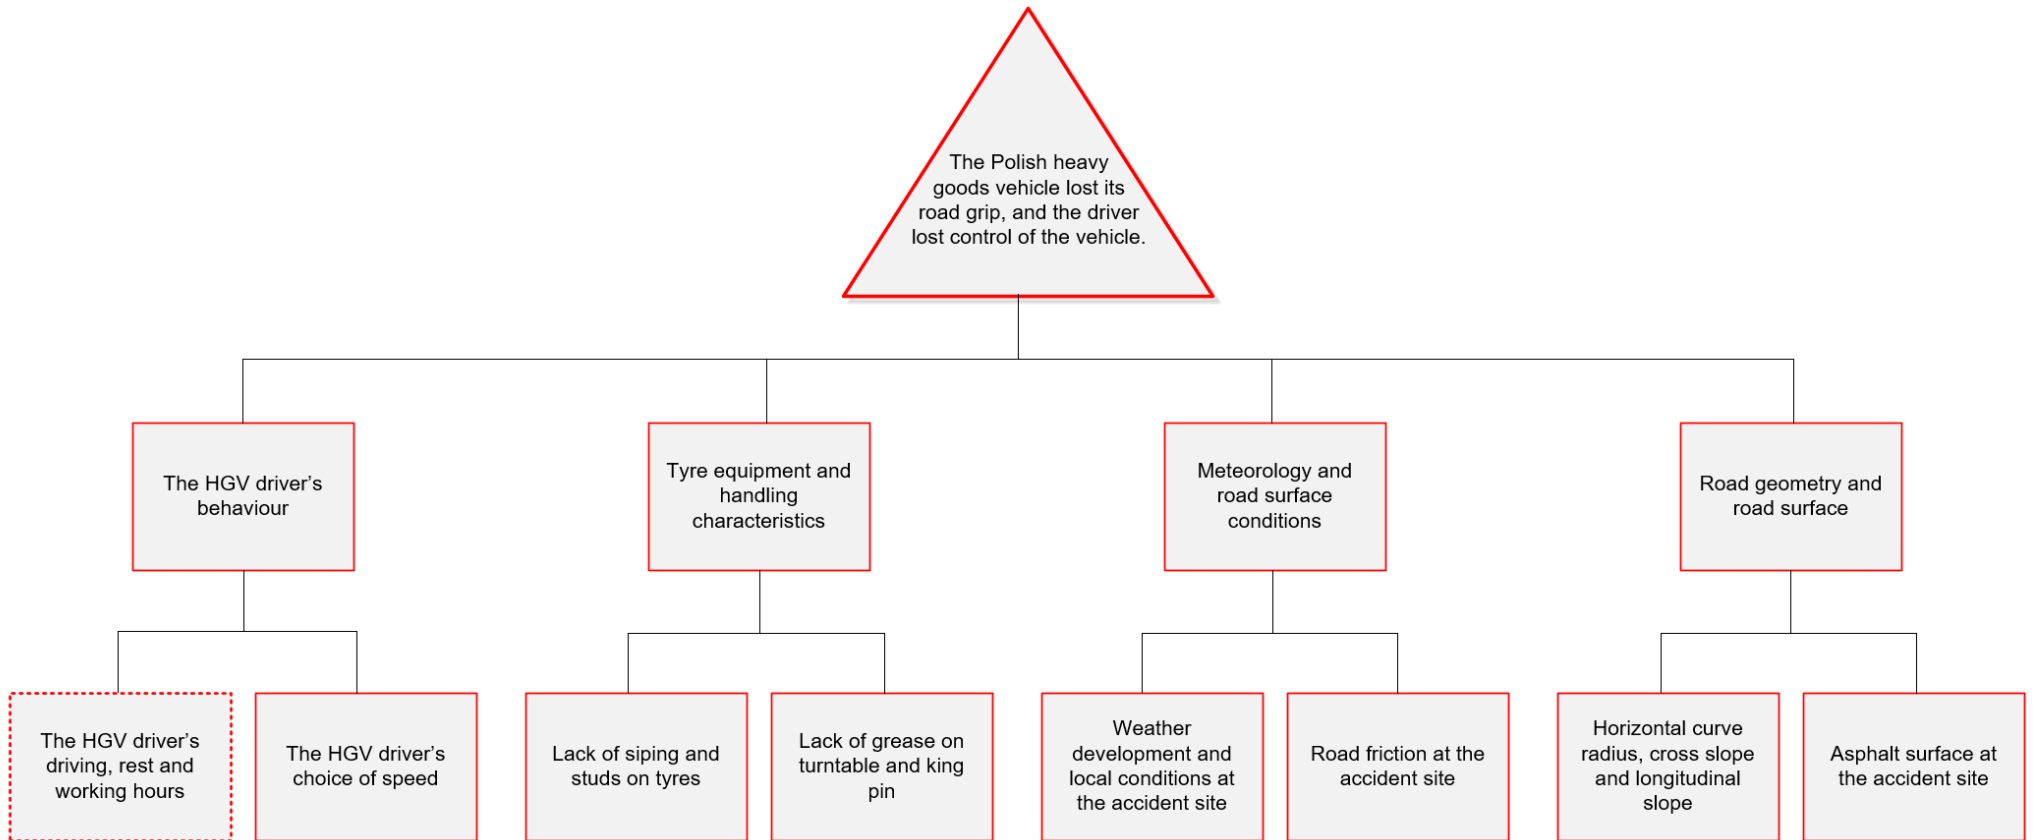
It is the NSIA's assessment that low road friction at the accident site was the immediate cause of the southbound heavy goods vehicle losing its road grip and entering the opposite lane. However, the investigation has shown that the accident was a result of interaction between several elements of the traffic system (see Figure 27).

The identified contributory causes of the accident are illustrated in Figure 27.³⁷ The figure must not be considered exhaustive, but refers to the factors that the NSIA, in the course of its investigation, has found to have had a negative impact on the sequence of events.

³⁷ The investigation has not identified circumstances relating to the Polish HGV driver's driving, rest and working hours that the NSIA believes may have contributed to the accident (dotted line in Figure 27).

Figure 27: The safety problem that was the immediate cause of the collision between the heavy goods vehicles, and contributory factors to the accident. Illustration: NSIA

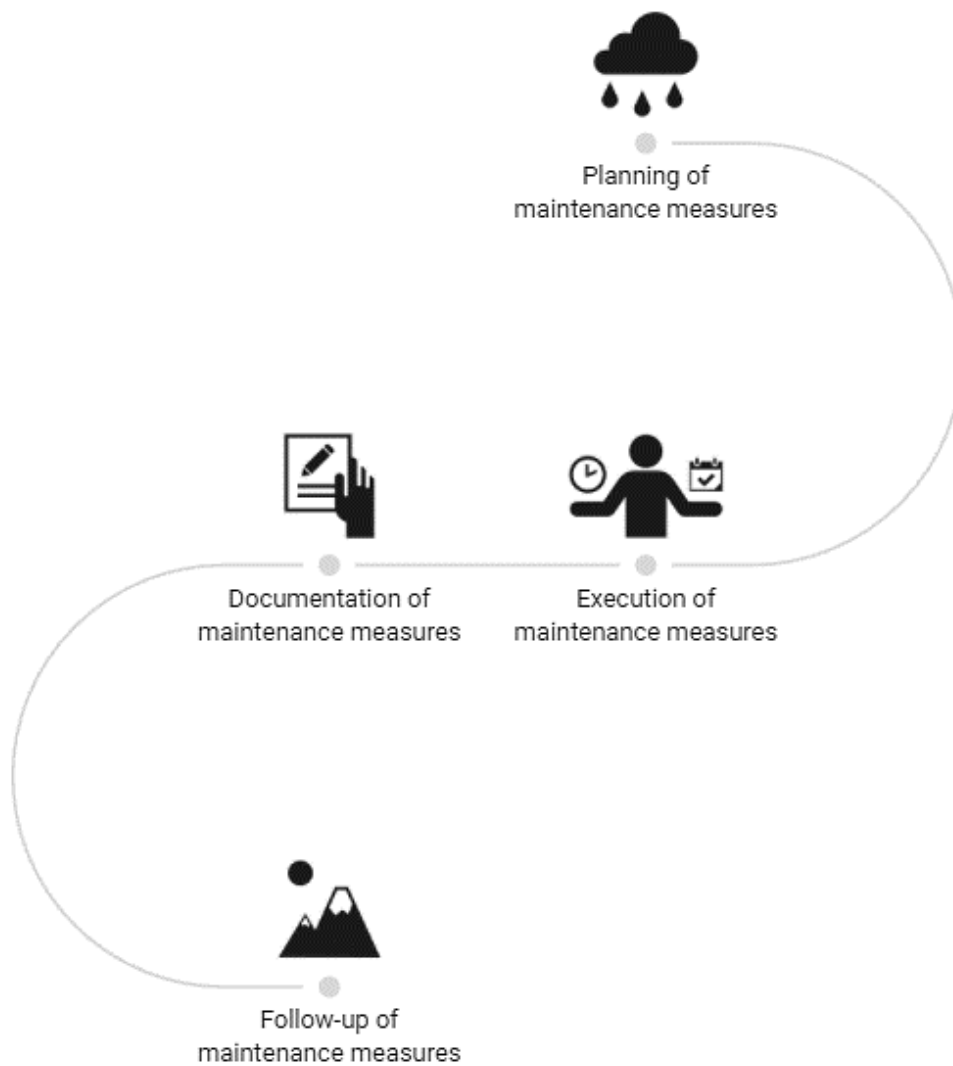
The investigation identified several shortcomings relating to winter road maintenance. The relevant findings have been thematically considered, and the categories are presented in Figure 28.

Figure 28: Thematic categorisation of investigation findings relating the contractor's winter road maintenance. Illustration: NSIA

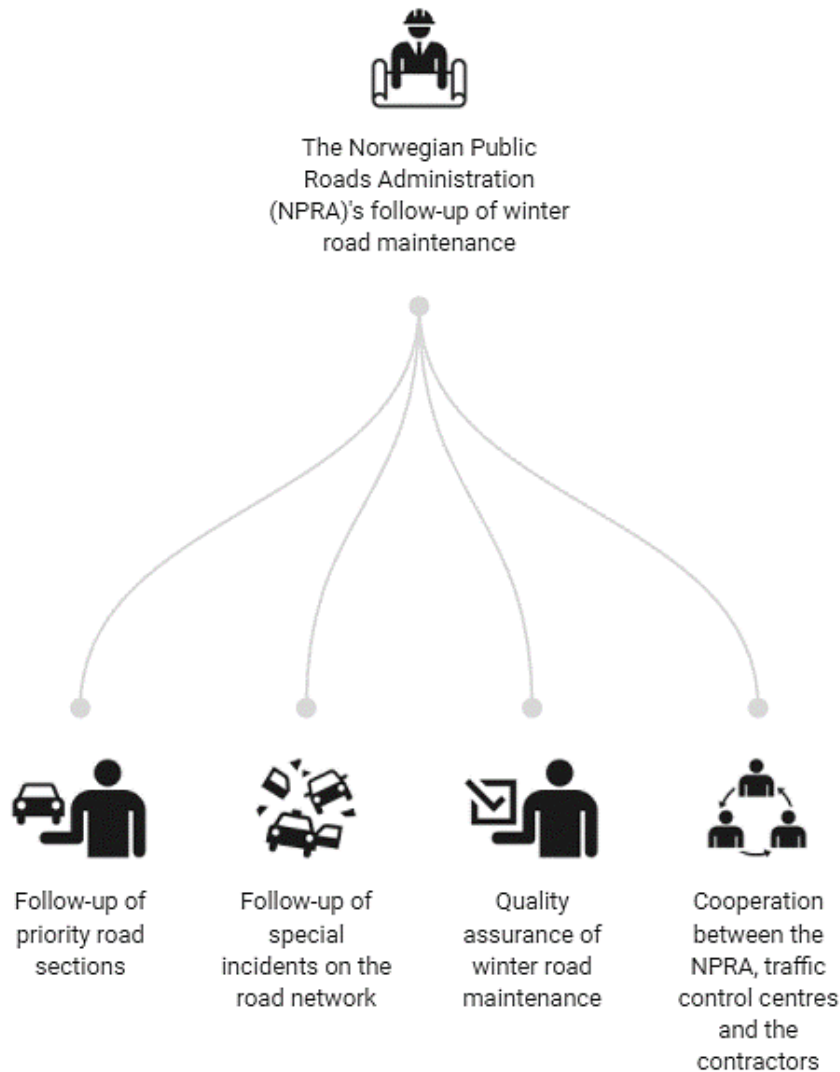
Investigation findings relating to the NPRA's follow-up of the winter road maintenance have also been thematically considered, and the categories are presented in Figure 29.

Figure 29: Thematic categorisation of investigation findings relating the NPRA's follow-up of the winter road maintenance. Illustration: NSIA
