# REPORT

ROAD 2022/06

*Accident involving a passenger car and  
an HGV driver on the E18 road near  
Arendal on 29 May 2020*

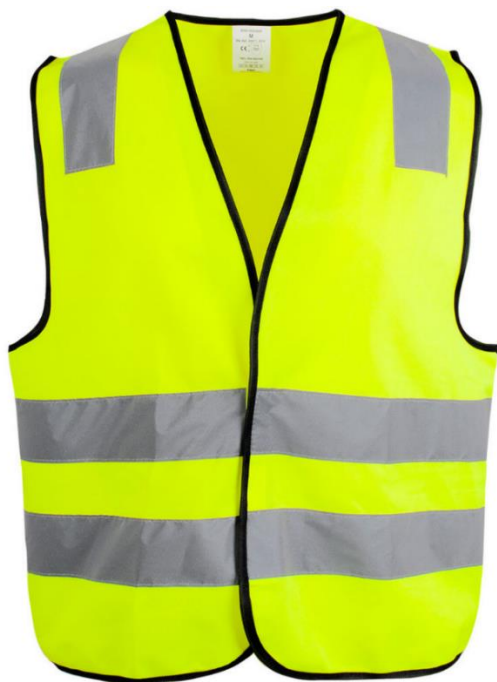
The HGV driver was wearing a yellow high-visibility vest with two reflective stripes around the waist and reflective stripes on the shoulders (see figure 2). The vest was torn along the seam in the right side.

Figure 2: High-visibility vest similar to the one worn by the HGV driver. Source: YOU Odense high-visibility vest

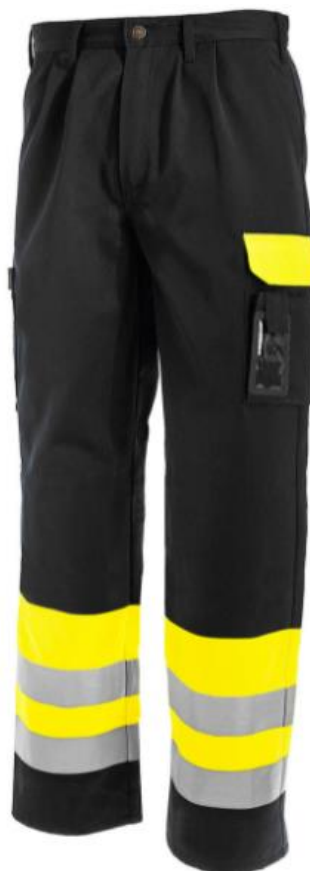
He was also wearing a pair of black work trousers of the brand 'Blåkläder' (see figure 3).

Figure 3: Work trousers similar to the pair worn by the HGV driver. Source: Blåkläder

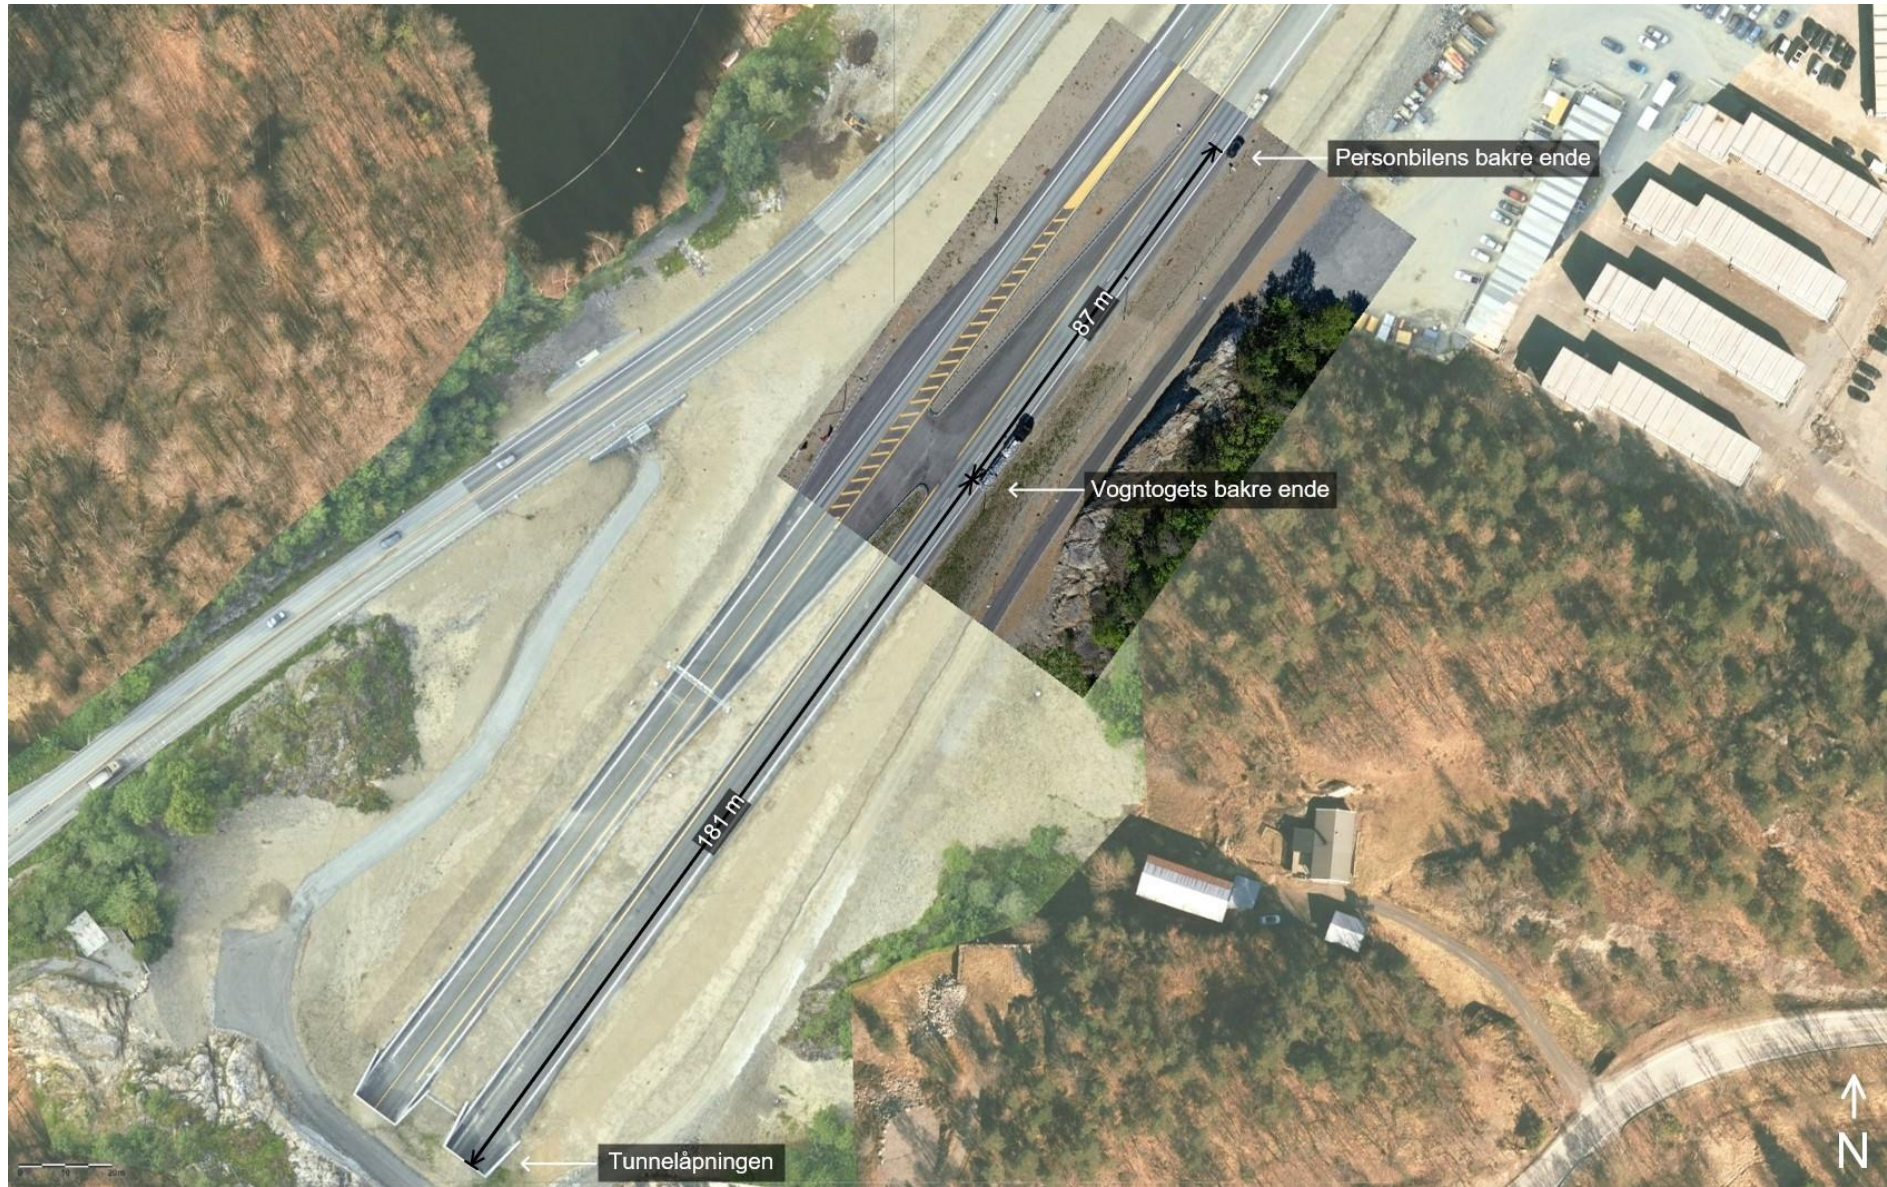
The accident happened in the northbound lane of the E18 road near Arendal, about 1.5 km north-east of Harebakken. The accident site is located on a straight stretch of road 181 metres north-east of the Torsbuås tunnel exit (see figure 8).

Figure 8: Overview photo and drone photo of the accident site. Map: © Norwegian Mapping Authority. Photo: The police. Illustration: NSIA

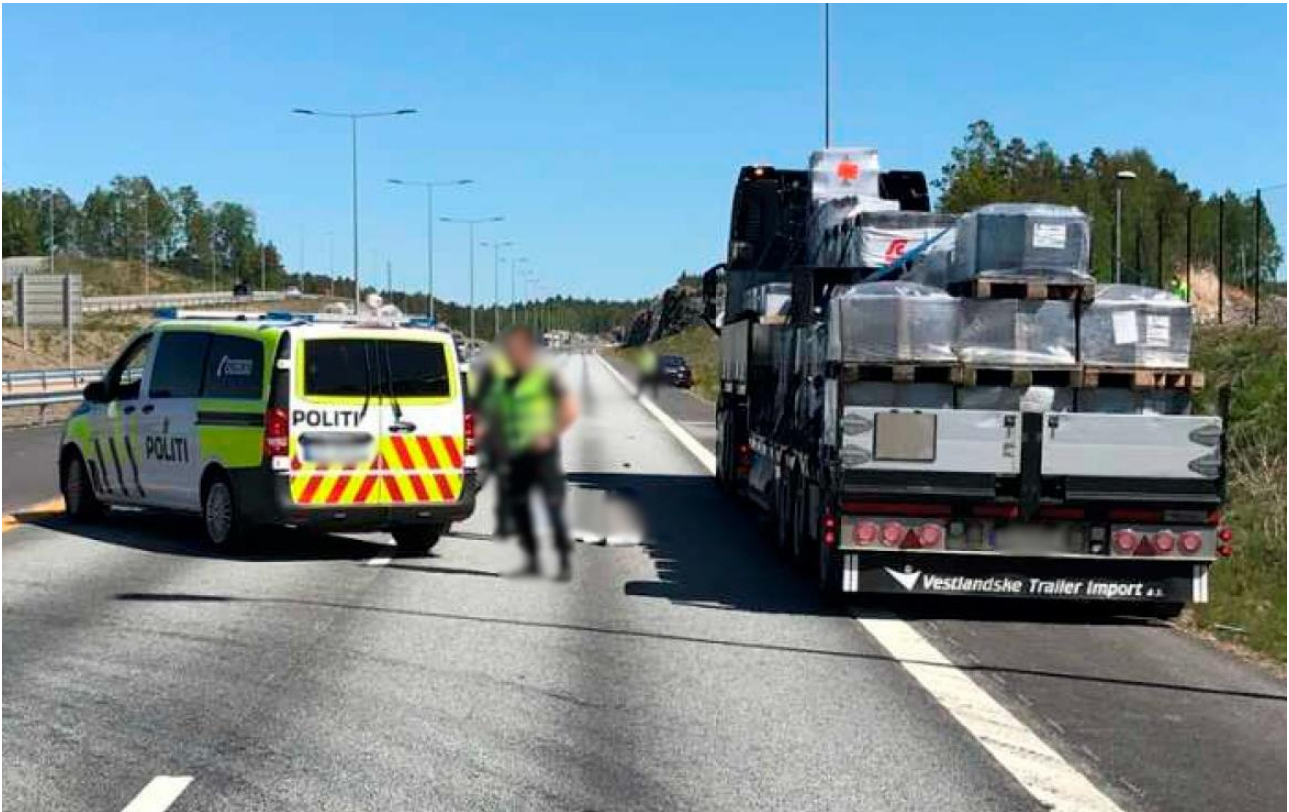
Figure 12 and figure 13 show the shadow conditions and the extent of the shadows cast on the roadway by the HGV approx. 50 minutes after the accident. The police took these photos between 12:08 and 12:10. According to PC-Crash and Sun Surveyor, the sun was then 50.9° above the horizon and 152.3° south-southwest in the sky.

Figure 12: Extent of the shadows cast on the roadway by the HGV between 12:08 and 12:10. The photo was taken from the northbound lane looking north. Photo: The police

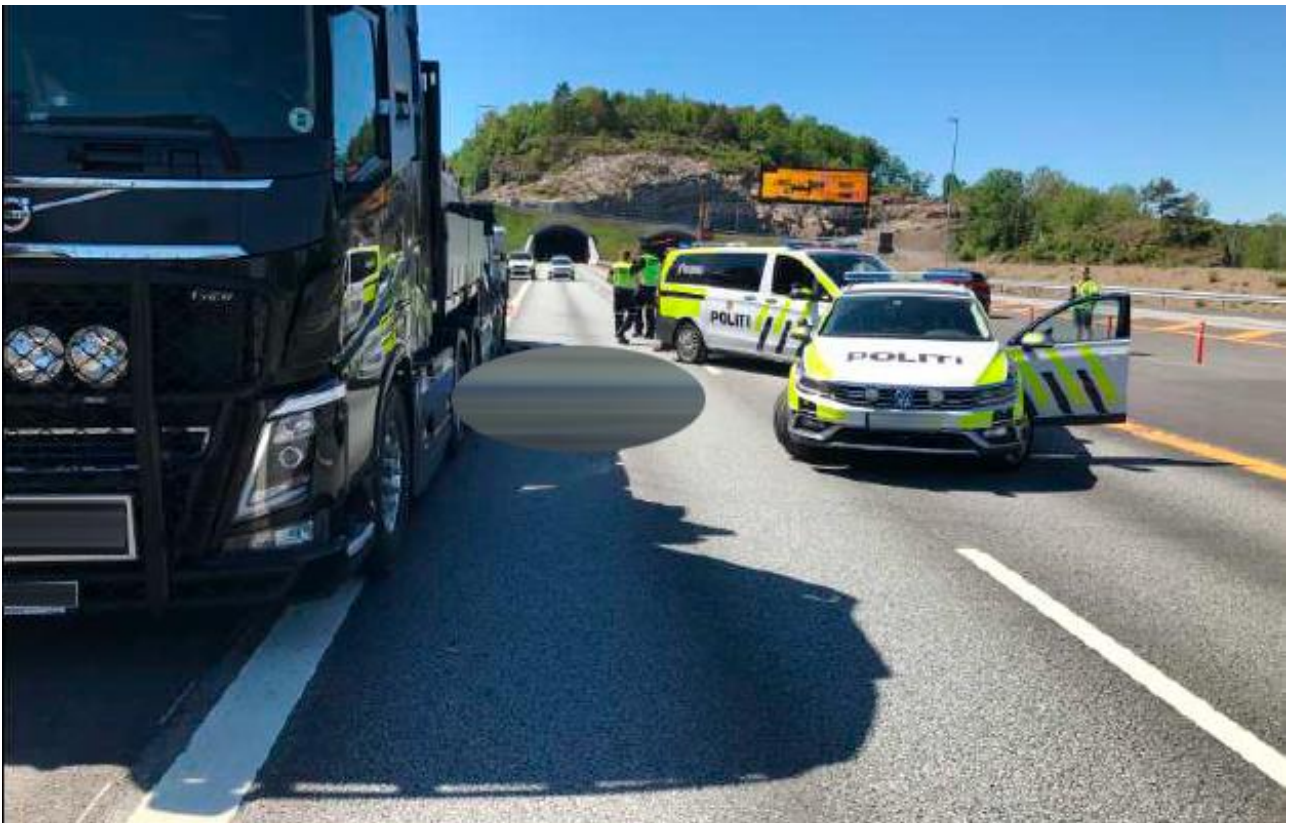
Figure 13: Extent of the shadows cast on the roadway by the HGV between 12:08 and 12:10. The photo was taken from the northbound lane looking south. Photo: The police

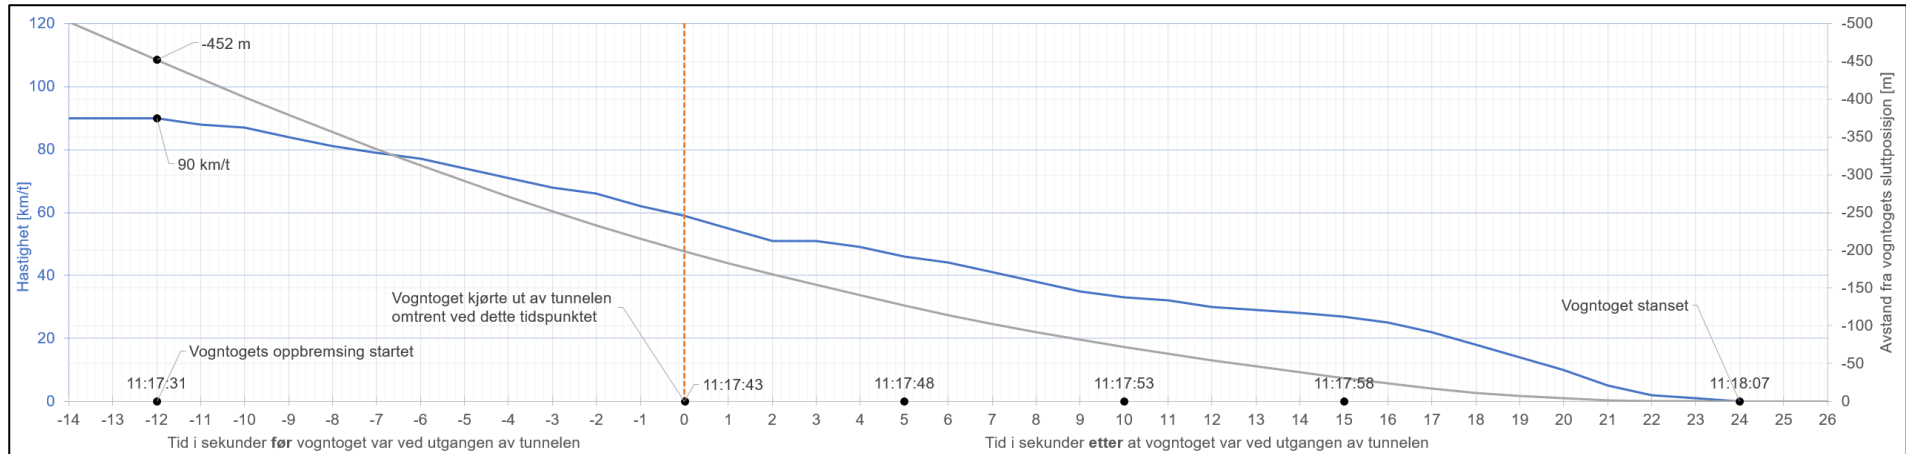
Tachograph data<sup>4</sup> downloaded from the heavy goods vehicle show that the vehicle was travelling at a speed of approx. 90 km/h before it began to slow down (see figure 17). This was while the HGV was inside the Torsbuås tunnel, approx. 450 metres from its final position. It took the HGV approx. 24 seconds to travel from the tunnel exit to the place on the E18 road where it stopped.

Figure 17: The HGV's speed and calculated distance from its final position before and after exiting the Torsbuås tunnel.<sup>6</sup> Source: NPRA. Illustration: NSIA

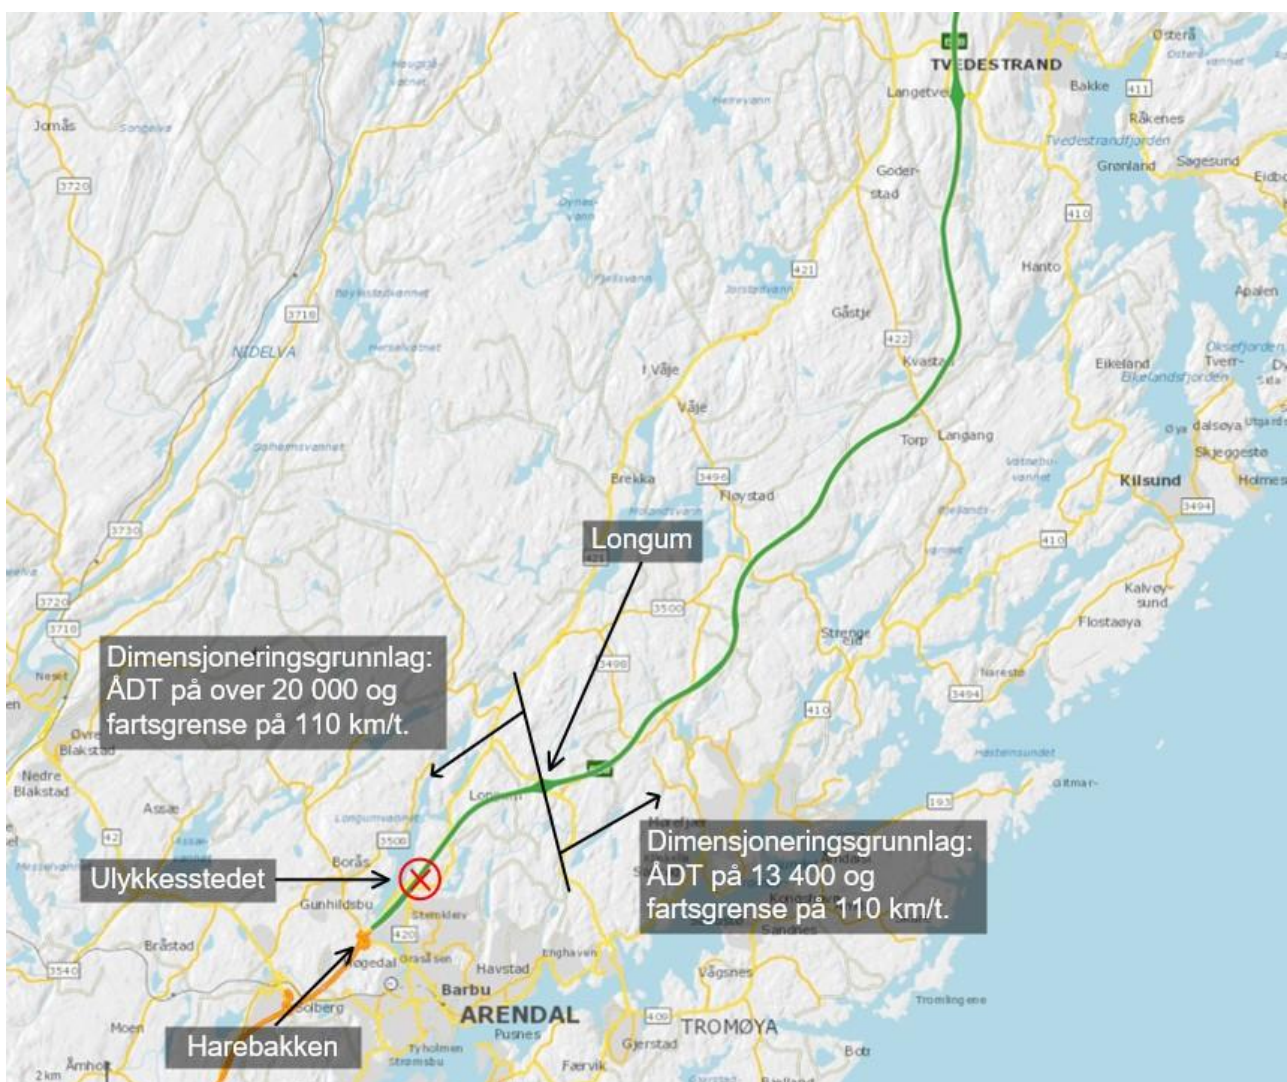
The section south of Longum, which is where the accident happened, was dimensioned for an AADT of more than 20,000 vehicles/day and has a speed limit of 110 km/h (see figure 18). The section had an annual average daily traffic AADT of 10,279 vehicles/day in 2020.

Figure 18: Overview map with basis for dimensioning. The new part of the E18 road is shown in green. Map: Vegkart.no. Illustration: NSIA

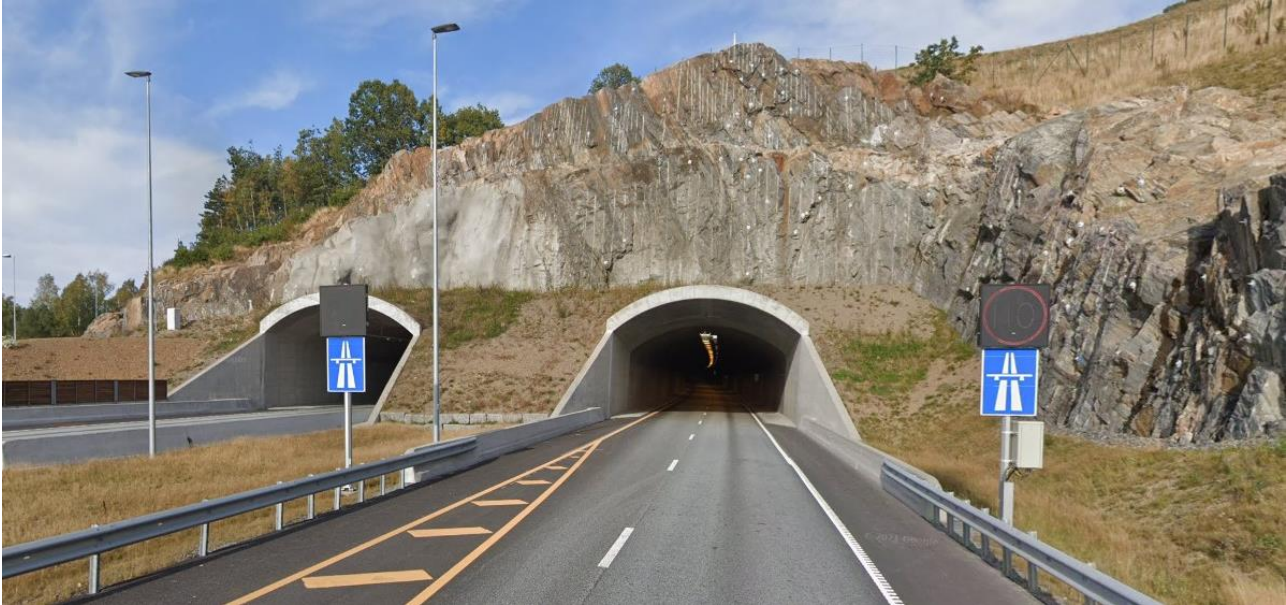
The speed limit on the E18 road is 80 km/h up to a point just before the entrance to the Torsbuås tunnel when travelling north. The road changes from one to two lanes at the same point. At the time of the accident, remotely controlled variable speed limit signs were placed here, and the speed limit was set to 110 km/h (see figure 19). Such variable speed limit signs were also installed just before the accident site, about 70 metres south of the rear end of the HGV. These signs were also set to 110km/h at the time of the accident.

Figure 19: The portal of the Torsbuås tunnel with electronic speed limit signs, view when travelling north.  
Photo: Google Maps

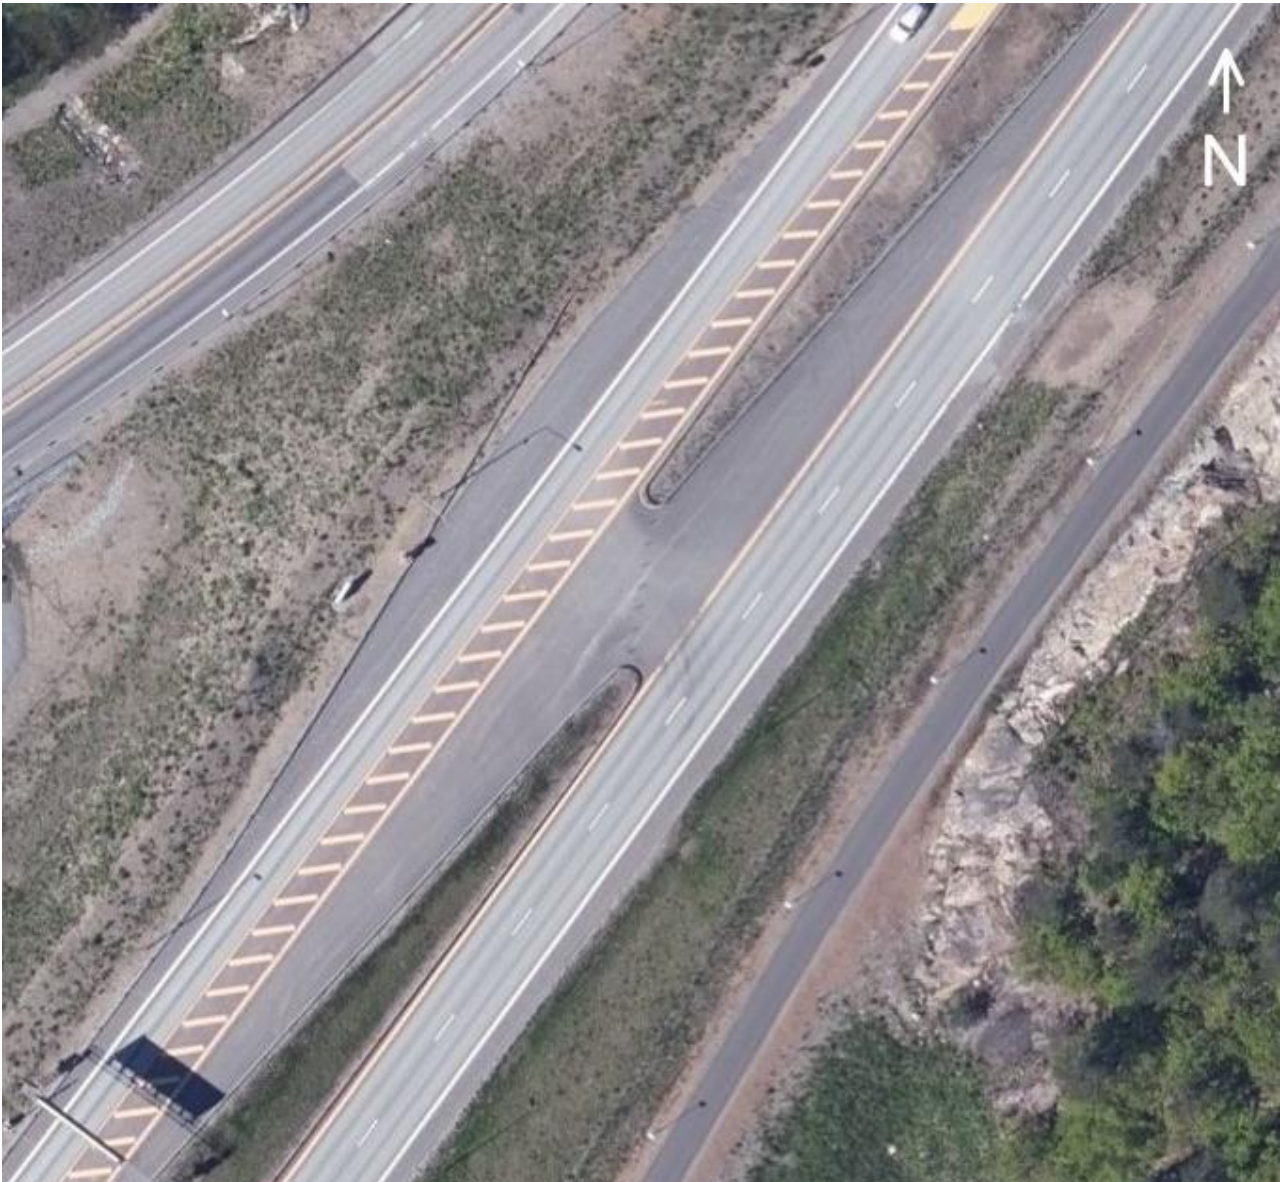
At the accident site, there are two northbound lanes and one southbound lane. In the southbound direction, the road narrows from two to one lanes just north of the accident site. In the area where the HGV stopped, there is a tarmacked service passage between the northbound and southbound lanes (see figure 20).

Figure 20: Overview photo of the section of road where the accident occurred. Photo: NPRA

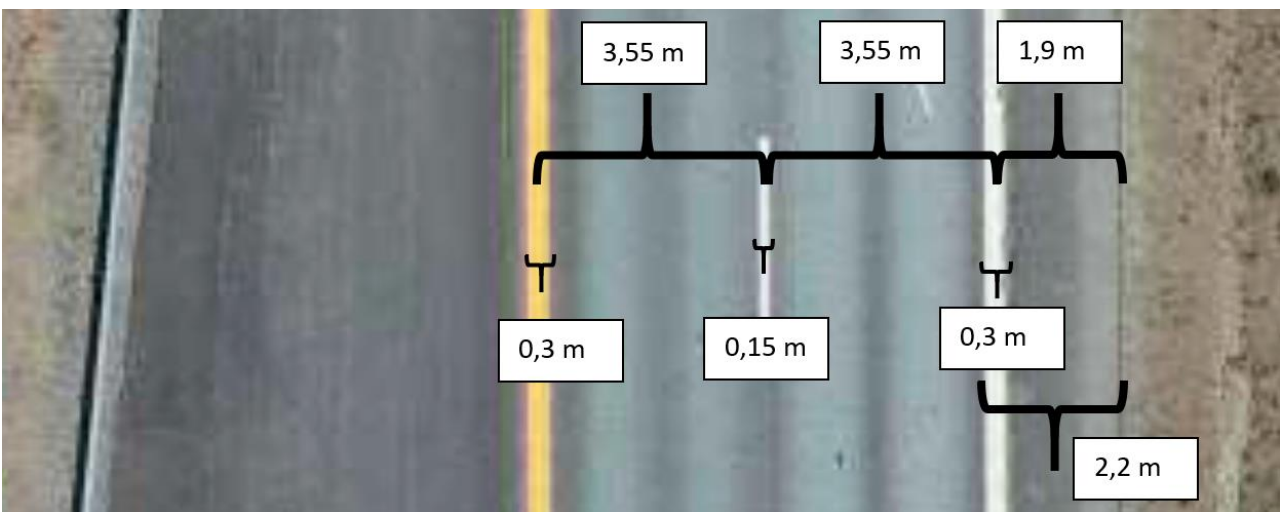
The police measured the distance from the centre of the road's edge line to the edge of the tarmac of the hard shoulder to be approx. 1.9 metres. The width of both lanes was measured to be approx. 3.55 metres measured from the centre of the lines. Both the yellow centre line and the edge line were approx. 30 cm wide, while the line separating the lanes was approx. 15 cm wide (see figure 21). The width of the lanes between the road marking lines was approx. 3.33 metres.

Figure 21: Northbound lane with measured distances. Source: The police. Illustration: NSIA

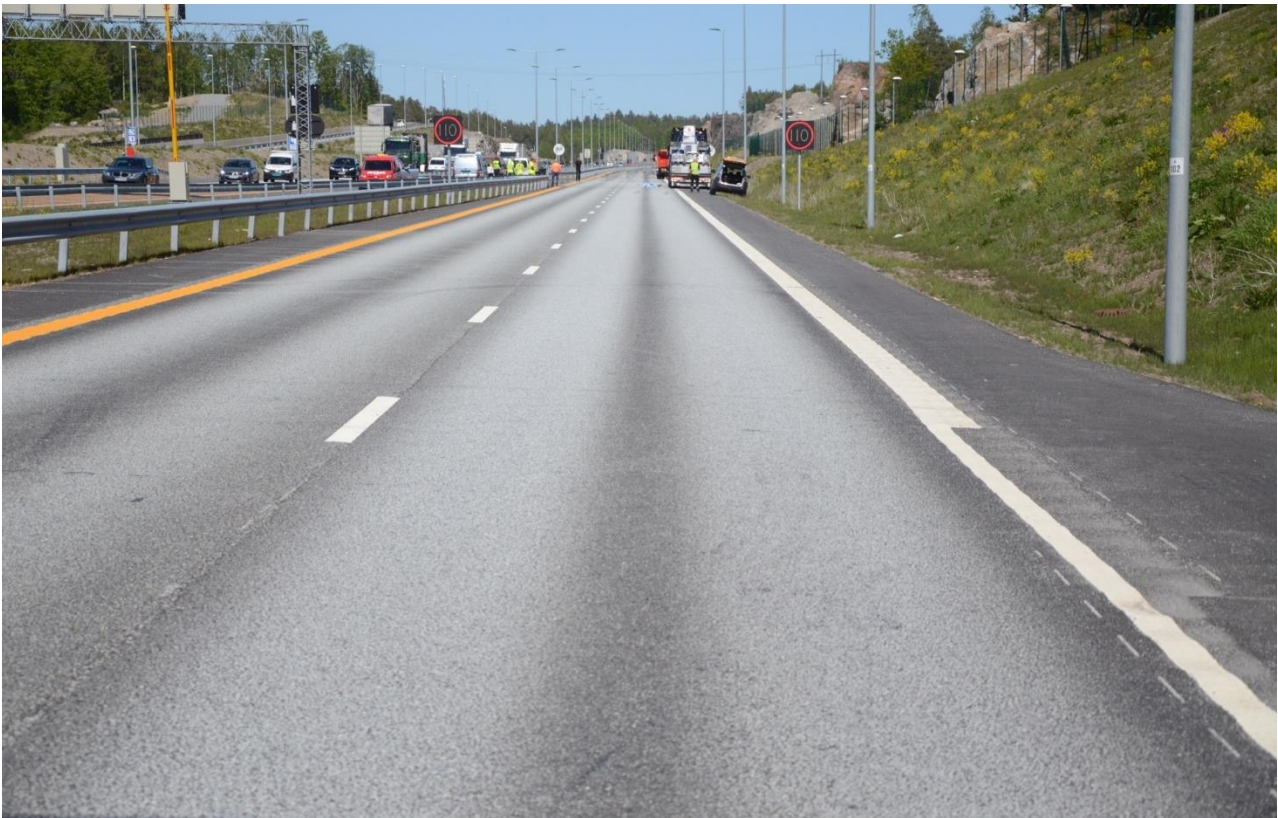
Figure 23 and figure 24 show the visibility from the exit of the Torsbuås tunnel, when travelling north, at a distance of 181 and 54 metres, respectively, from the HGV's final position.

Figure 23: Visibility from the tunnel portal, 181 metres from the HGV. Photo: The police

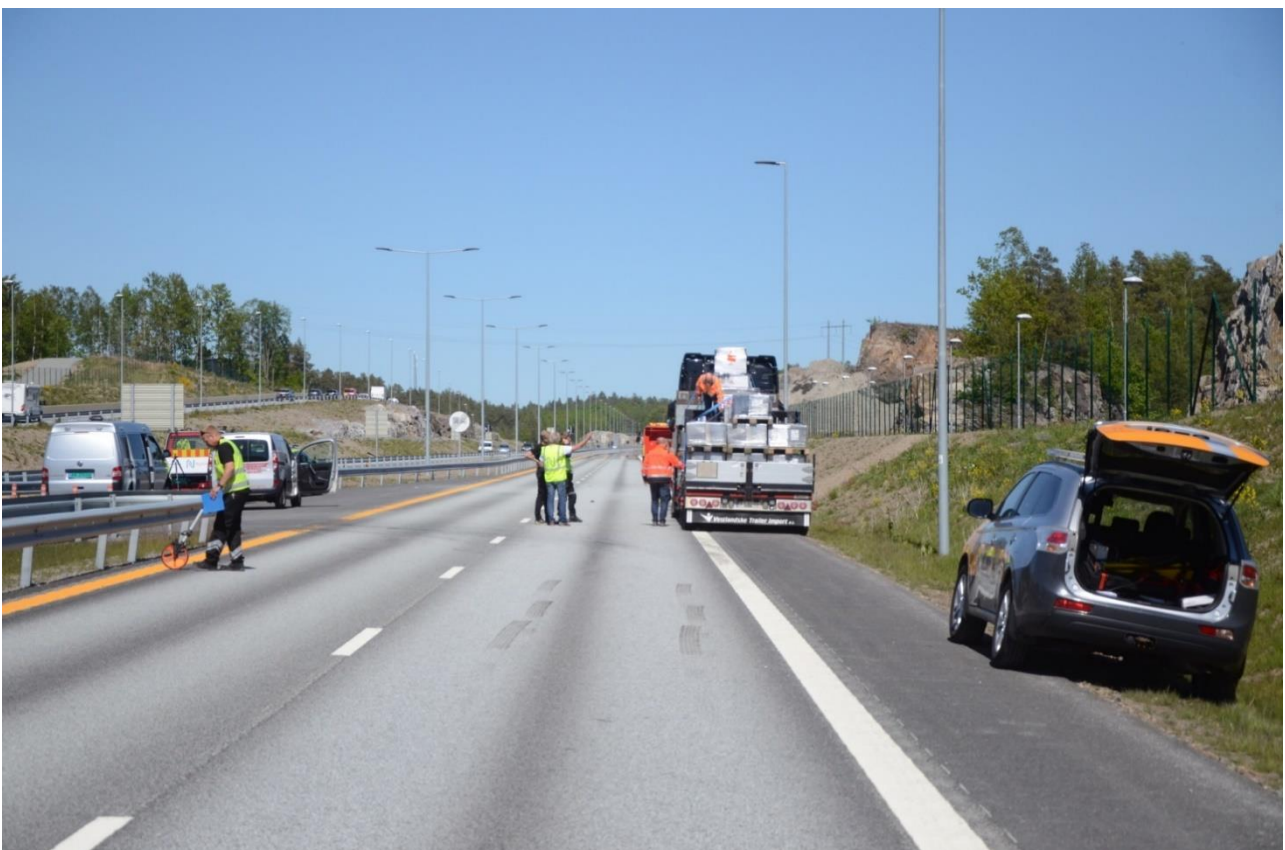
Figure 24: Visibility from the tunnel portal, 54 metres from the HGV. Photo: The police

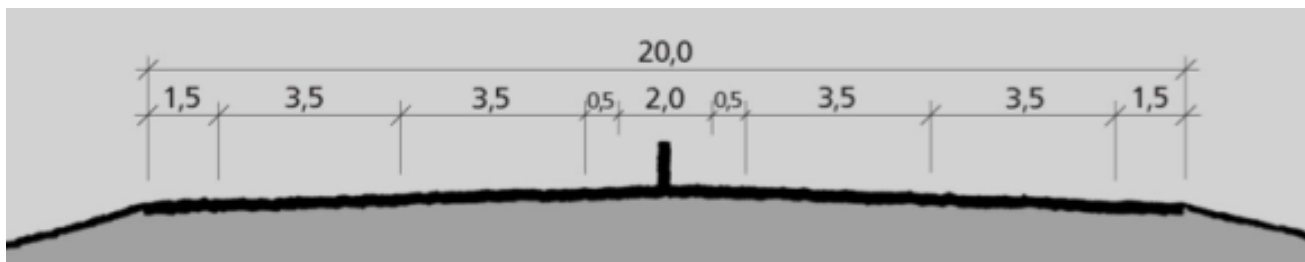
Figure 25: Cross section for AADT 12,000–20,000 vehicles/day with a speed limit of 110 km/h. Source: NA circular 2015/2, Norwegian Public Roads Administration

Nye Veier hired the consultancy company COWI AS to carry out a risk analysis in connection with the possible decision to use a road profile with a width of 20 metres (see figure 25), despite the fact that the AADT was projected to exceed 20,000 vehicles/day by 2040.

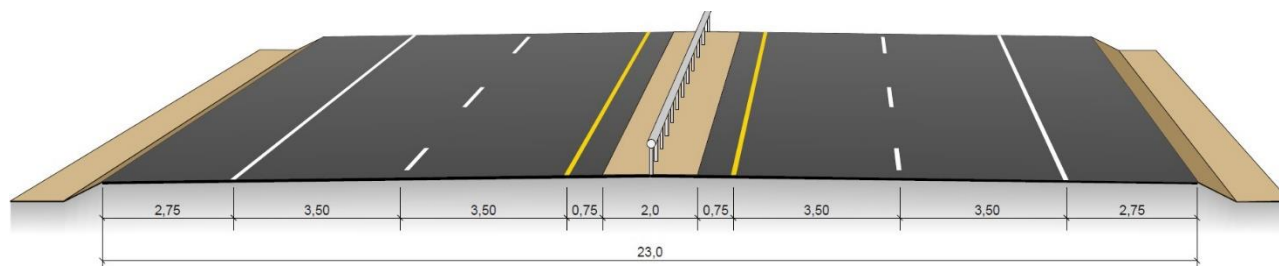
The applicable road design requirements for national main roads (H3) with an AADT of more than 12,000 vehicles/day and a speed limit of 110 km/h<sup>13</sup> are described in figure 30.

Figure 30: Standard profile, H3, for national main roads with an AADT of more than 12,000 vehicles/day. Source: Road design norm N100 Veg- og gateutforming (2021), NRPA
