SAFETY NOTE AFTER THE THEMATIC INVESTIGATION OF SEVERAL INCIDENTS IN WHICH SEMI-TRAILERS DETACHED FROM THE TRACKING VEHICLE DURING TRANSPORT

Road 2024/SN1

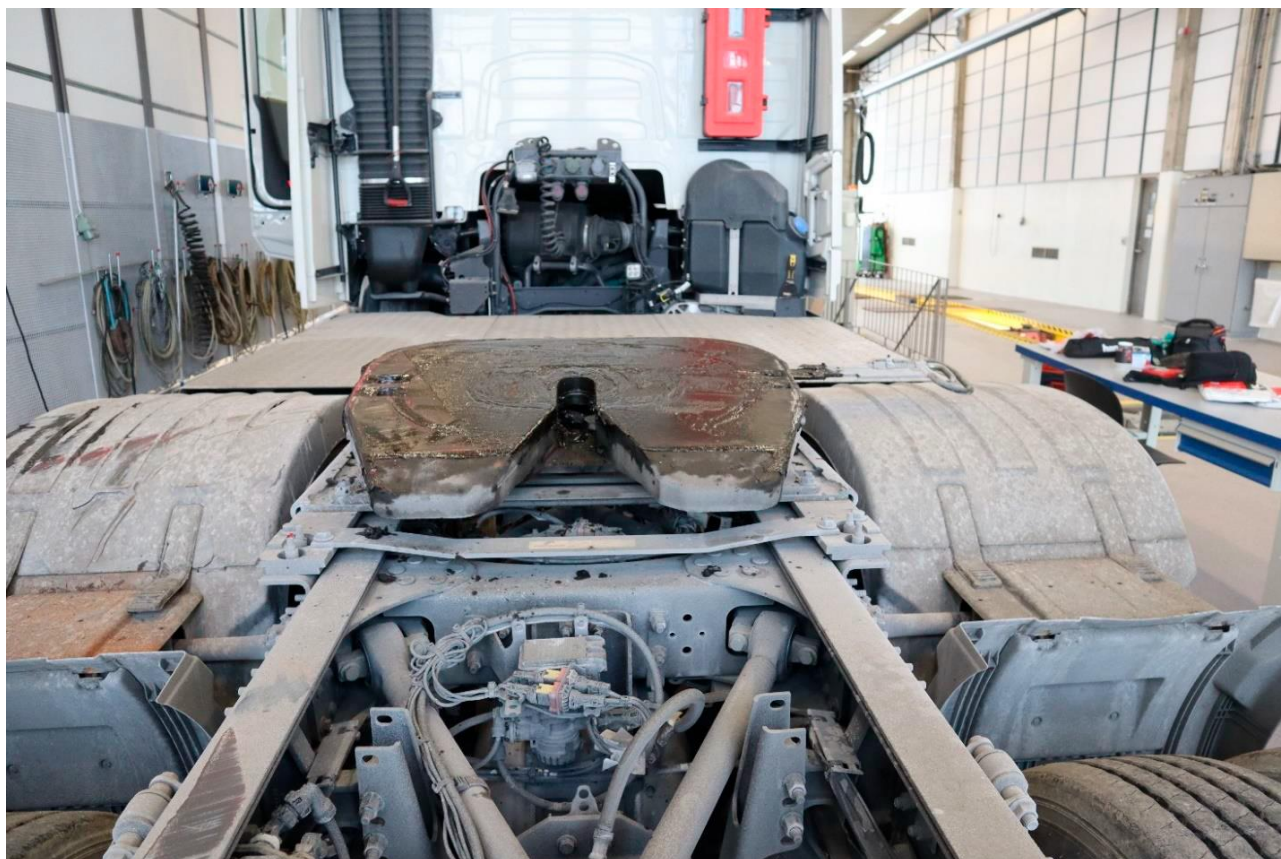
Figure 1: A fifth wheel is a device for connecting a tractor unit to a semi-trailer. The semi-trailer rests on the fifth wheel and is locked to the fifth wheel with a king pin. Photo: NSIA

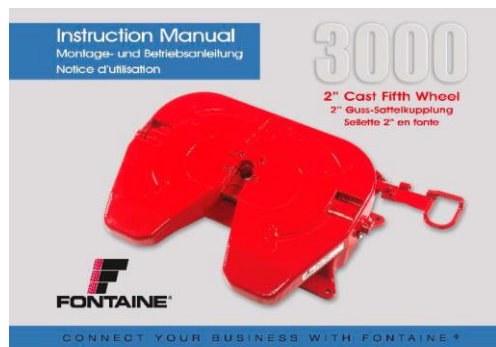
- Many users test the coupling between tractor unit and semi-trailer by conducting a 'pull test'. The NSIA, in cooperation with the NPRA, has conducted a practical test with a vehicle combination, which showed that a fifth wheel that was not locked in the safe position still passed the 'pull test'. The NSIA therefore considers that the 'pull test' as a method is not sufficient as a safety check on its own and that the check must also involve a physical inspection to ensure that the release handle is securely locked (cf. Fontaine 3000 user manual, see Figure 6 and Figure 7).

Figure 6: Front page of Fontaine user manual. Source: Fontaine

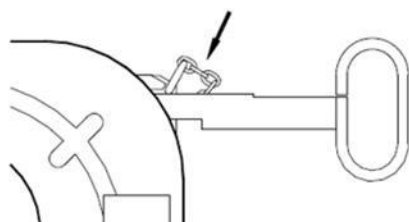
The fifth wheel is only correctly locked when the inside notch in the handle is hidden under the fifth wheel and the safety clip can be fitted in the hole (see Figure 5).

Figure 5 - Locking of a fifth wheel with a Standard handle

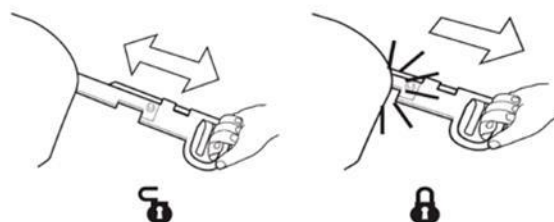
The fifth wheel is only correctly locked when the inside notch in the handle is hidden under the fifth wheel and the handle plunger is correctly positioned in the locking slot under the fifth wheel (see Figure 6).

Figure 6 - Locking of a fifth wheel with an Interlock handle

Figure 7: Two different locking handles on Fontaine fifth wheel couplings. Source: Fontaine
