# REPORT

ROAD 2025/02

***Head-on collision between a passenger car and a heavy goods vehicle on the Rv 7 road in Flå on 21 May 2024***

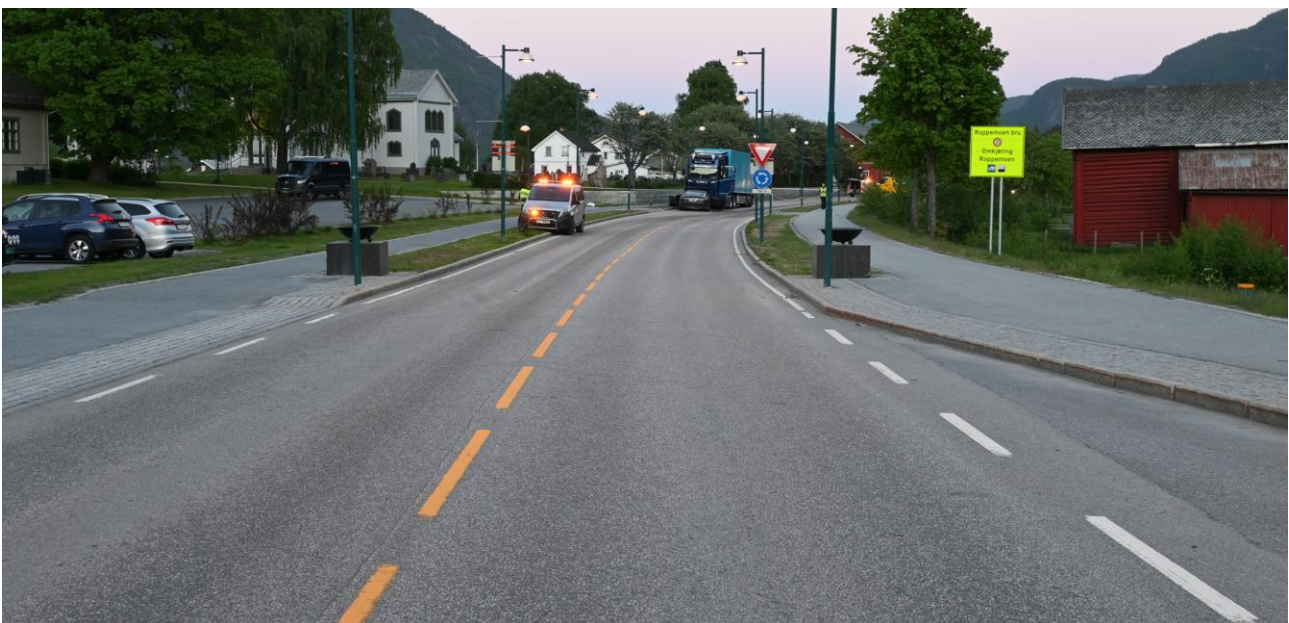
The driver of the HGV, who was in the opposite lane, has described that as he drove north towards Flå centre, a car approached that appeared to be preparing to turn into a car park a little further ahead of him. The car was then level with a red barn further ahead on the opposite side of the road, see Figure 2. The HGV driver slowed down to allow space and time for a possible exit, but noticed that the passenger car continued straight ahead and into his lane. The HGV's automatic emergency braking system activated, the driver honked his horn and braked hard before the collision.

Figure 2: Final positions of the vehicles, road alignment in the passenger car's travel direction and the position of the red barn by the side of the road. Photo: Norwegian Public Roads Administration

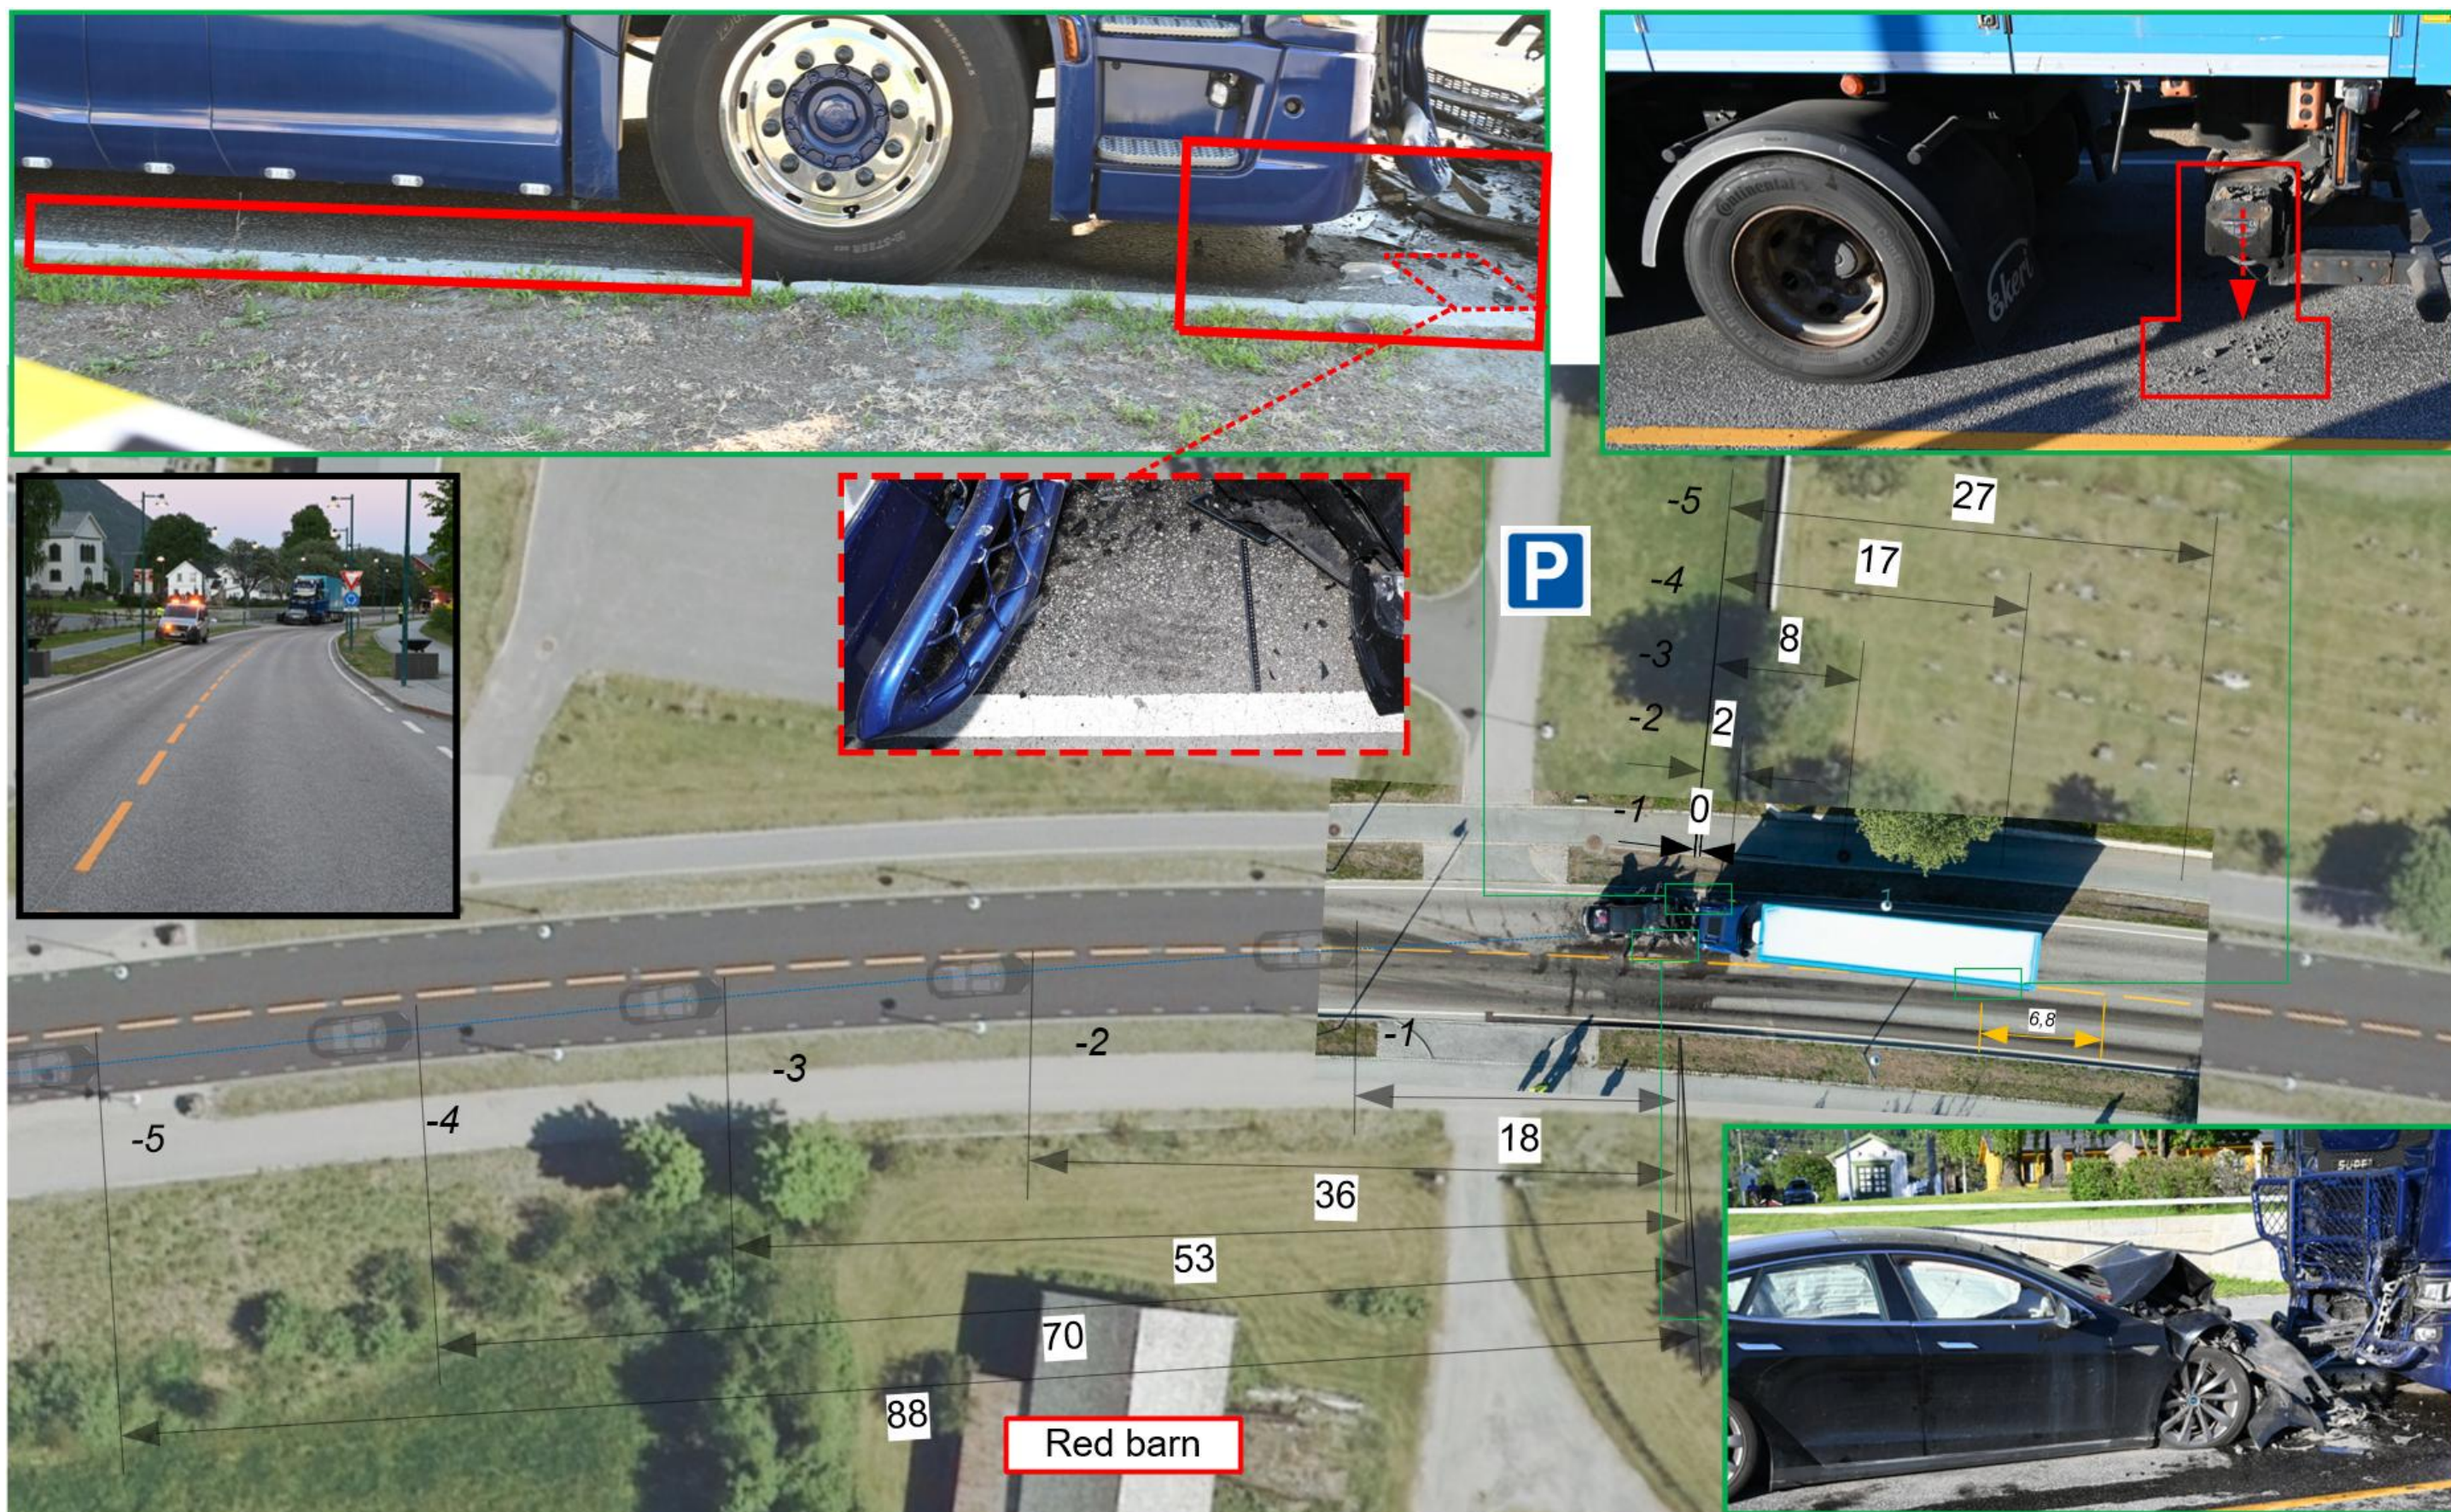
An illustration of the accident site with collated evidence is shown in Figure 11. Photos from the accident site showed no evidence of debris under or behind the front wheels of the tractor unit, indicating that the HGV was stationary when the collision occurred. There were skid marks from the semi-trailer's dual wheels approximately 6.8 metres behind the HGV, and under the front wheels up to its final position. The NSIA has illustrated where the vehicles may have been five seconds before the collision, based on distance/time calculations in section 1.11.1. The red barn and the car park described by the HGV driver are also marked in the figure.

Figure 11: Illustration of the accident site and external damage to vehicles, the front of the passenger car and the HGV's distance in time five seconds before the collision (section 1.11.1). Debris and traces in the roadway are highlighted in red. Drone: Tangen foto, aerial photo: © norgebilder.no (Hallingdal 2020), photo: Norwegian Public Roads Administration, Police, illustration: NSIA

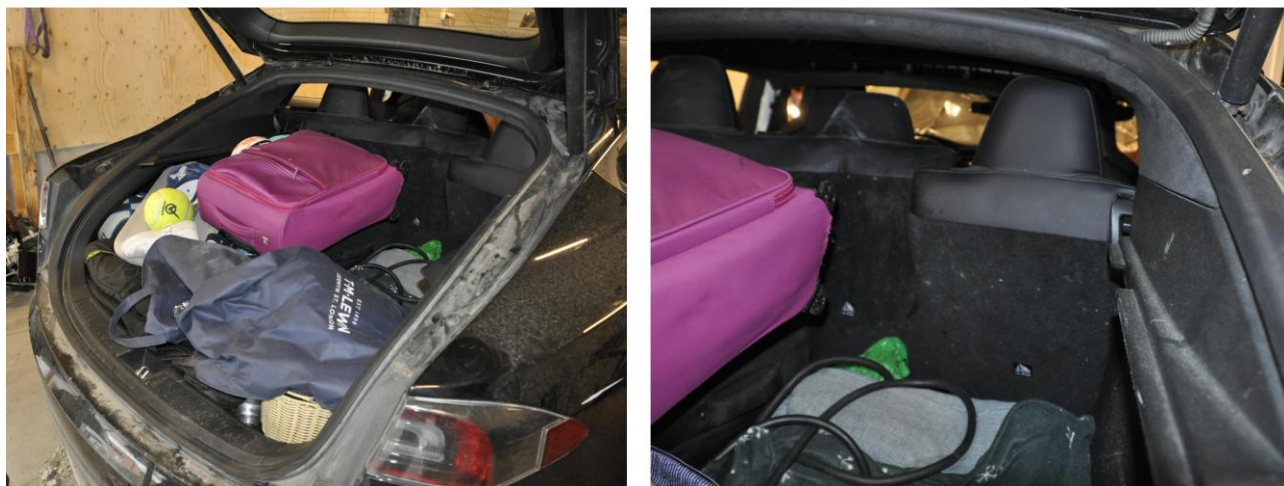
The NSIA weighed all the luggage a few days after the accident. In the front luggage compartment (frunk) there was approximately 30 kg of luggage. The boot primarily contained four items; a suit in a suit bag, two soft suitcases and a backpack (3.0 kg, 7.6 kg and 16.3 kg, 4.9 kg), as well as various unsorted items, including a charging cable, totalling 20 kg. The heaviest suitcase was placed lowest and close to the seat-back. The total weight of all luggage was approximately 52 kg. In addition, the dog weighed approximately 15 kg and was placed on a dog blanket behind the right rear seat-back (40-part).

Figure 13: : Luggage virtually untouched until weighed. The dog was on the right side on a dog blanket.  
Photo: NSIA

The total weight in the boot was approximately 67 kg. The estimated total weight with luggage in the frunk and in the boot, and all occupants was approximately 2,445 kg. This was within the permitted total weight by approximately 145 kg.

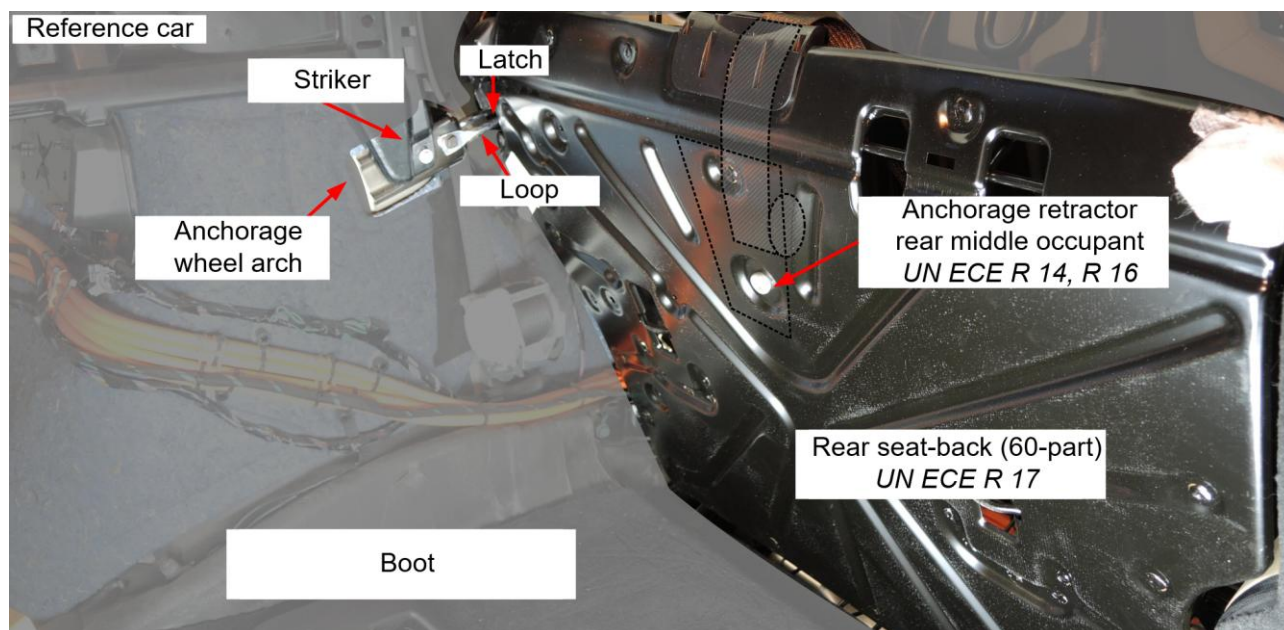
The entire rear seat-back connection to the car body consisted of four elements; a latch mounted in the rear seat-back, which was locked to a striker loop attached to a bracket, the striker, and finally the anchorage of the striker to the rear left wheel arch, shown in Figure 26.

Figure 26: All elements that made up the anchorage of the rear seat-back to the car body (back of the seat-back). Photo: NSIA

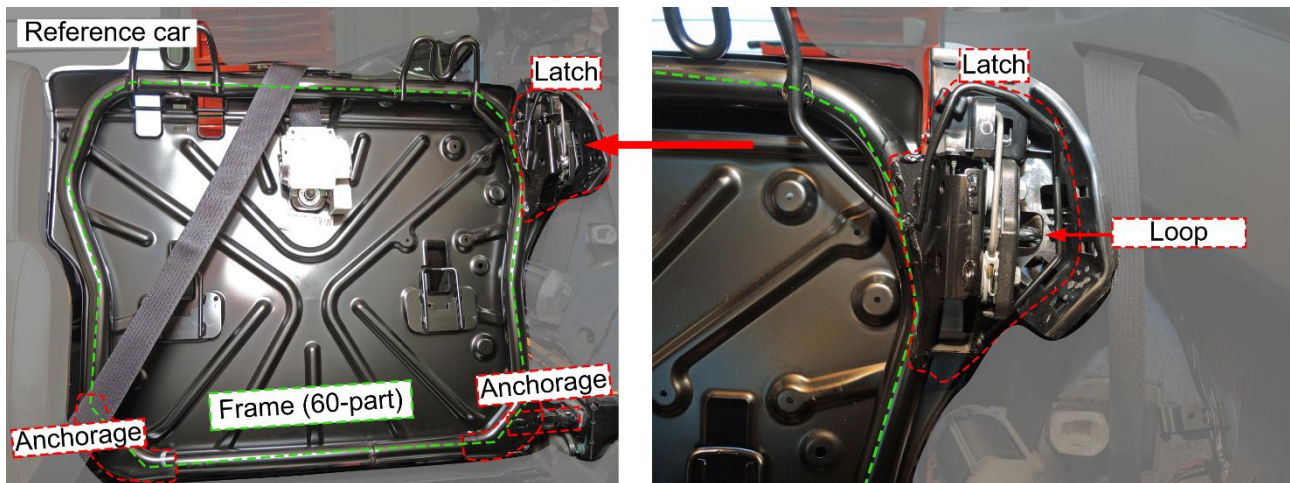
Figure 27: Front of rear seat-back 60-part with frame, anchors and lock welded to the outside of the frame. Photo: NSIA

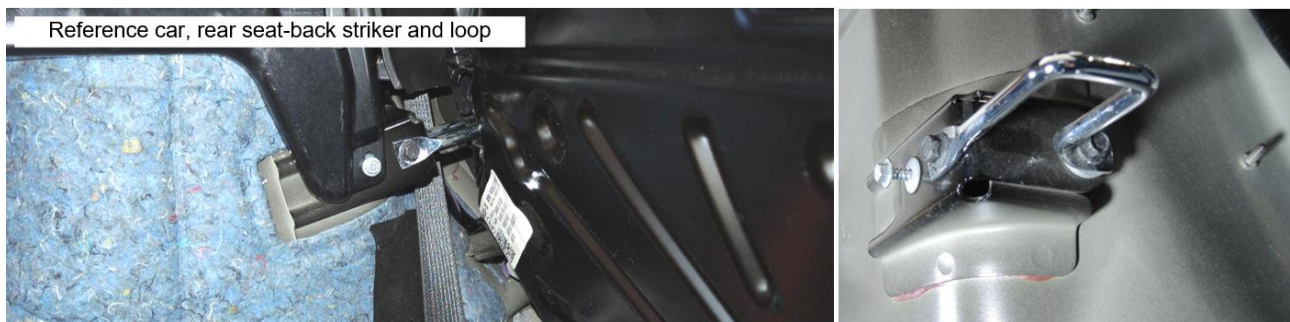
The rear seat was documented in phases as covers were removed. The reference car and the accident car had slightly different designs, where the accident car's striker anchorage to the wheel arch was reinforced by four bolts.

Figure 28: The striker with bracket and striker loop facing the rear seat-back latch (without reinforcement bolts). Photo: NSIA

The bracket that constituted the striker was a 2 mm thick aluminium plate, which was bent and folded into a shape adapted to the wheel arch. The striker had a loop, which was screwed to it with two bolts, one in a longitudinal direction through two aluminium layers and one lateral bolt through one aluminium layer in the striker. This striker loop locked the 60-part of the rear seat-back.

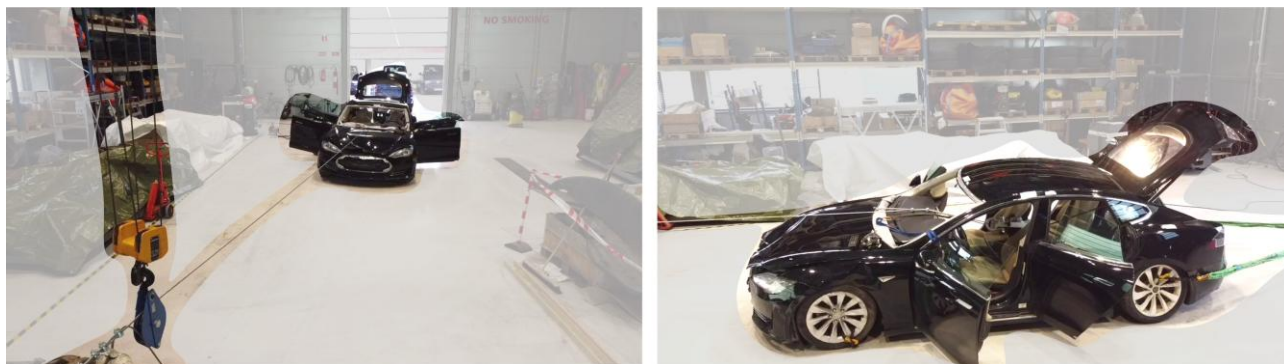
The NSIA performed quasi-static tensile tests on the 60-part section of the rear seat back in the reference car. The purpose of the tensile tests was to see how much load the rear seat could withstand when pulled longitudinally, and whether it was possible to find out what caused the rear seat-back to tear off.

Figure 32: Setup for tensile tests with pull-cable, load cell and counterhold in the reference car. Photo: NSIA

The first test (#1) was an indirect tensile test on the rear seat-back via the middle shoulder belt in the rear seat. As the lower part of the shoulder belt was fastened to the floor, the load on the back of the seat was reduced in relation to the total load on the shoulder belt. The second test (#2) involved direct longitudinal tension at the top of the rear seat-back near the shoulder belt routing. The third and final test (#3) involved direct longitudinal tension on the striker itself.

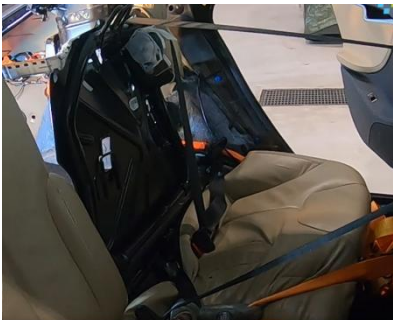
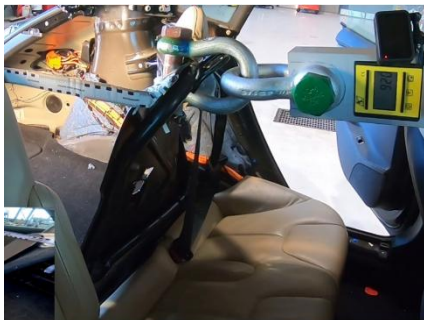
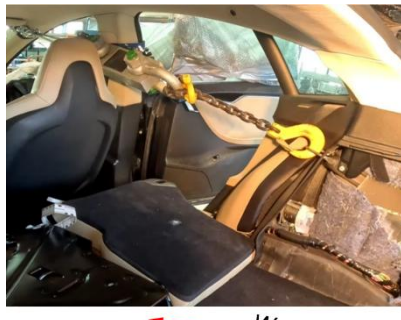
Table 7: Overview of tensile tests and results. Source: NSIA

Shoulder belt tensile test, indirect rear seat-back (60-part)	Tensile test directly on rear seat-back (60-part)	Tensile test directly on the striker (40-part).
<b>Result:</b> The shoulder belt tore after 20 s, at 1,660 kg (16.3 kN) ~ 20 cm displacement of the rear seat-back.	<b>Result:</b> The striker broke after 17 s, at 920 kg (9.0 kN) ~ 35 cm displacement of the rear seat-back.	<b>Result:</b> No breakage after 30 s, at 1,480 kg (14.5 kN). Test terminated.

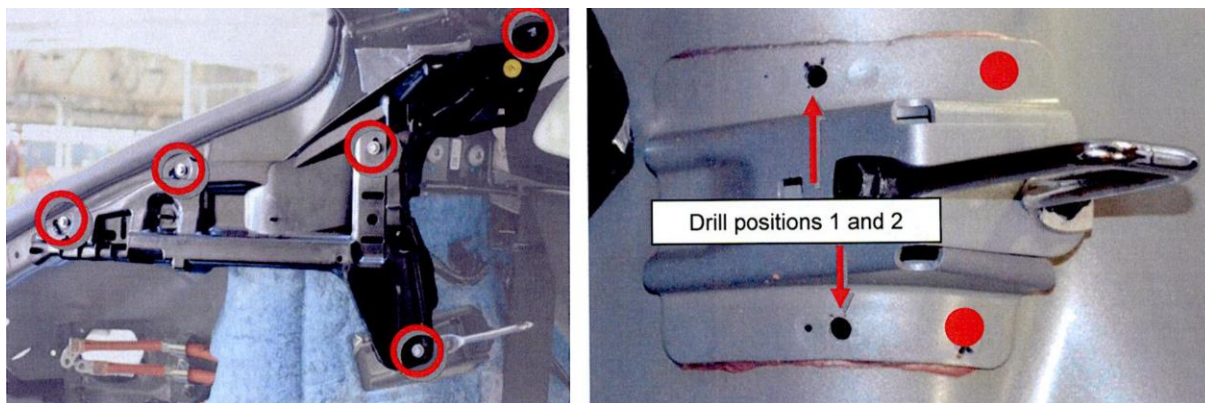
Tesla issued a recall in June 2013 for 2013 Model S cars in the US and Canada<sup>12</sup>. The recall was due to a possible defect in the welding points on the left rear seat striker. The defect, which could arise during production, could result in the seat back not staying in the upright position during a collision. To rectify the problem, four bolts were retrofitted to the striker bracket of the left rear seat. The reinforcement was implemented before the car was introduced in Europe.

Figure 41: Removal of the cover over the striker loop for the left rear seat and reinforcement drill holes.  
Source: Tesla

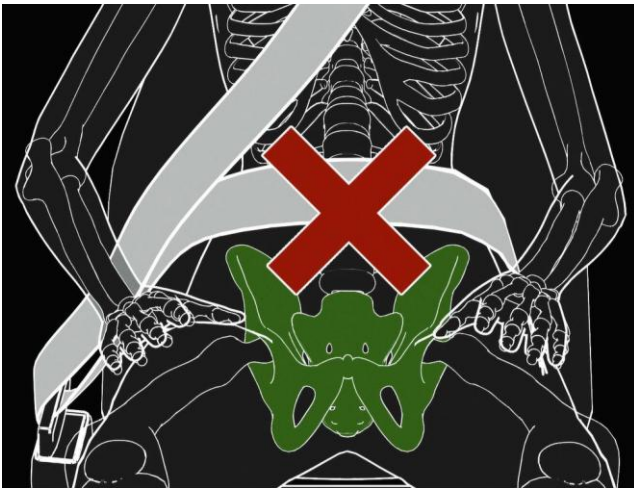
The middle rear seat occupant sustained critical injuries from both the shoulder part of the seat belt on the right side of the torso, and from the lap section of the seat belt across the abdomen. The occupant has indicated that the seat belt was not initially tightened at the hip and that the seating position was relaxed. See Figure 46 and Figure 47 for the correct positioning of the lap section of the seat belt.

Figure 46: Incorrect positioning of the lap section of the seat belt. Illustration: NSIA

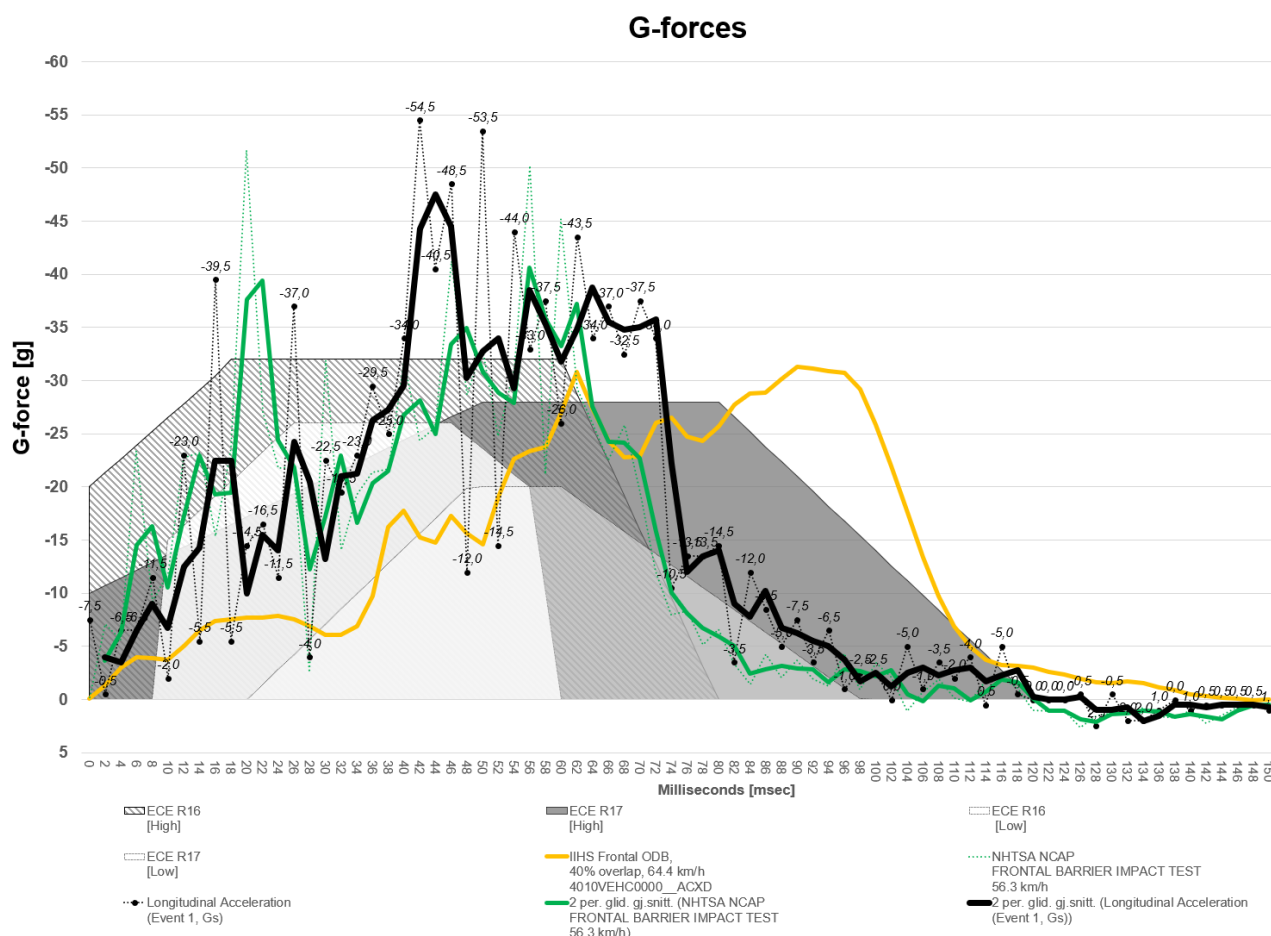
Figure 48: Comparison of g-forces over time from the car's EDR report, NCAP and IIHS crash test of the same model, shoulder belt load on crash-test dummy in the NCAP test and test corridors in UN ECE R16 and 17 in the background. Source: Tesla, NHTSA, UN ECE, IIHS. Collation: NSIA

A comparison between the NHTSA test and the collision in the accident shows relatively similar values<sup>17</sup>, despite the different collision speeds. The fact that the values are relatively similar can be explained by the fact that, in the NHTSA test, the car collides with an immovable wall, while in the accident in question, the car collided with the front of an HGV that absorbed the impact at the front. Both the crash in the accident and the NHTSA test have values that are both above and below the UN ECE test corridors at different times. The collation also shows that the collision was more high-energy than the IIHS test, which simulates a frontal collision with an oncoming car. Both the

Based on Figure 48, the NSIA is of the opinion that the acceleration in the collision in the accident is comparable to the NHTSA test. Nor does the collision in the accident deviate significantly from the minimum requirements of UN ECE R 16, even though it is at the top of the corridor. This indicates that the forces involved in the accident were great, but still within the level the vehicles should be able to withstand in terms of safety.

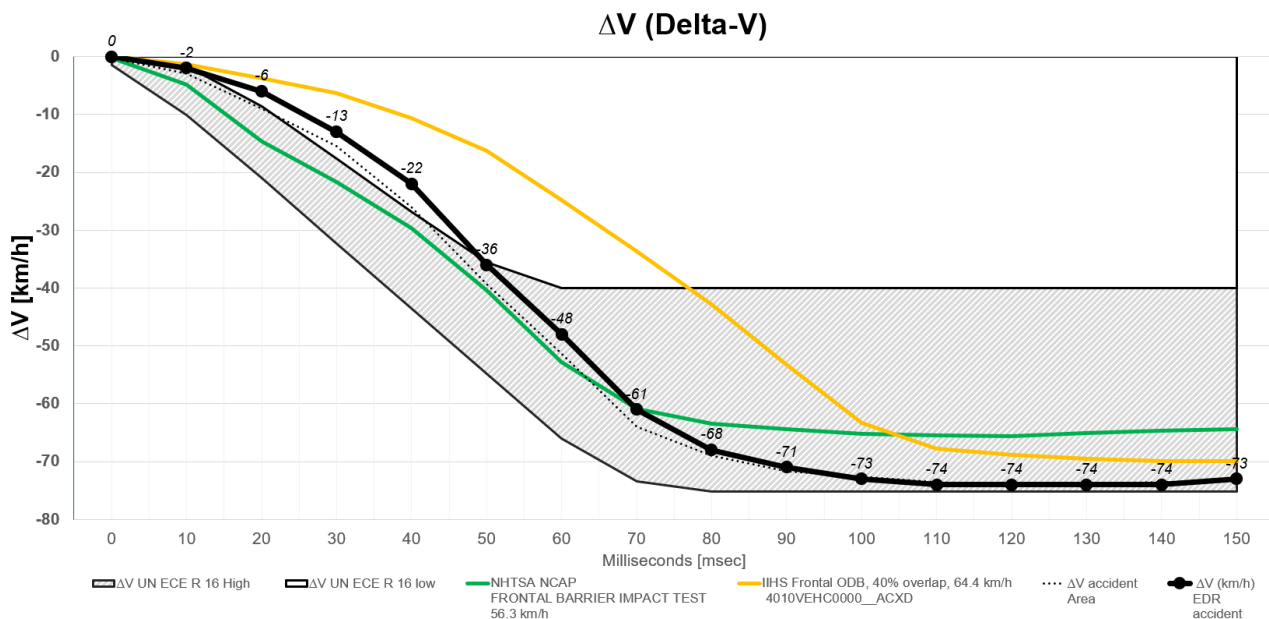
Figure 49 shows a comparison of the Delta-V curve calculated on the basis of the values in Figure 48. Delta-V in the UN ECE R 16 test corridor is in the 40–75 km/h range. The collision in the accident and the NHTSA test have values that are at the very top of the corridor, but achieve a maximum Delta-V over time more slowly than UN ECE R 16.

Figure 49: Comparison of the build-up of  $\Delta V$  between the collision, NHTSA and IIHS test and UN ECE R16. Source: Tesla, NHTSA, IIHS and UN ECE. Collation: NSIA

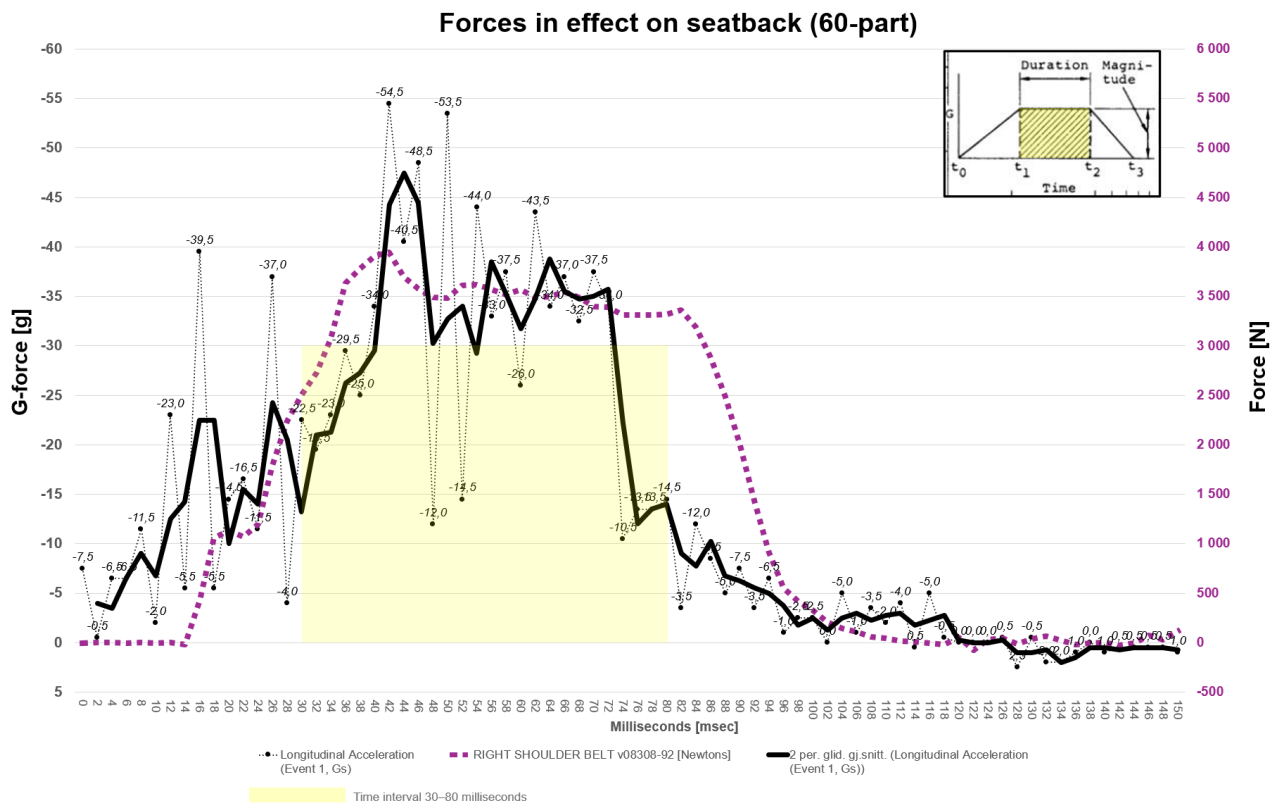
Figure 50: Average acceleration from luggage and tensile force from the right shoulder belt in the NHTSA NCAP test over 50 milliseconds. Source: Tesla, NHTSA. Collation: NSIA

The EDR report has recorded that in the period 30–80 milliseconds, the average acceleration in the passenger car was -30 G. The average force on the shoulder belt from the corresponding NHTSA test from the crash-test dummy on the right side was 3,450 N. The NSIA considers these values to be representative of the load on the shoulder belt from the middle occupant of the rear seat in the accident, due to weight similarity with the test dummy in the NHTSA test.

The calculations above shows that the rear seat-back could withstand less than 30 kg of pressing load when the rear seat-back simultaneously secured a light adult person, like the conditions in the accident. The NSIA is aware that rear seats can collapse in high-energy head-on collisions where pressure from luggage is a contributing factor. This was a high-energy collision, but the NSIA believes that the dynamic forces in the accident were within what the vehicle's design should be able to withstand in terms of the mass of luggage and occupant weight.

The Norwegian Safety Investigation Authority recommends that Tesla Norway investigate whether the safety of rear seat occupants in the car model (Tesla Model S) can be improved with regard to the design and anchorage of the rear seat-back and the securing of luggage in the boot.
