Issued June 2026

REPORT ROAD 2026/02

Thematic investigation of frontal collisions involving buses: active and passive safety

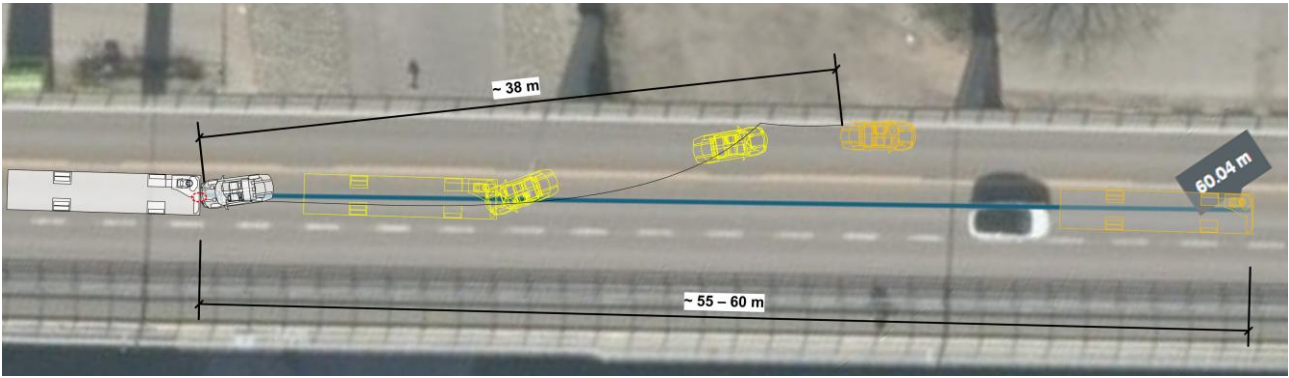
In 2021, a full-frontal collision occurred on the Fredrikstad Bridge between a coach and a passenger car. The collision occurred in the centre lane of the three-lane road. The NSIA was not notified about the accident. Available information indicates that the coach was travelling at the speed limit, around 60 km/h, when the accident occurred. The passenger car's speedometer was stuck at around 40 km/h after the collision. The passenger car was thrown backwards with rotation, struck the safety barrier, and came to a stop after approximately 38 m. The coach stopped after approximately 55–60 m, as shown in Figure 10.

Figure 10: Diagram of the collision site, estimated point of impact and distance to the vehicles' final positions. Map: vegkart.no Illustration: NSIA

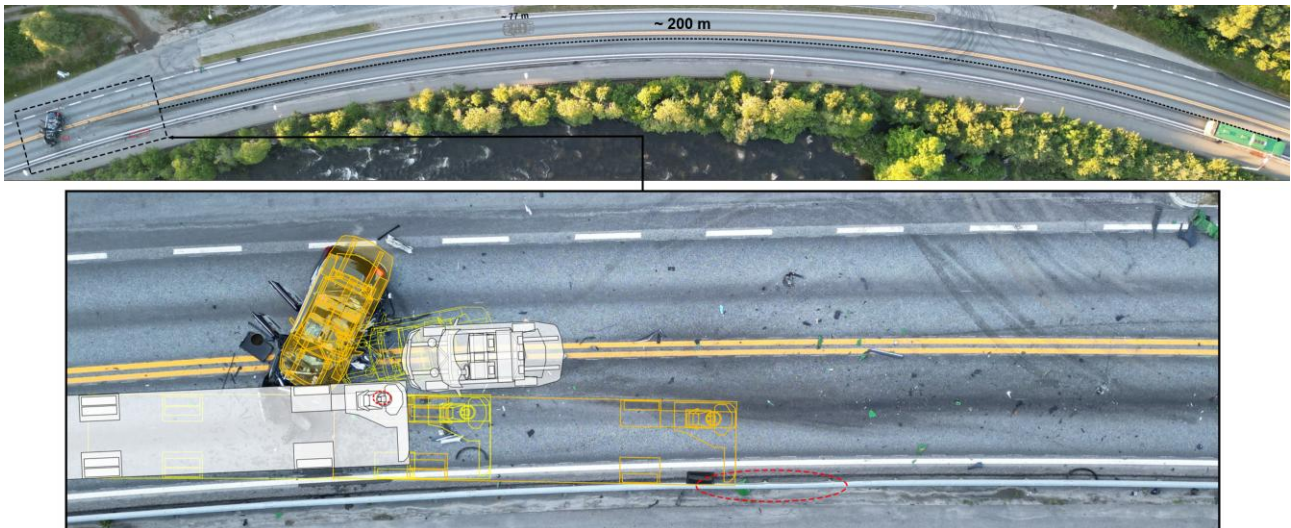
In 2023, a corner-to-corner collision occurred at Figgjo in Sandnes municipality, involving a bus and a passenger car with three occupants. The collision took place in the bus's lane, on a two-lane road with a double solid line. The NSIA was notified but did not deploy to the scene. Stored data from the vehicles indicates that the bus was travelling at a steady speed of approximately 61 km/h, braked during the final second before the collision, and impacted at a speed of approximately 52 km/h. The bus struck the nearside safety barrier and continued for approximately 200 m after the collision. The car was travelling at a steady speed of approximately 55–56 km/h before the collision. Immediately following the collision, the car's speed was reduced to approximately 3–4 km/h, and it stopped approximately 2 metres past the point of impact, as shown in Figure 13².

Figure 13: Overview of the accident site, estimated point of impact, and vehicle movement immediately following the collision. Photo: Norwegian Public Roads Administration. Illustration: NSIA

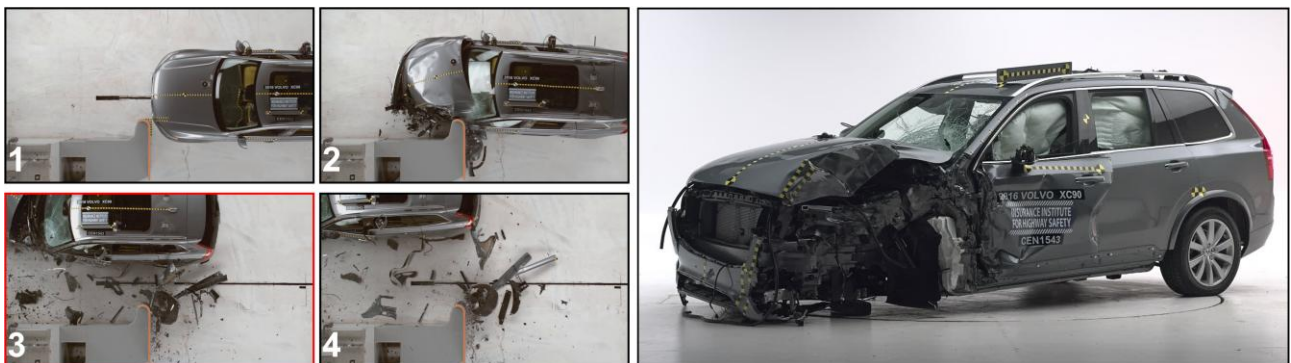
Figure 18 shows the test of a 2016 Volvo XC90 impacting an immovable barrier with a 25% overlap. In the test, the car was deflected and pushed to the side, and continued past the safety barrier without stopping. The driver dummy registered a peak acceleration of approximately 23–24 g. A comparison between data from the crash test and the actual collision is shown in Appendix A.

Figure 18: Test of a 2016 Volvo XC90 ([CEN1543](#)) Small Overlap Front Test, sequences 1–4, and damage post-test. Source: [IIHS](#)

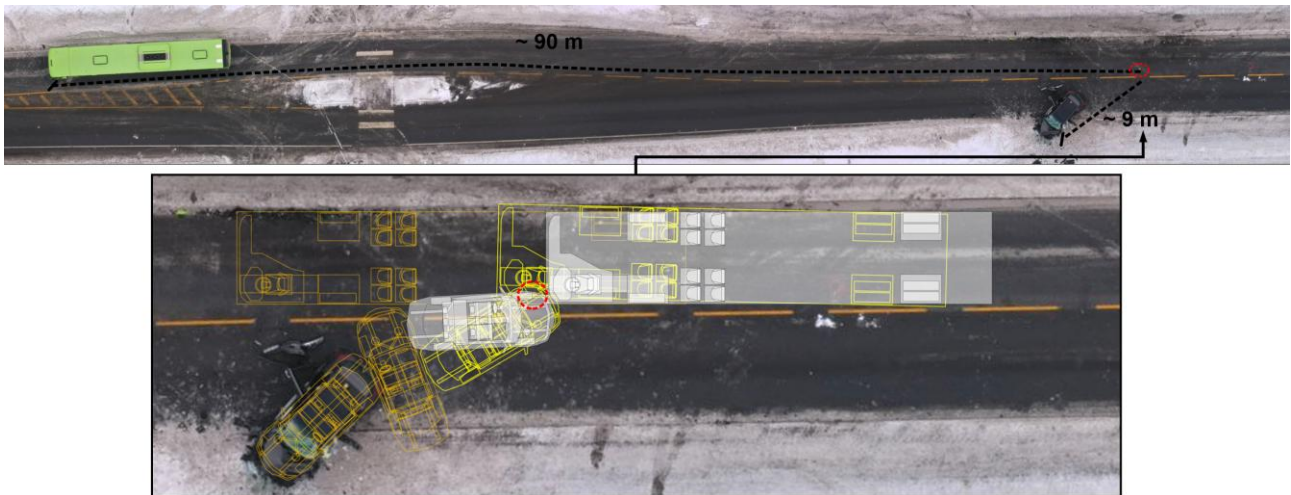
In 2024, a corner-to-corner collision occurred north of Sagmoen in Eidsvoll municipality, involving a bus and a passenger car with a sole occupant. The collision took place on a two-lane road in the bus's lane. The NSIA was notified and deployed to the accident site. Logged data from the bus indicates that it had a speed of approximately 38 km/h at the point of impact. The speedometer of the passenger car remained stuck at approximately 55 km/h after the collision. The bus continued for approximately 90 metres following the collision, while the passenger car was thrown backwards approximately 9 metres with rotation following the impact, as shown in Figure 19.

Figure 19: Overview of the collision site and the estimated point of impact with damage the roadway. Photo, markings and illustration: NSIA

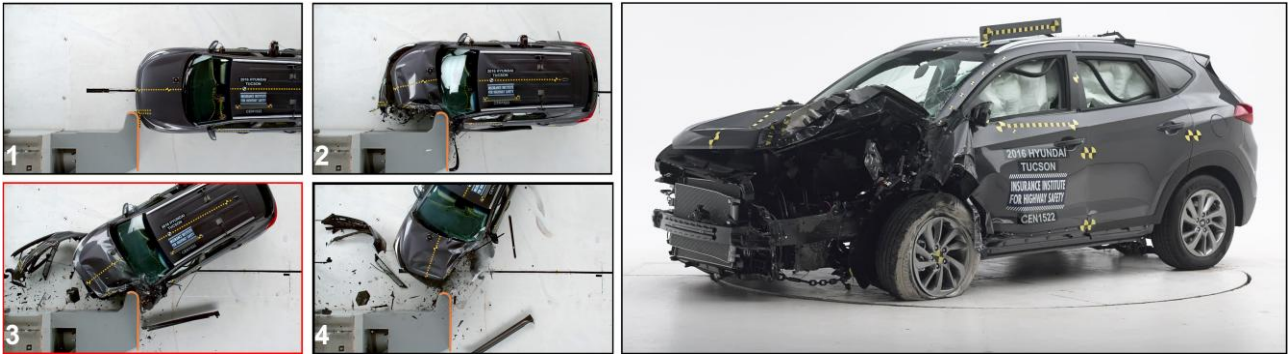
Figure 22 shows the test of a 2016 Hyundai Tucson impacting an immovable barrier with a 25% overlap. In the test, the front of the car stopped against the barrier and the vehicle rotated approximately 90 degrees outwards alongside the barrier. In the test, as in the actual accident, the side airbag to the left of the driver deployed. The driver dummy registered a peak acceleration of approximately 64–65 g.

Although data from the actual collision was unavailable, the crash test is comparable to the accident since the vehicle, in both cases, came to a complete stop and rotated laterally. Data from the test is shown in Appendix A.

Figure 22: Test of a 2016 Hyundai Tucson ([CEN1522](#)) Small Overlap Frontal Test, sequences 1–4, and damage post-test. Source: [IIHS](#)

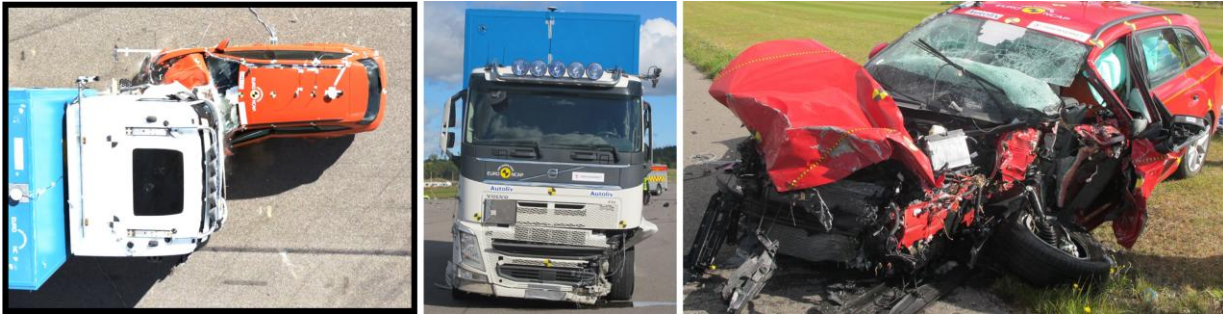
In one trial, a passenger car and a heavy goods vehicle without an energy-absorbing front structure collided head-on at speeds of 50 km/h, see Figure 28. The weight of the heavy goods vehicle was 28 tonnes, and the passenger car's weight was 1.57 tonnes¹². The change in velocity over 0.2 seconds was approximately 6 km/h for the heavy goods vehicle and approximately 100 km/h for the passenger car. The heavy goods vehicle continued forward and stopped after 82 m, and the passenger car was thrown nearly 25 m backwards against its original direction of travel.

Figure 28: Crash test and vehicle damage with a rigid front on the heavy goods vehicle. Each vehicle had an impact speed of 50 km/h in the tests. Photo: Swedish Transport Administration/Chalmers

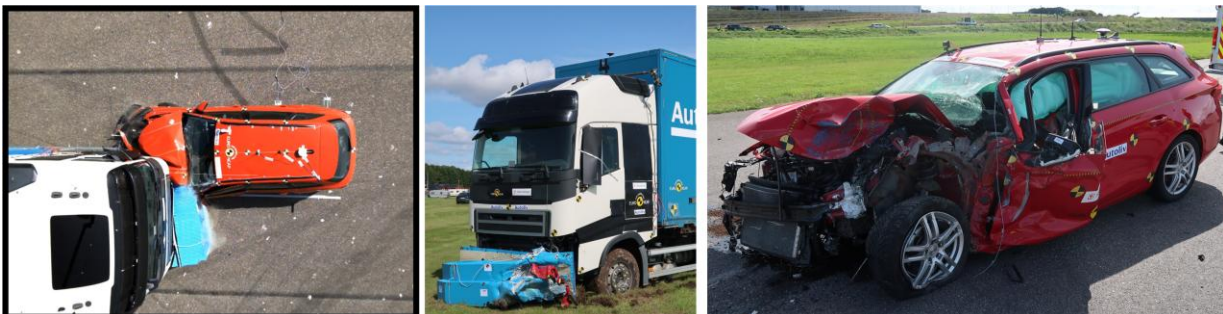
In a corresponding test, an energy-absorbing structure was installed on the front of the heavy goods vehicles. The [final report](#) for this test notes that the acceleration and deformation of the passenger car were improved compared to the reference test with a rigid heavy goods vehicle without an energy-absorbing front.

Figure 29: Collision trial and vehicle damage with an energy-absorbing front structure in the form of a solid plate installed on the heavy goods vehicle. Each vehicle had an impact speed of 50 km/h in the tests. Photo: Swedish Transport Administration/Chalmers

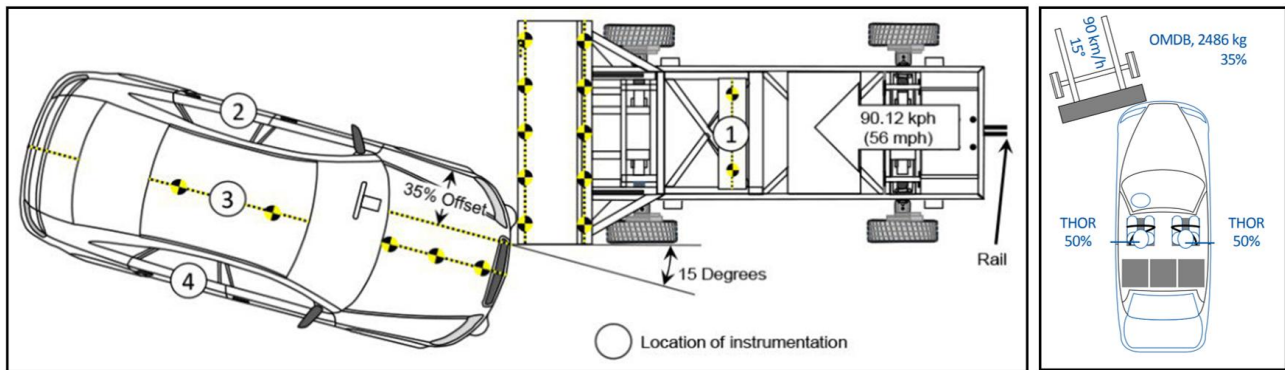
In addition to the IIHS '[Small Overlap Front Test](#)', it is relevant to describe one of the test protocols that has been under development for over 10 years within the National Highway Traffic Safety Administration's (NHTSA) NCAP system, known as '[Small Overlap and Oblique Testing](#)'. This protocol addresses oblique corner-to-corner collisions. In this test, a test rig (OMDB) of approximately 2,500 kg at 90 km/h approaches obliquely toward a stationary test car, impacting with approximately 35% overlap, as shown in Figure 30. Studies from [2018](#), showed this test series generally yielded repeatable and reproducible results.

Figure 30: Test series with a 2.5-tonne test rig at 90 km/h impacting at an oblique 15-degree angle and 35% overlap against a stationary passenger car. Illustrations: left: [NHTSA \(2018\)](#), right: [Safetwissen, carhs \(2026\)](#)

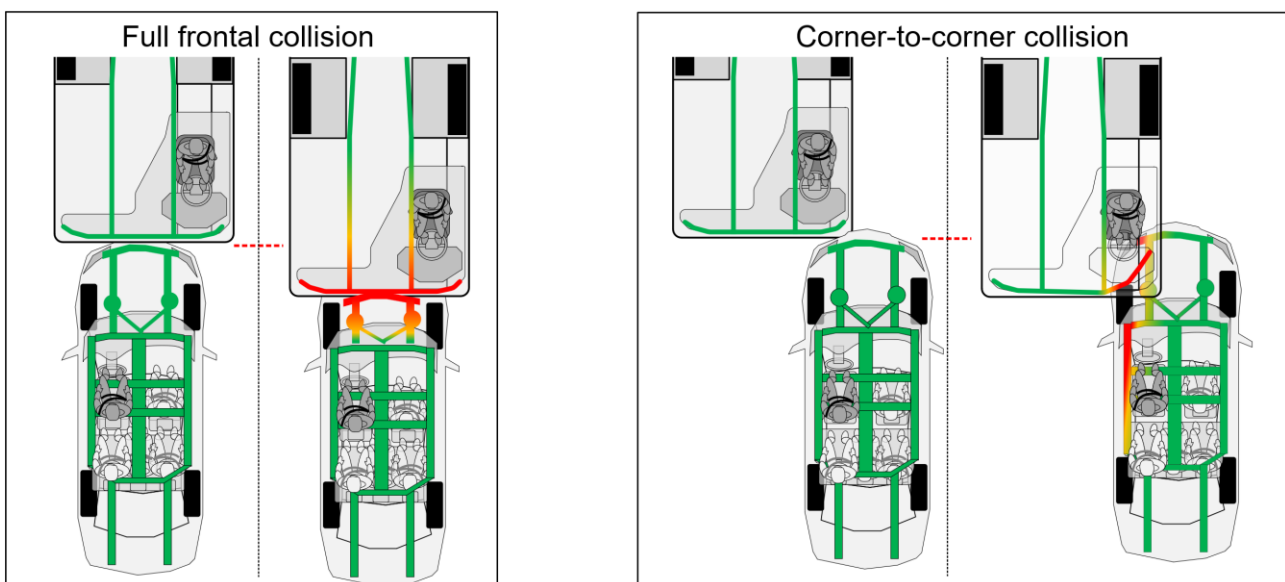
The design of underrun protection devices is characterised by being relatively flat across the entire width of the front, with attachment points in the vehicle's structural chassis. However, the NSIA's investigations of frontal collisions with a small overlap show that vehicle chassis do not achieve the same level of force transmission in corner-to-corner collisions as they do in a full-frontal collision. Figure 32 illustrates the differences in force transmission within the chassis between a full frontal collision and a corner-to-corner collision involving a bus and a lighter vehicle.

Figure 32: Illustration of force transmission between a full-frontal collision (left) and a corner-to-corner collision (right) involving a bus and a lighter vehicle. Illustration: NSIA

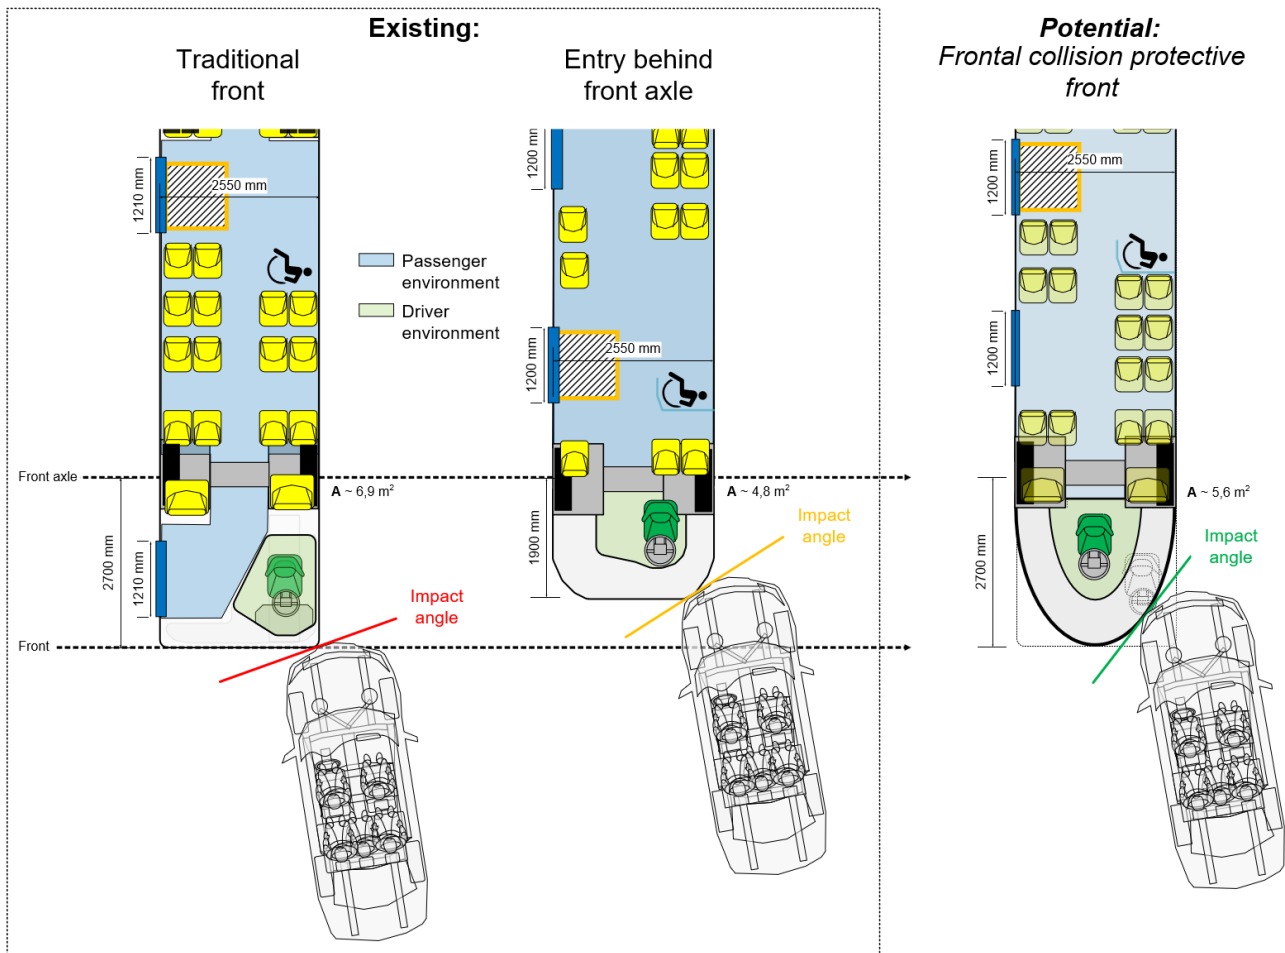
A frontal crash protection system that both absorbs compression forces and deflects oncoming vehicles will have a greater space requirement in order to establish a deflecting impact angle with an oncoming vehicle. The NSIA believes that there is already scope for this within existing regulations. Figure 33 shows two different existing bus fronts, alongside an example of a deflecting, and thus more crashworthy, bus front.

Figure 33: Left: two existing bus fronts showing differences in overhang, location of the front passenger entrance and driver's compartment. Right: an illustration of a front end that has potential for better crash protection and an improved deflecting impact angle against a vehicle approaching obliquely with approximately 35% overlap. Illustration: NSIA

The illustration shows the opportunities that present themselves when the location of the front passenger entrance and driver compartment are altered. When the front entrance is moved behind the front axle, the driver's compartment can be moved to a less vulnerable area. This will provide better protection for the bus driver, the steering gear and the braking system.

In the illustration, the passenger area (light blue) and the driver's compartment (light green) are separated. The illustration is also dimensioned¹³ to show the differences in area and layout in the zone between the front and the front axle across the various solutions. A curved front results in a smaller footprint in front of the front axle compared to a traditional front end. Nevertheless, the number of passenger seats remains the same, and a curved front provides better protection in a collision and a more favourable impact angle against an oncoming vehicle. The impact angle between a lighter vehicle and a traditional bus front end (red and yellow lines) and a curved front end (green line) is shown in Figure 33.

The NSIA therefore submits a safety recommendation to the Norwegian Public Roads Administration to continue international efforts to develop a regulation that incorporates both of these characteristics into the front structure of buses.

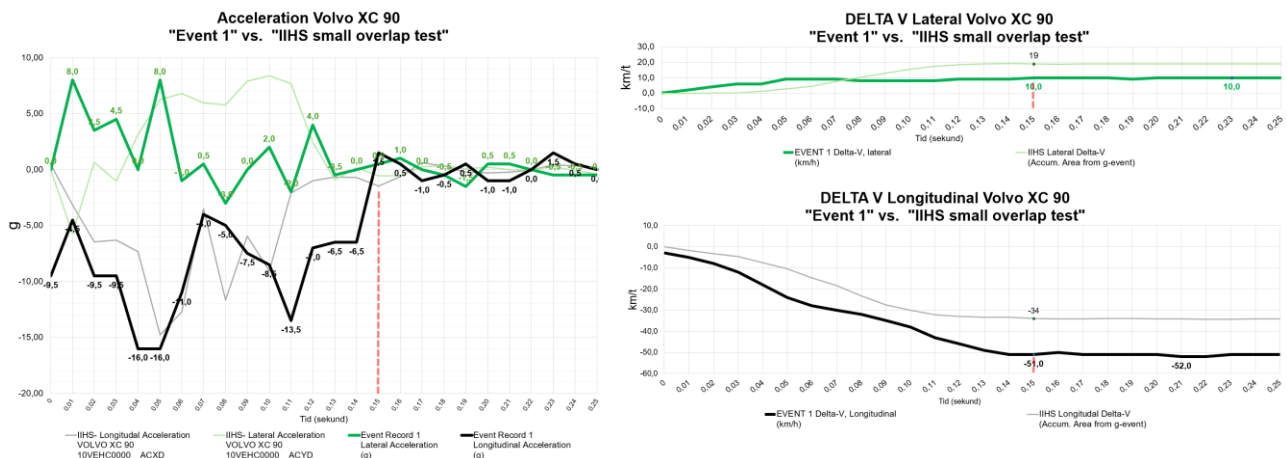
Figure 37: Longitudinal and transverse acceleration and Delta-V. Comparison of accident data from Figgjo accident compared to small overlap crash test on a Volvo XC 90. Source: IIHS, NSIA

The acceleration graphs from the car in both the accident and the test show that the impact in both cases is virtually complete after approximately 0.15 seconds.

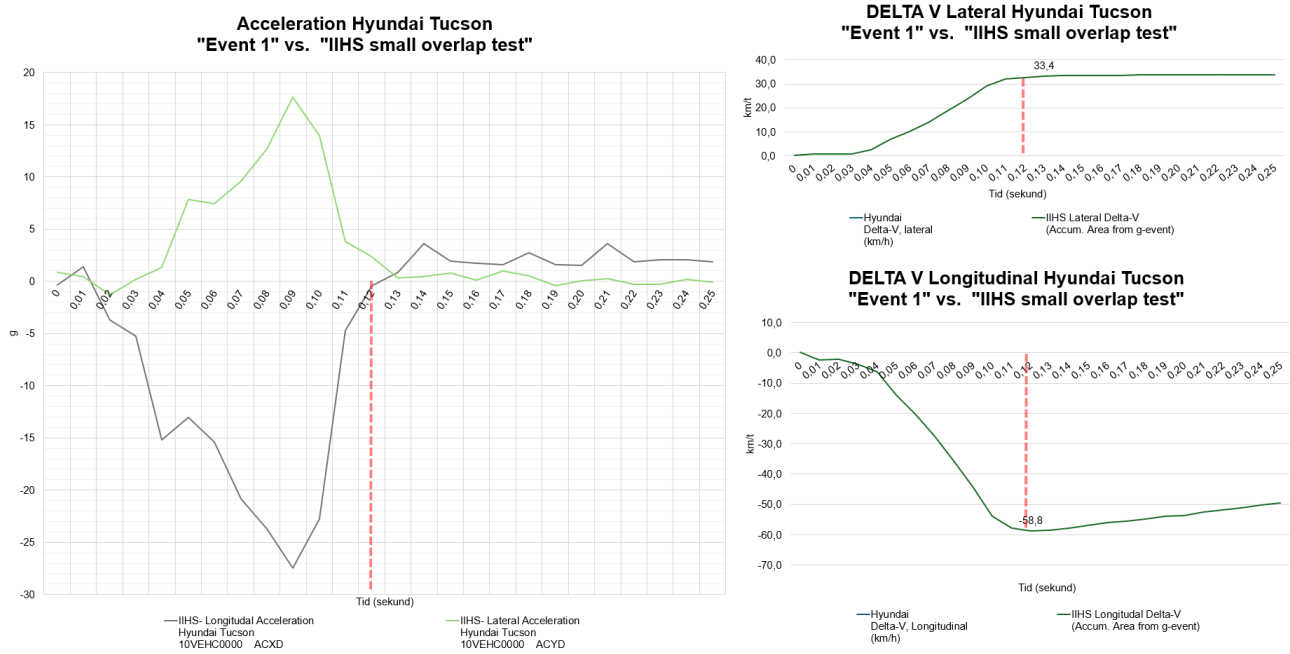
from the crash test, the car sustained a change in velocity, Delta-V, of -59 km/h from an initial speed of 64 km/h, and a transverse velocity change of 33 km/h laterally.

Figure 38: Longitudinal and transverse acceleration and Delta-V. Small overlap crash test on a Hyundai Tucson. Source: IIHS, NSIA
