REPORT

SL 2009/02

REPORT ON THE SERIOUS INCIDENT OVER
GLACIER FOLGEFONNA, NORWAY ON
14. SEPTEMBER 2005 WITH ATR 42-320, LN-FAO,
OPERATED BY COAST AIR AS

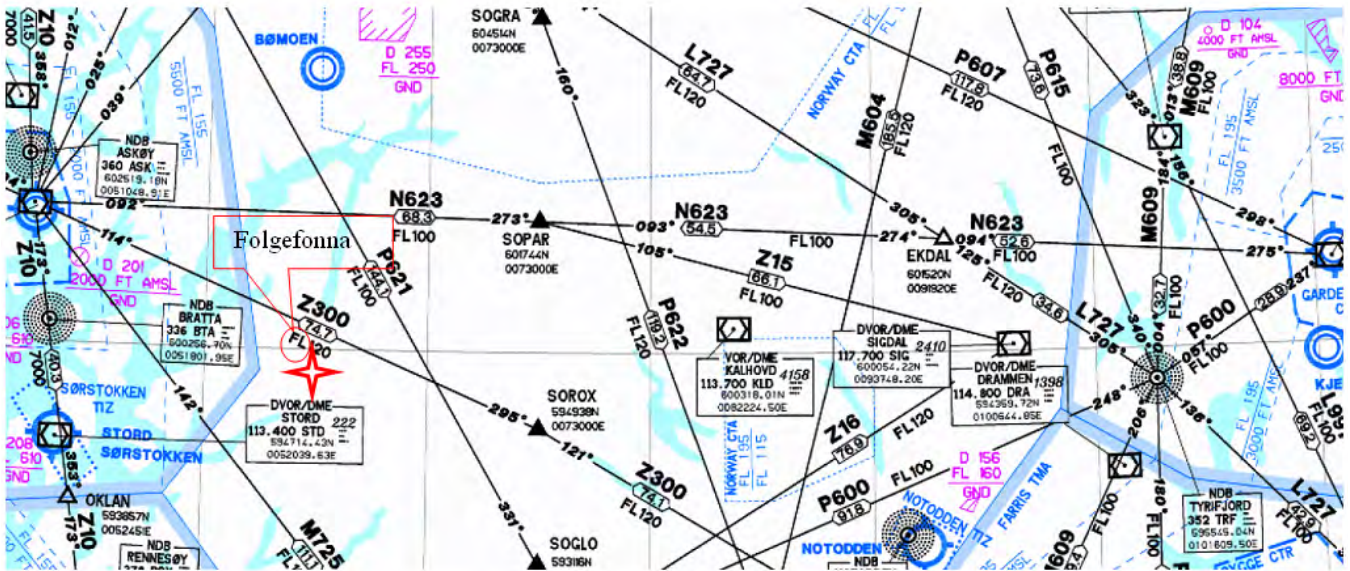
- 1.1.16 Normally, radar recordings from Avinor (RaADS) are stored for a minimum of 30 days, and they were not recorded over when the AIBN requested them. This meant it was possible to plot the altitude profile from take-off until the aircraft was established at its cruising altitude of FL150. The data show that control was first lost at 07:23:27. The aircraft was then at approx. FL144 directly southeast of the glacier Folgefonna, around 35 NM east of Stord (59°55'N 006°31'E). The minimum safe flying altitude (MSA) in the area was 7000 ft.

Figure 1: Map section Stord – Oslo (AIP Norway ENR 6.2-1) indicating positions of Folgefonna (red circle) and the incident (red star).

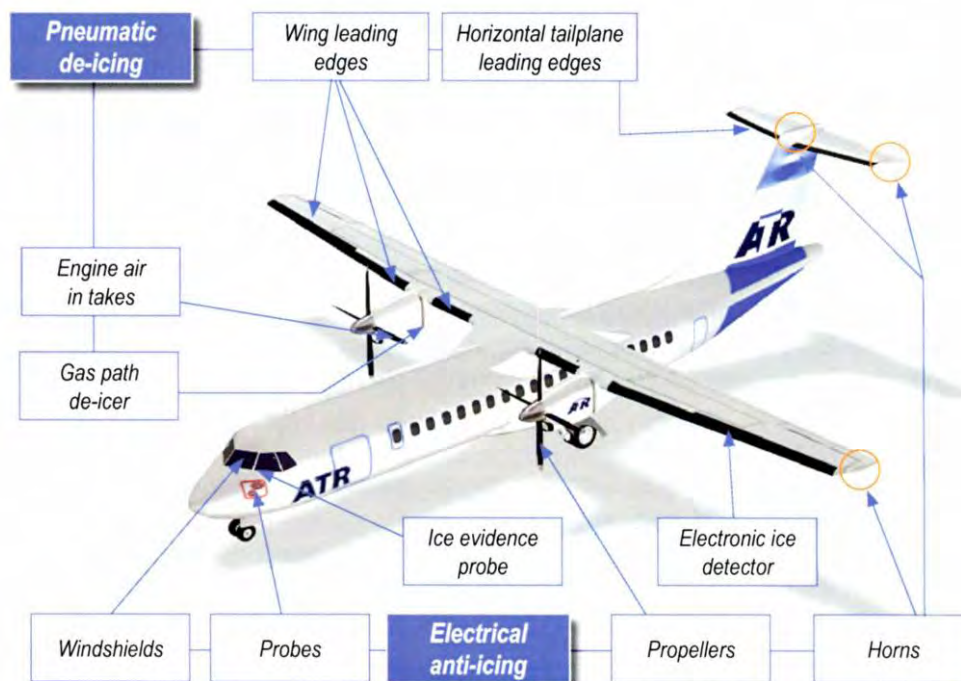
Figure 4: Example of standard system for protection against icing on ATR (The figure shows ATR 72-212A).

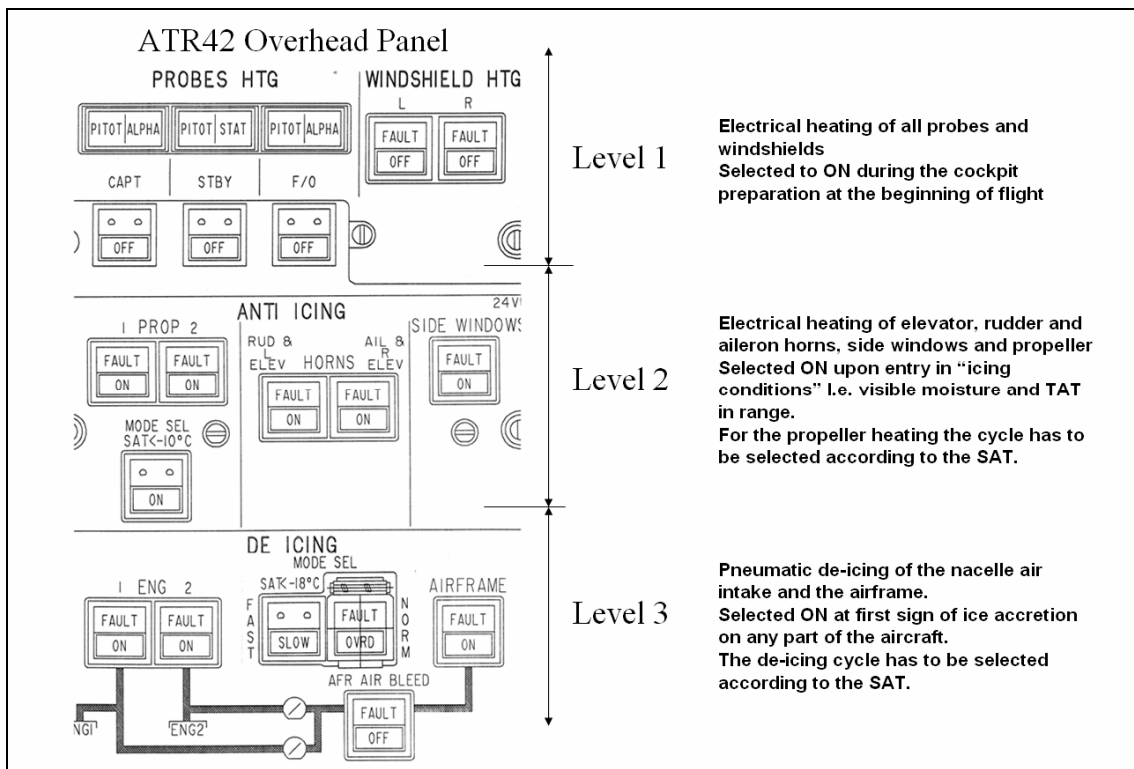
1.6.2.3 The selector panel for the systems and a simple description of the systems' various levels and their use is contained in Figure 5.

Figure 5: Description of anti- and de-icing systems levels 1, 2 and 3.

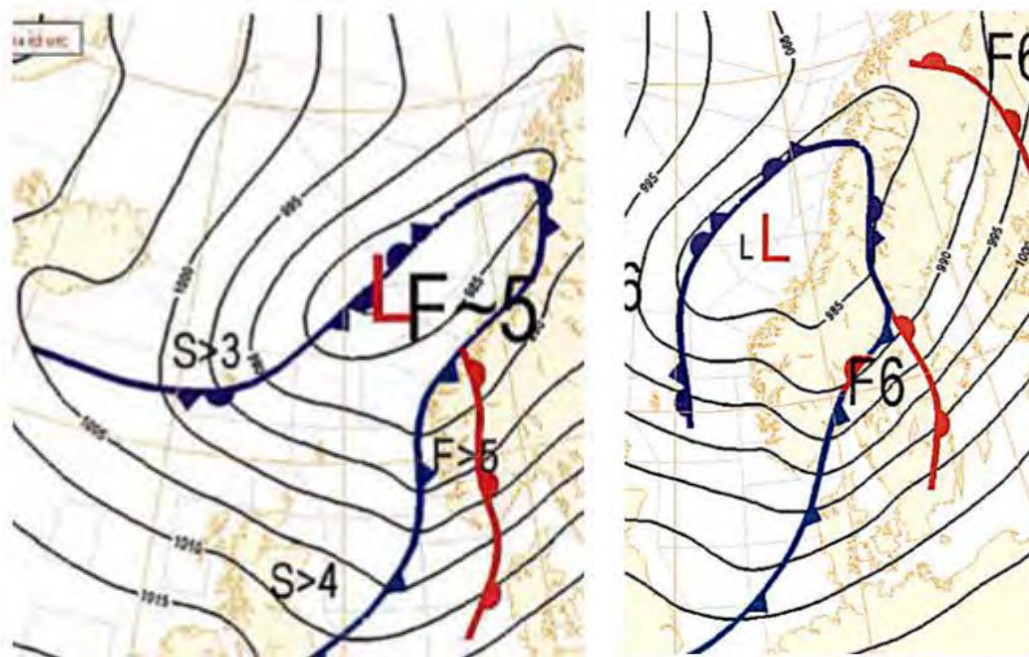
“There was also some orographic precipitation with the westerly wind. The westerly wind lifted the moist mass of air, which again produced an increased concentration of supercooled water droplets. The temperature at 14,000 ft was most probably between -5 and -15 degrees C. Icing is often observed at these temperatures.”

Analysis 14 Sept, 0300 UTC

Analysis 14 Sept, 0600 UTC

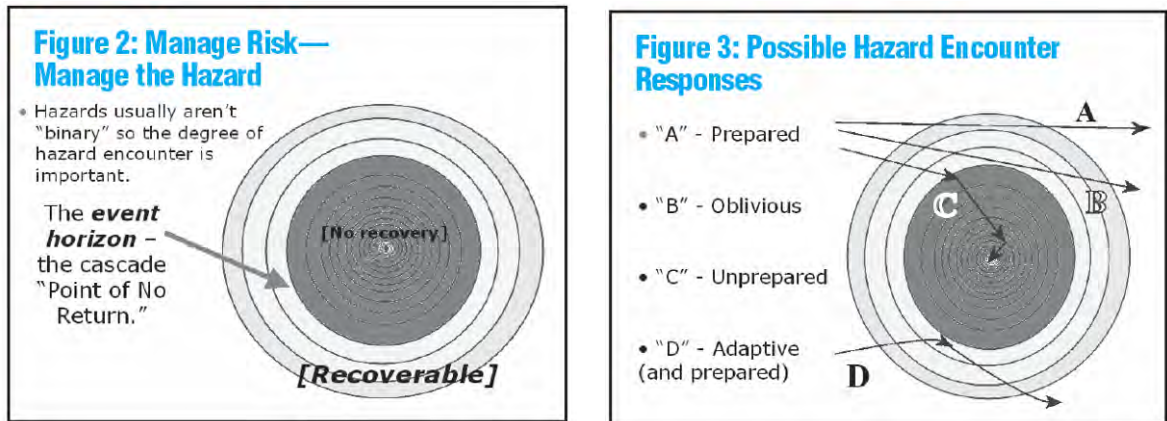
Figure 9: Hazard illustrated as astrophysical black hole. "A" - Prepared, "B" - Oblivious, "C" - Unprepared, "D" - Adaptive (and prepared). (Source: April–June 2007 ISASI Forum – "Accidents & Astrophysics" by Rick Clarke).

2.1.4 The idea behind this model is that a hazard can be compared to what is called a black hole in astrophysics. The hazard zone around the hole is illustrated as a funnel with its attractive force increasing as the centre is approached. If the subject goes too far down into the funnel, there is a risk of being caught up in the black hole. In case A, passage is inside the hazard area but high enough up in the funnel/at such a great distance, that there is no risk of being caught. This may be due both to planning and coincidence. In case B, passage is further down in the funnel, right on the limit of where it is possible to turn around (the event horizon, Point of No Return). Anyone involved who follows this track will probably not be aware that the hazard exists, or will be ignorant of the actual scale of the risk. In case C, a course is steered, unprepared, right down into the funnel and "disappears into the black hole" with a fatal outcome. In case D, the aircraft is about to do the same thing, but makes it through. This may be due to luck, but also to the fact that the crew had undergone some training and had implemented the correct countermeasures at the correct moment, and that the aircraft had the excess performance required. (Clarke, R. "Accidents & Astrophysics" [April–June 2007 ISASI Forum](#) Page 14).

- 2.3.1.1 Good planning allows a reassuring distance to be kept from the “black hole”, see path A in the model in Figure 9. The weather forecasts available to the crew before take-off indicated that there was a moderate risk of icing locally. Both TAF, METAR and the weather map indicated a cold front passing through during the hours of the morning. The front was stretched out north-south along the coast. In addition, an Ice Message was issued and with record precipitation during the previous 24-hour period and a strong westerly wind, there was reason to anticipate icing where the moist air rises up towards the mountains. On the windward sides of mountains, stationary icing zones can be quite extensive. The hazards have different significance for different operations and aircraft types. For turboprop aircraft this can be a factor to be taken into consideration.

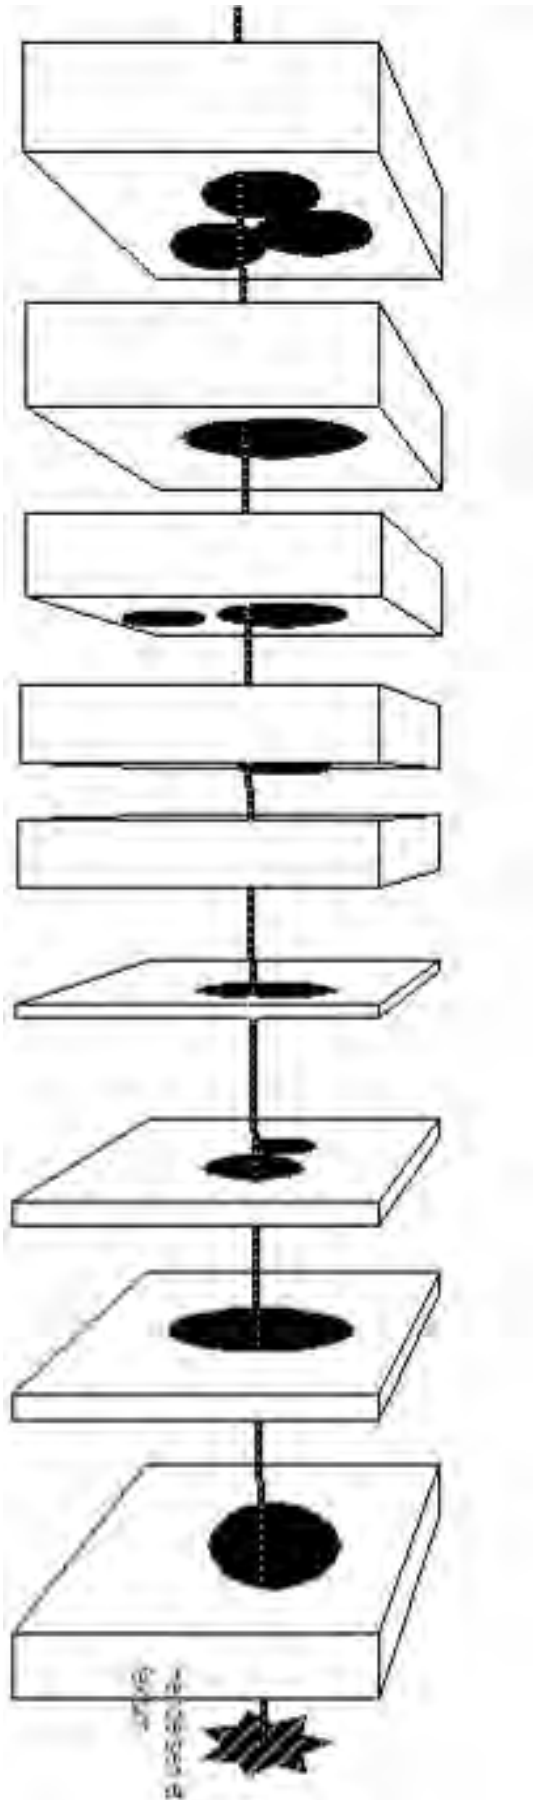
Did not interpret
airframe ice as
severe icing
symptoms

Non-optimal recovery
technique when loss of
control occurred

Recommendations & Accomplishments
