SL REP.: 25/2005

**REPORT ON THE ACCIDENT
AT BROKSKAR, TROMS COUNTY, NORWAY 17 MAY 1999,
INVOLVING EUROCOPTER (AEROSPATIALE)
SA 365N DAUPHIN 2, LN-OLT
OPERATED BY LUFTRANSPORT AS**

**SUBMITTED
May 2005**

**ACCIDENT INVESTIGATION BOARD, NORWAY (AIBN)
P.O. Box 213
N-2001 LILLESTRØM
NORWAY**

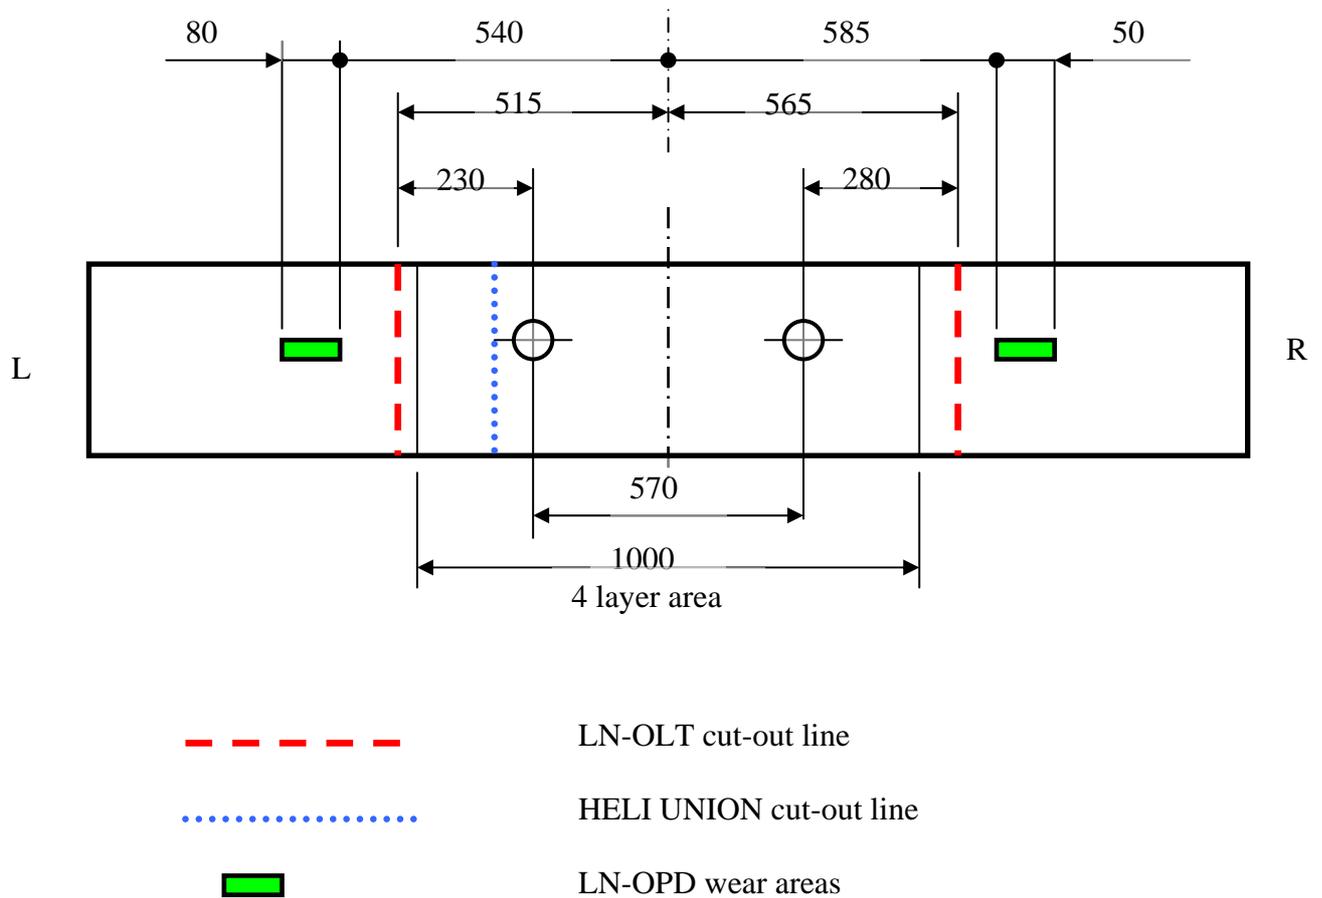
**Figure 1: HORIZONTAL STABILIZER SCHEMA
TOP VIEW – NO SCALE**

- 1.6.2.1.4 The stabiliser is made up of a main spar and an auxiliary spar, which, with the skin plates, make up a torsion box to absorb the aerodynamic bending, tension and torsion loading. The skin consists of 4 layers of carbon fibre fabric from the attachment area close to the tail boom. Approx. 30 cm out from the tail boom the 4-layer area ends and continues as 3 layers of carbon fibre fabric. (Ref. Figure 1, page 19).

The aforementioned wear on the skin plate was also found in the examination of STAB 2 (LN-OPD), on both the left and right sides. This wear eventually caused the skin plate to become perforated. (§ 1.16.6).

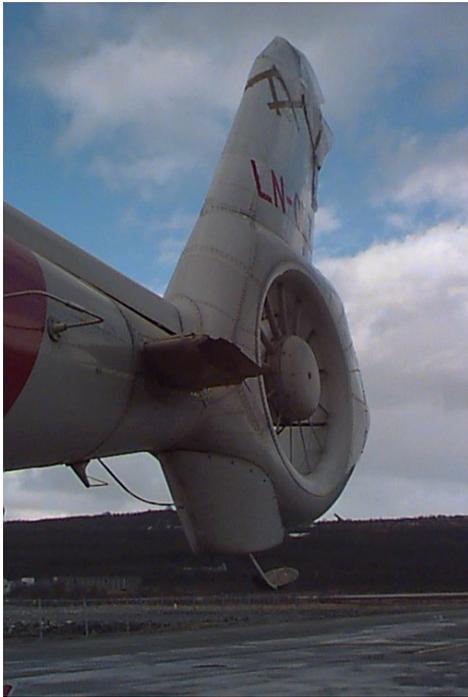
Image 1. Left Stabilizer

- A break on the RH stabiliser approx. 30 cm beyond of the right-hand mounting bolt (Image 2).
- A break on the LH stabiliser approx. 25 cm beyond the left-hand mounting bolt (Image 1).
- The upper part of the skin on the LH stabiliser between the crack and the vertical fin remained attached to the helicopter during landing.

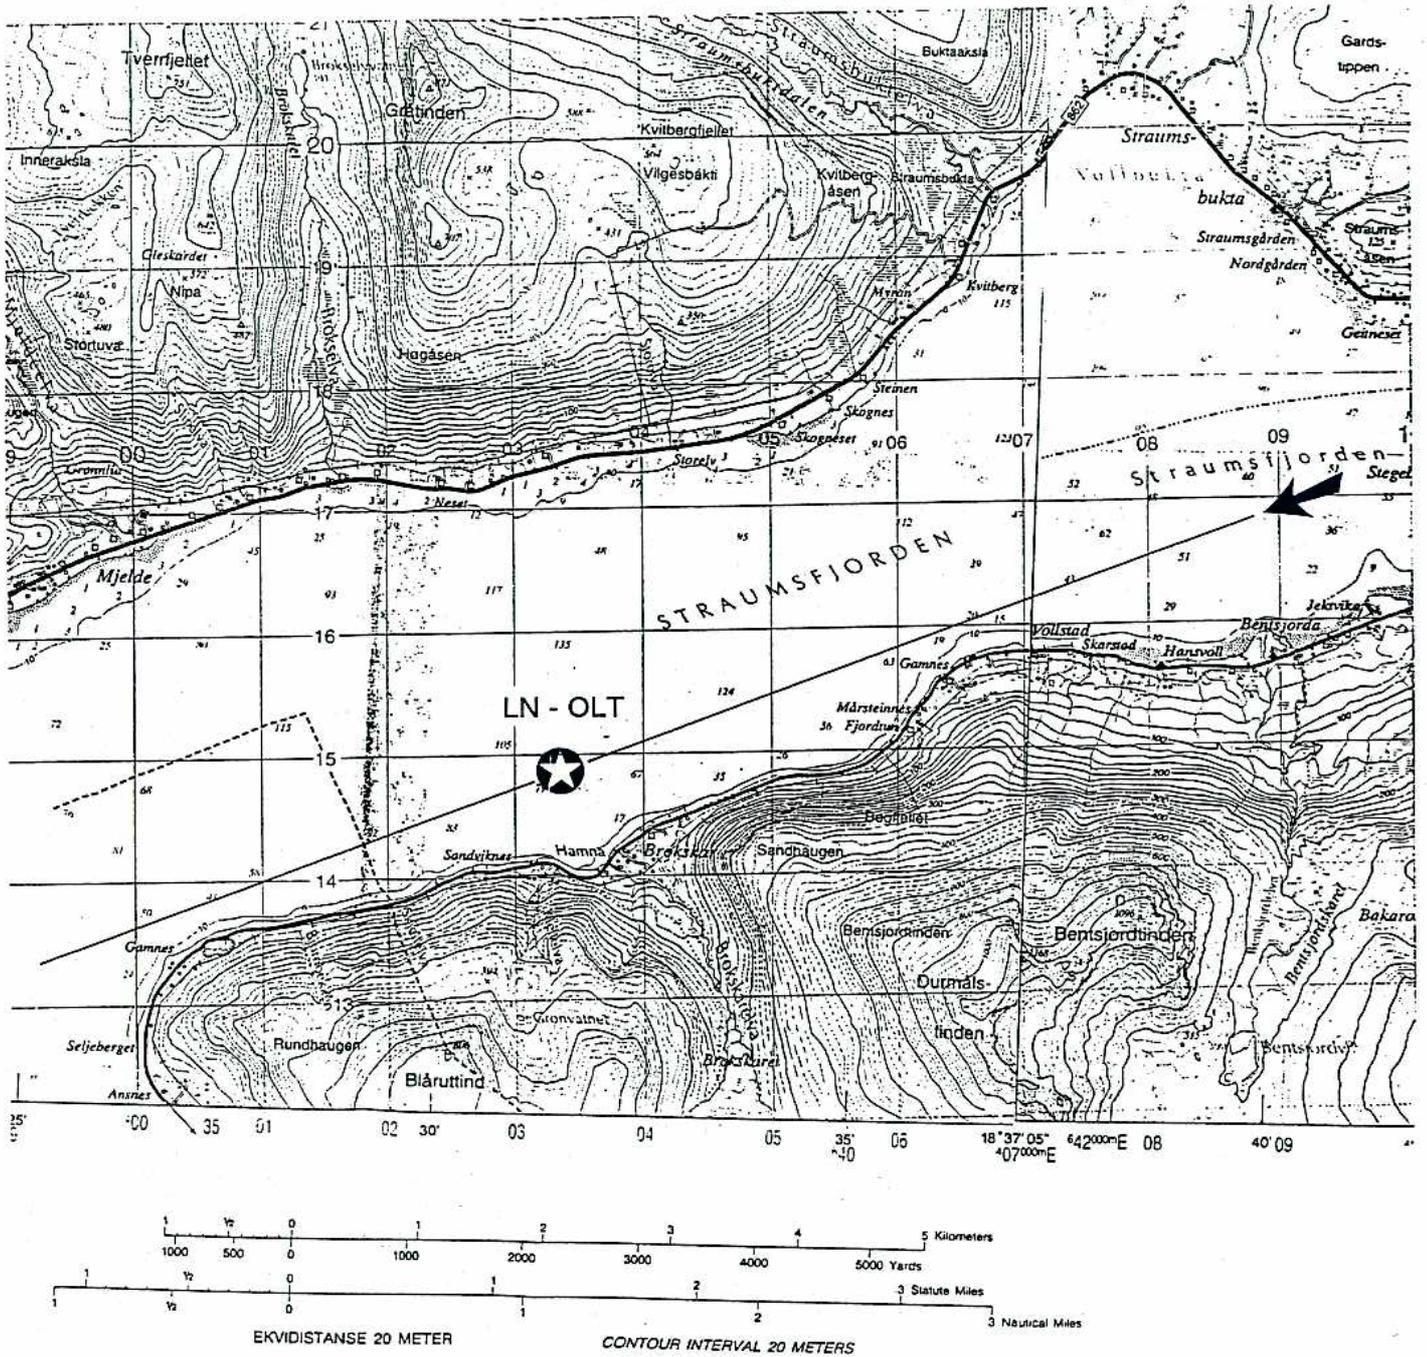
FIGURE 1 - Straumfjorden area in Northern Norway (Troms county)

On May 17, 1999 a helicopter of type Aerospatiale SA 365 Dolphin 2, registration code LN-OLT, was flying over Straumfjorden (south of Tromsø, Norway) in a westward direction, see figure 1. The flight altitude was 800 ft (=244 m) and the speed was 150 knots (=77 m/s). The wind was heavy (40-50 knots) and came from the south.

Figure 1 shows the assumed flight path of the helicopter with indicated location for the sudden pitch down occurrence. This spot lies at the mouth of the river Brokskarselva which again forms a canyon between the two mountain peaks Bentsjordtinden (1168 m)

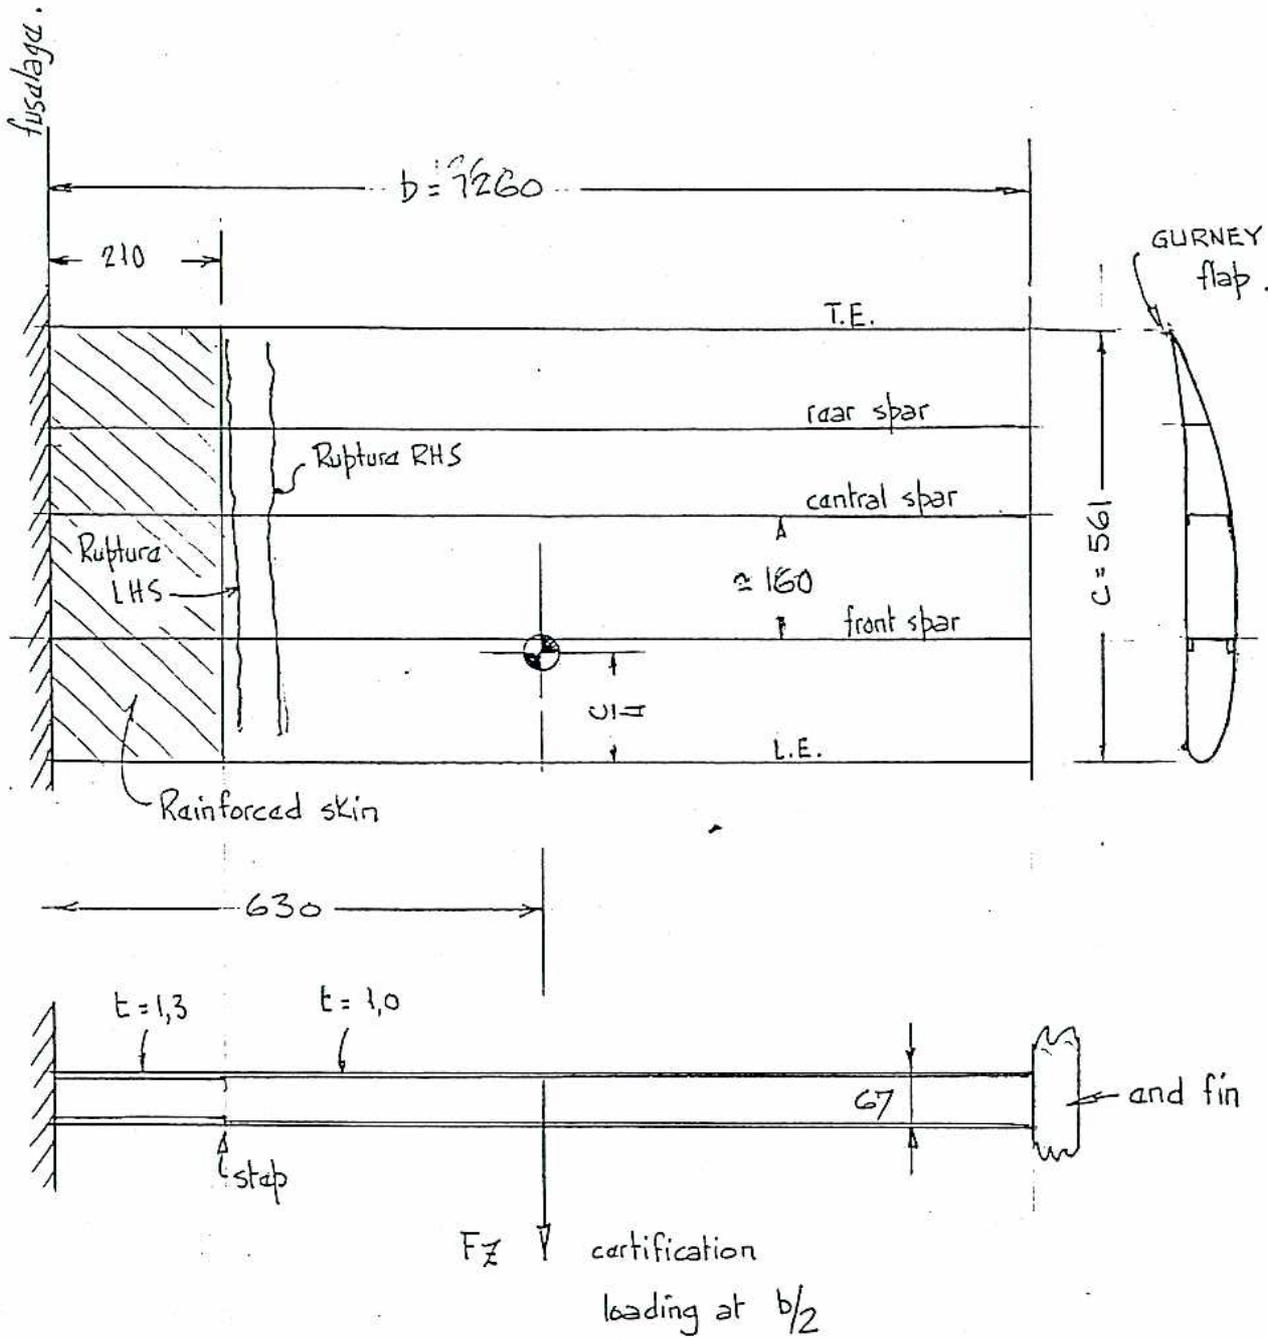
LN. OLT ~ Approximate stabiliser geometry

1.3 Ultimate bending moments at the stabilizer root are based on the 1-2 gust case, $M_{ULT} = 1.5 \times 312.2 \times 0.63 = 295 \text{ mdaN}$, assuming uniform spanwise loading (see fig. 1 for approximate stabilizer geometry).
